# UgIFT Asset Verification Report

*Field findings, service gaps and recommended actions*

Ministry of Finance, Planning and Economic Development

27 September 2026

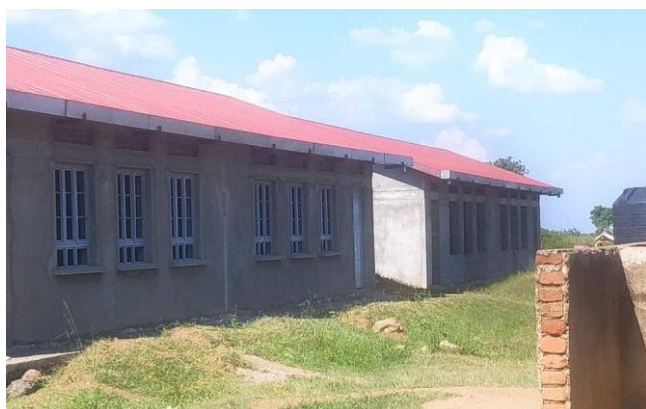
**Figure 2: Unfinished school block at Got Apwoyo Seed Secondary School, Nwoya District (Acholi)**

At Got Apwoyo, Ndhew and Mamba seed schools, unfinished buildings delayed the use or installation of equipment. At Rupa Seed School, the library and computer laboratory block had been put to another use. Completion plans should bring buildings, electricity, furniture, equipment and staffing together so that handover leads to an operating service.

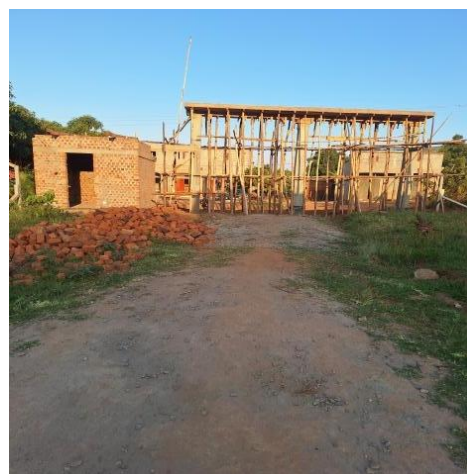
**Figure 3: Building works at a seed secondary school, Kiboga District (Buganda)**

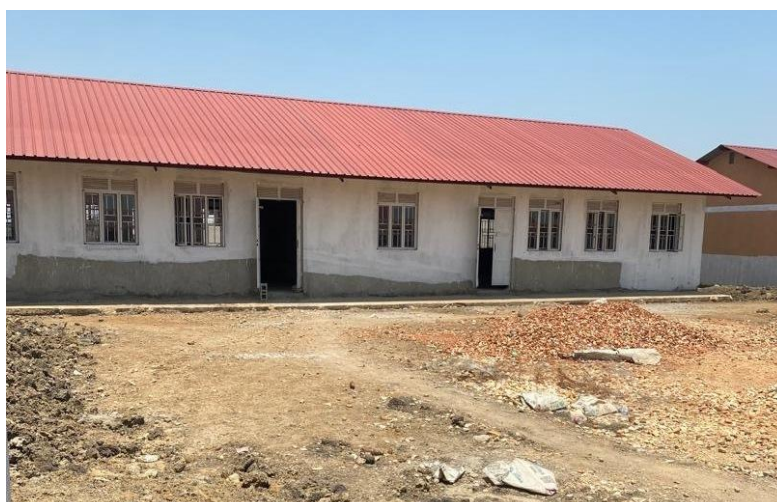
**Figure 4: School block awaiting completion at Butungama Seed Secondary School, Ntoroko District (Tooro)**

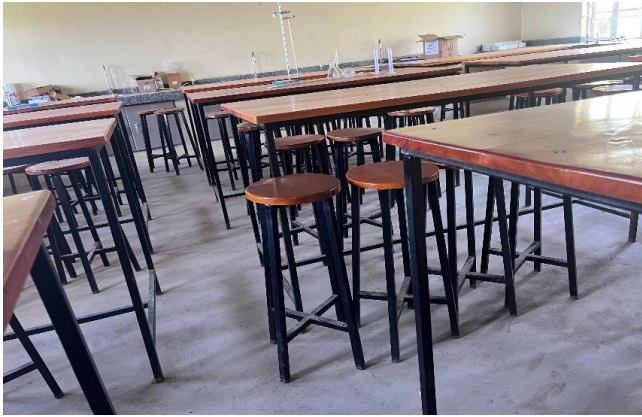
**Figure 5: Science laboratory tables and stools at a seed secondary school, Kalangala District (Buganda)**

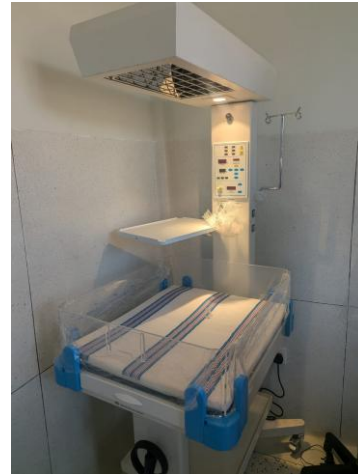
**Figure 6: Infant radiant warmer at a health centre, Makindye-Ssabagabo Municipal Council (Buganda)**

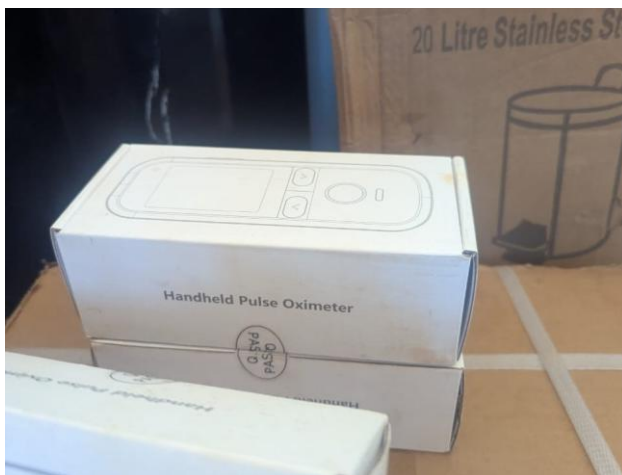
**Figure 7: Boxed pulse oximeters at a health centre, Makindye-Ssabagabo Municipal Council (Buganda)**

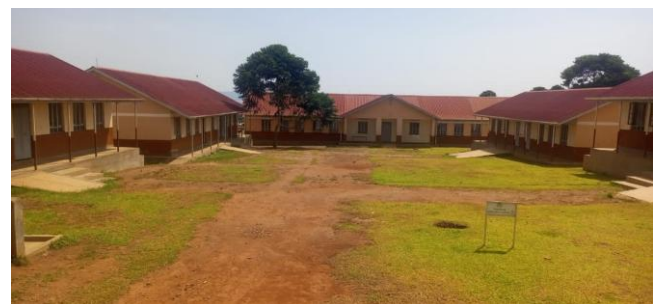
**Figure 8: School buildings and courtyard at a seed secondary school, Buvuma District (Buganda)**

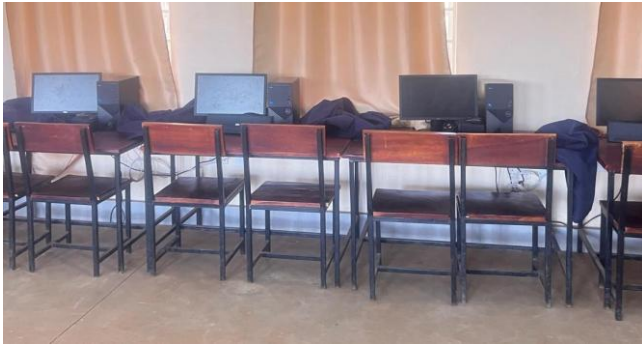
**Figure 9: Desktop computers and classroom furniture at a seed secondary school, Busia District (Bukedi)**

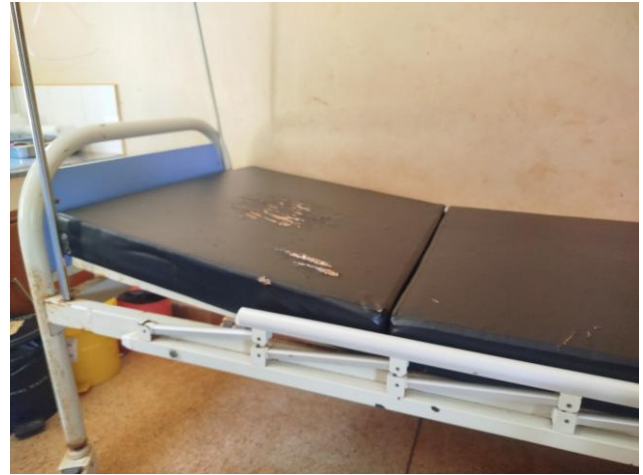
**Figure 10: Delivery bed with a torn mattress cover at a health centre, Busia District (Bukedi)**

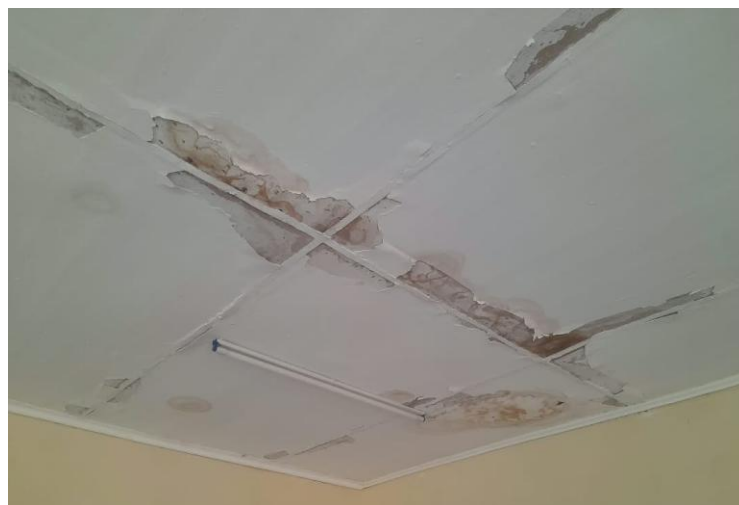
**Figure 12: Stained and peeling ceiling at a health centre, Sironko District (Bugisu)**

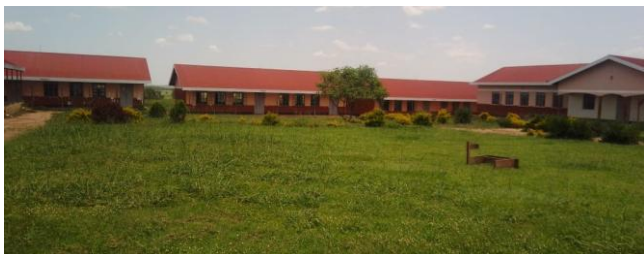
**Figure 13: Buildings at a seed secondary school, Nwoya District (Acholi)**

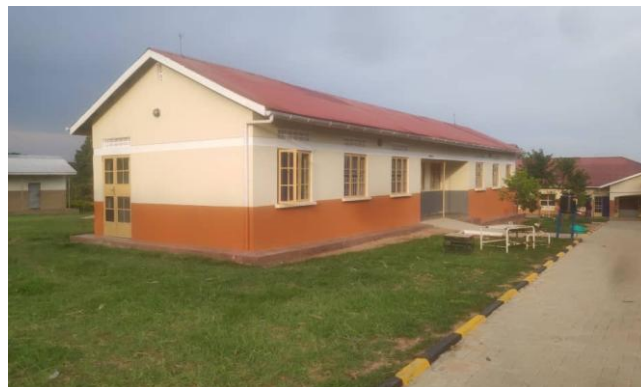
**Figure 14: Health centre building, Nwoya District (Acholi)**

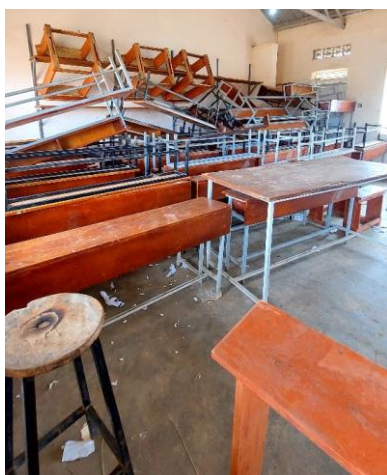
**Figure 15: Stacked desks, chairs and stools at a seed secondary school, Napak District (Karamoja)**

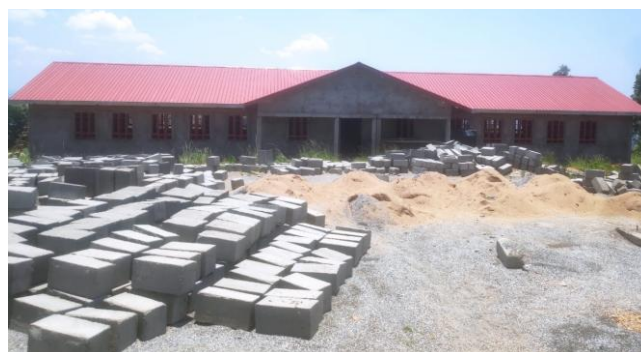
**Figure 16: Building works and construction materials at Ndhew Seed Secondary School, Nebbi District (West Nile)**

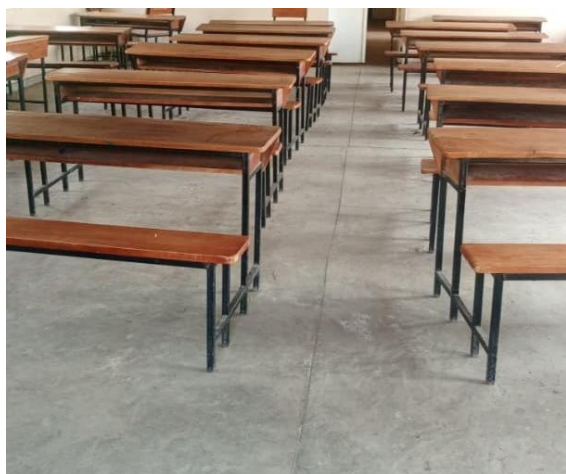
**Figure 17: Classroom desks at a seed secondary school, Ntoroko District (Tooro)**

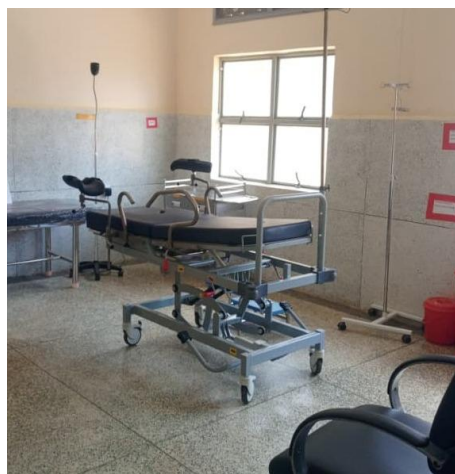
**Figure 18: Delivery bed and clinical furniture at a health centre, Kabarole District (Tooro)**

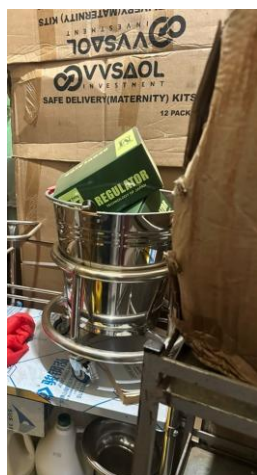
**Figure 19: Clinical equipment packed among cartons at a health centre, Hoima City (Bunyoro)**

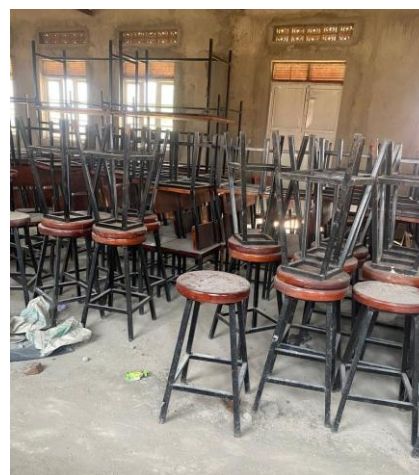
**Figure 20: Laboratory stools and other school furniture in storage, Ntoroko District (Tooro)**

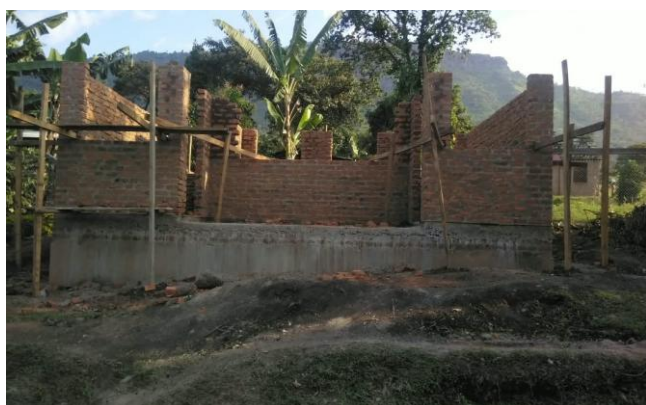
**Figure 21: Unfinished laboratory building at a health centre, Sironko District (Bugisu)**

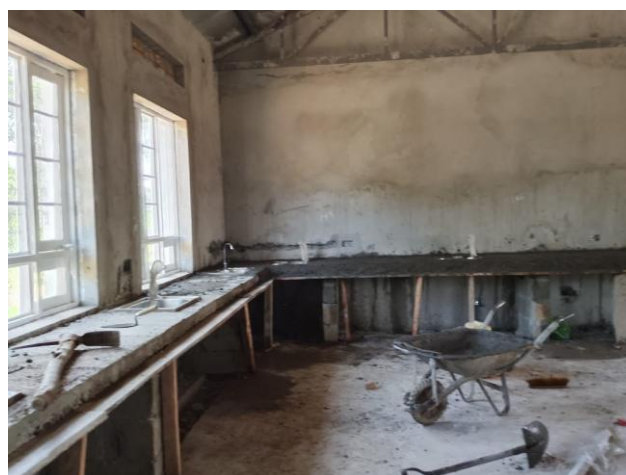
**Figure 22: Biology laboratory under construction at a seed secondary school, Buliisa District (Bunyoro)**

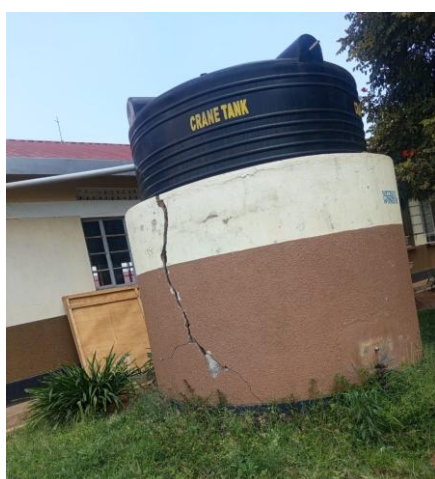
**Figure 23: Water tank on a cracked base at a seed secondary school, Kibuku District (Bukedi)**

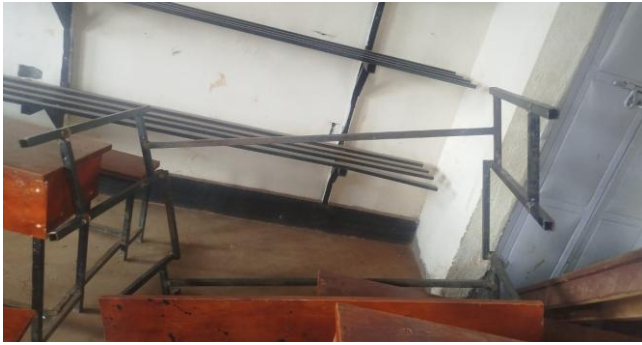
**Figure 25: Broken desk frame at a seed secondary school, Namisindwa District (Bugisu)**

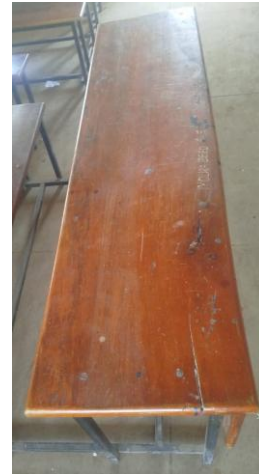
**Figure 26: Cracked desk surface bearing a school marking, Tororo District (Bukedi)**

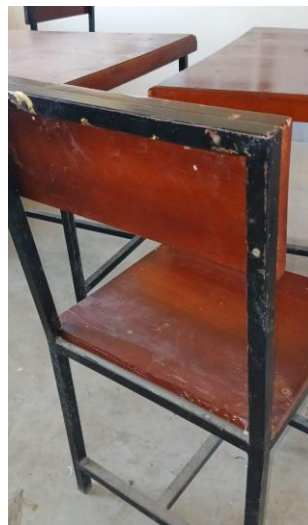
**Figure 27: Damaged chair back joint at a seed secondary school, Budaka District (Bukedi)**

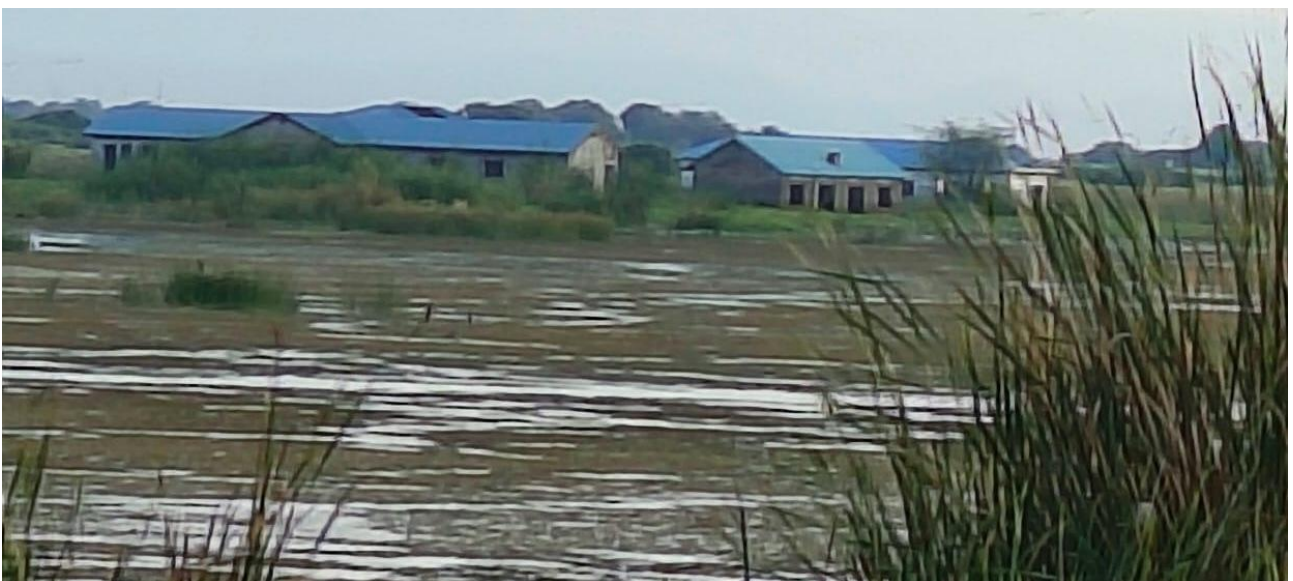
**Figure 28: Flood-affected older health facility at Butiaba, Buliisa District (Bunyoro)**

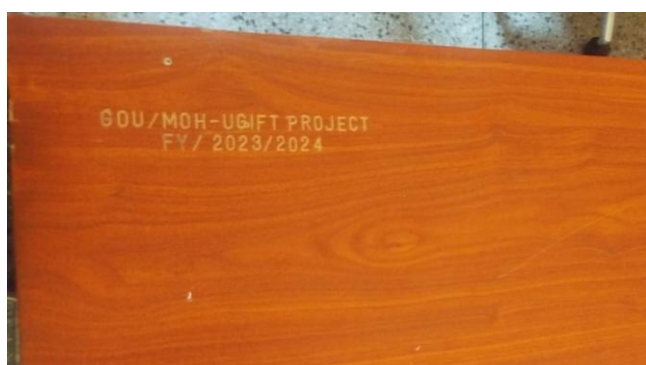
**Figure 30: UgiFT identification on a desk at a seed school, Tororo District (Bukedi)**

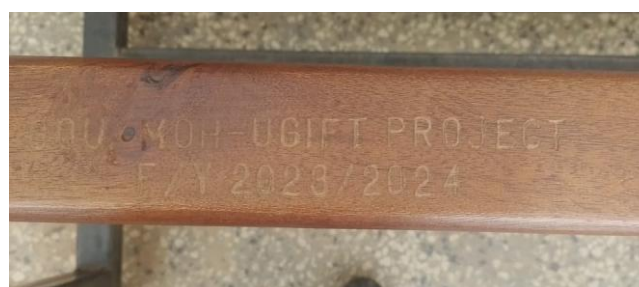
**Figure 31: UgiFT engraving on a health centre bench, Bududa District (Bugisu)**

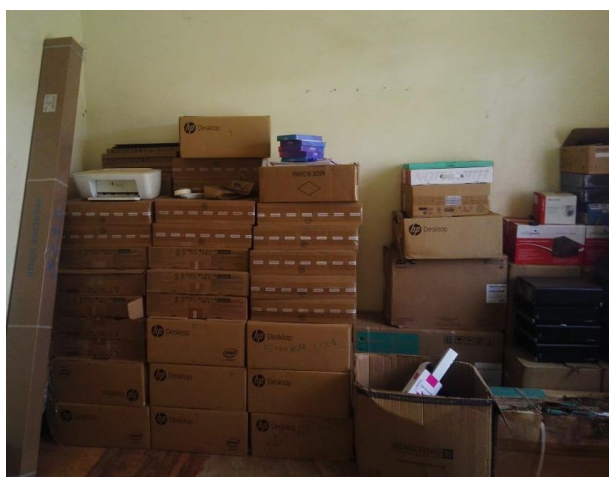
Stored equipment needs a plan for use. Lungulu needed power, Got Apwoyo needed completed buildings, and Avogera needed repair support for items it could not restore locally. Kalemungole had unopened and wrapped equipment requiring a check of readiness for installation and use.

**Figure 32: Boxed computers and related equipment in a seed school store, Nwoya District (Acholi)**

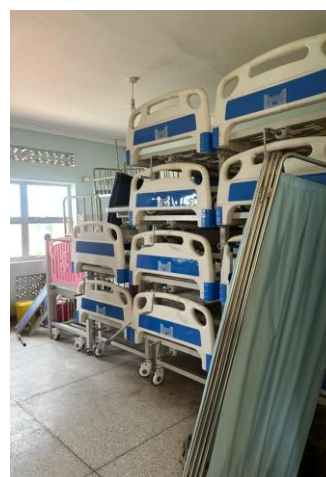
**Figure 33: Hospital beds and screens stacked in storage at a health centre, Kagadi District (Bunyor)**

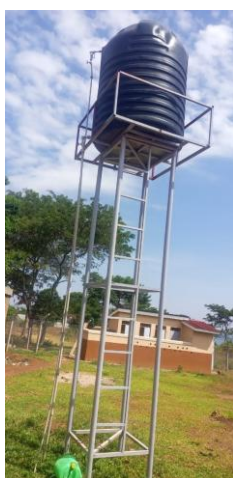
**Figure 34: Raised water storage tank at a seed secondary school, Buvuma District (Buganda)**

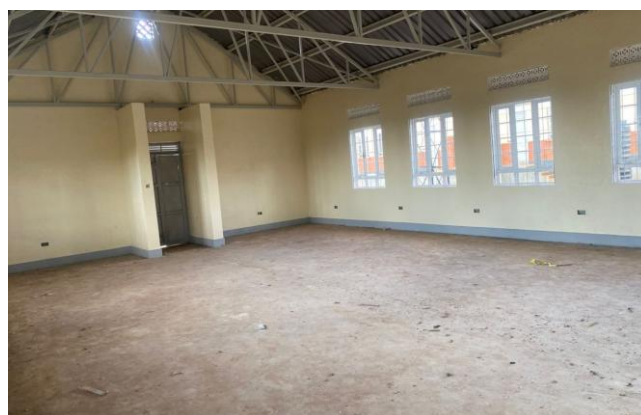
**Figure 35: Empty computer laboratory at a seed secondary school, Kween District (Sebei)**
