**CONSULTANCY SERVICES TO VERIFY AND RECORD ASSETS  
UNDER THE UGIFT PROGRAMME**

**REF: MOFPED/UGIFT/CONS/25/26/00015**

**ASSET VERIFICATION REPORT**

**September 2026**

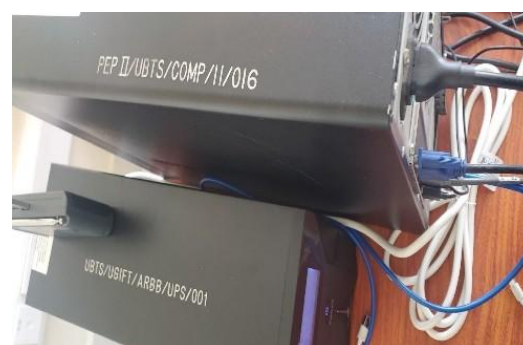
Figure 63: Markings PEP II/UBTS/COMP/11/016 and UBTS/UGIFT/ARBB/UPS/001 on uninterruptible power supplies at Arua Regional Blood Bank, Arua City (West Nile)

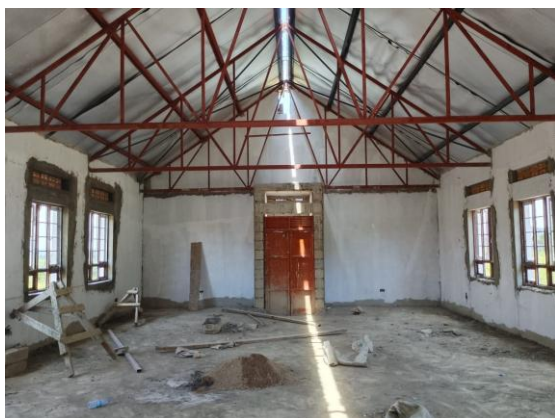
**Figure 84: Library interior under construction at Kihungya Seed Secondary School, Buliisa District (Bunyoro)**
