**CONSULTANCY SERVICES TO VERIFY AND RECORD ASSETS  
UNDER THE UGIFT PROGRAMME**

**REF: MOFPED/UGIFT/CONS/25/26/00015**

**ASSET VERIFICATION REPORT**

**September 2026**

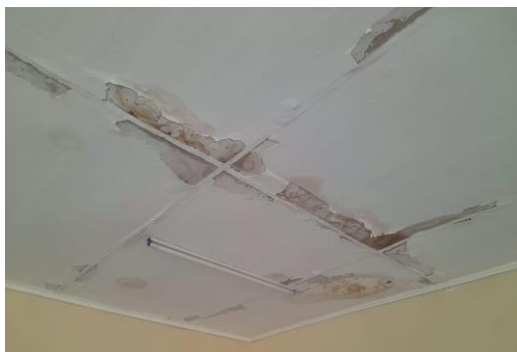
**Figure 11: Stained and peeling ceiling at a health centre, Sironko District (Bugisu)**

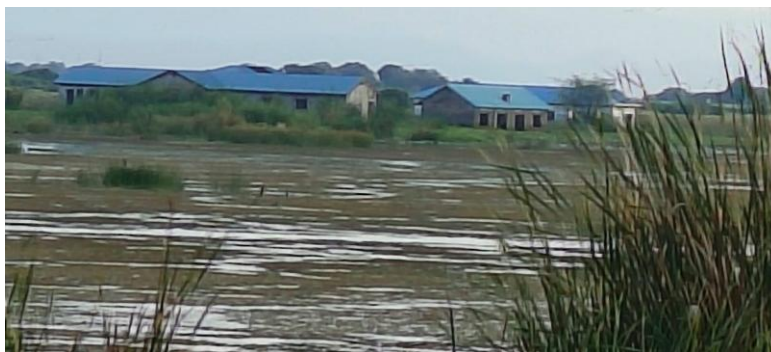
**Figure 12: Flood-affected older health facility at Butiaba, Buliisa District (Bunyoro)**

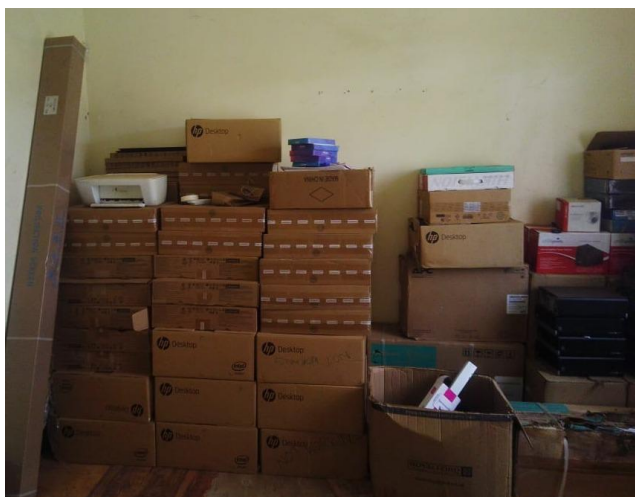
The field visits show how those numbers sit in a facility. At Lungulu Seed Secondary School in Nwoya District, desktop computers, a printer and UPS units were still boxed because the school was waiting for a power connection. At Nansanga Seed Secondary School in Budaka, 27 of 28 desktop computers remained packed for lack of reliable power. Broken desks and stools were in classrooms and stores at seed schools in Namisindwa and Napak. A delivery bed at a health centre in Busia District had a torn mattress cover. At Arua Regional Blood Bank, six blood pressure machines were damaged or not functional. The same pattern runs through the categories in the sections that follow: most assets work and are in use, a smaller group is in store and still sound, and a smaller group again is broken.

**Figure 13: Desktop computers, a printer and UPS units still boxed in the store at Lungulu Seed Secondary School, Nwoya District (Acholi), awaiting a power connection for installation**

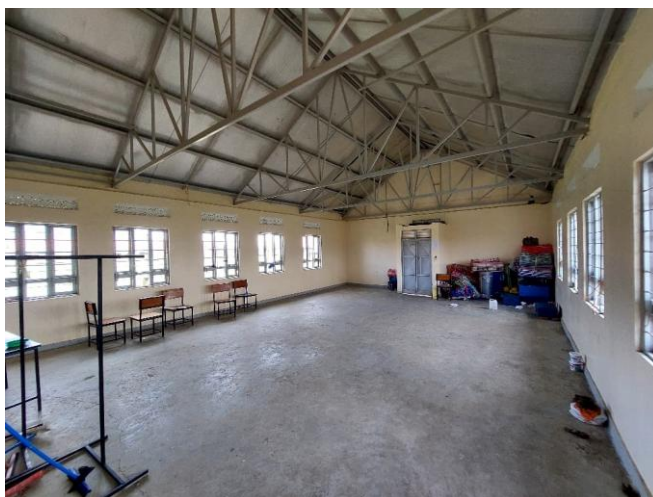
**Figure 14: Largely empty ICT and library block with a few chairs and items kept in one corner at Iriiri Seed Secondary School, Napak District (Karamoja), not yet in use while the school remained with the contractor**

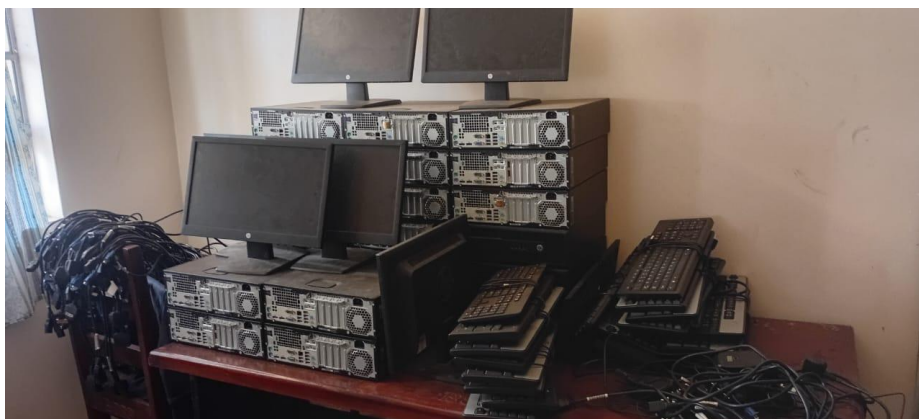
**Figure 15: HP computer sets stacked in store with cables still bundled and not installed at Bumufuni Seed Secondary School, Bulambuli District (Bugisu)**

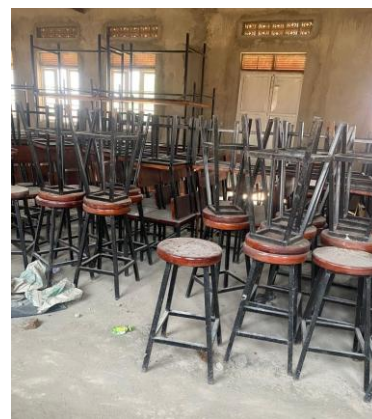
**Figure 16: Laboratory stools and desks stored and not yet in use at Butungama Seed Secondary School, Ntoroko District (Tooro), where the school buildings were still under construction**

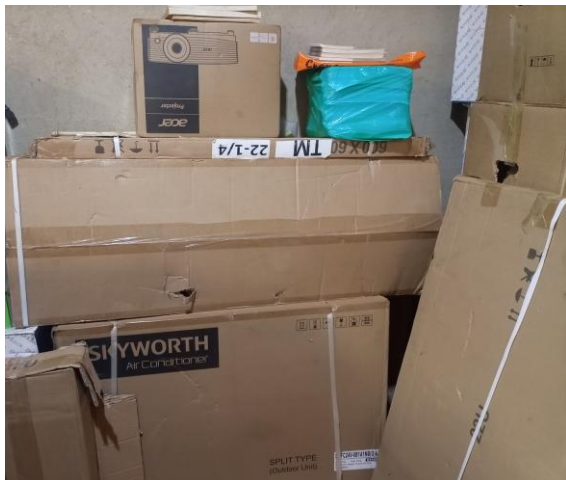
**Figure 17: Boxed projector, air conditioner and other equipment in store at King Solomon Seed Secondary School, Kagadi District (Bunyoro), kept boxed because the school was still under construction**

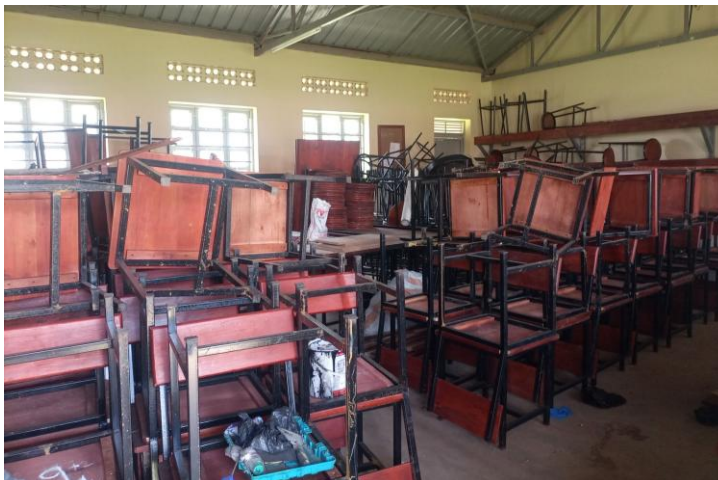
**Figure 18: Chairs, desks and laboratory stools stacked in a hall at King Solomon Seed Secondary School, Kagadi District (Bunyoro), where most assets remained in storage because the school was still under construction**

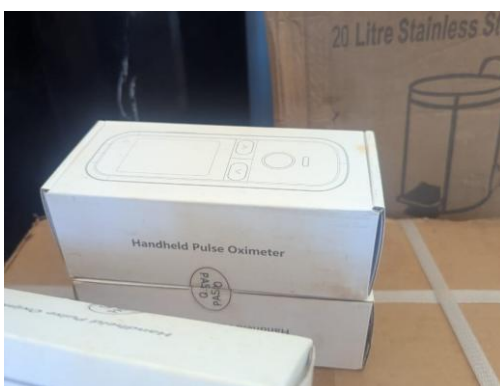
**Figure 20: Boxed handheld pulse oximeters at Kibiri Health Centre III, Makindye-Ssabagabo Municipal Council (Buganda), where equipment was still being arranged after the facility opened on 31 August 2026**

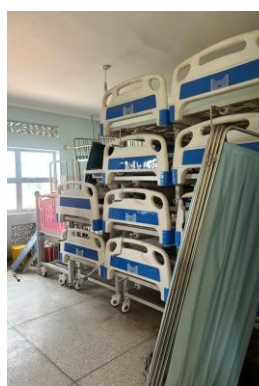
**Figure 21: Hospital beds and screens stacked in storage at a health centre, Kagadi District (Bunyoro)**

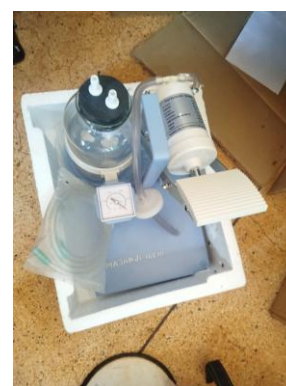
**Figure 22: Pedal suction unit marked MAJANJI H/C III still in its packing, recorded as not in use for lack of technical knowledge, Majanji Health Centre III, Busia District (Bukedi)**

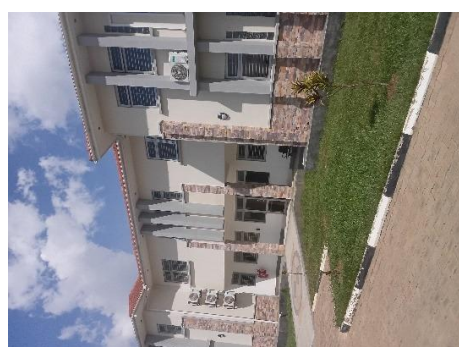
UgIFT financed the construction of the Arua and Hoima regional blood banks, which were completed and commissioned, and the rehabilitation of Soroti Regional Blood Bank. The photographs show the buildings, donor rooms and cold-chain equipment, and the engraving found on equipment at Arua and Hoima.

Figure 61: Completed blood bank building at Arua Regional Blood Bank, Arua City (West Nile)

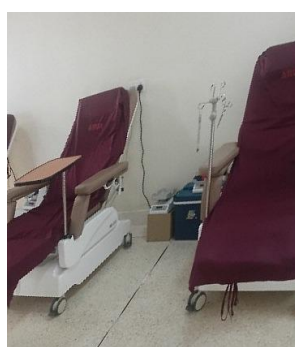
Figure 62: Donor couches in the donor room at Arua Regional Blood Bank, Arua City (West Nile)

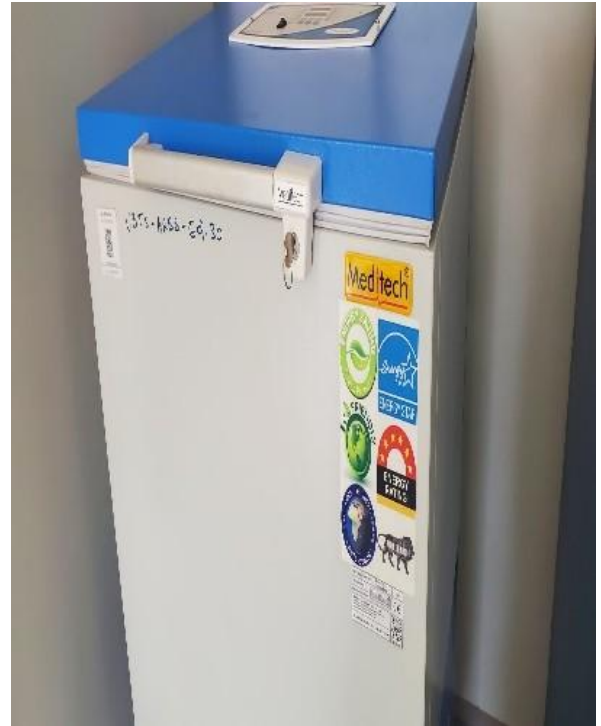
**Figure 66: Chest freezer at Arua Regional Blood Bank, Arua City (West Nile)**

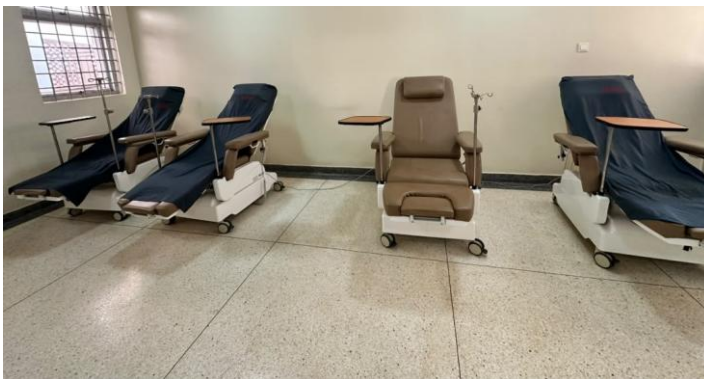
**Figure 67: Donor couches in the donor room at Hoima Regional Blood Bank, Hoima City (Bunyoro)**

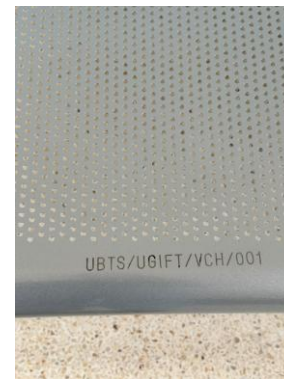
**Figure 68: Engraving reading UBTS/UGIFT/VCH/001 on equipment at Hoima Regional Blood Bank, Hoima City (Bunyoro)**

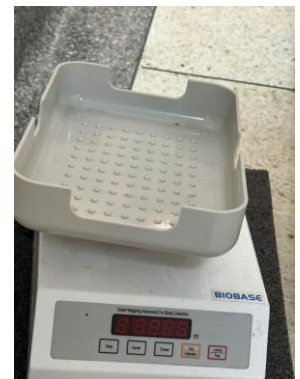
**Figure 69: Blood collection balance at Hoima Regional Blood Bank, Hoima City (Bunyoro)**

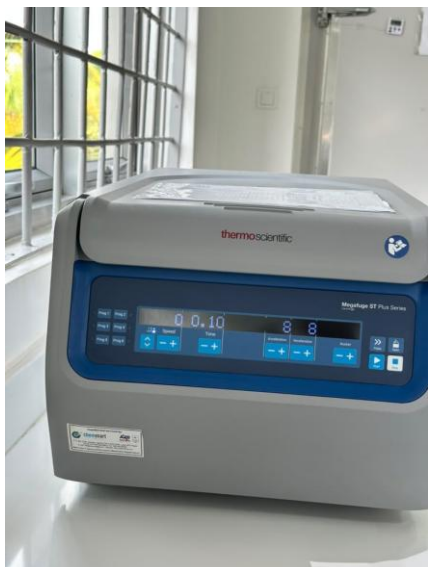
**Figure 70: Benchtop centrifuge at Hoima Regional Blood Bank, Hoima City (Bunyoro)**

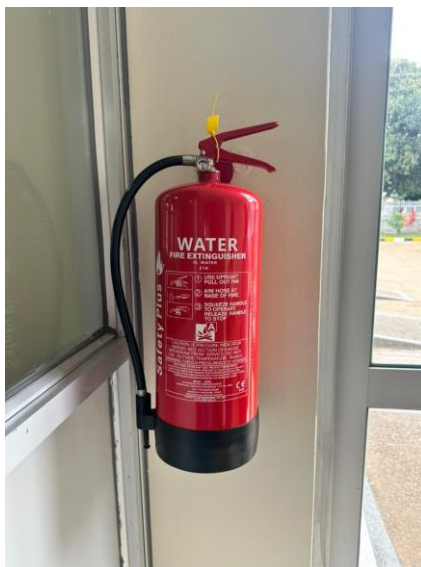
**Figure 71: Water fire extinguisher at Hoima Regional Blood Bank, Hoima City (Bunyoro)**

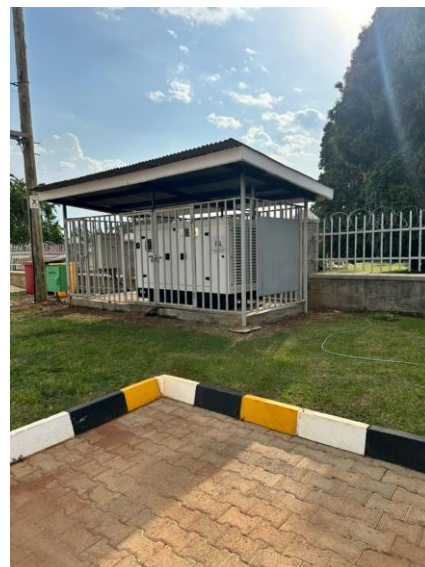
**Figure 72: Generator in an outdoor enclosure at Hoima Regional Blood Bank, Hoima City (Bunyoro)**
