**CONSULTANCY SERVICES TO VERIFY AND RECORD ASSETS  
UNDER THE UGIFT PROGRAMME**

**REF: MOFPED/UGIFT/CONS/25/26/00015**

**ASSET VERIFICATION REPORT**

**September 2026**

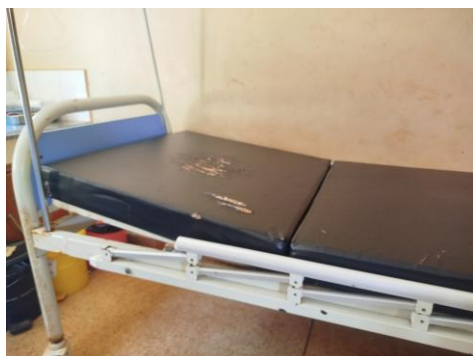
Figure 5: Delivery bed with a torn mattress cover at a health centre, Busia District (Bukedi)

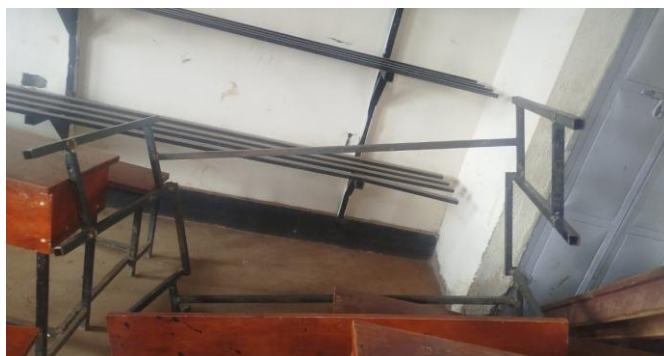
Figure 7: Broken desk frame at a seed secondary school, Namisindwa District (Bugisu)

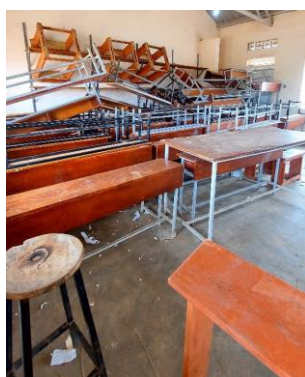
Figure 8: Stacked desks, chairs and stools, some recorded as broken and none engraved, at Napak Seed Secondary School, Napak District (Karamoja)

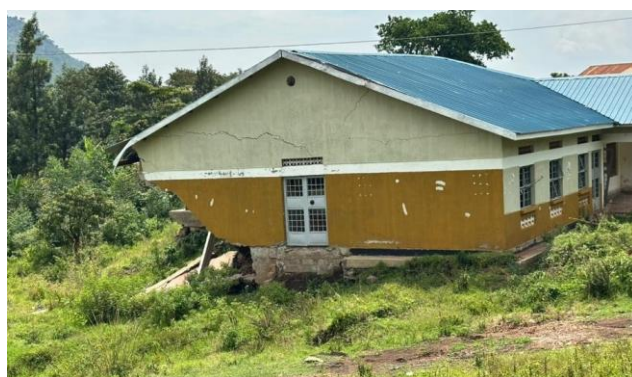
Figure 9: Cracked health centre block above collapsed ground, Bulambuli District (Bugisu)

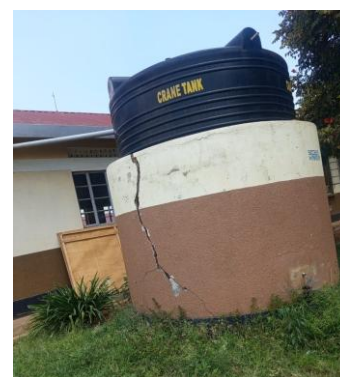
Figure 10: Water tank on a cracked base at a seed secondary school, Kibuku District (Bukedi)

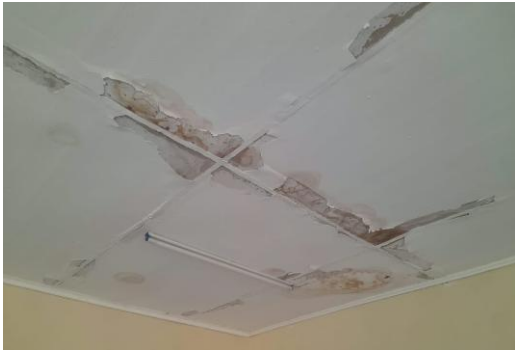
**Figure 11: Stained and peeling ceiling at a health centre, Sironko District (Bugisu)**

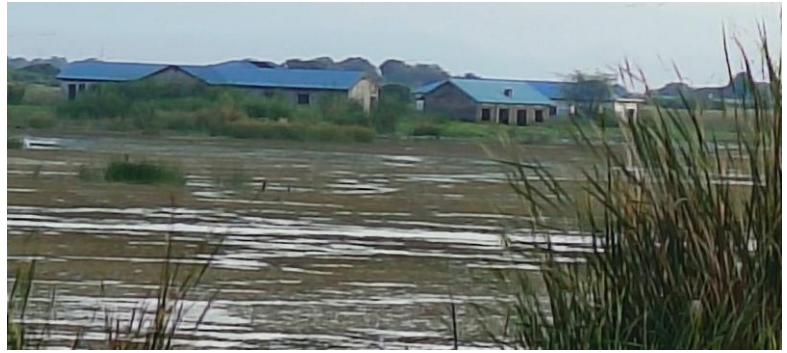
**Figure 12: Flood-affected older health facility at Butiaba, Buliisa District (Bunyoro)**

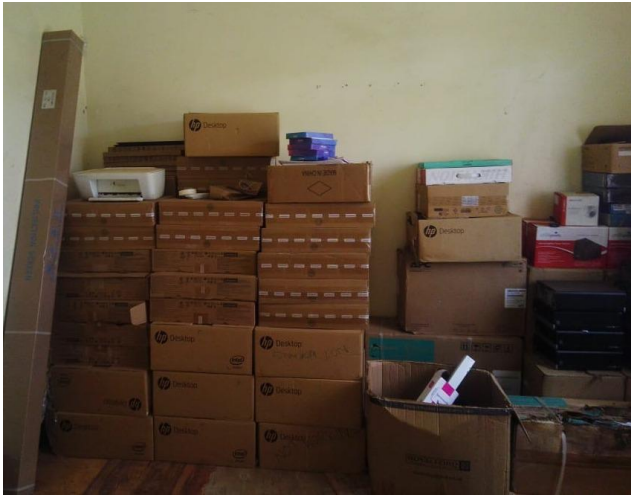
The 3,200 assets in storage were at 181 facilities, 2,681 (83.8%) of them at health centres, with clinical equipment the largest group (1,685). Of the stored assets, 190 (5.9%) were waiting for a power connection, 80 (2.5%) for a building or room and 141 (4.4%) were held at district stores or at another facility, while 519 (16.2%) were described as new, boxed or in good condition. Examples include 211 stored assets at health centres in Kabarole and 159 in Omoro, and computer equipment kept in store at Akadot Seed Secondary School in Pallisa, which has no electricity, and at Lungulu Seed Secondary School in Nwoya, which was awaiting a power connection.

**Figure 13: Desktop computers, a printer and UPS units still boxed in the store at Lungulu Seed Secondary School, Nwoya District (Acholi), awaiting a power connection for installation**

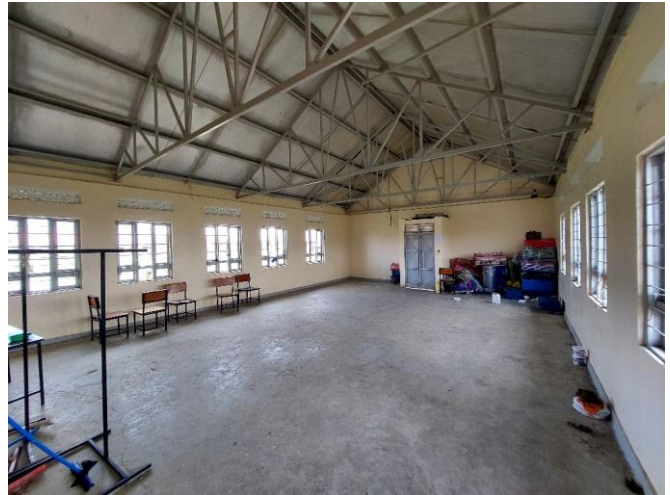
**Figure 14: Largely empty ICT and library block with a few chairs and items kept in one corner at Iriiri Seed Secondary School, Napak District (Karamoja), not yet in use while the school remained with the contractor**

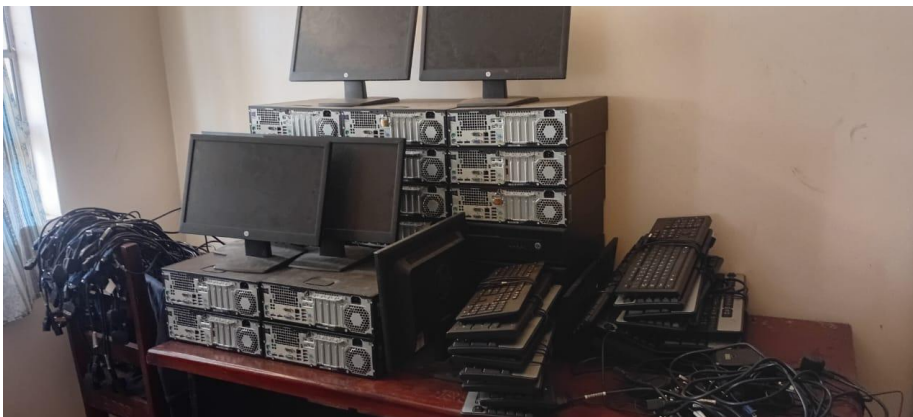
**Figure 15: HP computer sets stacked in store with cables still bundled and not installed at Bumufuni Seed Secondary School, Bulambuli District (Bugisu)**

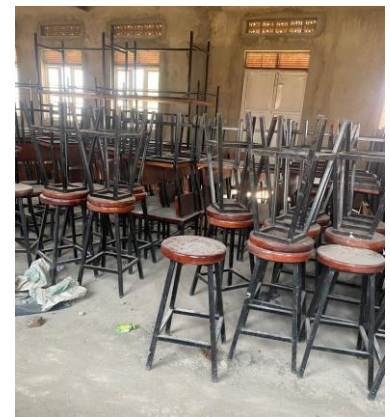
**Figure 16: Laboratory stools and desks stored and not yet in use at Butungama Seed Secondary School, Ntoroko District (Tooro), where the school buildings were still under construction**

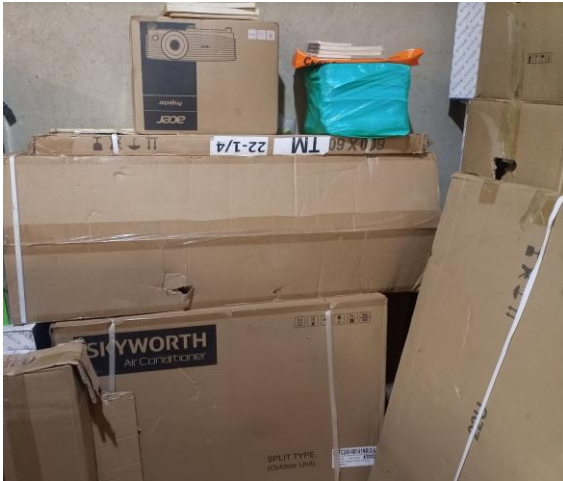
**Figure 17: Boxed projector, air conditioner and other equipment in store at King Solomon Seed Secondary School, Kagadi District (Bunyoro), kept boxed because the school was still under construction**

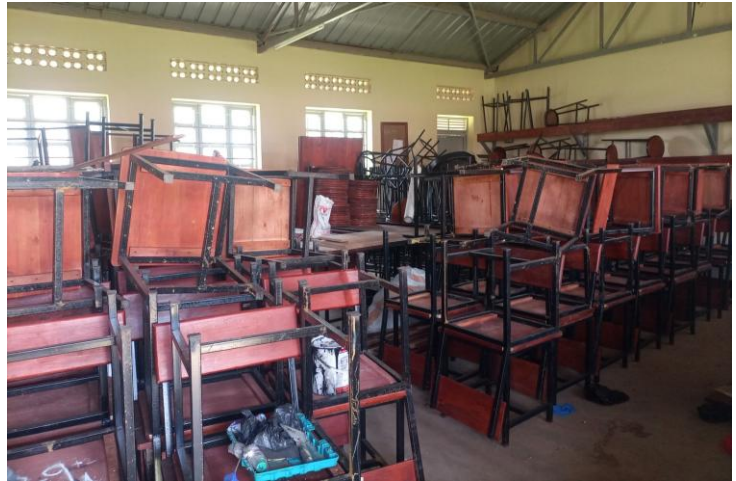
**Figure 18: Chairs, desks and laboratory stools stacked in a hall at King Solomon Seed Secondary School, Kagadi District (Bunyoro), where most assets remained in storage because the school was still under construction**

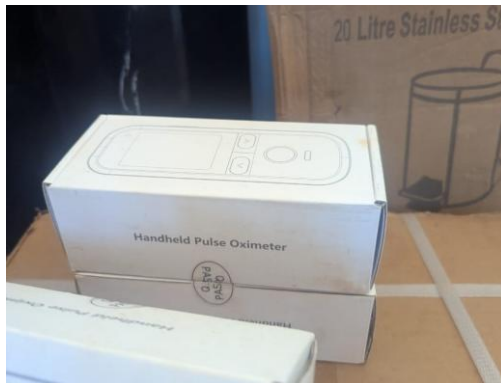
**Figure 20: Boxed handheld pulse oximeters at Kibiri Health Centre III, Makindye-Ssabagabo Municipal Council (Buganda), where equipment was still being arranged after the facility opened on 31 August 2026**

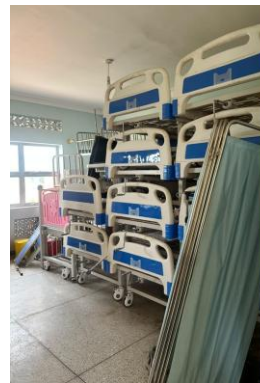
**Figure 21: Hospital beds and screens stacked in storage at a health centre, Kagadi District (Bunyoro)**

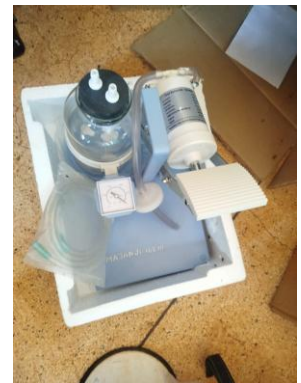
**Figure 22: Pedal suction unit marked MAJANJI H/C III still in its packing, recorded as not in use for lack of technical knowledge, Majanji Health Centre III, Busia District (Bukedi)**

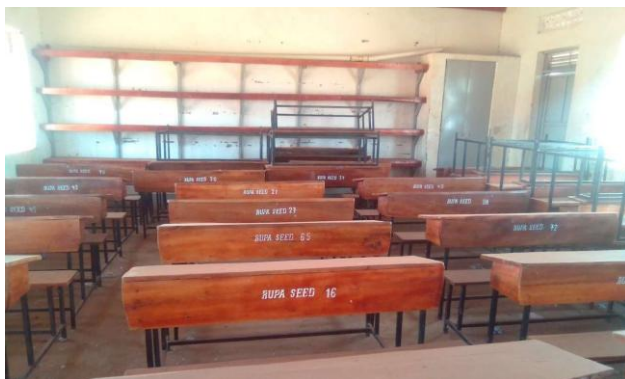
Figure 37: Classroom desks marked RUPA SEED with serial numbers, without a UgIFT marking, at Rupa Seed School, Moroto District (Karamoja)

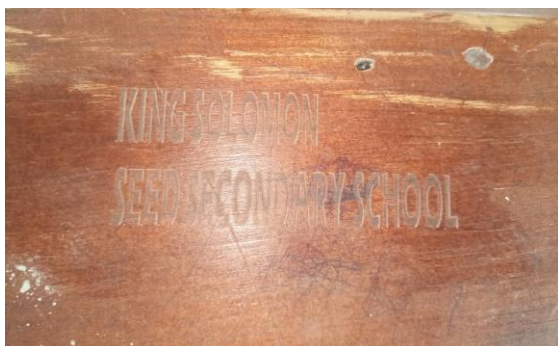
Figure 39: Engraving reading KING SOLOMON SEED SECONDARY SCHOOL, without a UgIFT marking, on furniture at King Solomon Seed Secondary School, Kagadi District (Bunyoro)

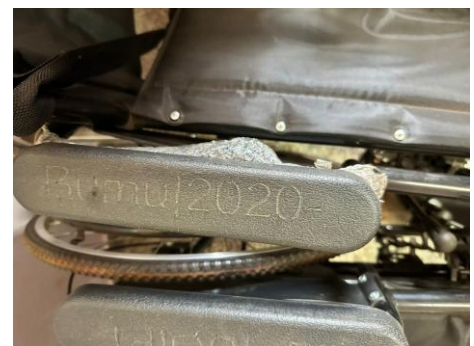
Figure 41: Hand-scratched marking beginning Bumugibole on a wheelchair armrest at Bumugibole Health Centre III, Bulambuli District (Bugisu)

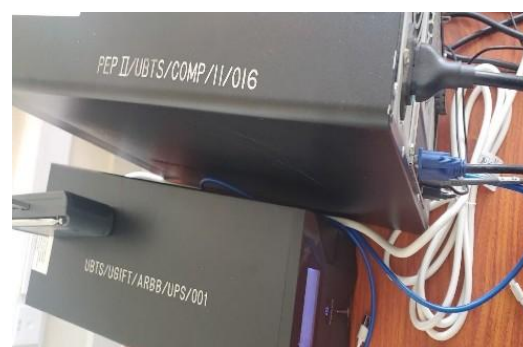
Figure 63: Markings PEP II/UBTS/COMP/11/016 and UBTS/UGIFT/ARBB/UPS/001 on uninterruptible power supplies at Arua Regional Blood Bank, Arua City (West Nile)

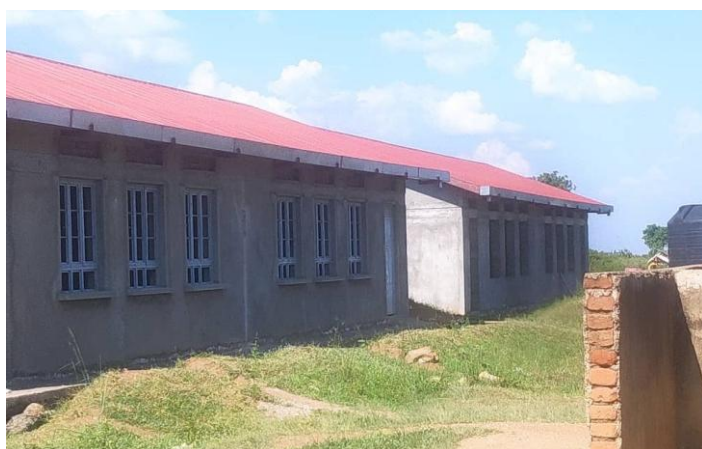
Figure 74: Unfinished school block at Got Apwoyo Seed Secondary School, Nwoya District (Acholi)

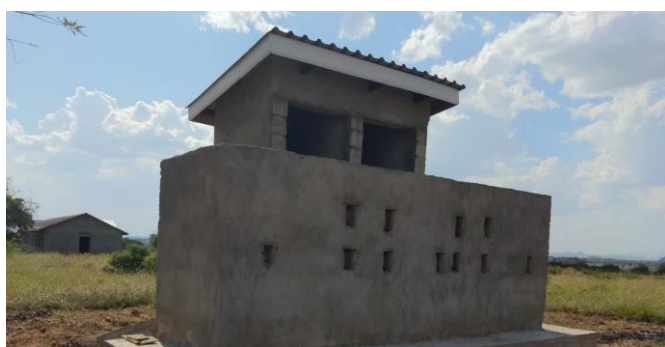
| Location | Expected position and field finding | Gap or service implication | Recommended action |
|---|---|---|---|
| Sidok Seed Secondary School, Kaabong | <b>Expected:</b> Sidok school needed completed buildings and checked equipment before the investment could support full operations.<br><b>Found:</b> The team found blocks, a kitchen and toilets under construction, with termite workings on the plaster of two blocks. The school consignment remained unopened and its contents had not been counted. | Unfinished works and equipment still to be opened and checked kept the school from being ready for use. | Kaabong District should secure completion and treatment of the affected works, then arrange a witnessed opening, count and condition check of the equipment. Accepted items should be recorded, assigned to custodians and issued for use. |

Figure 76: Latrine block under construction at Sidok Seed Secondary School, Kaabong District (Karamoja)

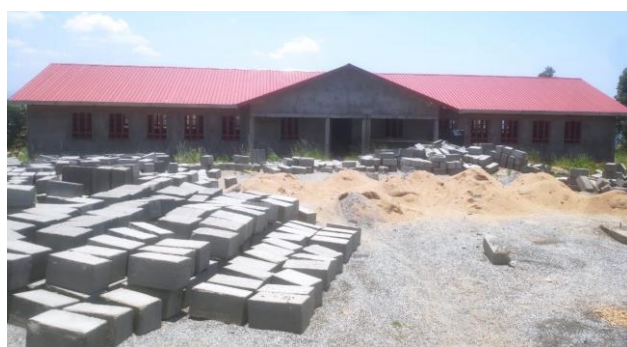
Figure 77: Building works and construction materials at Ndheh Seed Secondary School, Nebbi District (West Nile)

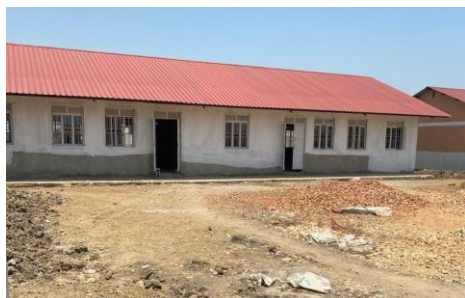
**Figure 78: School block awaiting completion at Butungama Seed Secondary School, Ntoroko District (Tooro)**

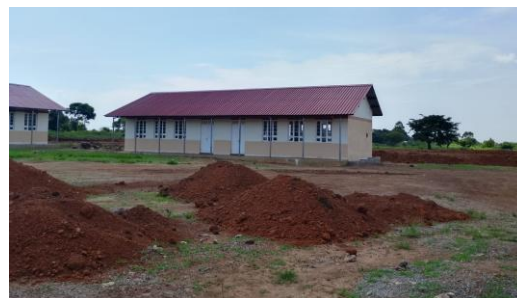
**Figure 80: Classroom block with earthworks in the foreground at Kihungya Seed Secondary School, Buliisa District (Bunyoro)**

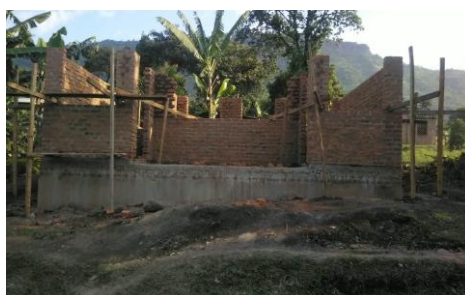
**Figure 81: Unfinished laboratory building at a health centre, Sironko District (Bugisu)**

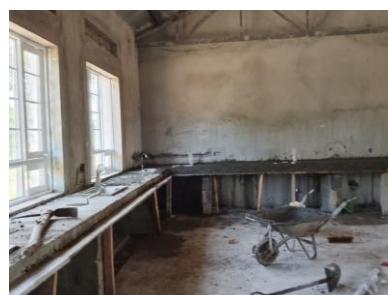
**Figure 82: Biology laboratory under construction at a seed secondary school, Buliisa District (Bunyoro)**

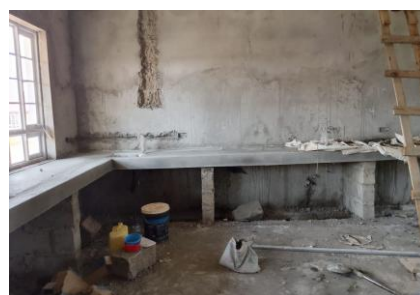
**Figure 83: Unfinished laboratory interior at Kihungya Seed Secondary School, Buliisa District (Bunyoro)**

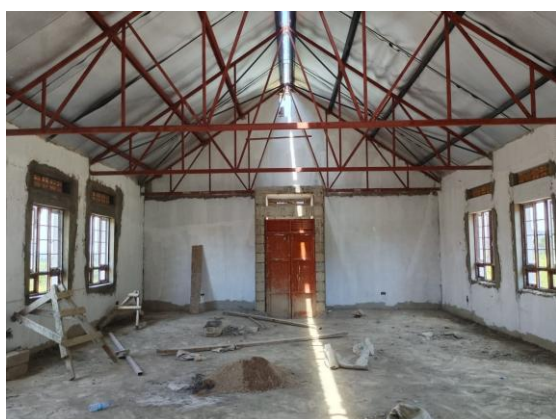
**Figure 84: Library interior under construction at Kihungya Seed Secondary School, Buliisa District (Bunyoro)**

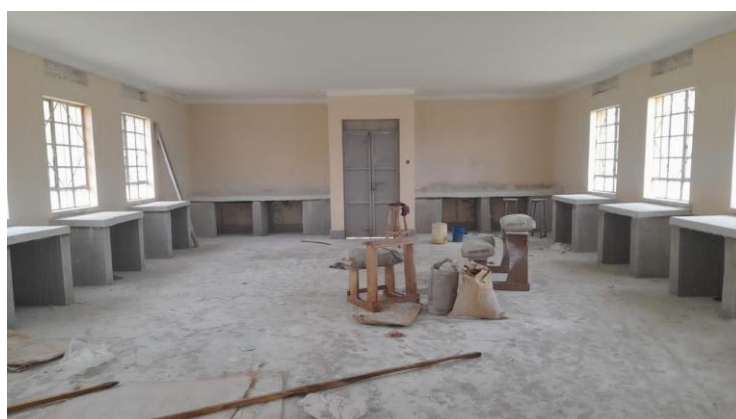
**Figure 85: ICT laboratory interior under construction at Kitawoi Seed Secondary School, Kween District (Sebei)**

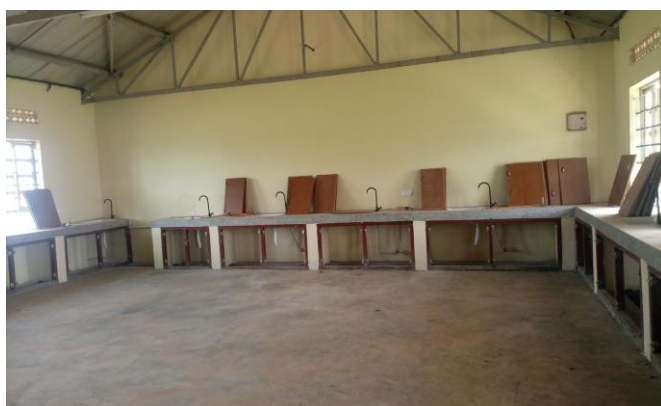
**Figure 86: Laboratory benches with cupboard doors not yet fitted, in a science laboratory block recorded as under construction, at King Solomon Seed Secondary School, Kagadi District (Bunyoro)**

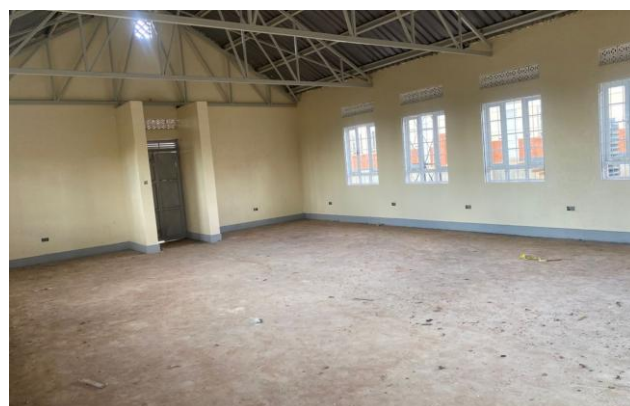
**Figure 87: Empty computer laboratory at Kaptum Seed Secondary School, Kween District (Sebei), where the buildings had not been handed over and no ICT equipment had been received**

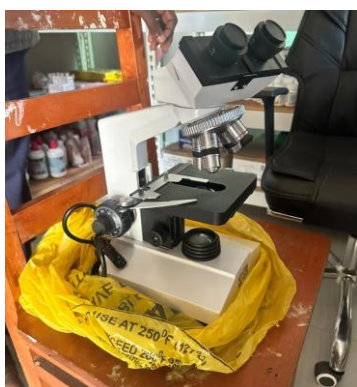
At Kihuukya Health Centre III in Hoima City, the renovated maternity block and walkways were recorded in use and a binocular microscope was seen functioning. Iruhura Health Centre III in Kabarole recorded adult weighing scales and waiting benches in use. Kamuli Health Centre III in Tororo reported improved service delivery, alongside continuing staffing and accommodation needs. Figures 89 to 93 show these health centre buildings and equipment in service.

**Figure 91: Binocular microscope at Kihuukya HC III, Hoima City (Bunyoro)**

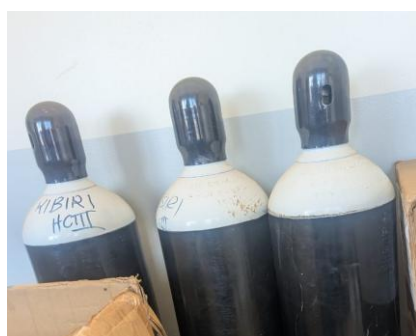
**Figure 101: Oxygen cylinders marked KIBIRI HCIII at Kibiri HC III, Makindye-Ssabagabo Municipal Council (Buganda)**

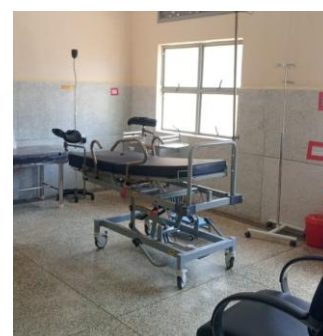
**Figure 103: Delivery bed and clinical furniture at a health centre, Kabarole District (Tooro)**

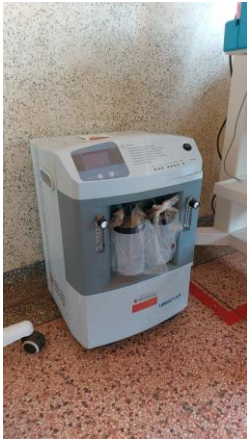
**Figure 104: Oxygen concentrator at Kalemungole HC III, Moroto District (Karamoja)**

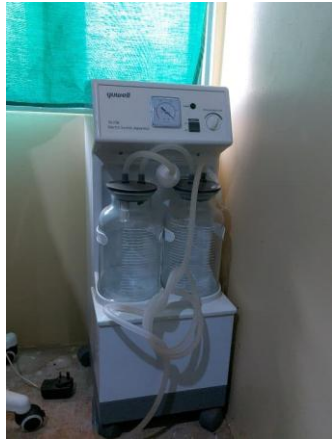
**Figure 105: Suction apparatus at Kalemungole HC III, Moroto District (Karamoja)**

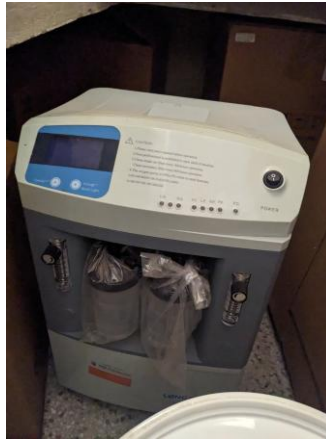
**Figure 106: Oxygen concentrator at Kamoru HC III, Kotido District (Karamoja)**

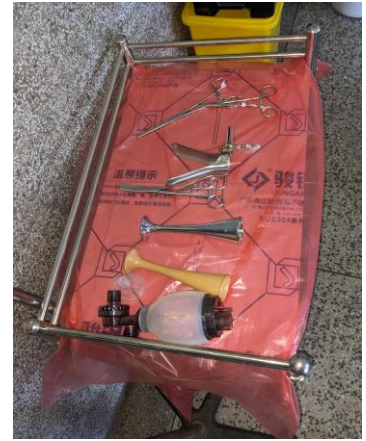
**Figure 107: Instrument trolley with delivery instruments at Kamoru HC III, Kotido District (Karamoja)**

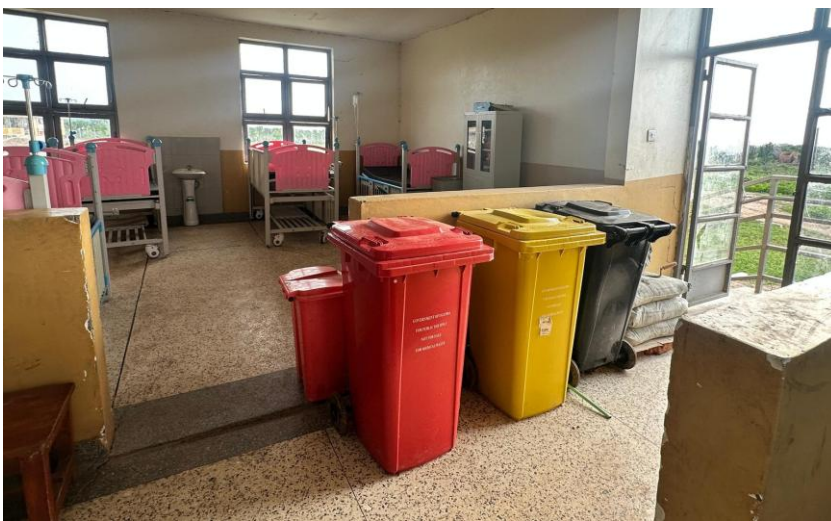
**Figure 108: Medical-waste bins and ward beds at Butiaba HC III, Buliisa District (Bunyoro)**

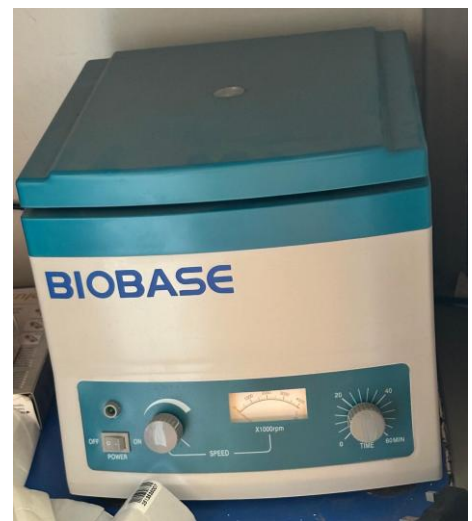
**Figure 109: Laboratory centrifuge at Butiaba HC III, Buliisa District (Bunyoro)**

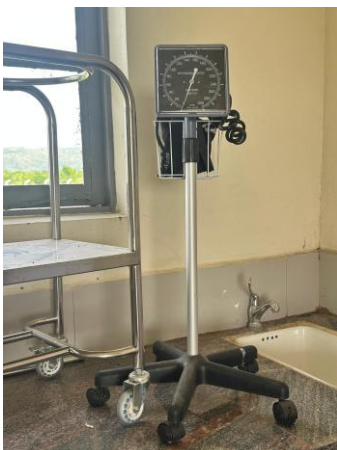
**Figure 110: Blood pressure apparatus on a mobile stand at Butiaba HC III, Buliisa District (Bunyoro)**

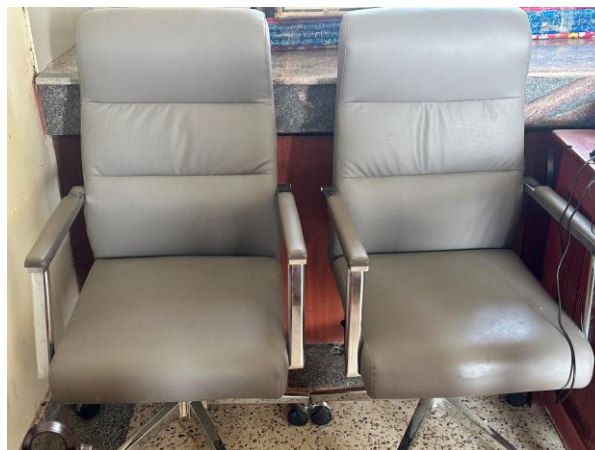
**Figure 111: Office chairs at Butiaba HC III, Buliisa District (Bunyoro)**

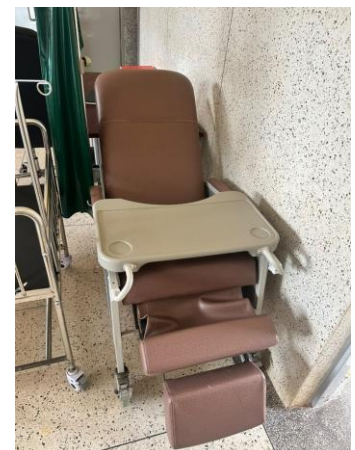
**Figure 112: Kangaroo care chair at Kyabasara HC III, Kagadi District (Bunyoro)**

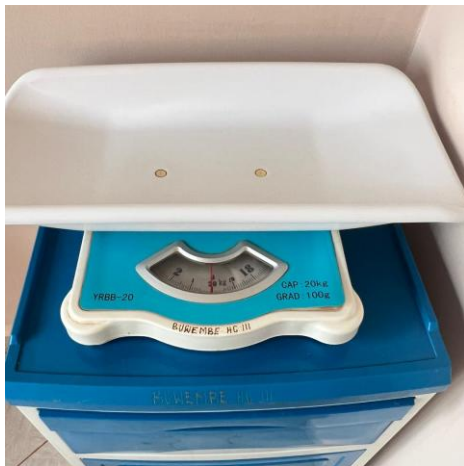
Figure 113: Infant weighing scale at Buwembe HC III, Busia District (Bukedi)

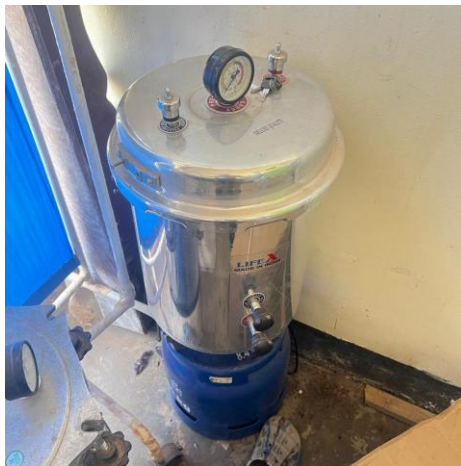
Figure 114: Autoclave above a gas cylinder at Buwembe HC III, Busia District (Bukedi)

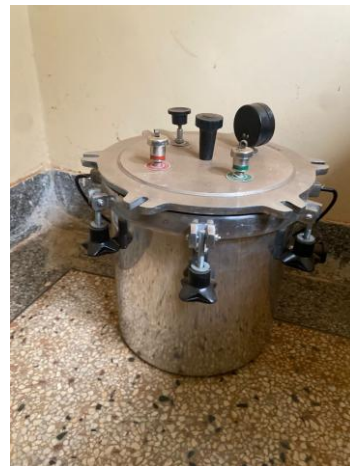
Figure 115: Autoclave at Atar HC III, Kween District (Sebei)

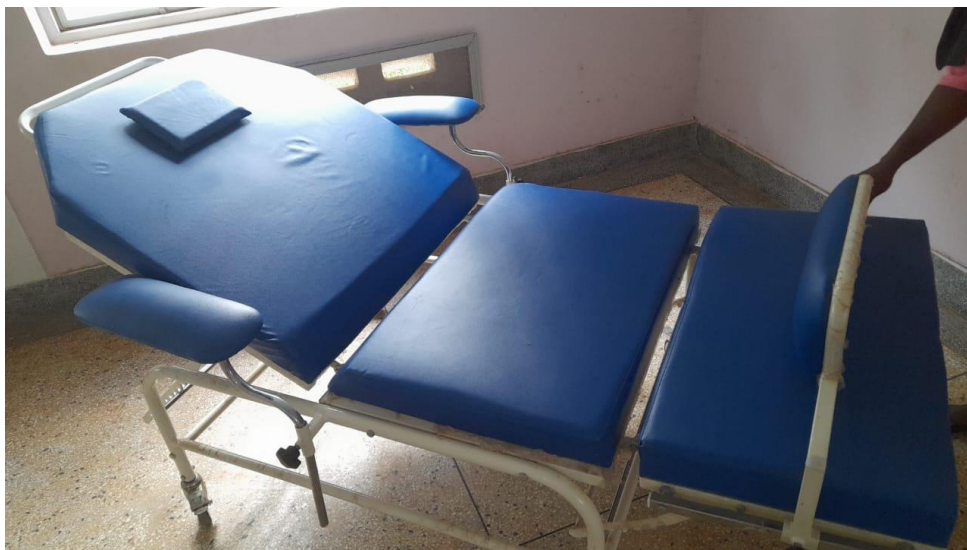
Figure 116: Kangaroo care chair at Atar HC III, Kween District (Sebei)

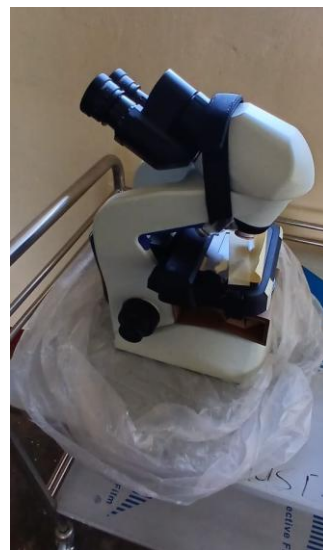
Figure 117: Binocular microscope on a trolley at Namusita HC III, Budaka District (Bukedi)

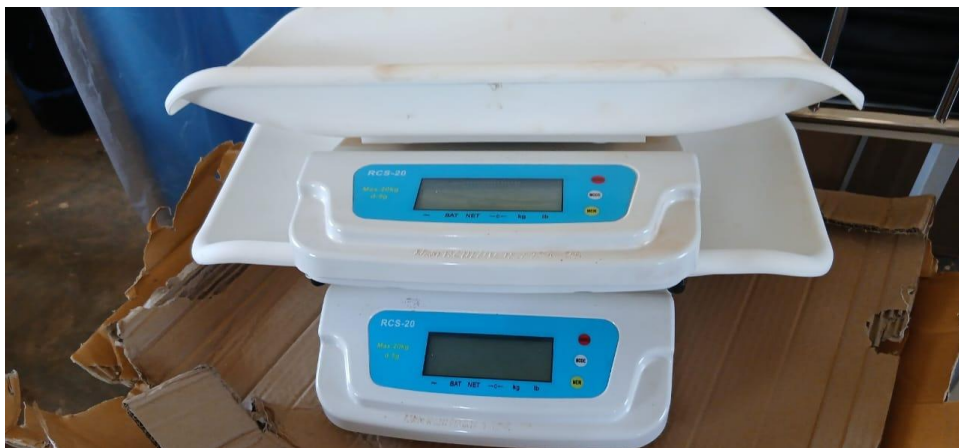
Figure 118: Infant weighing scales at Namusita HC III, Budaka District (Bukedi)

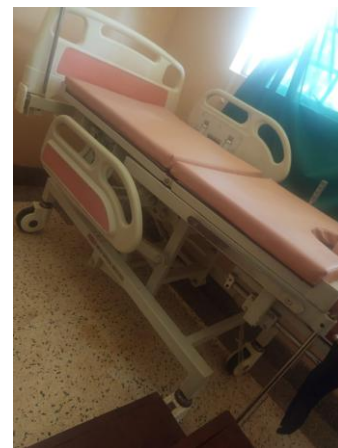
Figure 119: Delivery bed with side rails at Kabweri HC III, Kibuku District (Bukedi)

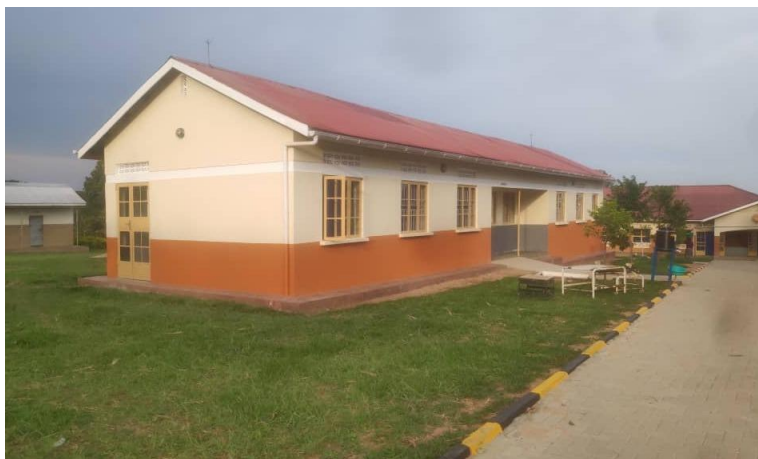
**Figure 120: Health centre building, Nwoya District (Acholi)**

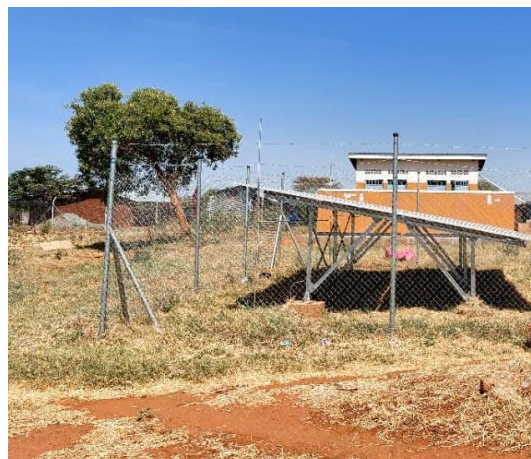
**Figure 121: Solar panels at Kalemungole HC III, Moroto District (Karamoja)**

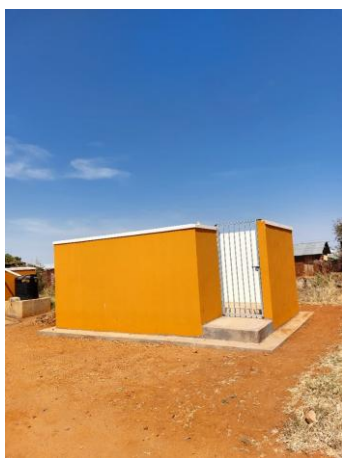
**Figure 122: Patient toilet block at Kalemungole HC III, Moroto District (Karamoja)**

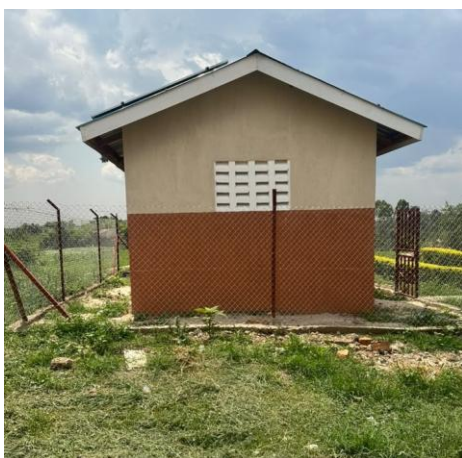
**Figure 123: Power house at Kyabasara HC III, Kagadi District (Bunyoro)**

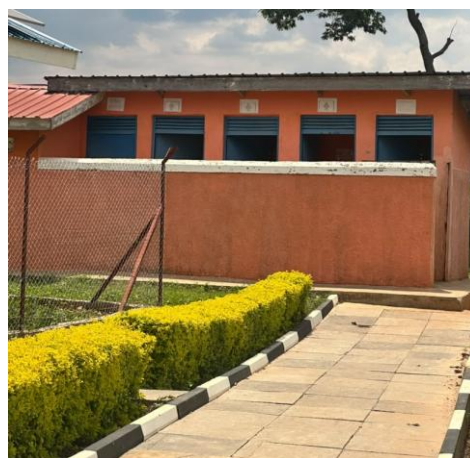
**Figure 124: Latrine block and paved access at Kyabasara HC III, Kagadi District (Bunyoro)**

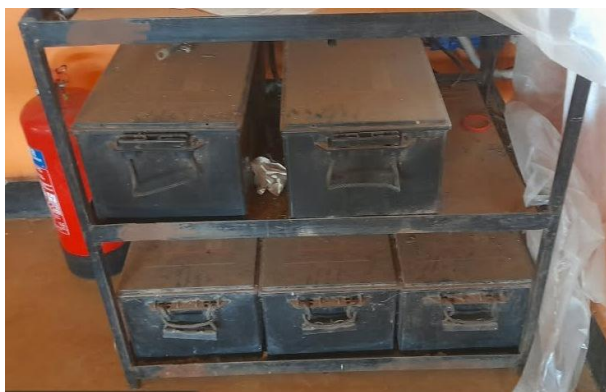
**Figure 125: Solar batteries at Bunangaka HC III, Bulambuli District (Bugisu)**

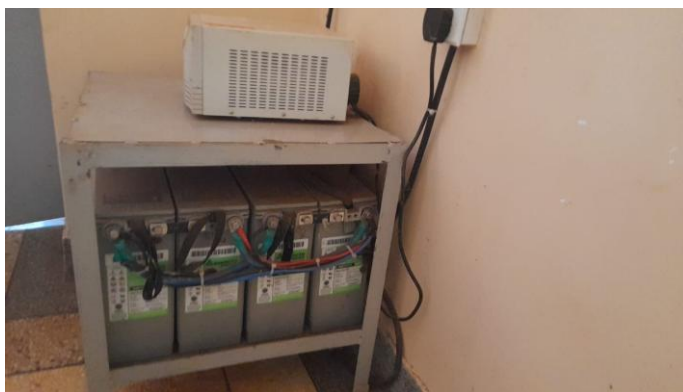
**Figure 126: Solar batteries and control equipment at Atar HC III, Kween District (Sebei)**

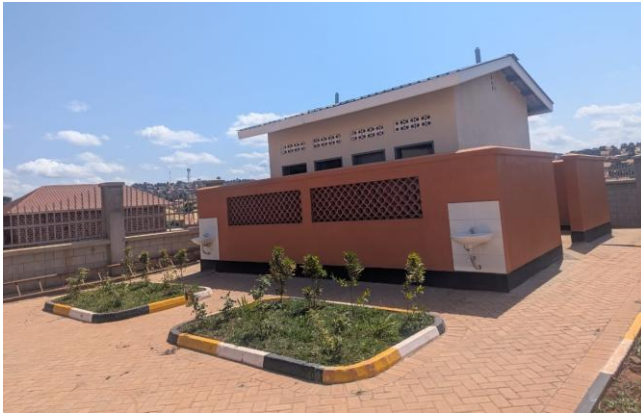
**Figure 127: Sanitation block with external handwashing basins at Kibiri HC III, Makindye-Ssabagabo Municipal Council (Buganda)**

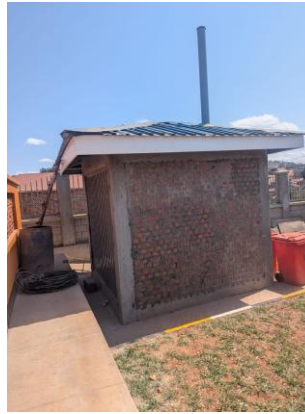
**Figure 128: Waste disposal structure at Kibiri HC III, Makindye-Ssabagabo Municipal Council (Buganda)**

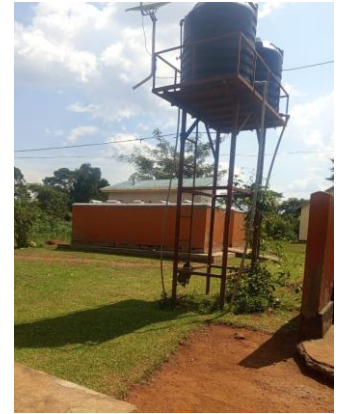
**Figure 129: Water tanks on a steel tower at Kabweri HC III, Kibuku District (Bukedi)**

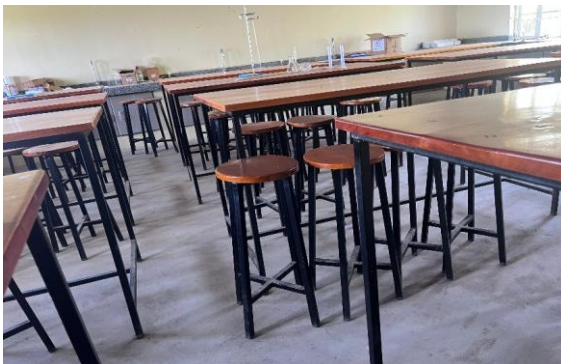
**Figure 130: Science laboratory tables and stools at a seed secondary school, Kalangala District (Buganda)**

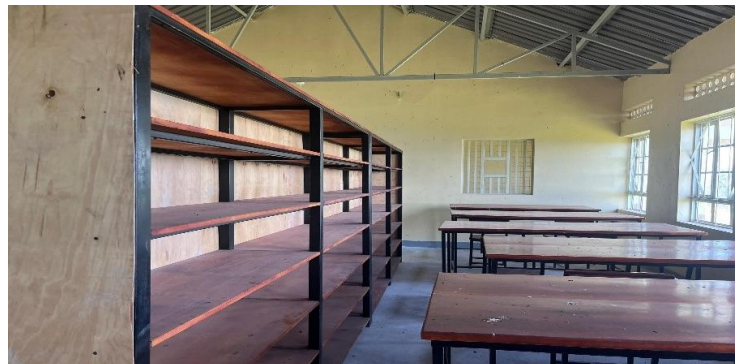
**Figure 131: Library shelves and reading tables at Gyagenda Memorial Seed Secondary School, Kalangala District (Buganda)**

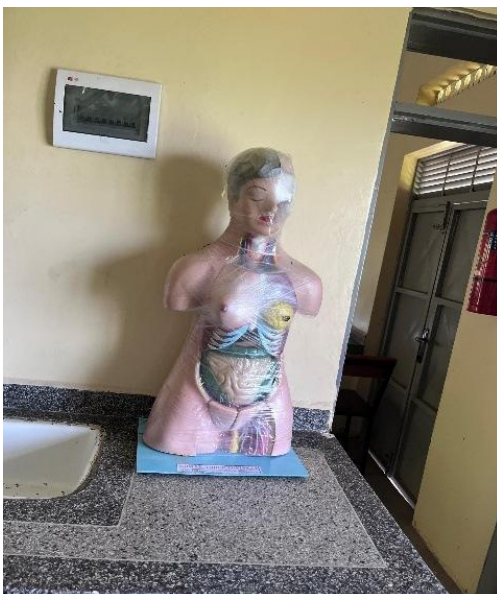
**Figure 132: Anatomical teaching model at Gyagenda Memorial Seed Secondary School, Kalangala District (Buganda)**

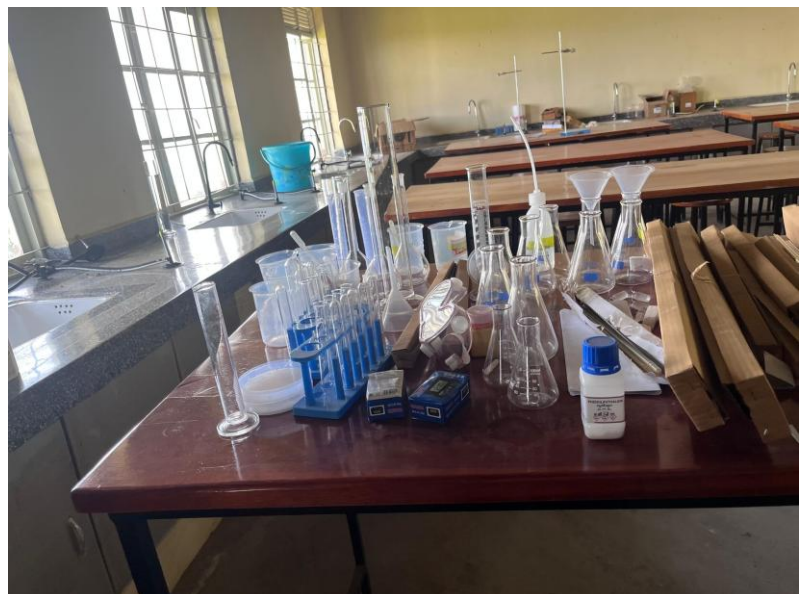
**Figure 133: Laboratory glassware and equipment at Gyagenda Memorial Seed Secondary School, Kalangala District (Buganda)**

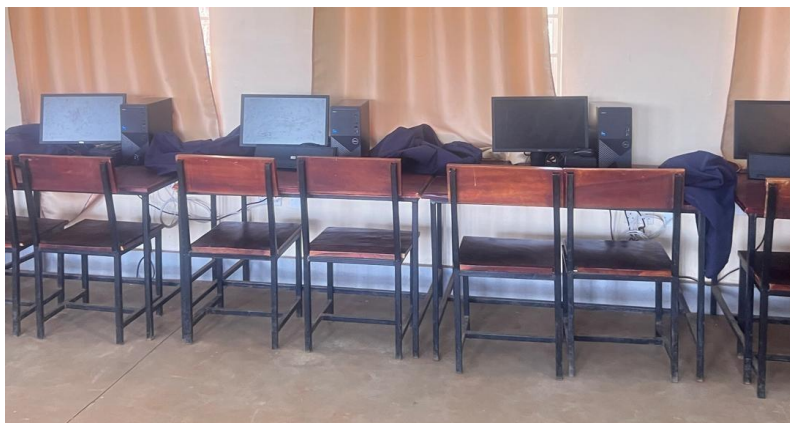
**Figure 134: Desktop computers and classroom furniture at a seed secondary school, Busia District (Bukedi)**

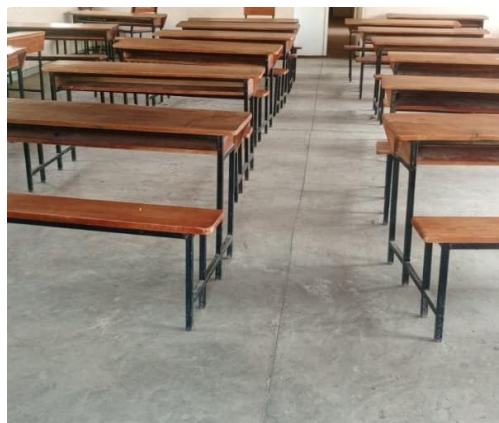
**Figure 135: Classroom desks at a seed secondary school, Ntoroko District (Tooro)**

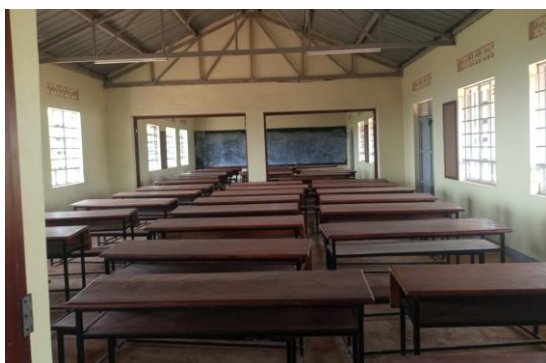
**Figure 136: Classroom desks at King Solomon Seed Secondary School, Kagadi District (Bunyoro)**

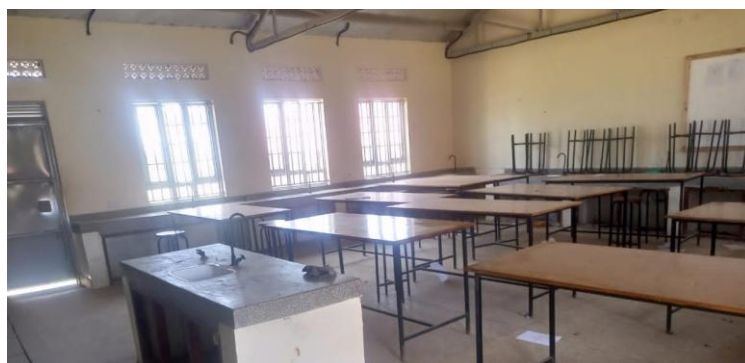
**Figure 137: Laboratory benches and sinks at Bweema Seed Secondary School, Buvuma District (Buganda)**

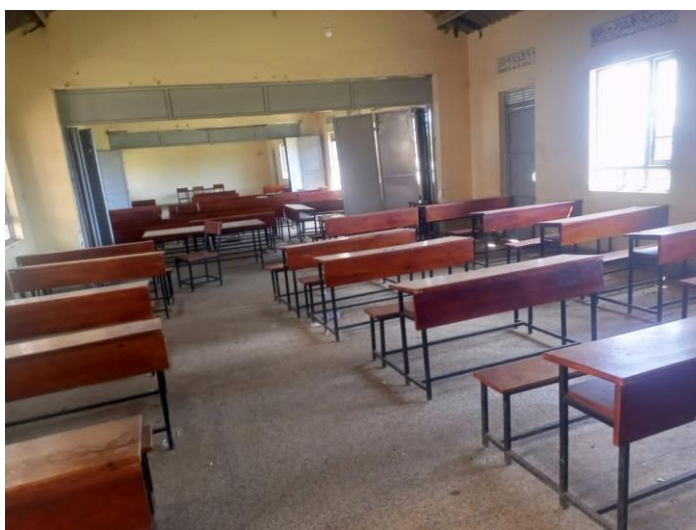
**Figure 138: Classroom desks at Bweema Seed Secondary School, Buvuma District (Buganda)**

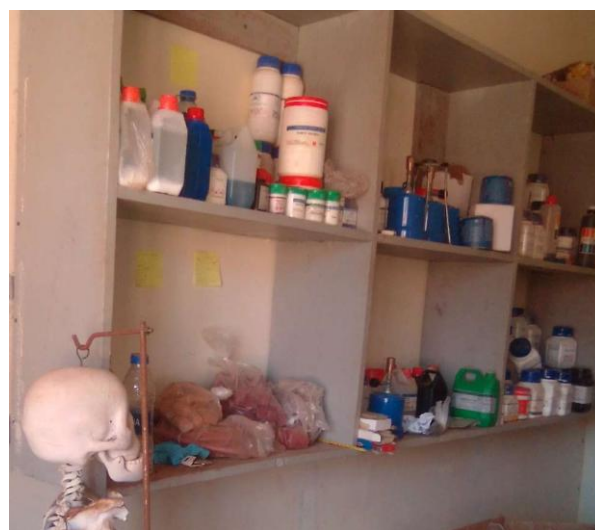
**Figure 139: Laboratory supplies and an anatomical teaching model at Rupa Seed School, Moroto District (Karamoja)**

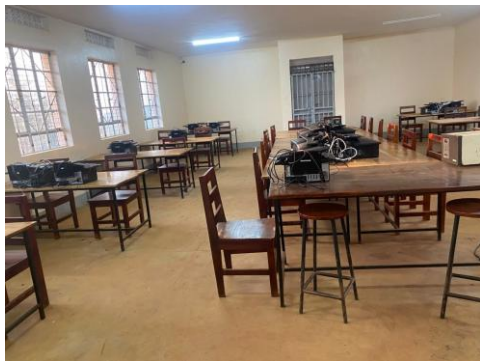
**Figure 140: Computer equipment in the school ICT room at Kabeywa Seed Secondary School, Kapchorwa District (Sebei)**

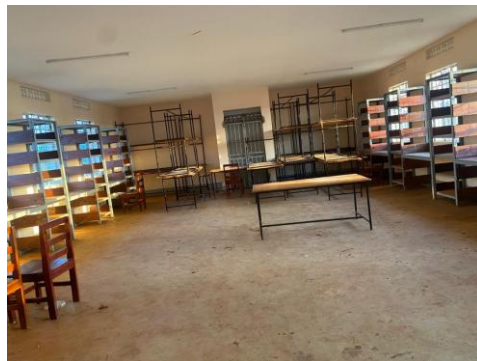
**Figure 141: Library shelving and tables at Kabeywa Seed Secondary School, Kapchorwa District (Sebei)**
