**CONSULTANCY SERVICES TO VERIFY AND RECORD ASSETS  
UNDER THE UGIFT PROGRAMME**

**REF: MOFPED/UGIFT/CONS/25/26/00015**

**ASSET VERIFICATION REPORT**

**September 2026**

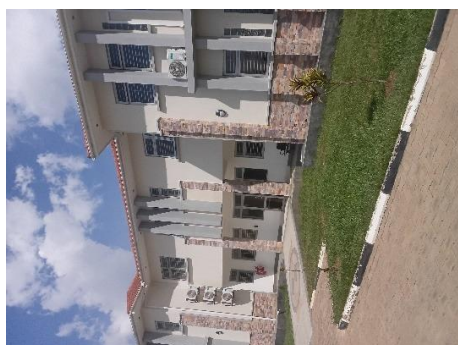
Figure 1: Completed blood bank building at Arua Regional Blood Bank, Arua City (West Nile)

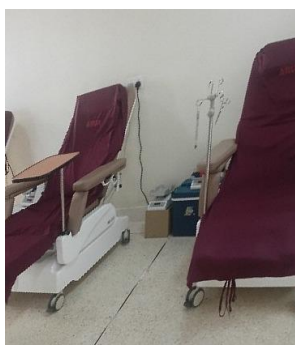
Figure 2: Donor couches in the donor room at Arua Regional Blood Bank, Arua City (West Nile)

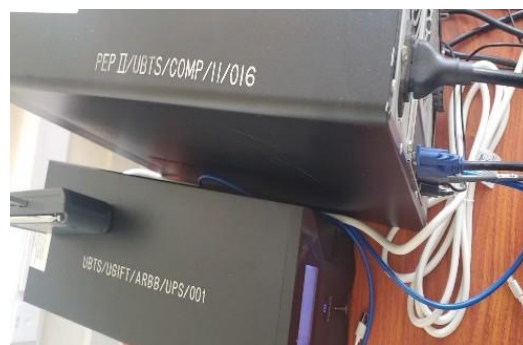
Of the 168 verified assets, 43 (25.6%) were engraved and 125 (74.4%) were not engraved. The 26 properly engraved assets (15.5%) carry the UgIFT marking and include donor couches, filing cabinets, office chairs and tables, the reception table, UPS units and the washing machine. The 17 not properly engraved assets (10.1%) carry UBTS equipment codes, mainly on laboratory equipment and desktop computers. The recorded value of the field return assets is UGX 1,045,918,115. Figures 1 to 6 show the completed building, donor couches, the markings on two uninterruptible power supplies, a blood bank refrigerator, a platelet agitator and a chest freezer.

Figure 3: Markings PEP II/UBTS/COMP/11/016 and UBTS/UGIFT/ARBB/UPS/001 on uninterruptible power supplies at Arua Regional Blood Bank, Arua City (West Nile)

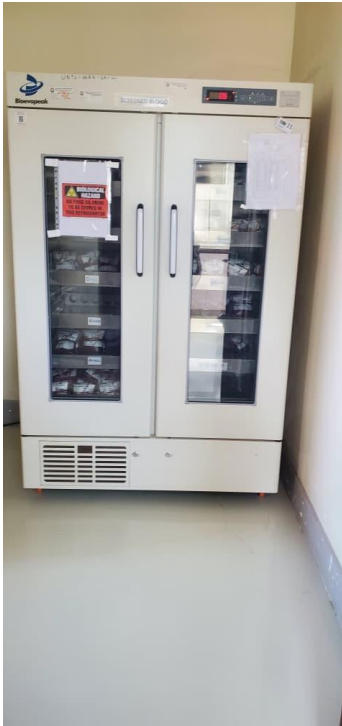
**Figure 4: Blood bank refrigerator at Arua Regional Blood Bank, Arua City (West Nile)**

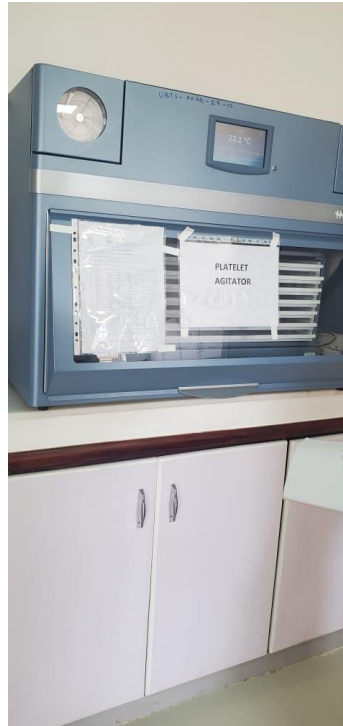
**Figure 5: Platelet agitator at Arua Regional Blood Bank, Arua City (West Nile)**

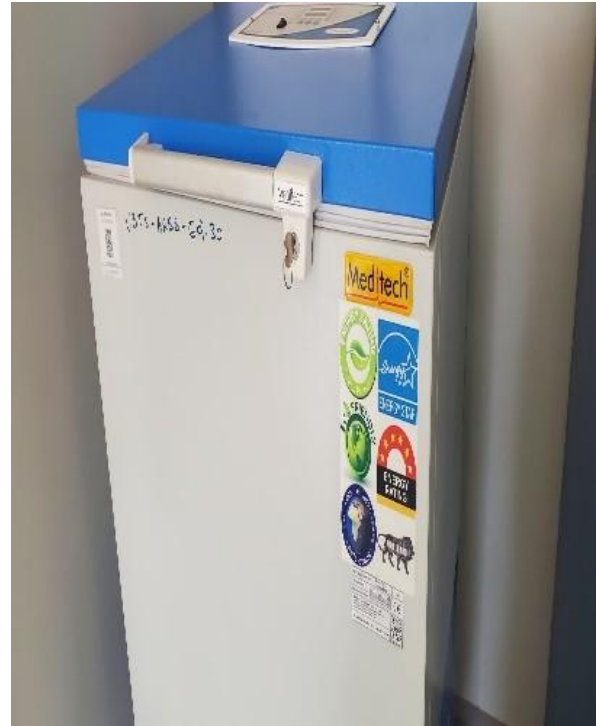
**Figure 6: Chest freezer at Arua Regional Blood Bank, Arua City (West Nile)**

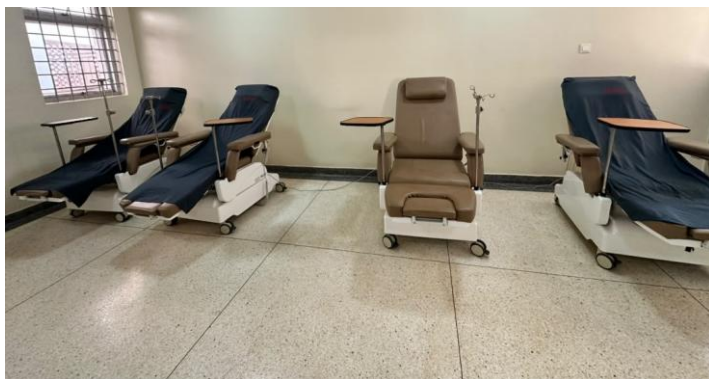
**Figure 7: Donor couches in the donor room at Hoima Regional Blood Bank, Hoima City (Bunyoro)**

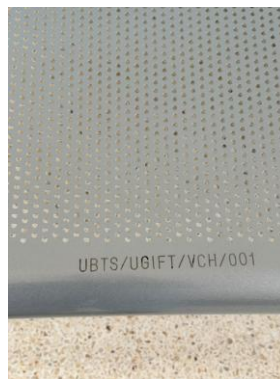
**Figure 8: Engraving reading UBTS/UGIFT/VCH/001 on equipment at Hoima Regional Blood Bank, Hoima City (Bunyoro)**

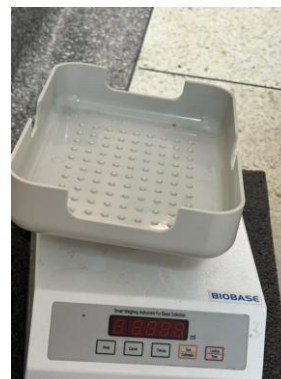
**Figure 9: Blood collection balance at Hoima Regional Blood Bank, Hoima City (Bunyoro)**

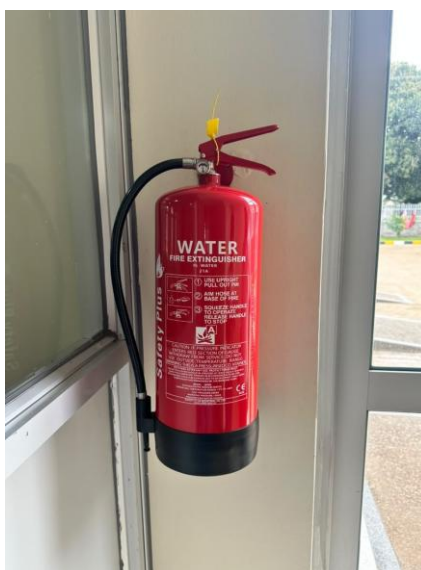
**Figure 11: Water fire extinguisher at Hoima Regional Blood Bank, Hoima City (Bunyoro)**

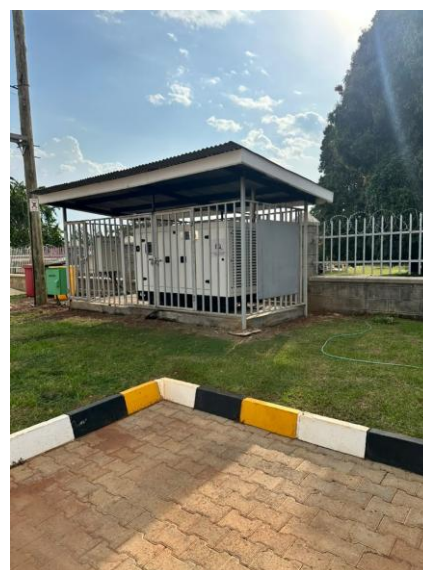
**Figure 12: Generator in an outdoor enclosure at Hoima Regional Blood Bank, Hoima City (Bunyoro)**

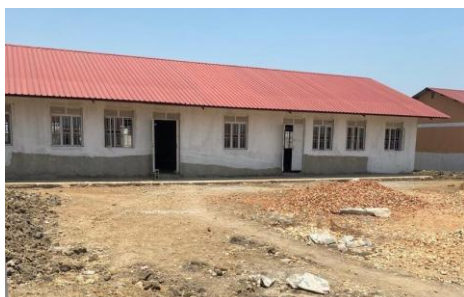
**Figure 18: School block awaiting completion at Butungama Seed Secondary School, Ntoroko District (Tooro)**

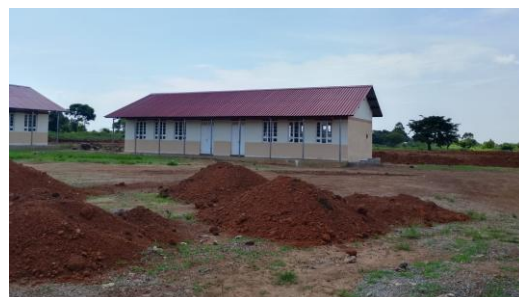
**Figure 20: Classroom block with earthworks in the foreground at Kihungya Seed Secondary School, Buliisa District (Bunyoro)**

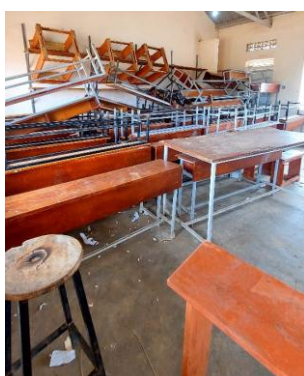
**Figure 33: Stacked desks, chairs and stools, some recorded as broken and none engraved, at Napak Seed Secondary School, Napak District (Karamoja)**

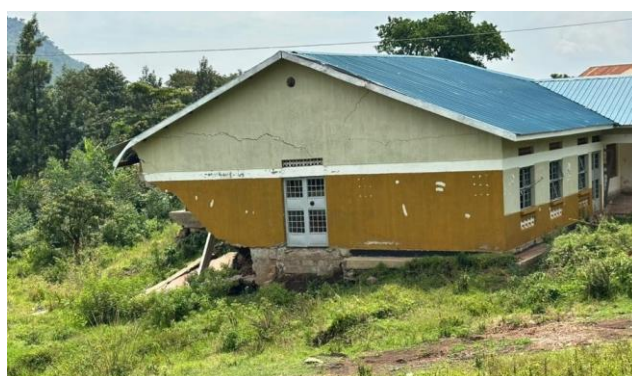
**Figure 34: Cracked health centre block above collapsed ground, Bulambuli District (Bugisu)**

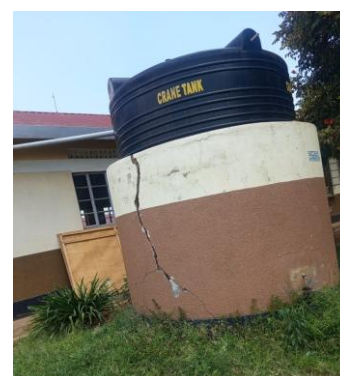
**Figure 35: Water tank on a cracked base at a seed secondary school, Kibuku District (Bukedi)**

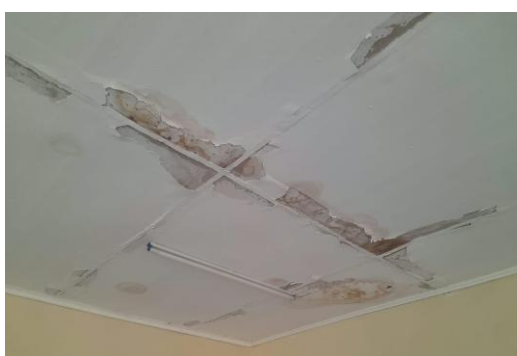
**Figure 36: Stained and peeling ceiling at a health centre, Sironko District (Bugisu)**

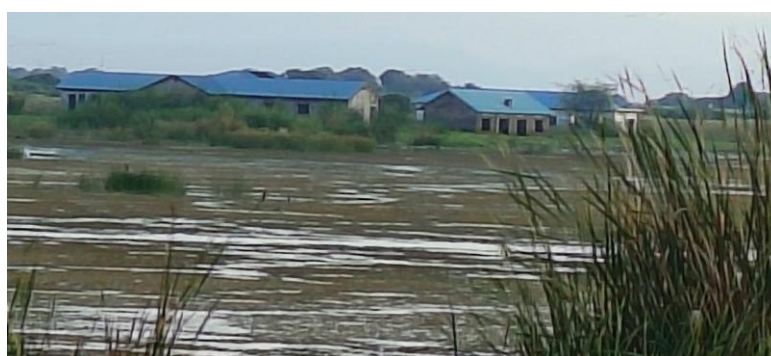
**Figure 37: Flood-affected older health facility at Butiaba, Buliisa District (Bunyoro)**

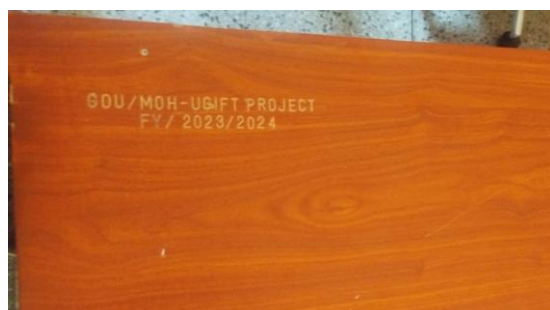
**Figure 39: Engraving reading GOU/MOH-UGIFT PROJECT FY/2023/2024 on a desk at Namwaya Health Centre III, Tororo District (Bukedi)**

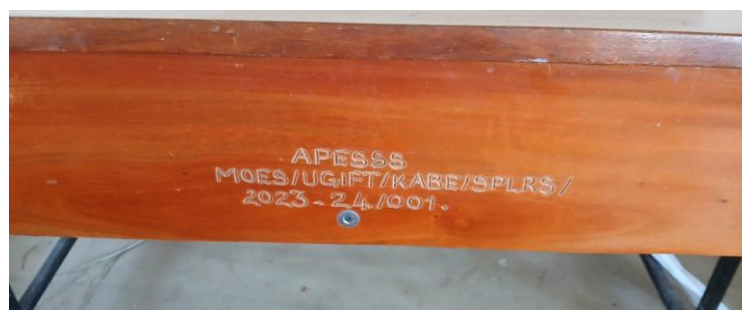
**Figure 40: Engraving reading APESSS MOES/UGIFT/KABE/SPLRS/2023-24/001 on a desk at Aperikira Seed Secondary School, Kaberamaido District (Teso)**

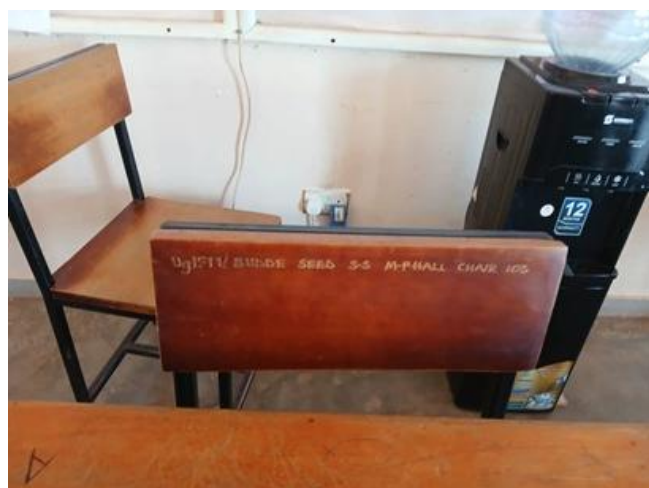
**Figure 41: Chair engraved UgIFT/ BUDDE SEED S.S M-PHALL CHAIR with a serial number at Budde Seed Secondary School, Butambala District (Buganda)**

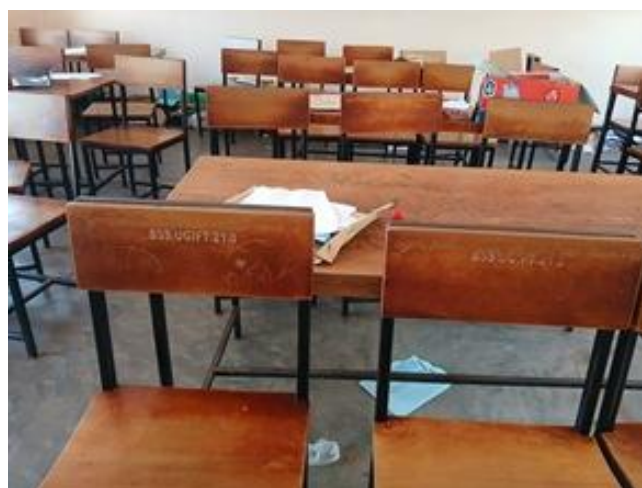
**Figure 42: Chairs engraved BSS UGIFT with serial numbers at Budde Seed Secondary School, Butambala District (Buganda)**

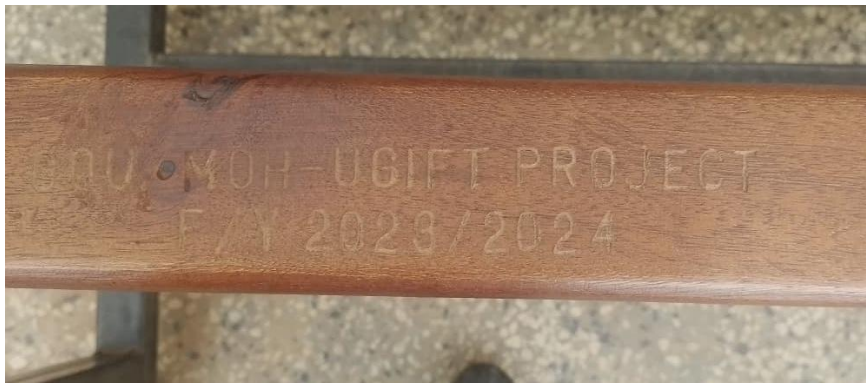
Figure 43: Engraving reading GOU/MOH-UGIFT PROJECT F/Y 2023/2024 on a bench at Bududa Health Centre III, Bududa District (Bugisu)

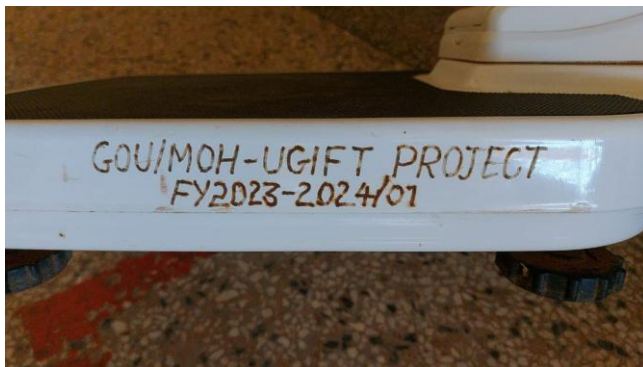
Figure 46: Engraving reading GOU/MOH-UGIFT PROJECT FY2023-2024/01 on a weighing scale at Kalemungole Health Centre III, Moroto District (Karamoja)

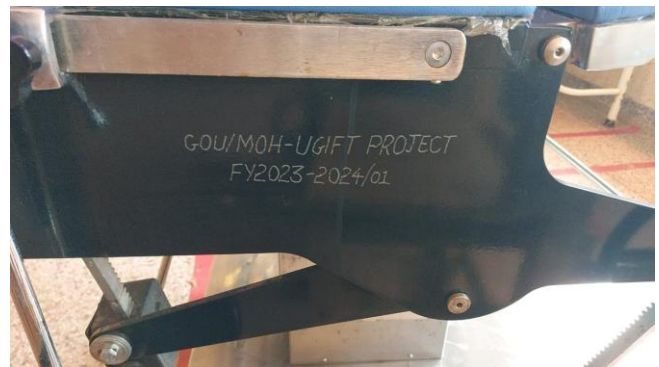
Figure 47: Engraving reading GOU/MOH-UGIFT PROJECT FY2023-2024/01 on a delivery bed at Kalemungole Health Centre III, Moroto District (Karamoja)

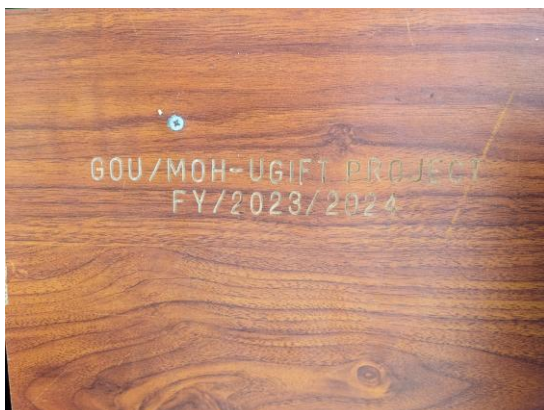
Figure 48: Engraving reading GOU/MOH-UGIFT PROJECT FY/2023/2024 on a table at Kamoru Health Centre III, Kotido District (Karamoja)

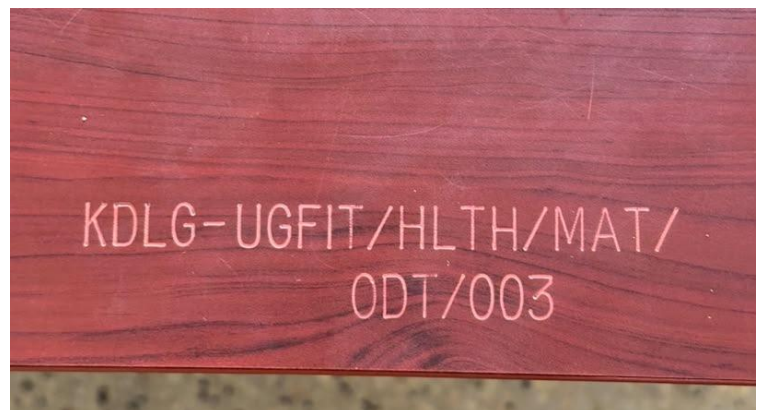
The programme marking appeared on a range of health centre items, including a bench at Bududa Health Centre III, a wheelchair, a refrigerator, a weighing scale and a delivery bed at Kalemungole Health Centre III, and a table at Kamoru Health Centre III in Kotido District (Figures 43 to 48). At Kyabasara Health Centre III in Kagadi District, the district code KDLG (Kagadi District Local Government) was combined with the programme identifier, which counts as proper engraving (Figure 49).

Figure 49: Engraving reading KDLG-UGFIT/HLTH/MAT/ODT/003 on a table at Kyabasara Health Centre III, Kagadi District (Bunyoro)

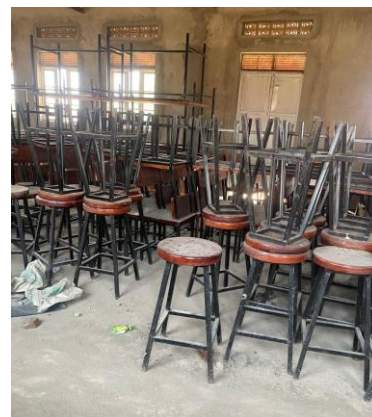
**Figure 58: Laboratory stools and desks stored and not yet in use at Butungama Seed Secondary School, Ntoroko District (Tooro), where the school buildings were still under construction**

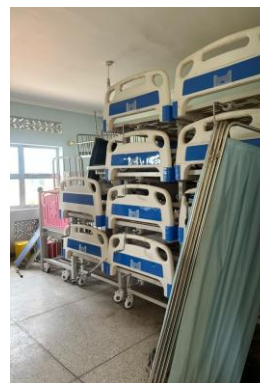
**Figure 63:** Hospital beds and screens stacked in storage at a health centre, Kagadi District (Bunyoro)

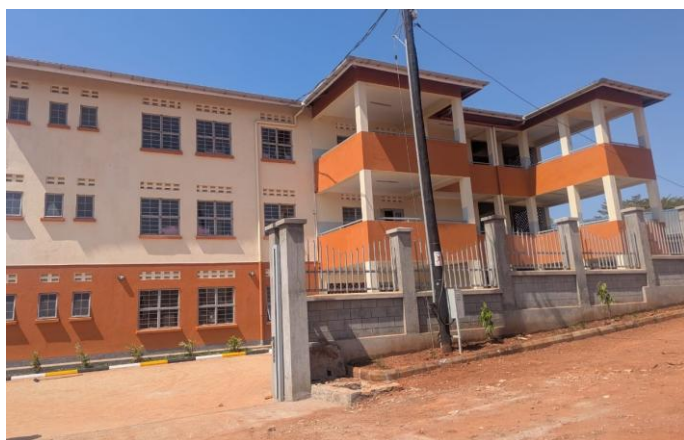
Health centres gave equally practical examples of wider services. Kachuru Health Centre III in Butebo now offers laboratory services, inpatient care and minor surgery, and at Mutungo Health Centre III in Makindye-Ssabagabo Municipal Council the new building replaced an open tent shelter. Kibiri Health Centre III, in the same municipality, had begun operations by 31 August 2026, while staff were still arranging some equipment.

**Figure 70: Health centre building at Kibiri HC III, Makindye-Ssabagabo Municipal Council (Buganda)**

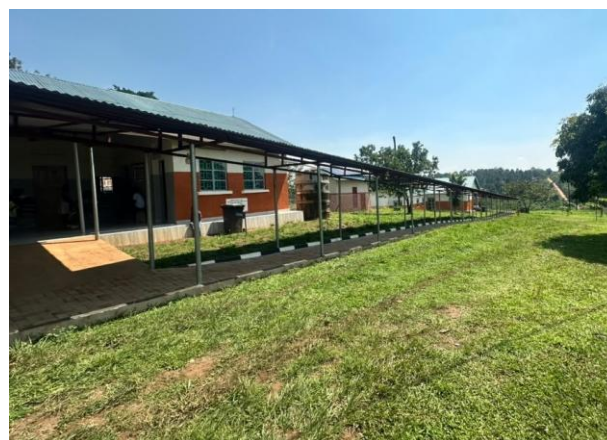
At Kihuukya Health Centre III in Hoima City, the renovated maternity block and walkways were recorded in use and a binocular microscope was seen functioning. Iruhura Health Centre III in Kabarole recorded adult weighing scales and waiting benches in use. Kamuli Health Centre III in Tororo reported improved service delivery, alongside continuing staffing and accommodation needs. Figures 70 to 74 show these health centre buildings and equipment in service.

**Figure 71: Health centre buildings and covered walkway at Kihuukya HC III, Hoima City (Bunyoro)**

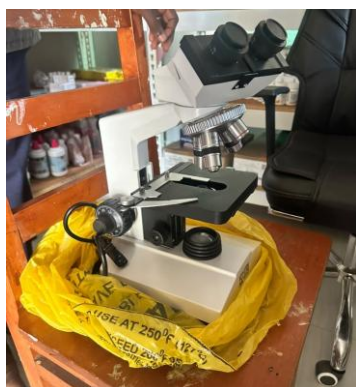
**Figure 72: Binocular microscope at Kihuukya HC III, Hoima City (Bunyoro)**

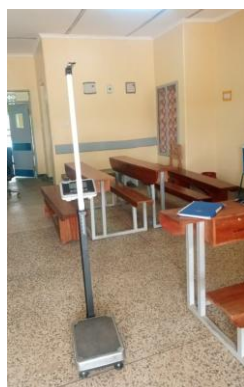
**Figure 73: Adult weighing scale with a height meter and waiting benches at Iruhura HC III, Kabarole District (Tooro)**

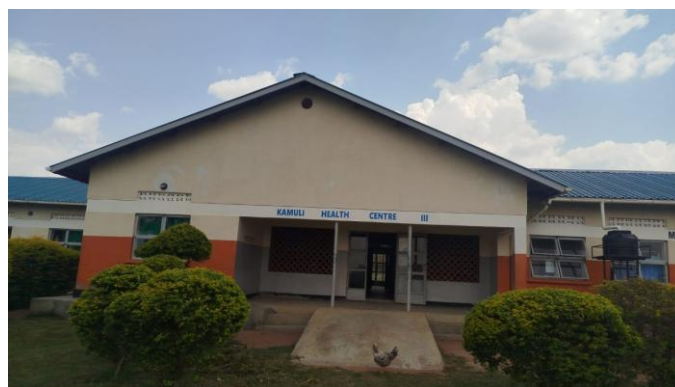
**Figure 74: Maternity block entrance and access ramp at Kamuli HC III, Tororo District (Bukedi)**

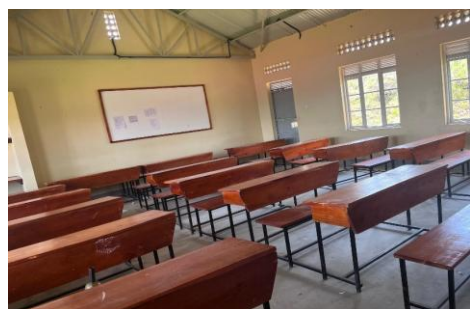
**Figure 75:** Classroom furnished with desks and a whiteboard at Gyagenda Memorial Seed Secondary School, Kalangala District (Buganda)

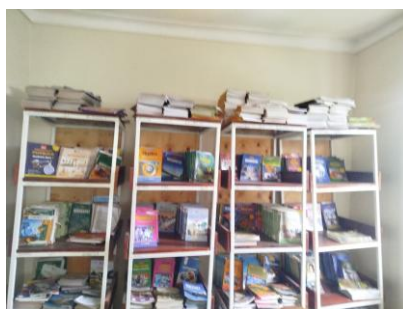
**Figure 76:** Books displayed on library shelves at Sibanga Seed School, Manafwa District (Bugisu)

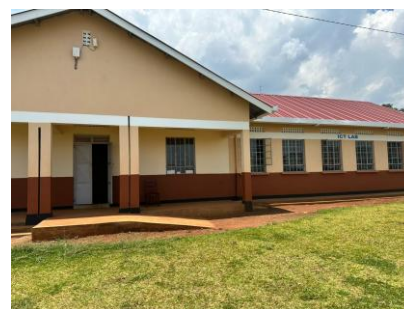
Sisiyi Seed Secondary School in Bulambuli recorded its buildings, furniture and ICT in use. Sibanga Seed Secondary School in Manafwa reported shorter distances for learners and less teenage pregnancy and school dropout, although full handover was still pending. Figures 75 to 77 show teaching spaces at Gyagenda Memorial, Sibanga and Sisiyi.

**Figure 77:** ICT laboratory block and entrance ramp at Sisiyi Seed Secondary School, Bulambuli District (Bugisu)

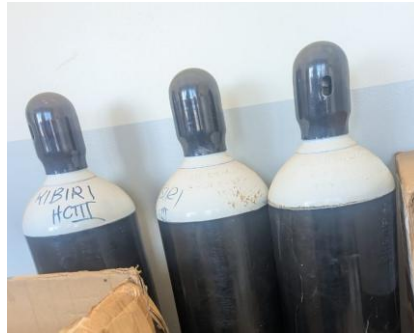
**Figure 82: Oxygen cylinders marked KIBIRI HCIII at Kibiri HC III, Makindye-Ssabagabo Municipal Council (Buganda)**

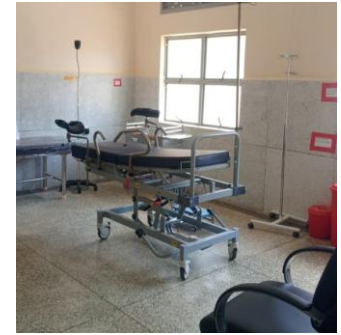
**Figure 84: Delivery bed and clinical furniture at a health centre, Kabarole District (Tooro)**

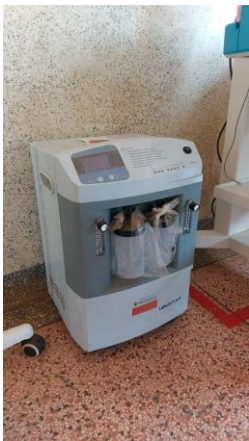
**Figure 85: Oxygen concentrator at Kalemungole HC III, Moroto District (Karamoja)**

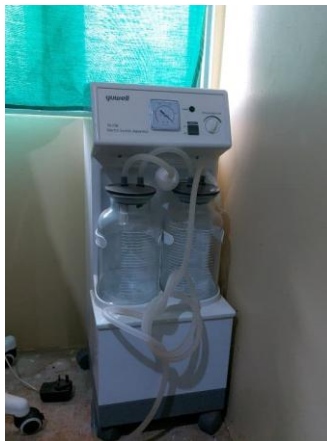
**Figure 86: Suction apparatus at Kalemungole HC III, Moroto District (Karamoja)**

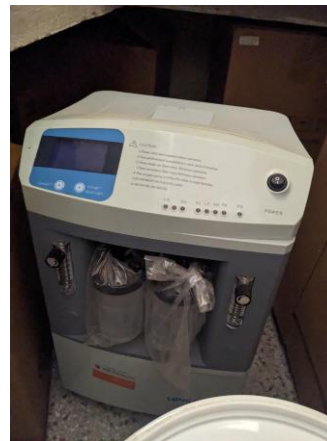
**Figure 87: Oxygen concentrator at Kamoru HC III, Kotido District (Karamoja)**

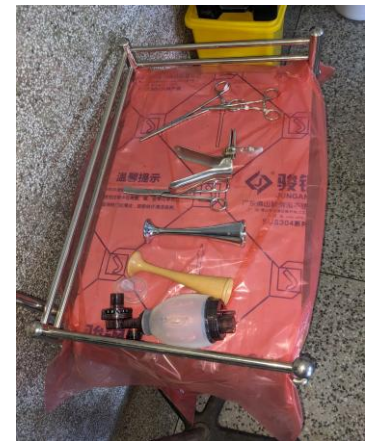
**Figure 88: Instrument trolley with delivery instruments at Kamoru HC III, Kotido District (Karamoja)**

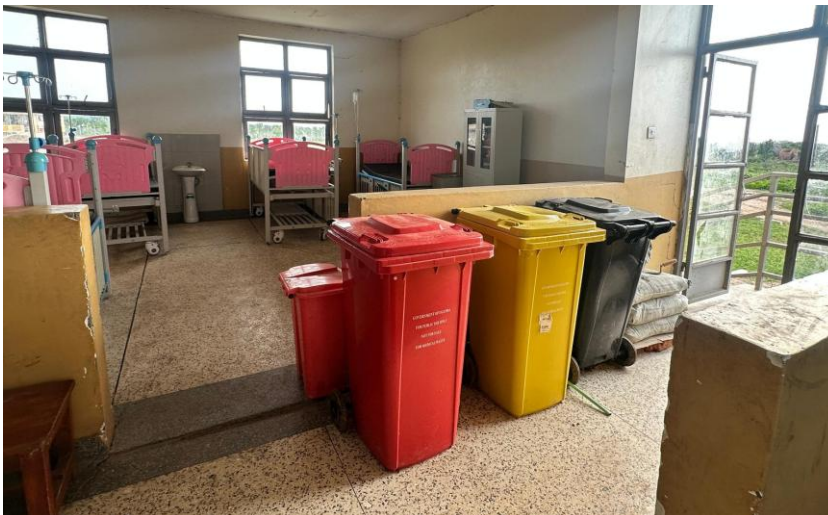
**Figure 89: Medical-waste bins and ward beds at Butiaba HC III, Buliisa District (Bunyoro)**

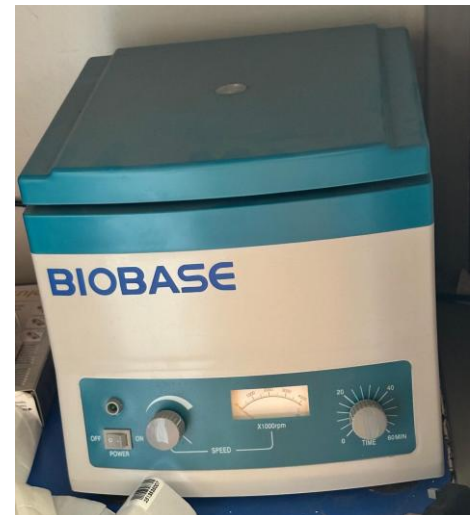
**Figure 90: Laboratory centrifuge at Butiaba HC III, Buliisa District (Bunyoro)**

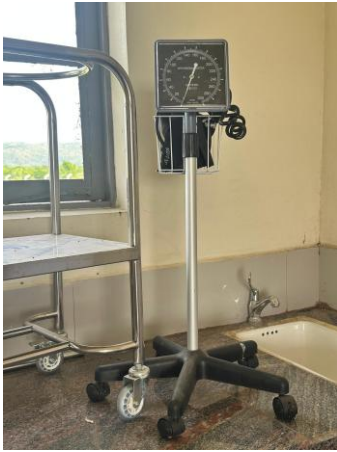
**Figure 91: Blood pressure apparatus on a mobile stand at Butiaba HC III, Buliisa District (Bunyoro)**

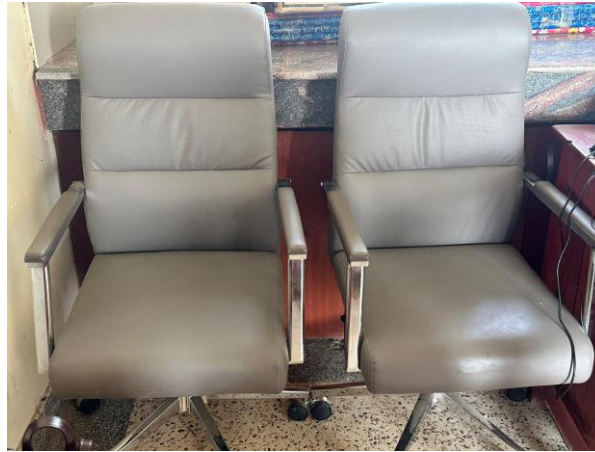
**Figure 92: Office chairs at Butiaba HC III, Buliisa District (Bunyoro)**

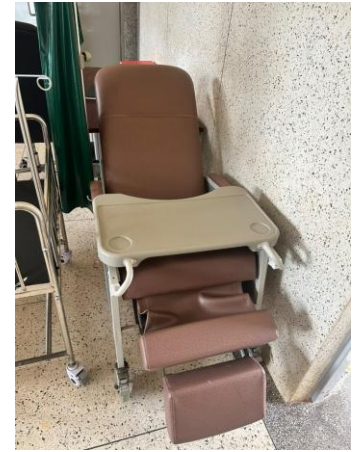
**Figure 93: Kangaroo care chair at Kyabasara HC III, Kagadi District (Bunyoro)**

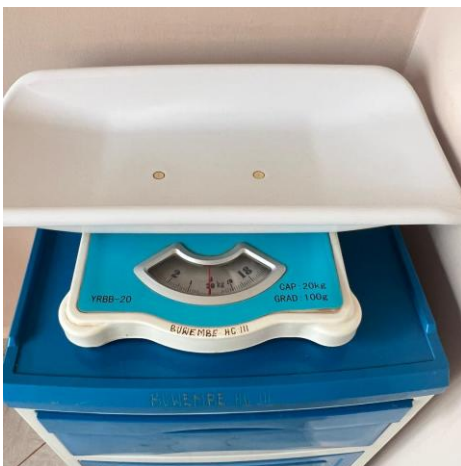
**Figure 94: Infant weighing scale at Buwembe HC III, Busia District (Bukedi)**

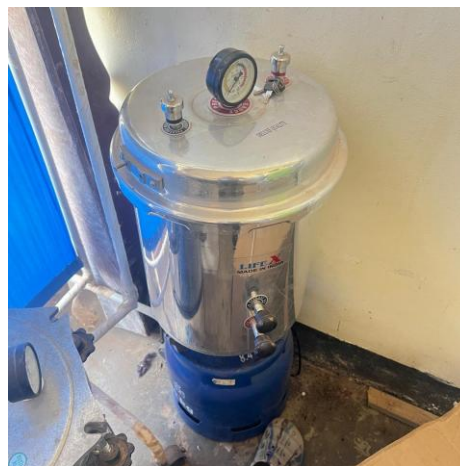
**Figure 95: Autoclave above a gas cylinder at Buwembe HC III, Busia District (Bukedi)**

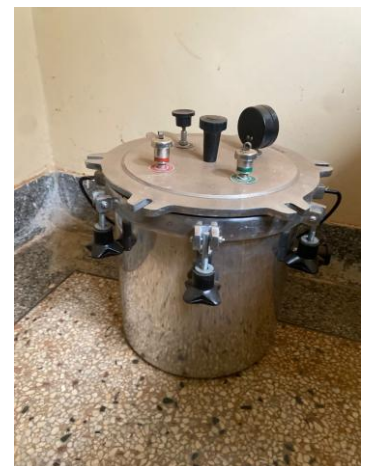
**Figure 96: Autoclave at Atar HC III, Kween District (Sebei)**

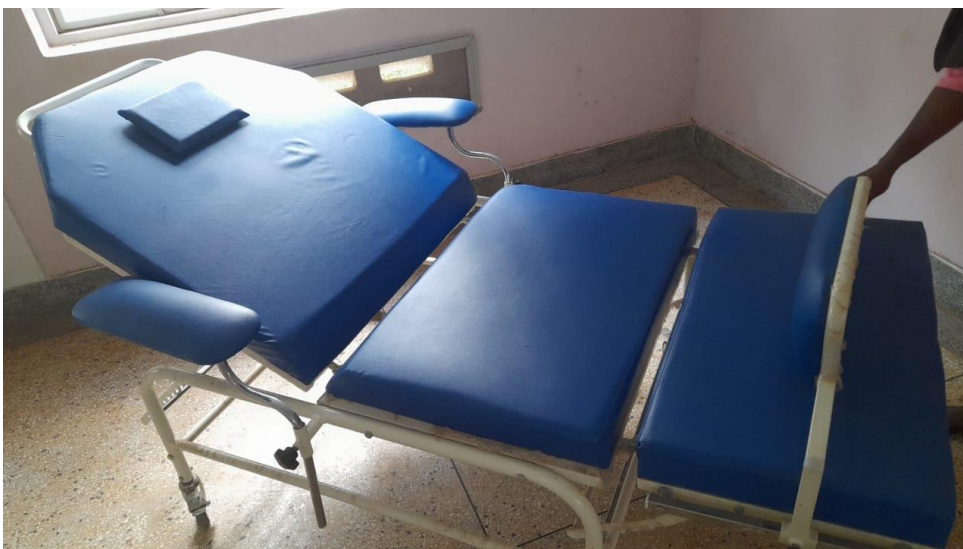
**Figure 97: Kangaroo care chair at Atar HC III, Kween District (Sebei)**

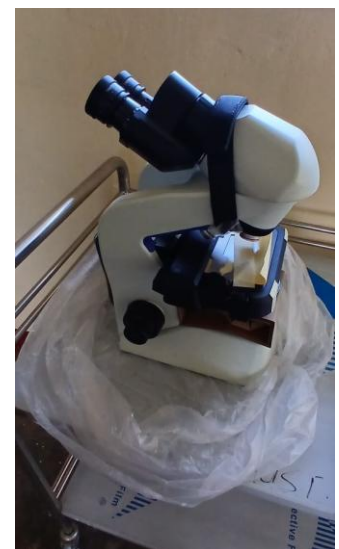
**Figure 98: Binocular microscope on a trolley at Namusita HC III, Budaka District (Bukedi)**

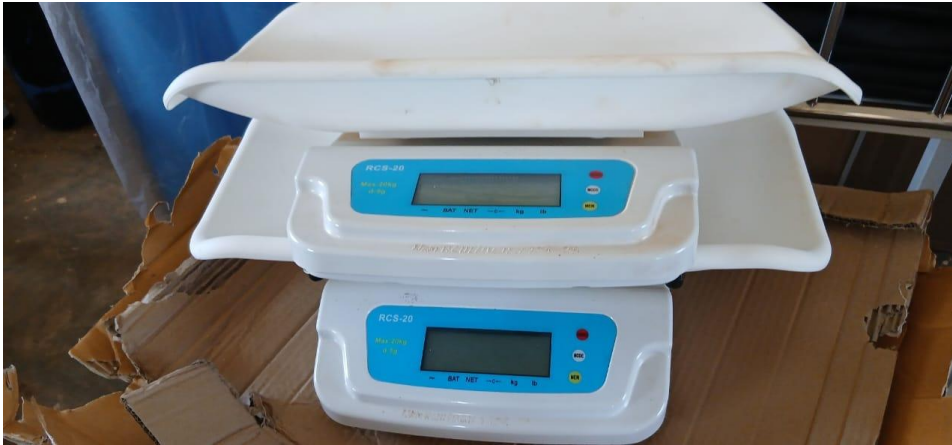
Figure 99: Infant weighing scales at Namusita HC III, Budaka District (Bukedi)

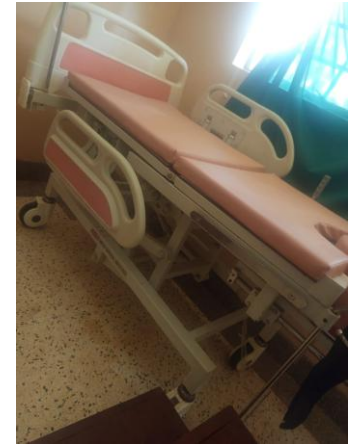
Figure 100: Delivery bed with side rails at Kabweri HC III, Kibuku District (Bukedi)

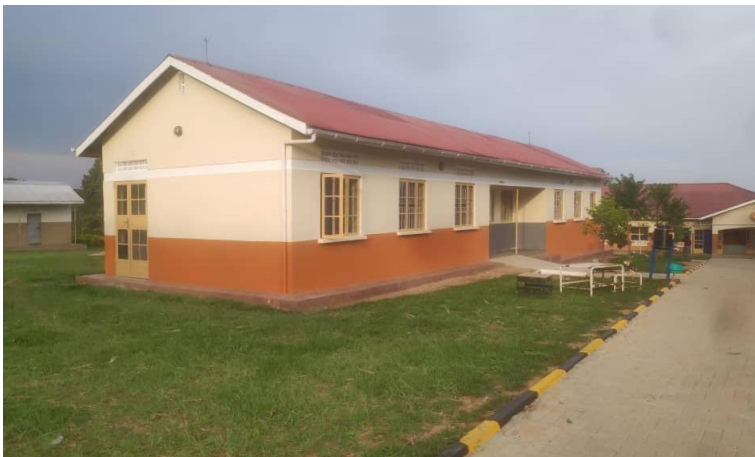
Figure 101: Health centre building, Nwoya District (Acholi)

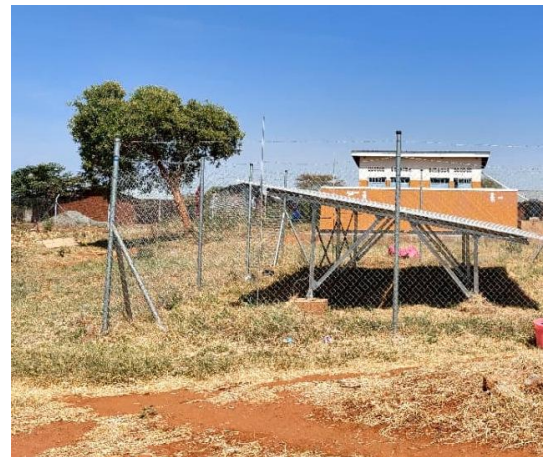
Figure 102: Solar panels at Kalemungole HC III, Moroto District (Karamoja)

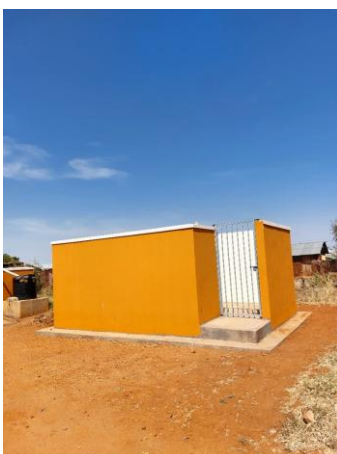
Figure 103: Patient toilet block at Kalemungole HC III, Moroto District (Karamoja)

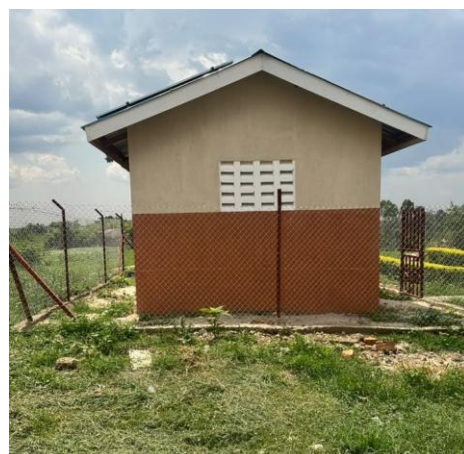
Figure 104: Power house at Kyabasara HC III, Kagadi District (Bunyoro)
