#### **ATLANTIS EM122 CALIBRATION NOTES**

Multibeam Advisory Committee (2017-03-21)

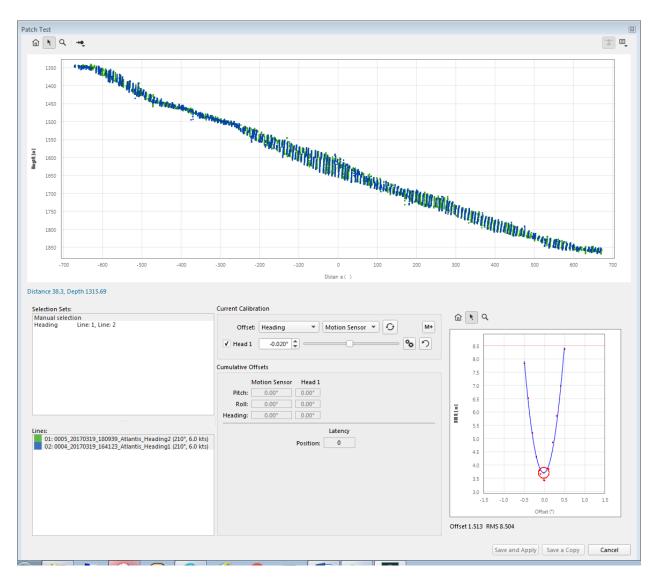
Yaw (with +0.04 pitch and -0.12 roll applied in Qimera)

Files: 0004 and 0005

## Initial result to enter in SIS Motion 1 Heading: -0.02°
