Safety Inspection Report

Alden Theatre
Worcester Polytechnic Institute
100 Institute Road
Worcester, MA 01609

Requested By: Kyle Hobin
Inspection Date: October 2, 2009
Inspector: Bill Sapsis

October 2, 2009

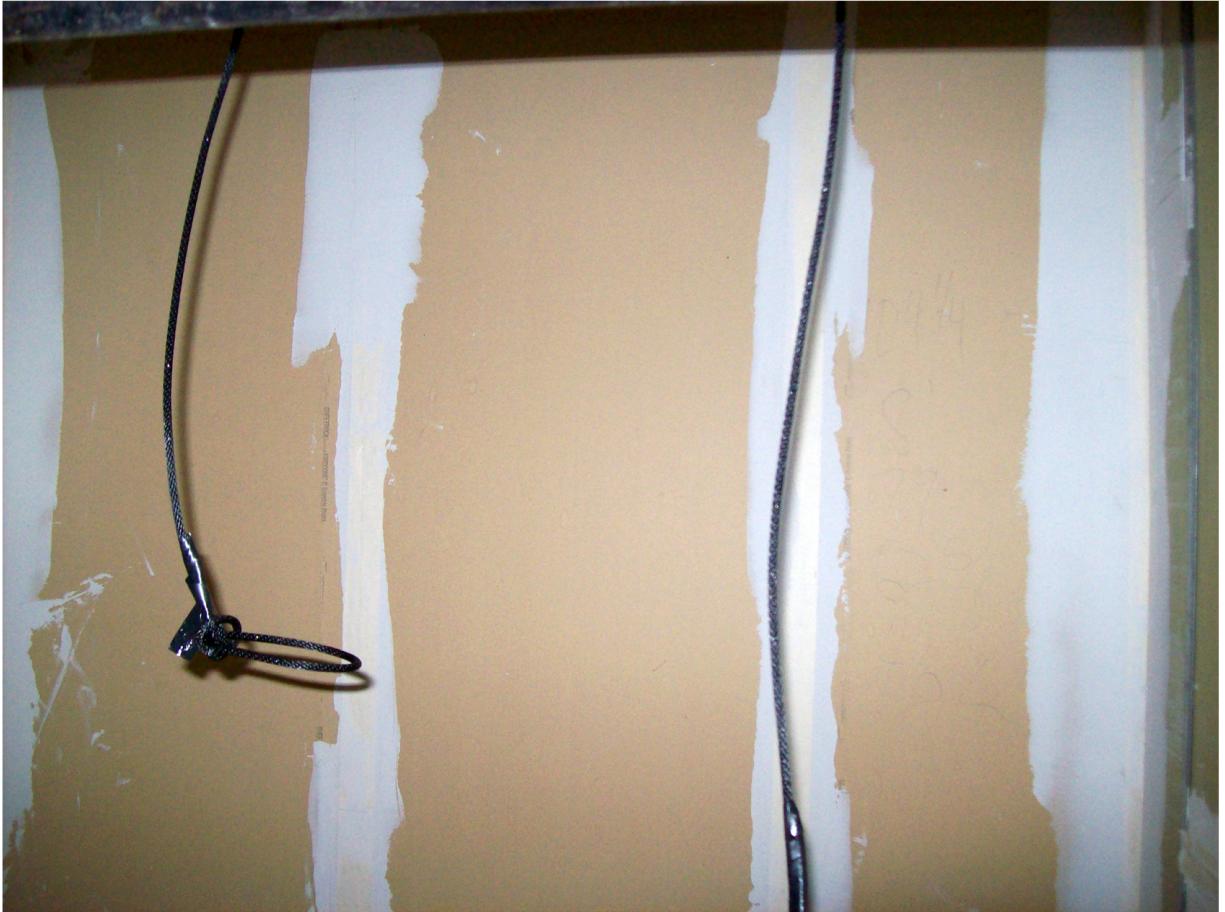
Photo 01.jpg

2.2. The smoke door manual release system is located at the smoke doors in the roof above the grid. This renders these release mechanisms useless as no one should go to the grid if there is a fire in the theatre. The manual release cables should be brought down to the stage level. **Photo 1**

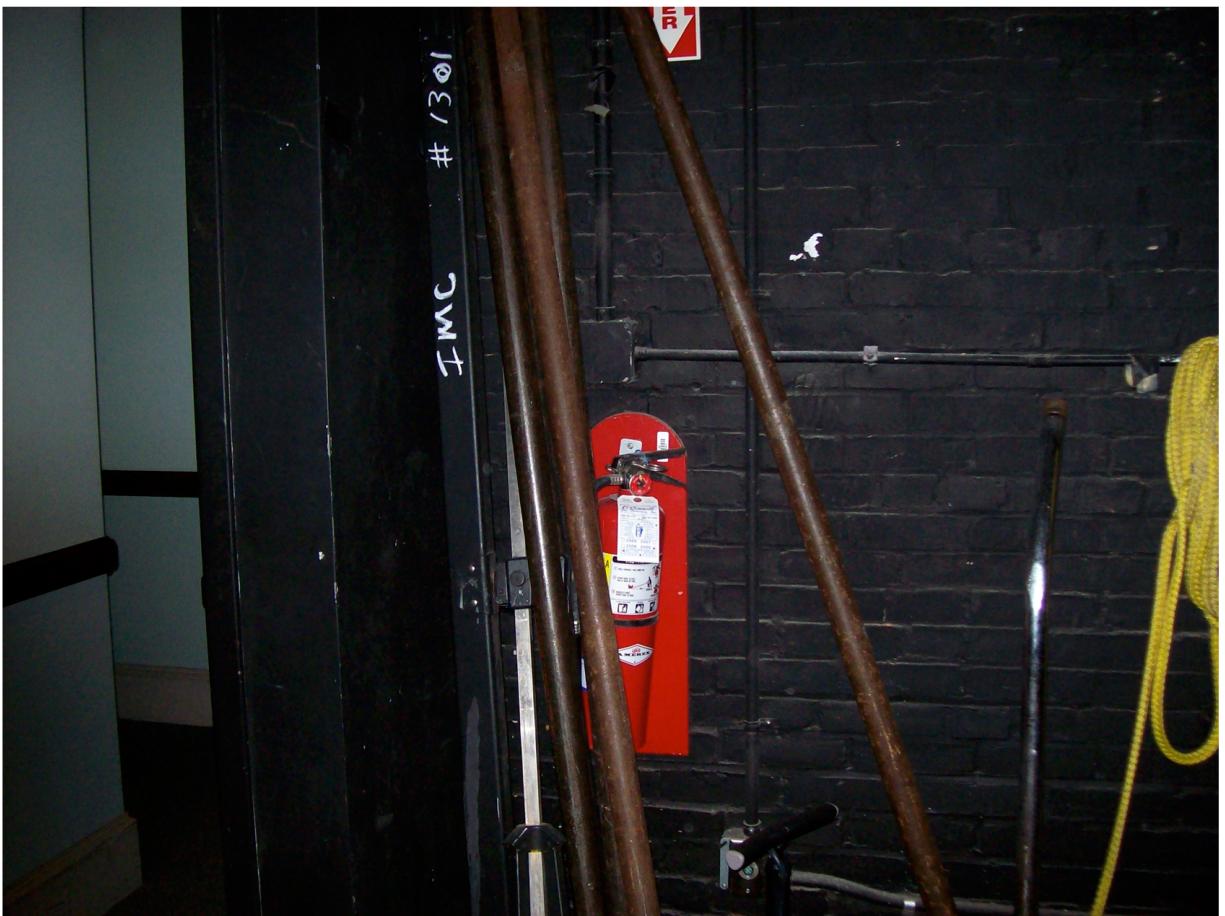
Photo 02.jpg

2.4. Access to the upstage right fire extinguisher is partially blocked. All extinguishers should be kept clear at all times. **Photo 2**

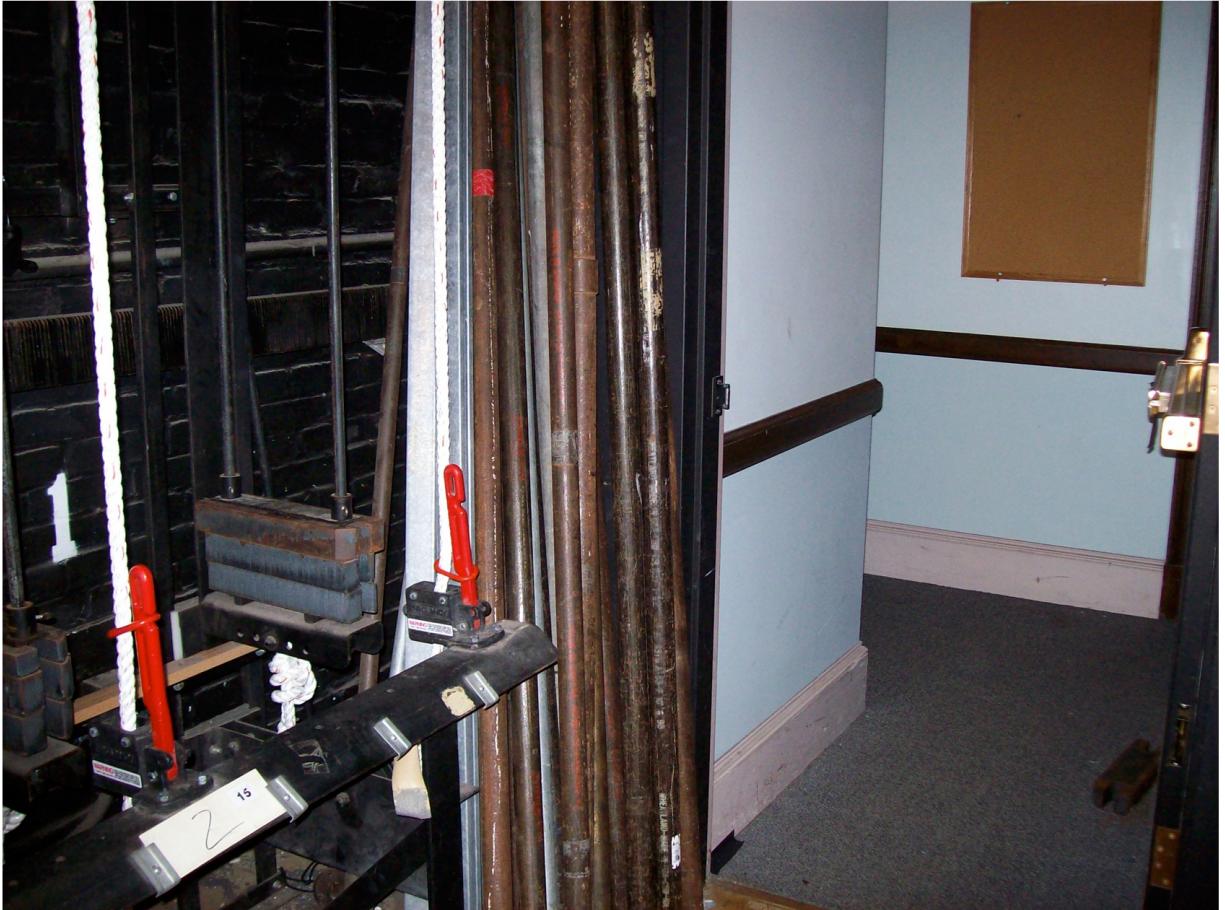
Photo 03.jpg

2.5. The pipe partially blocking the upstage right doorway should be moved. **Photo 3**

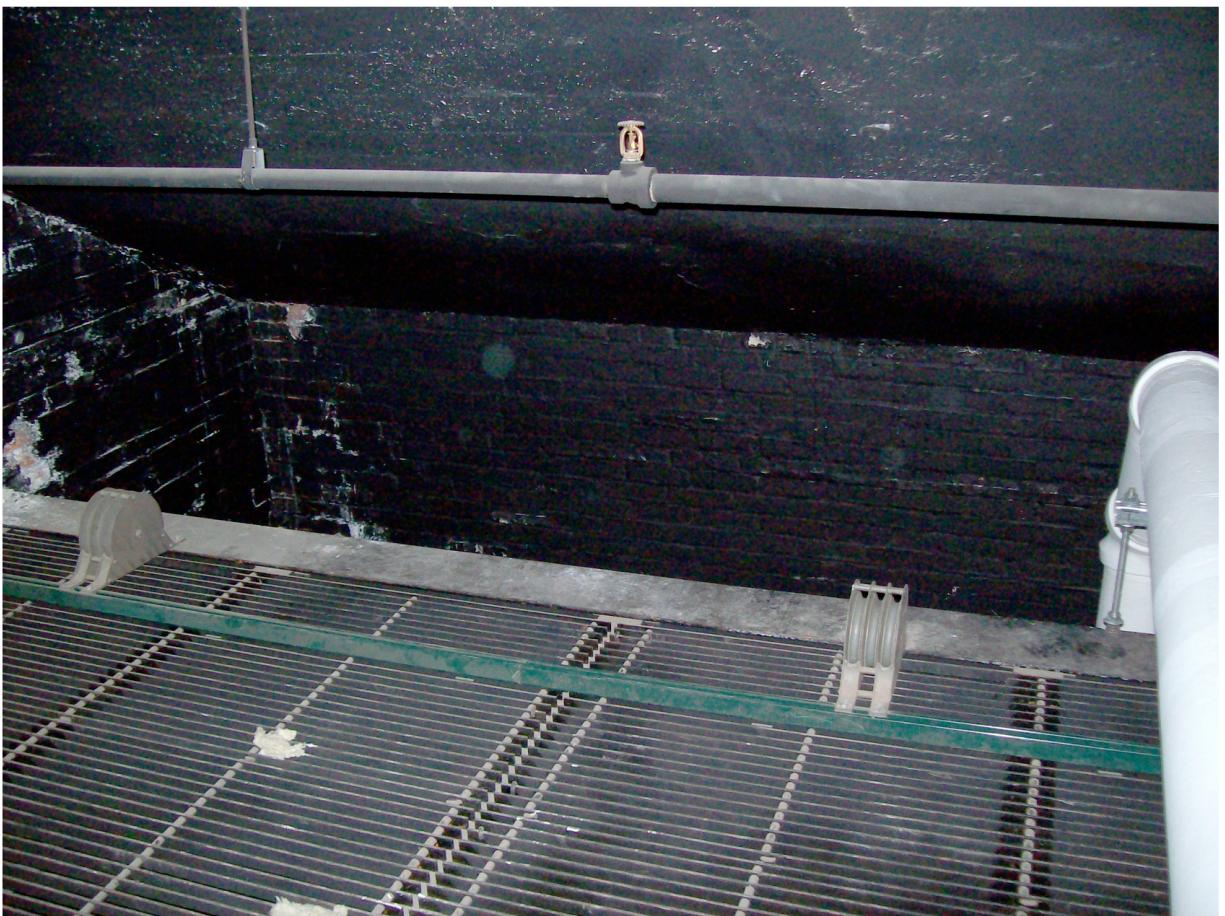
Photo 04.jpg

2.8. A railing is needed on the stage left side of the grid. **Photo 4**

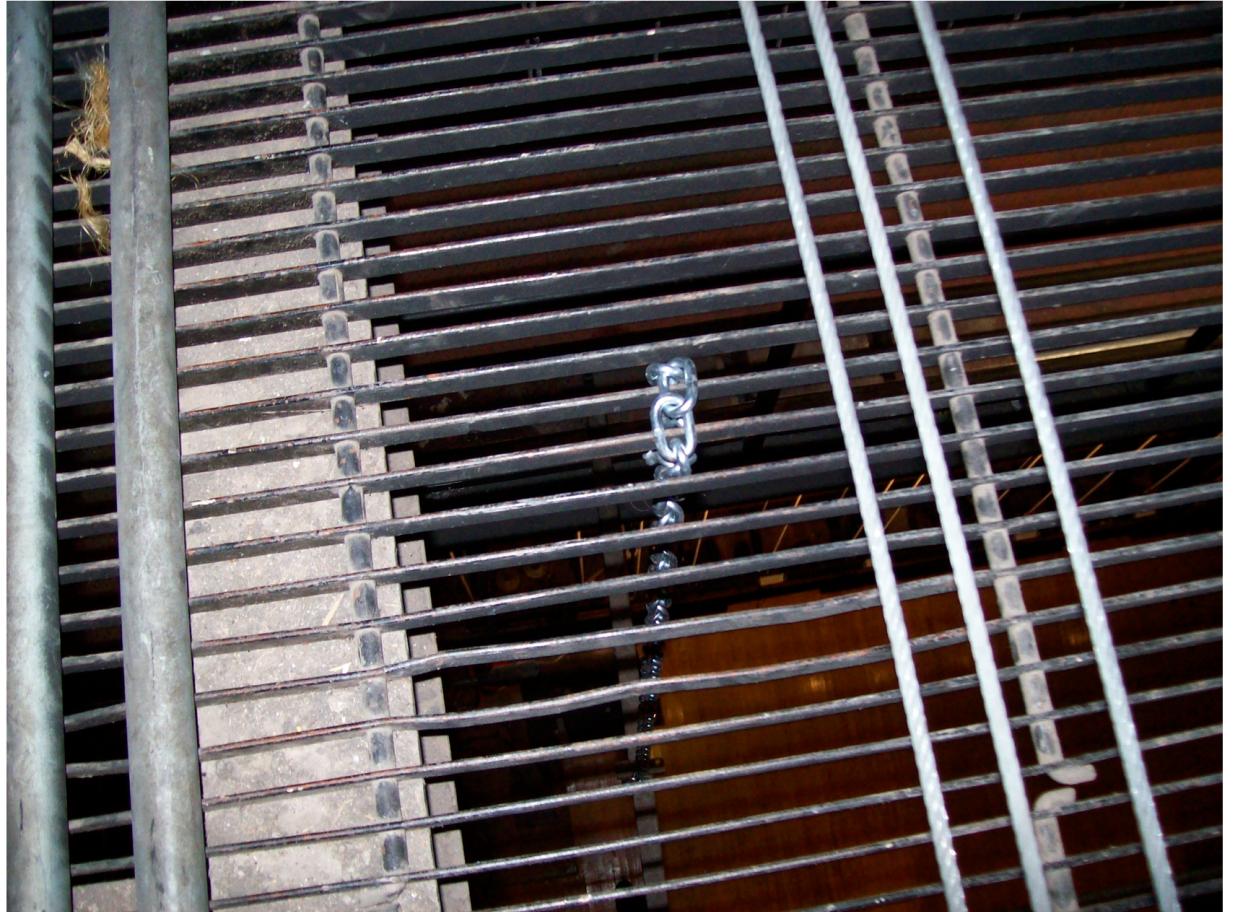
Photo 09.jpg

- 4.11. Several of the dead hang chains are wrapped around the subway grating. The grating was not designed to carry a concentrated load. A bracket that spreads the weight over a wider area would be more appropriate for this application. **Photo 9**

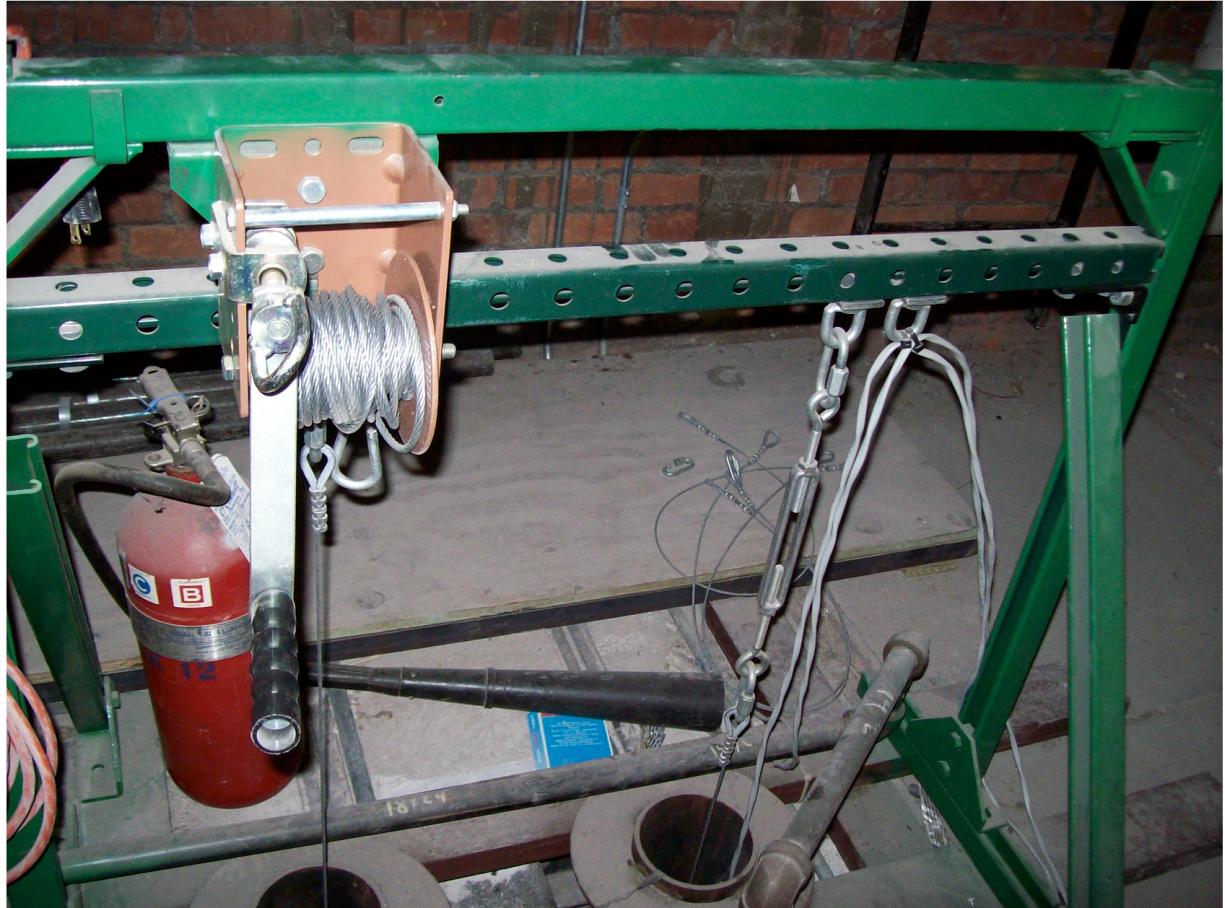
Photo 12.jpg

The rigging for the speaker cluster has the following problems: **Photo 12**

- 6.1. The 1/8" aluminum sleeves have only 2 crimps. 3 are required.
- 6.2. The non-rated screw eye used to support the tilt cable should be replaced with a load rated plate and lag bolts assembly.

6.3. There is no way to lock down the Unistrut hardware used throughout the rig.
Bolt-through connections would be more appropriate for this application.

6.4. There is an unrated turnbuckle used within this set up. It should be replaced.

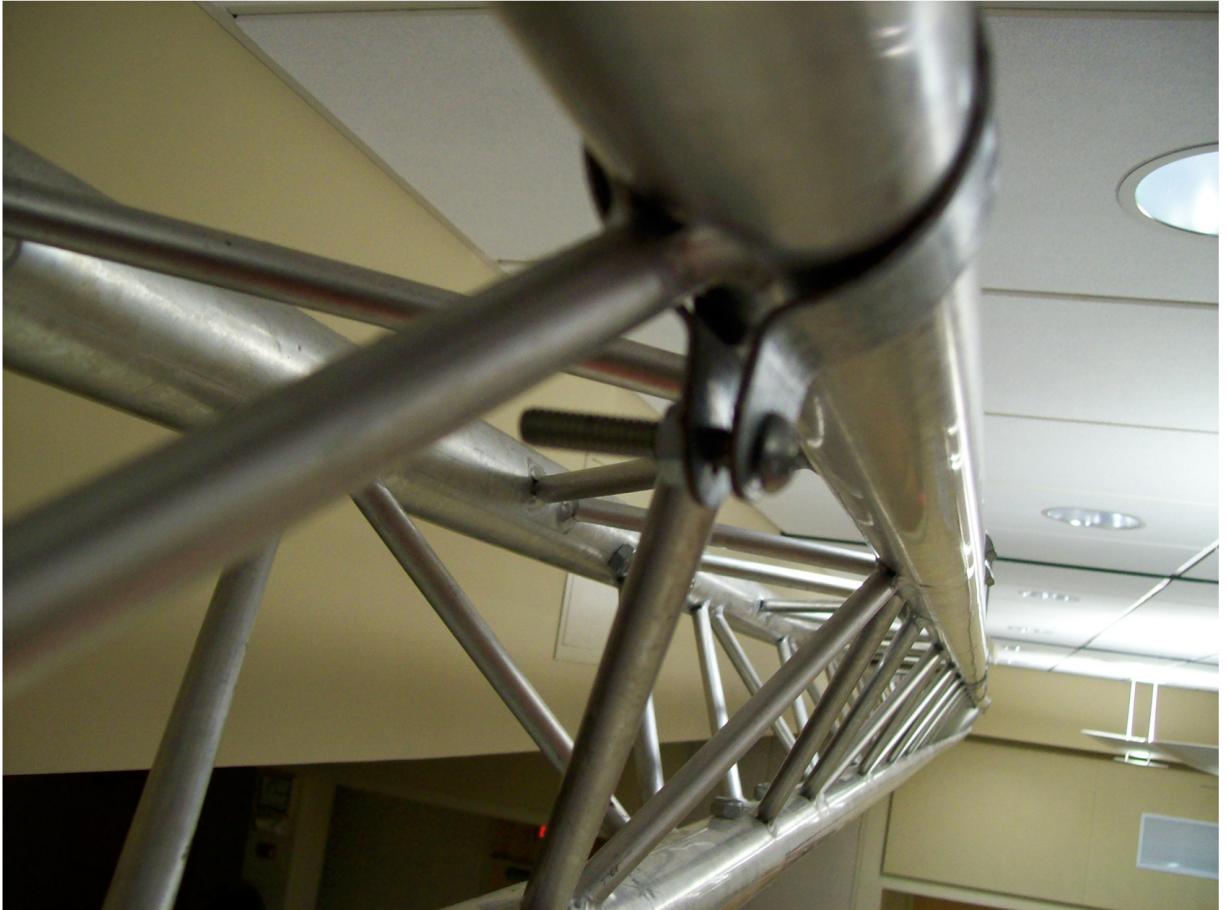
Photo 15.jpg

1. This is a hotel style meeting room. Lighting truss is suspended from ceiling mounted Unistrut track channel.
2. The room is used for college meetings.
3. The following problems were noted:
 - 3.1. There is no method for locking down the unistrut nuts that connect the threaded rod hangers to the unistrut. Two of these nuts are loose and no longer supporting the truss. **Photos 13 & 14**
 - 3.2. The load rating of the conduit hangers used to support the lighting truss should be determined. **Photo 15**

This situation is unsafe and should be addressed as quickly as possible.
