Ref. No.: IIT(BHU)/CE/KrKP/25-26/UPRNSS/ITI/Chhanbe/Mirzapur/Rooms/02 Date: 14/11/2025

### Third Party Inspection Report on Construction of Various Rooms in the Campus of ITI Chhanbe, Dist. Mirzapur (UP)

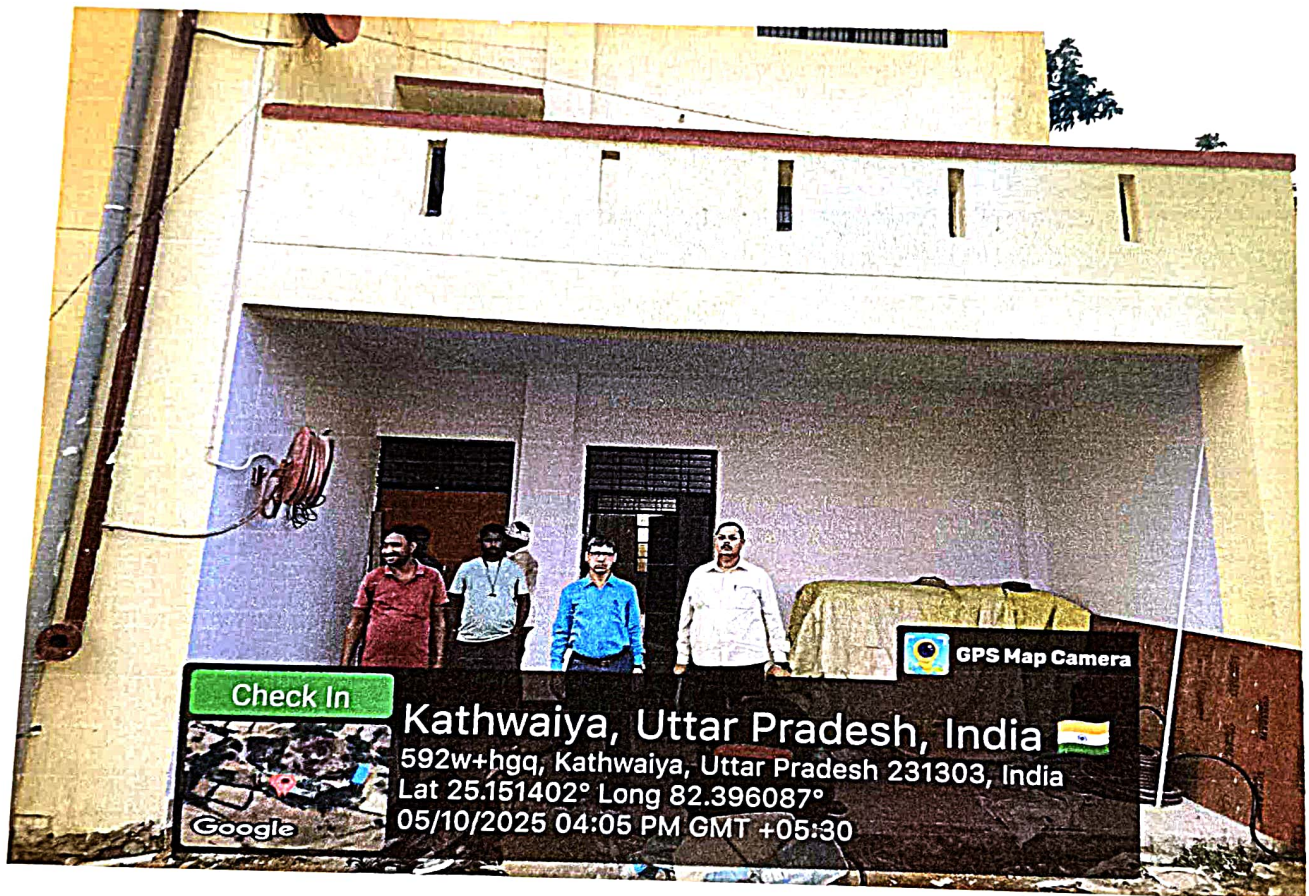
**Fig. 1:** Front view of the building

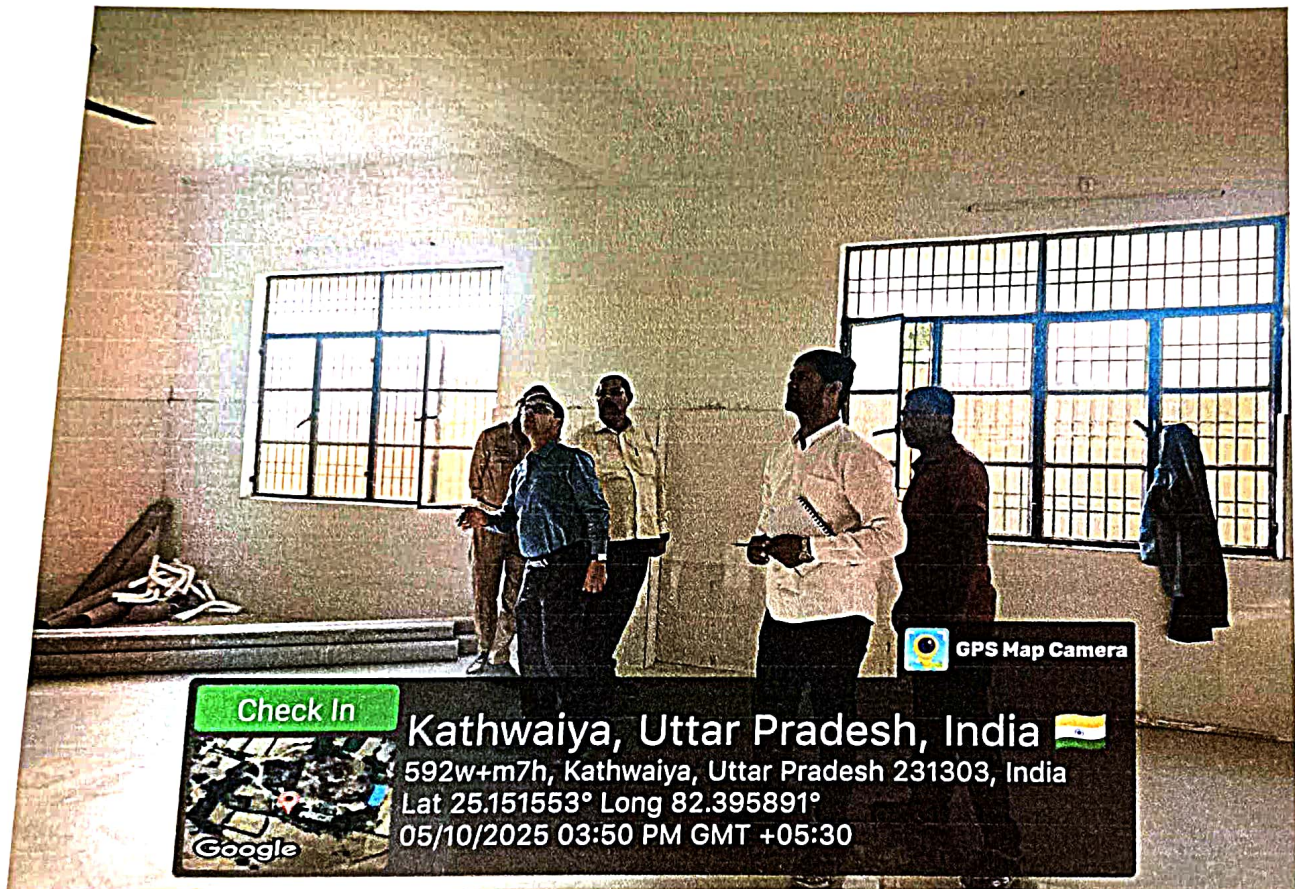
**Fig. 2:** Inspection of class room

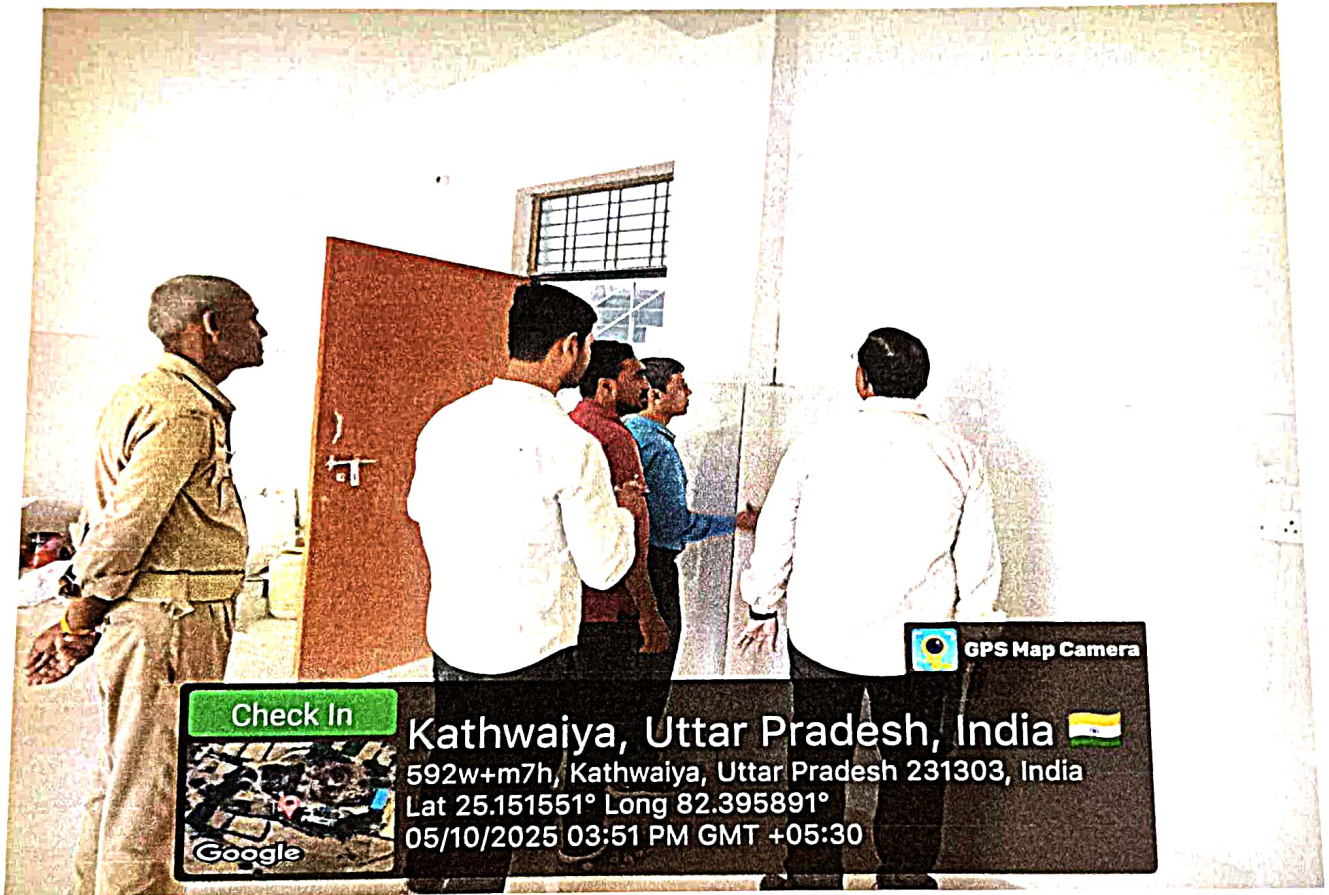
Fig. 3: Inspection of wall tiles

- Unfilled tile joints should be completed grouted.
- Column head on the terrace should be properly cast.
- Drain along the boundary wall should be properly laid.
- Signage should be placed on the building elements.
- Building should be properly cleaned before handover.

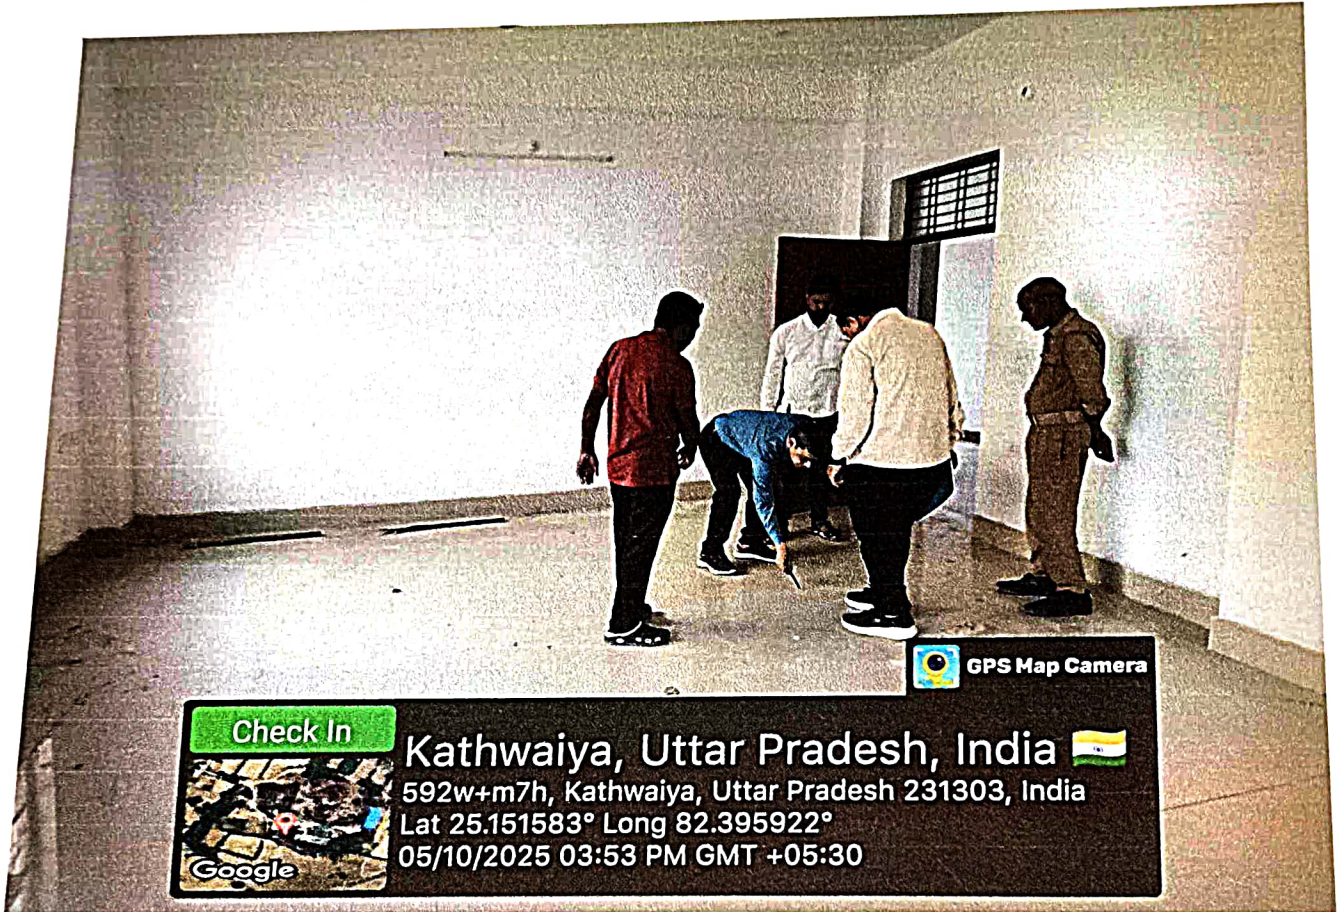
Fig. 4: Inspection of flooring

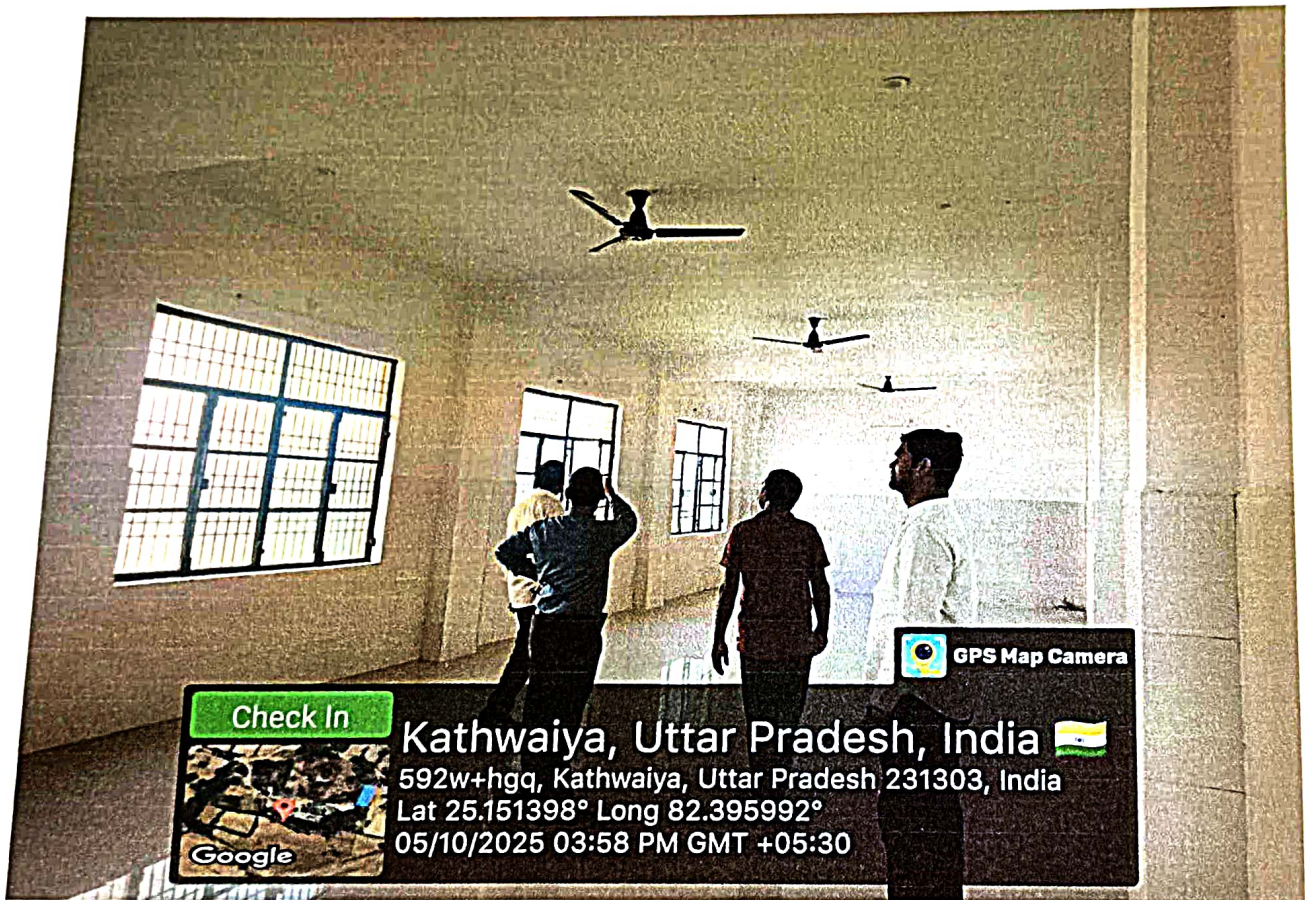
Fig. 5: Inspection of finishing work

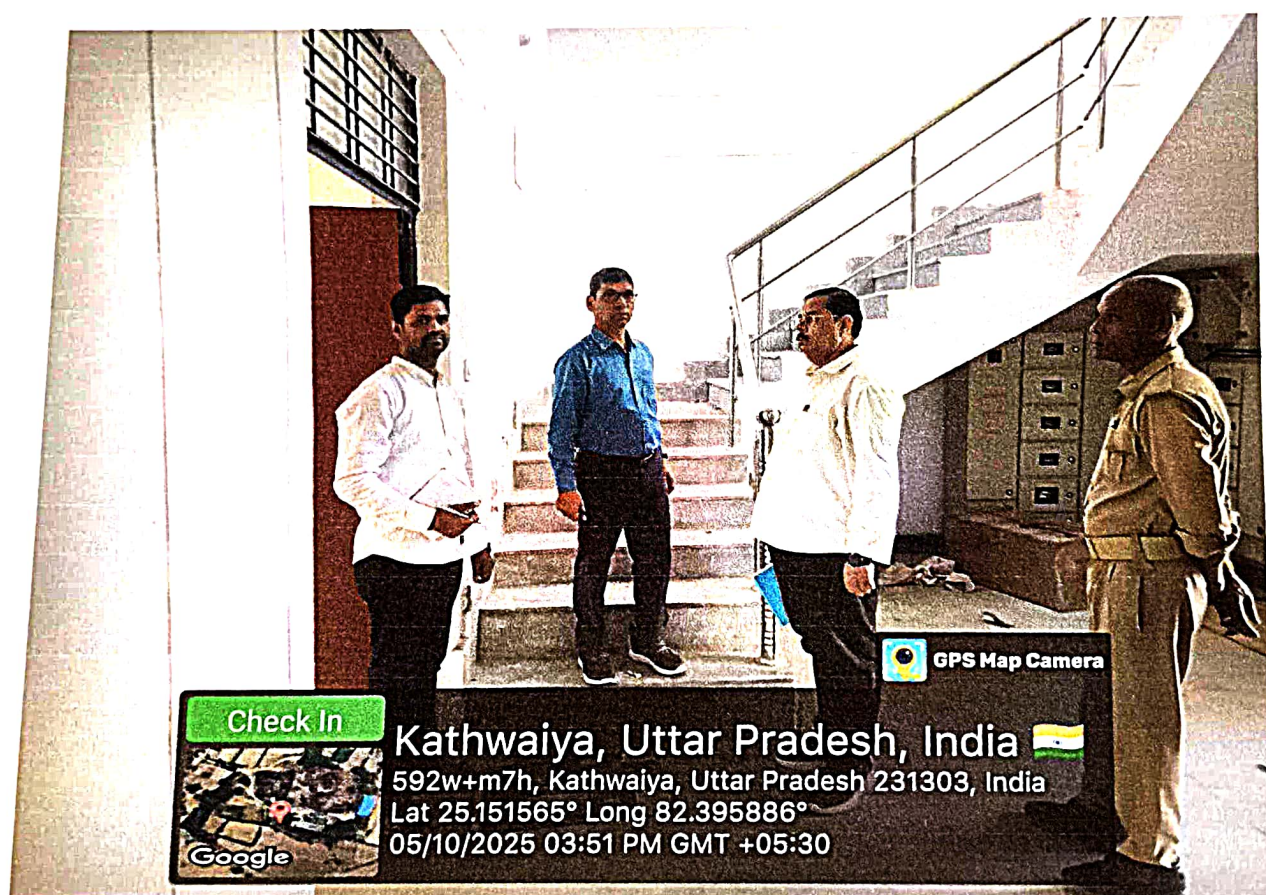
**Fig. 6:** Inspection of staircase

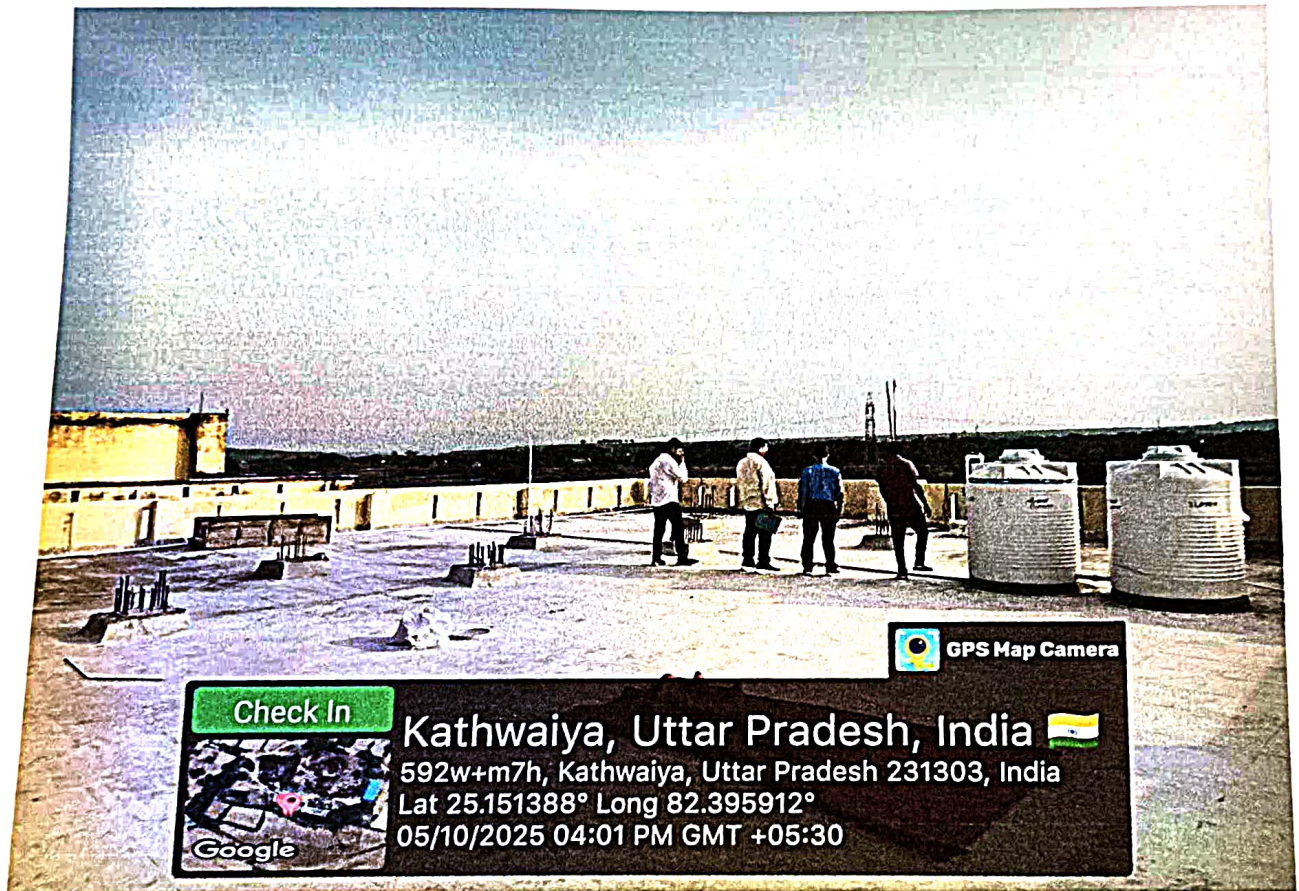
**Fig. 7:** Inspection of terrace
