INDIAN  
INSTITUTE OF  
TECHNOLOGY  
BANARAS HINDU UNIVERSITY

## Department of Civil Engineering

Ref. No.: IIT(BHU)/CE/KrKP/25-26/UPRNSS/ITI/ Mirzapur/02

### Third Party Inspection Report on Construction of Workshop and Residential Buildings in ITI Dist. Mirzapur (UP)

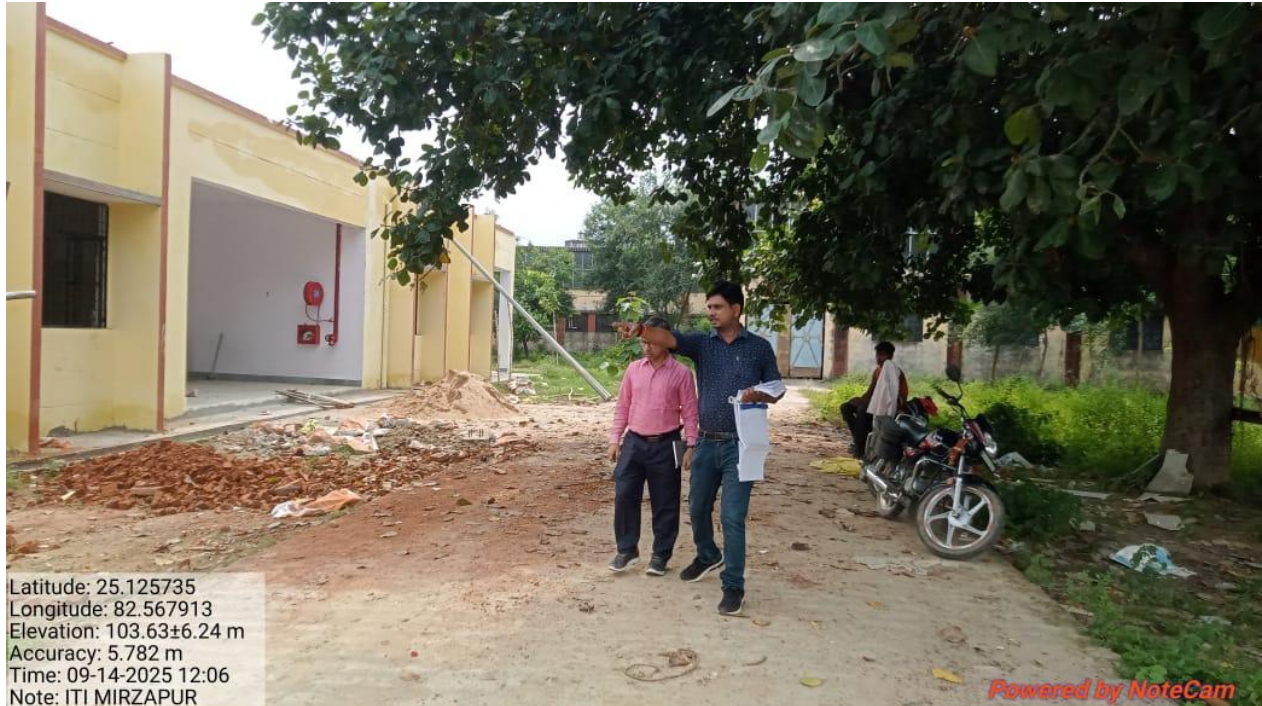
| Sr. No. | Elements | Progress | Remark |
|---|---|---|---|
| 1 | Plastic Processing Lab | Structure work is completed. Flooring and brick koba works are completed. Door window work completed. Plastering, painting and fire fighting works completed. Flooring work completed. Electrical and sanitary works are in progress. | Minor seepage is observed on the walls. It should be rectified.<br>Overall quality of construction is found satisfactory. |

**Fig. 1:** Plastic processing lab- Front view

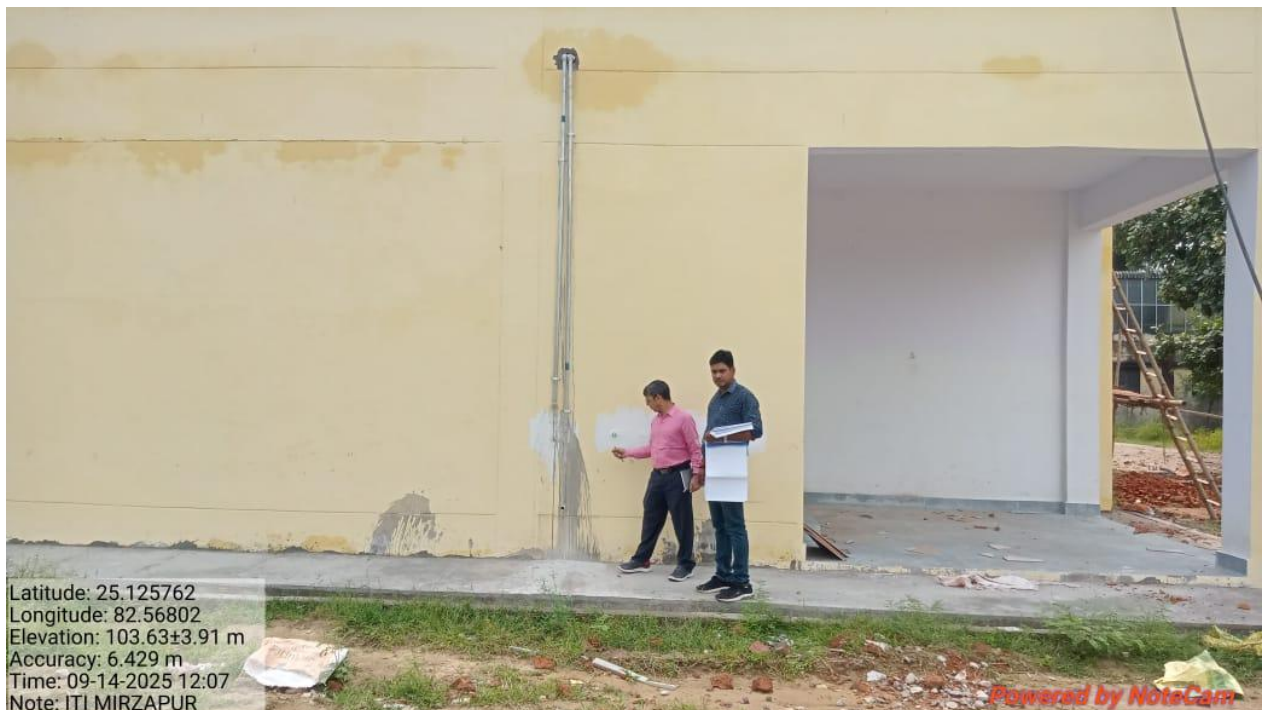
**Fig. 2:** Plastic processing lab-Side view

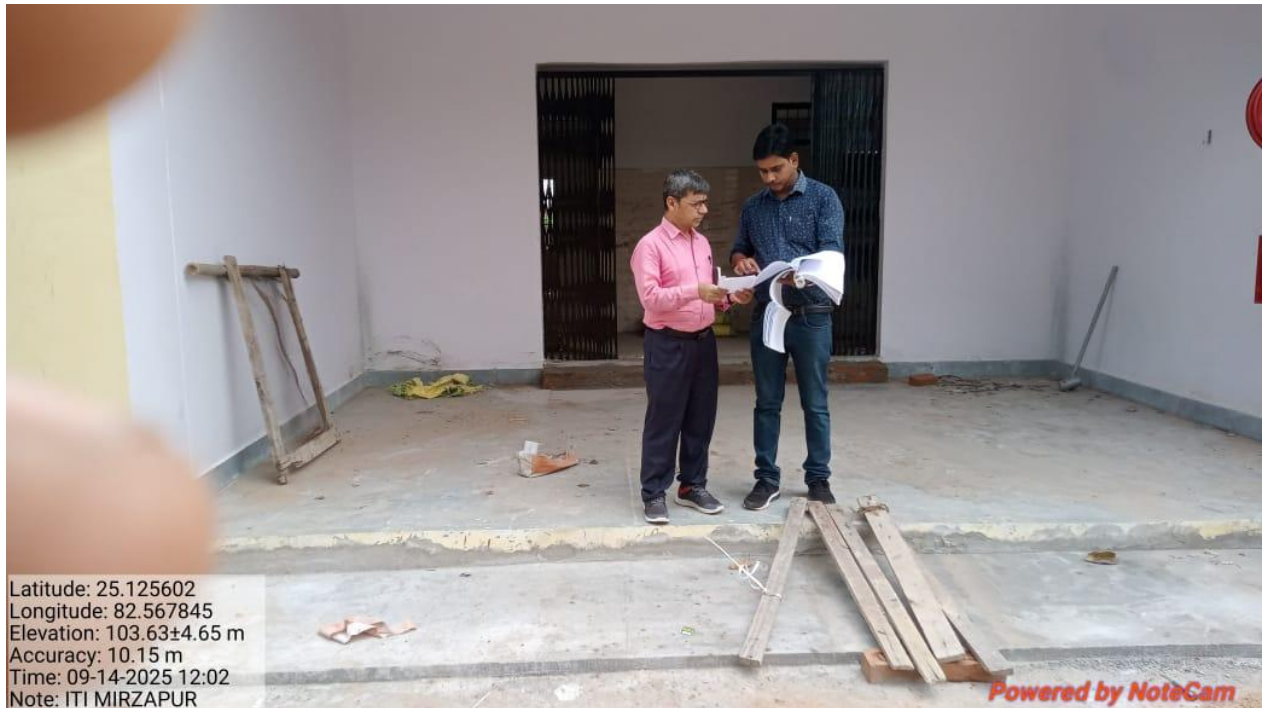
**Fig. 3: Study of documents**

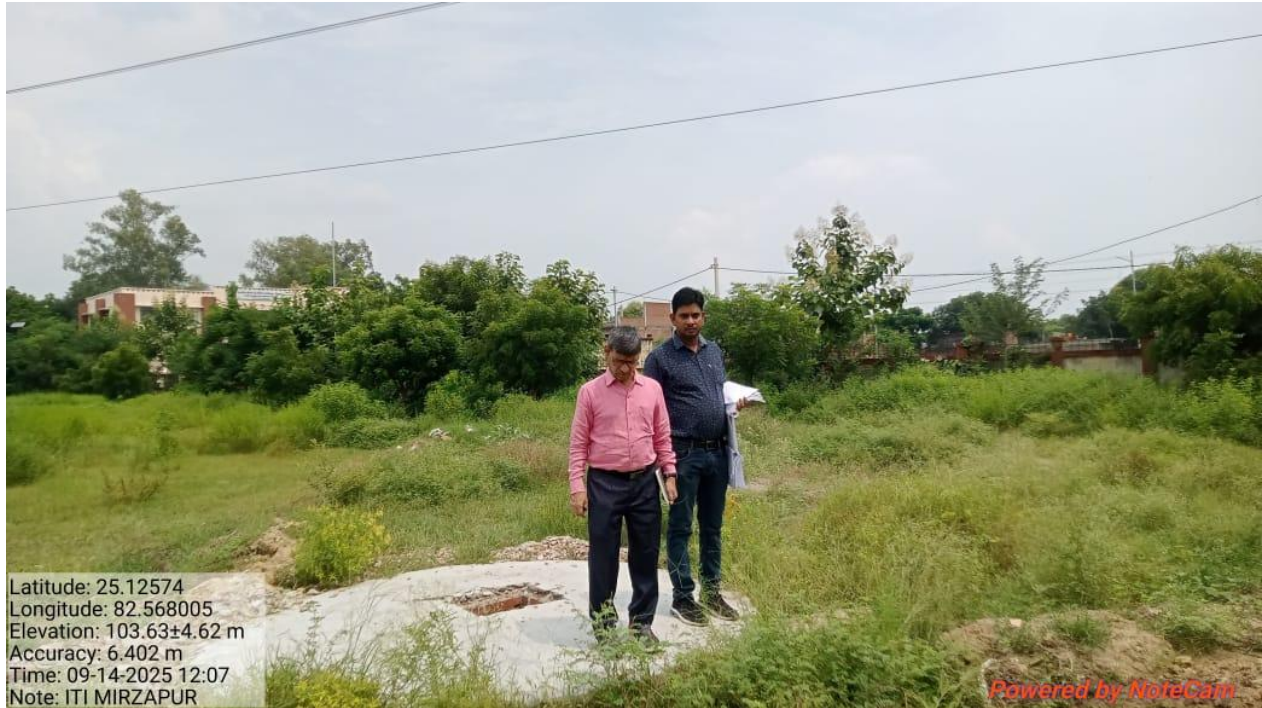
| Sr. No. | Elements | Progress | Remark |
|---|---|---|---|
| 4 | Rain water harvesting | Two numbers of Rain Water harvesting units have been constructed. | Overall quality of construction is found satisfactory. |

**Fig. 4:** Rain water harvesting pit

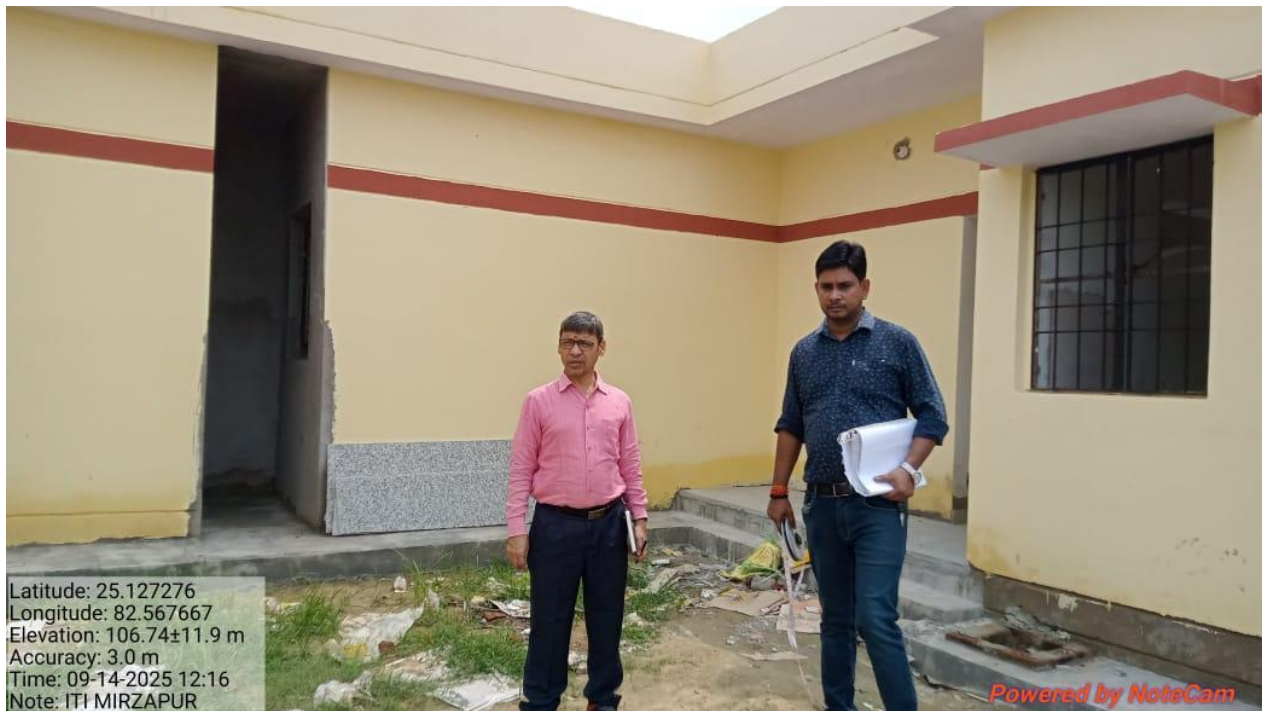
| Sr. No. | Elements | Progress | Remark |
|---|---|---|---|
| 2 | Type 3 (2 nos.) | Structure work is completed. Plastering is completed. Painting, electrical and sanitary works are in progress. | Overall quality of construction is found satisfactory. |

**Fig. 5:** Status of type 3 quarters

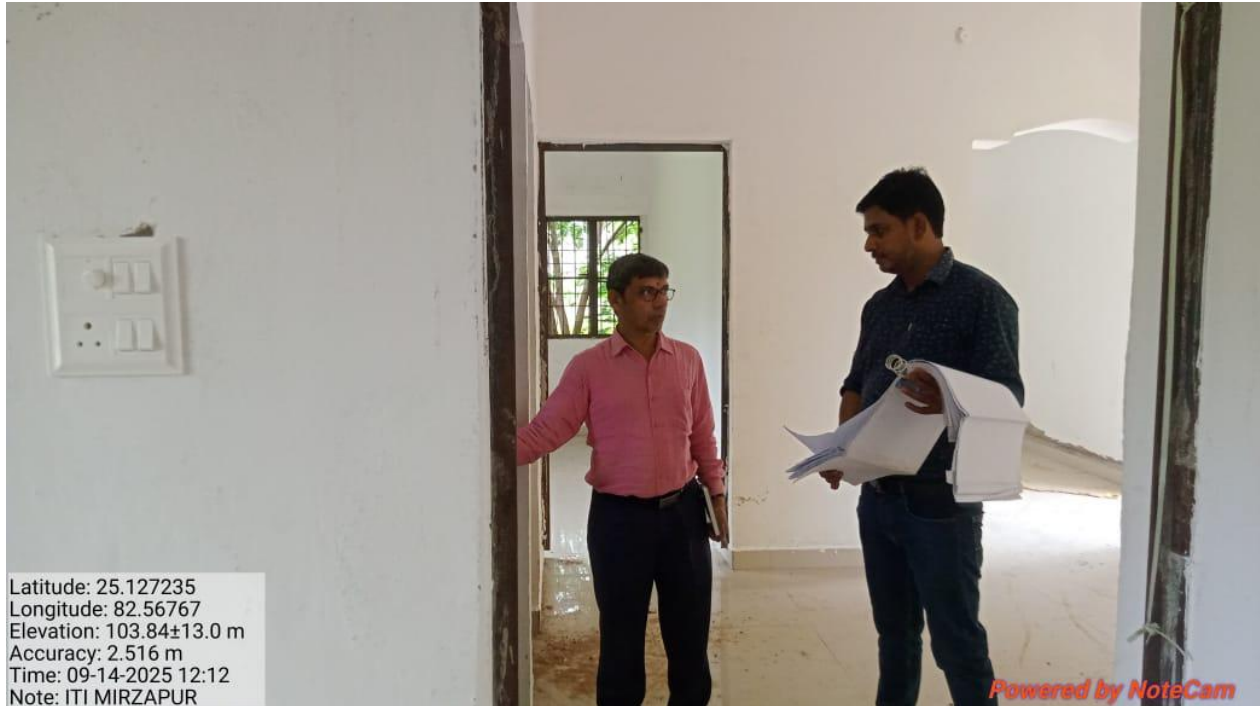
**Fig. 6:** Inspection of door fixing

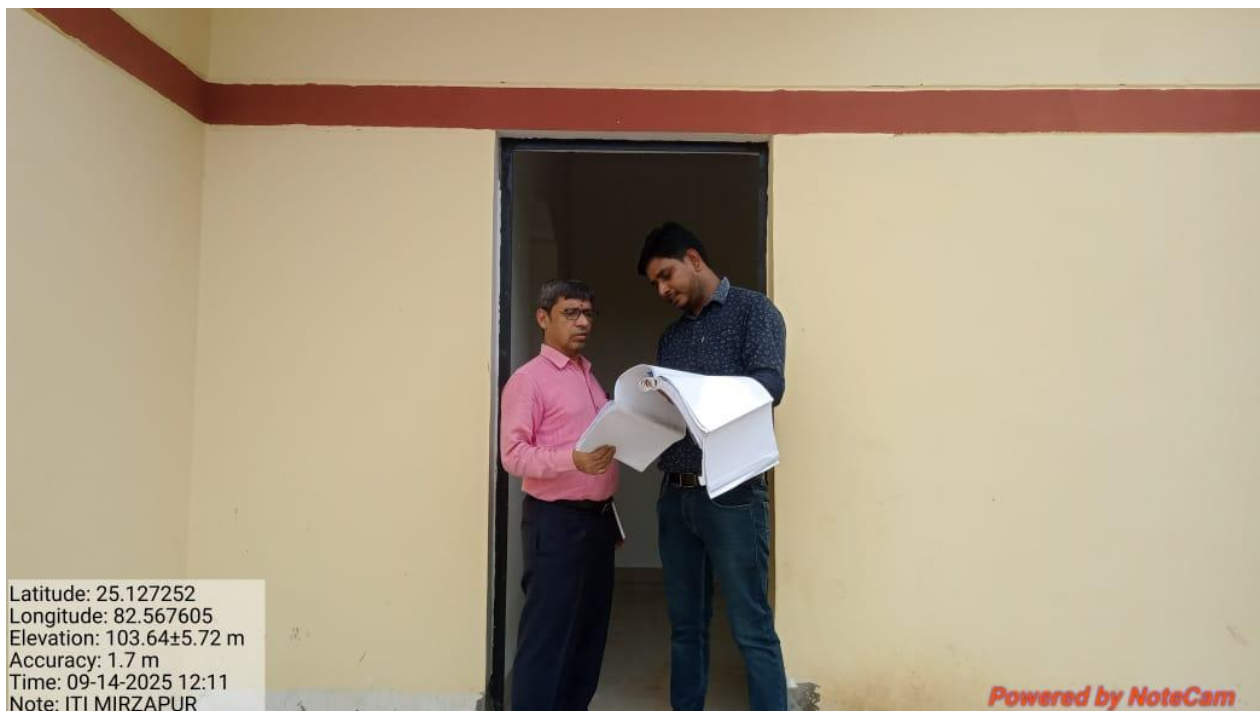
**Fig. 7:** Checking of documents

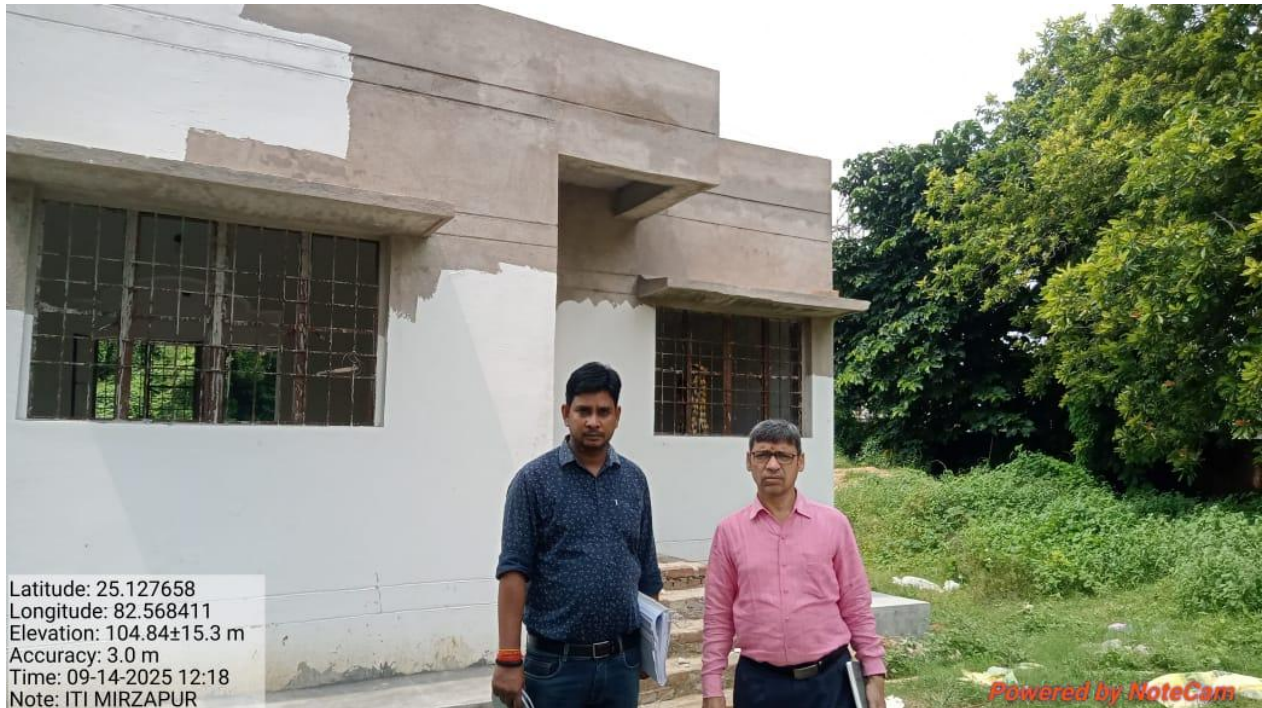
| Sr. No. | Elements | Progress | Remark |
|---|---|---|---|
| 3 | Type 2 (1 nos.) | Structure work is completed. Plastering is completed. Door window frame fixing works are in progress. Flooring works are in progress. | Overall quality of construction is found satisfactory. |

**Fig. 8:** Status of type 2 quarter

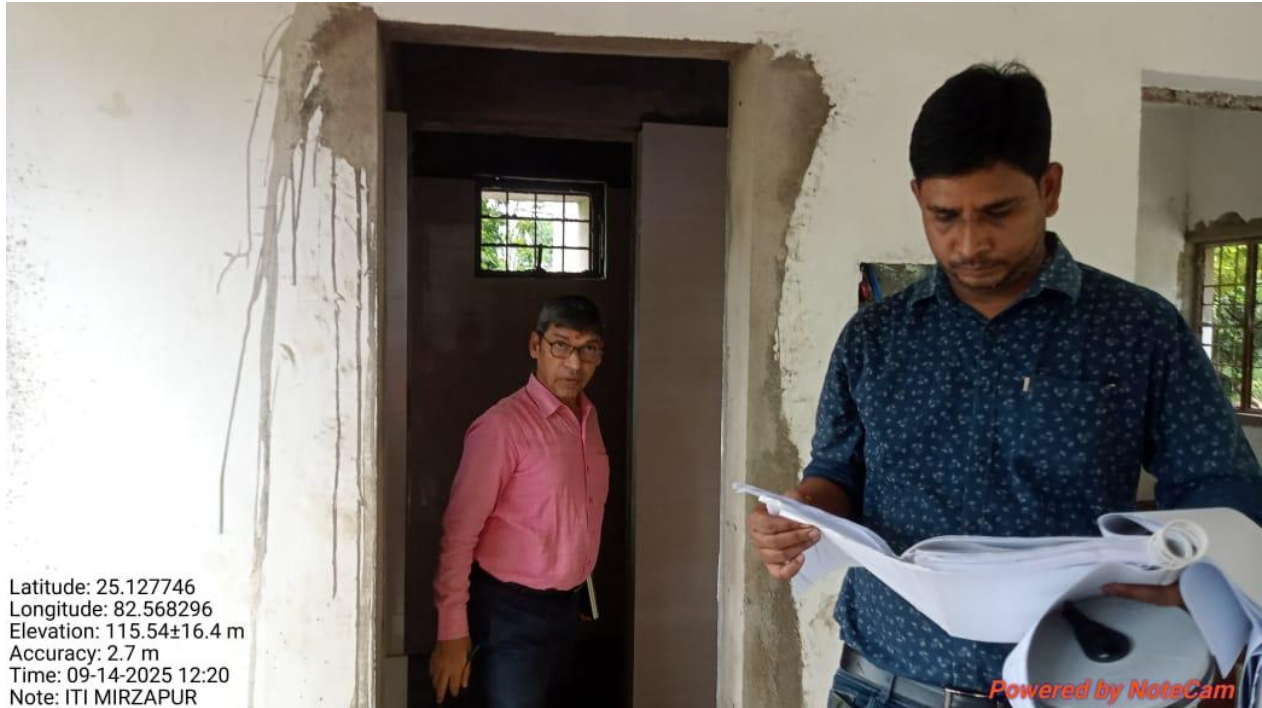
**Fig. 9:** Inspection of toilet

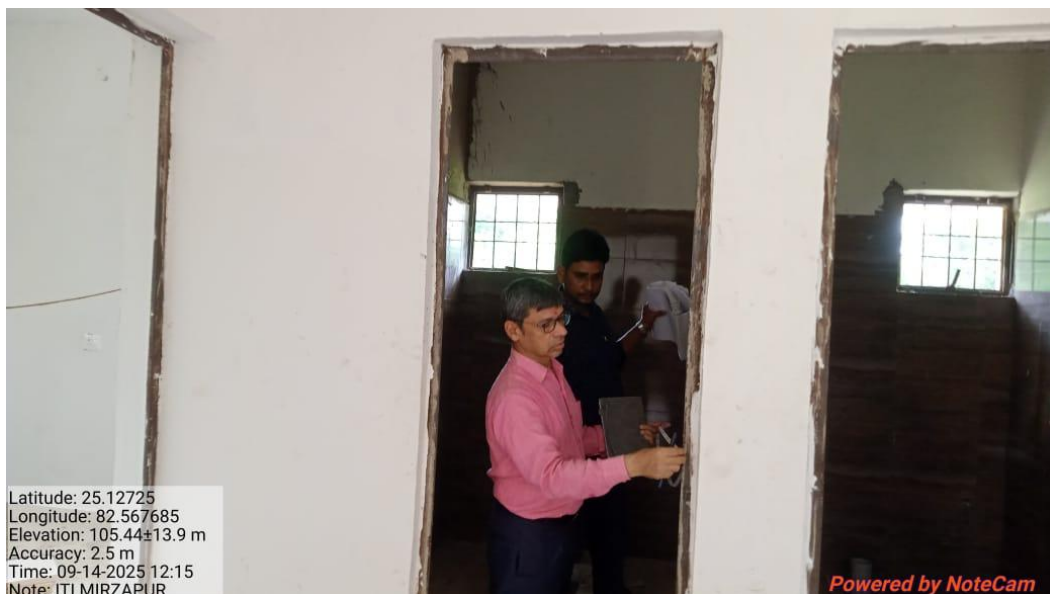
**Fig. 10:** Measurement of dimensions
