**Third Party Inspection Report on**  
**50 Bedded Field Hospital in the Campus of**  
**Community Health Centre, Dist. Bhadohi (UP)**

| 1 | Reference letter no. | 2113/Work-167, Dated: 21/12/2024 |
| 2 | Date of Inspection | 4 <sup>th</sup> Jan., 2025 |

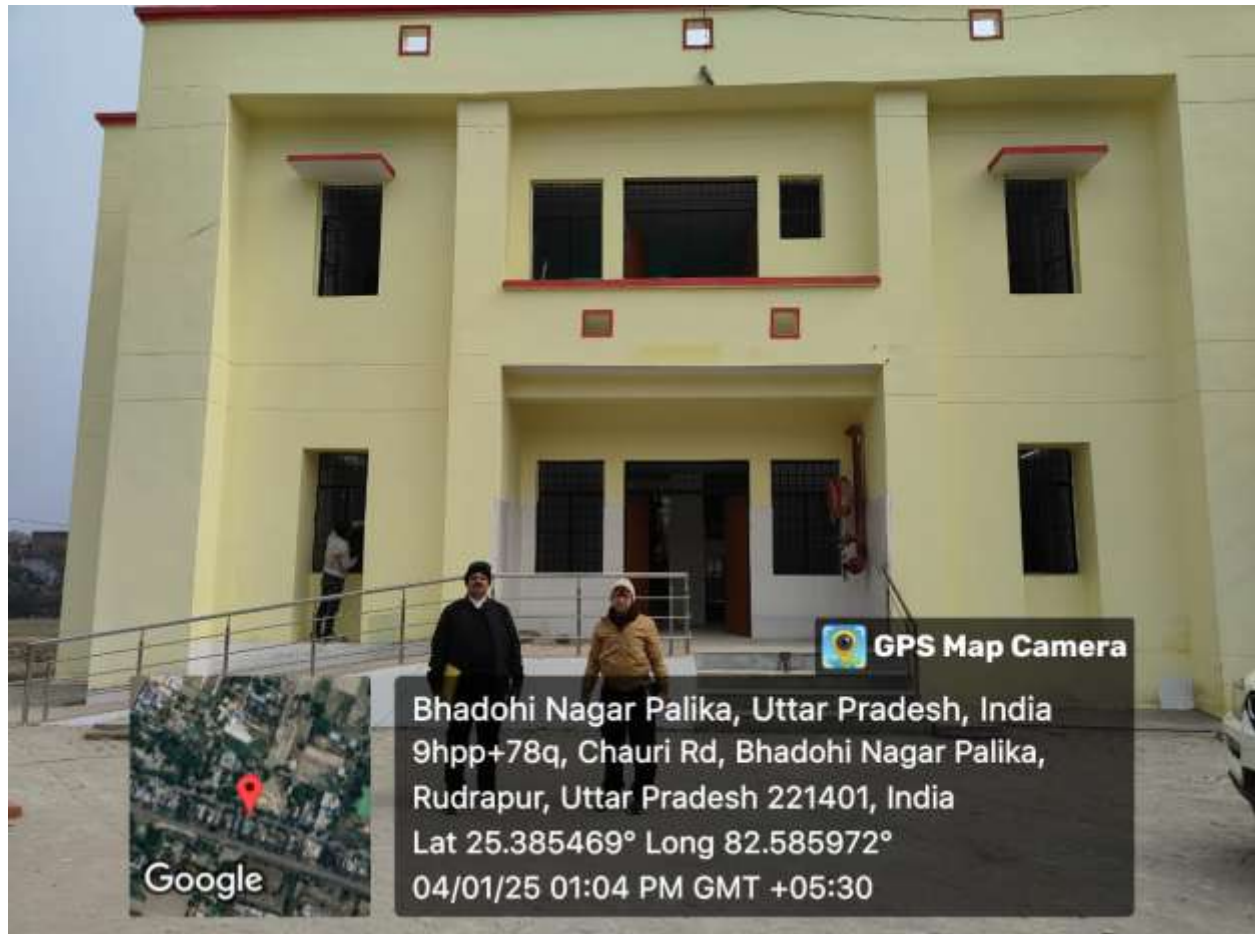
**Fig. 1:** Front view of the building

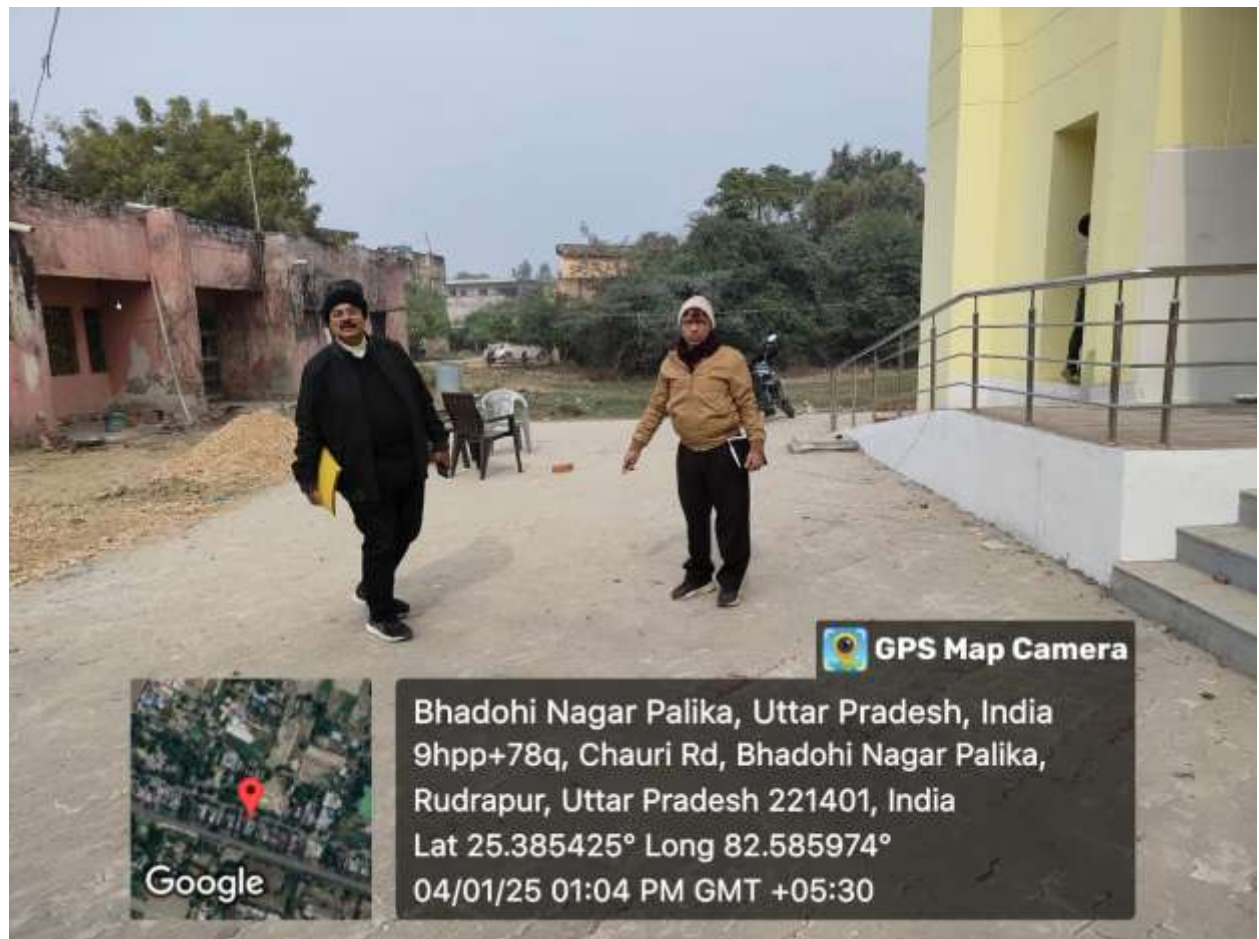
**Fig. 2:** CC road and railing

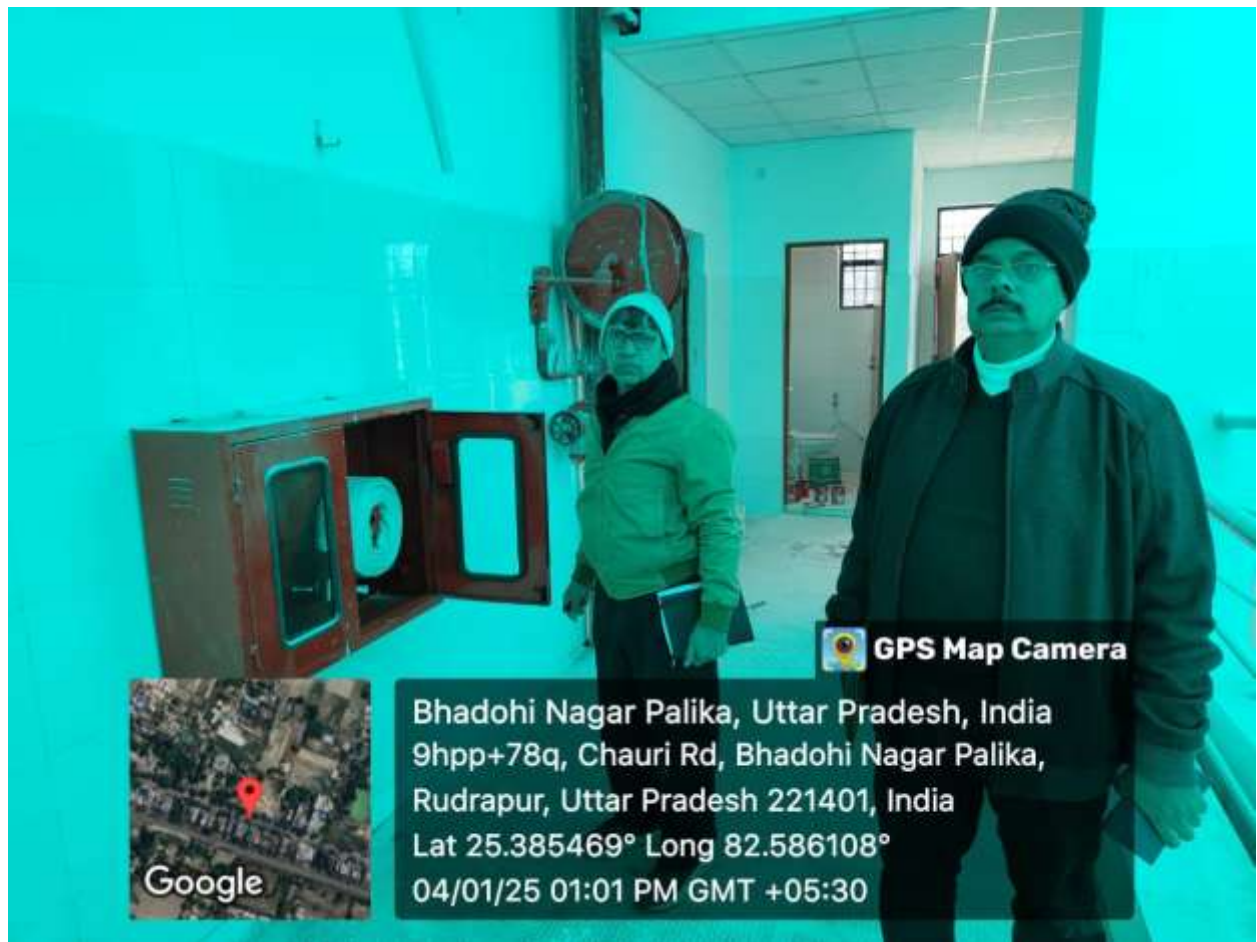
**Fig. 3:** Fire fighting work

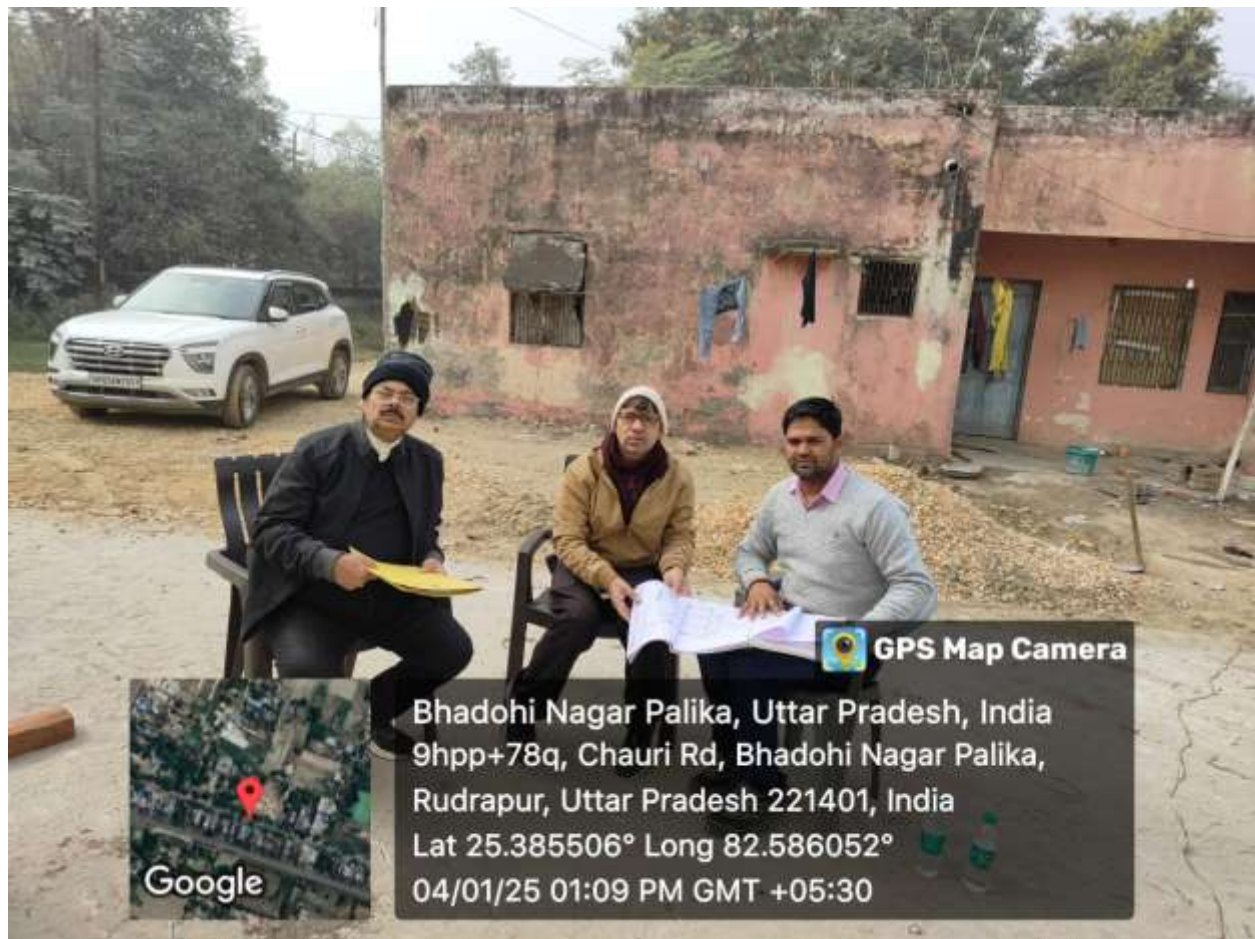
**Fig. 4:** Verification of the documents

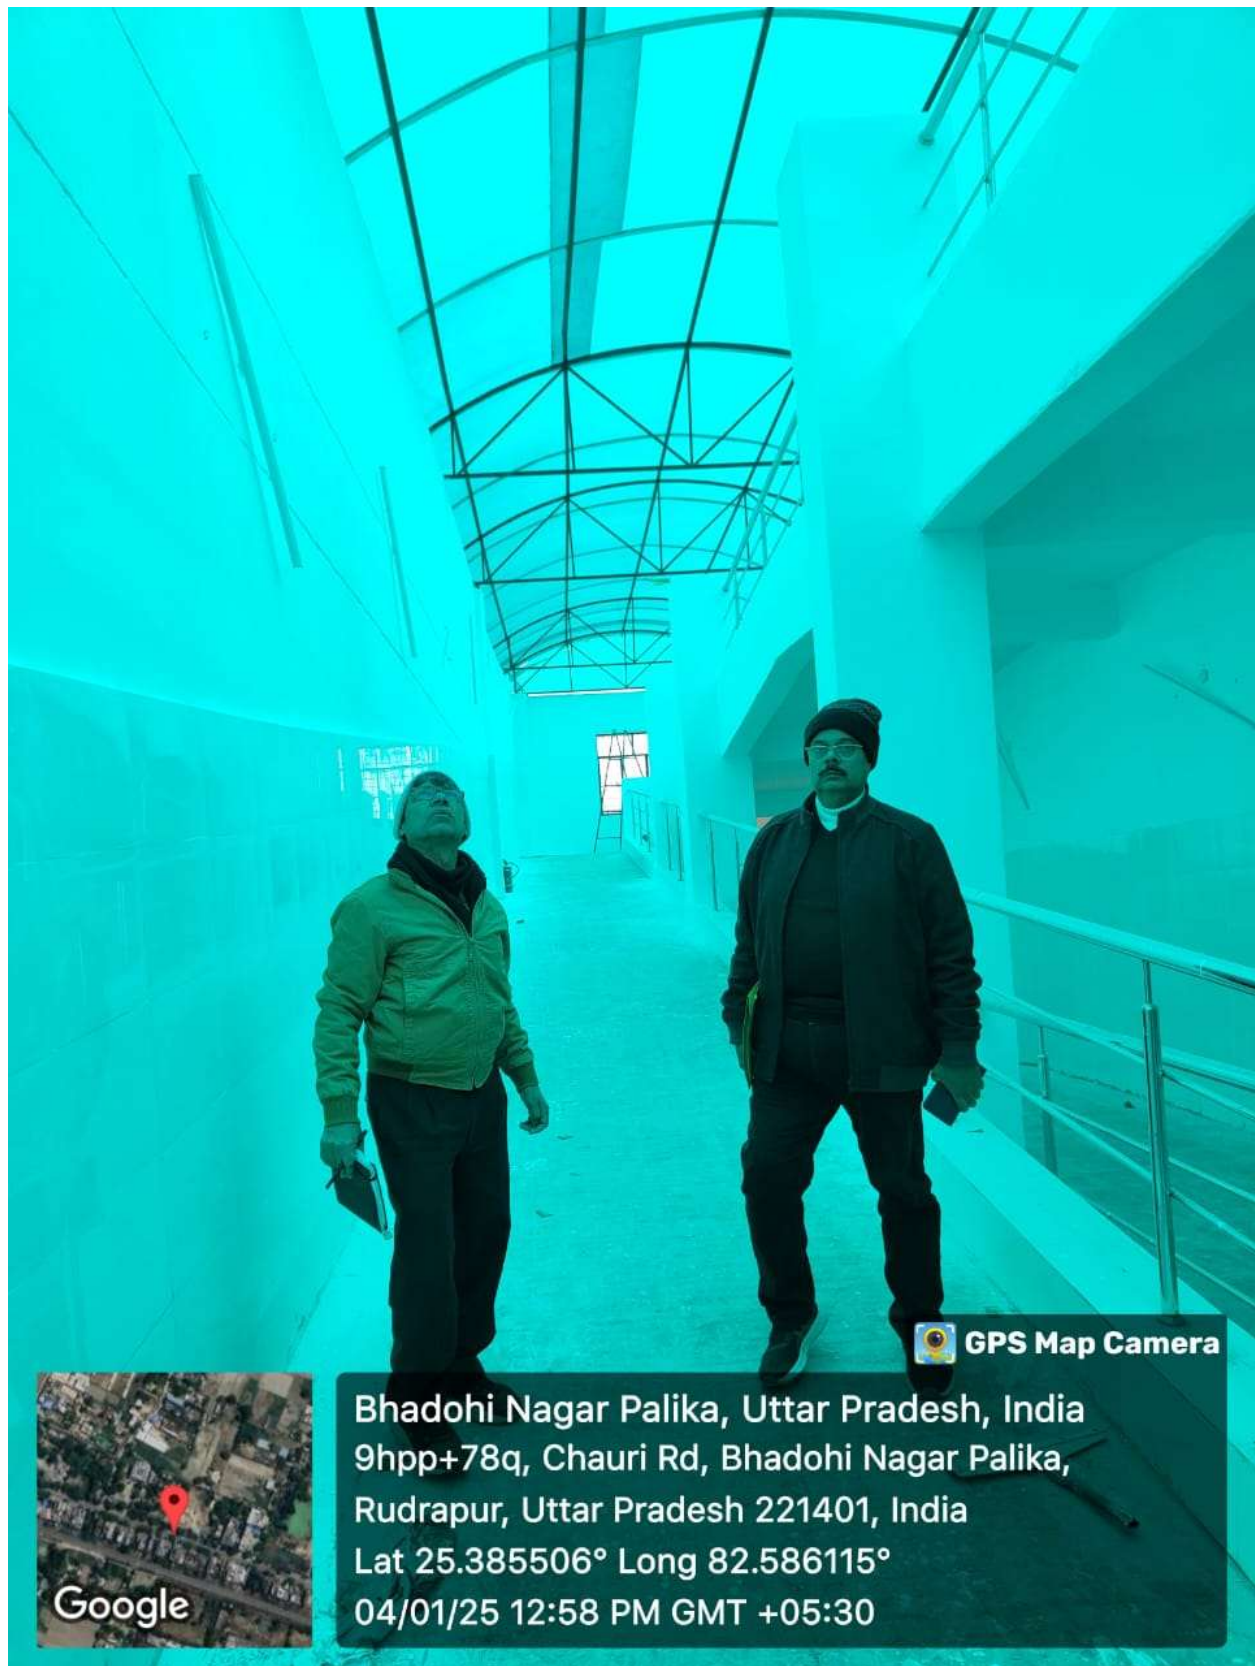
**Fig. 5:** Ramp sheet covering

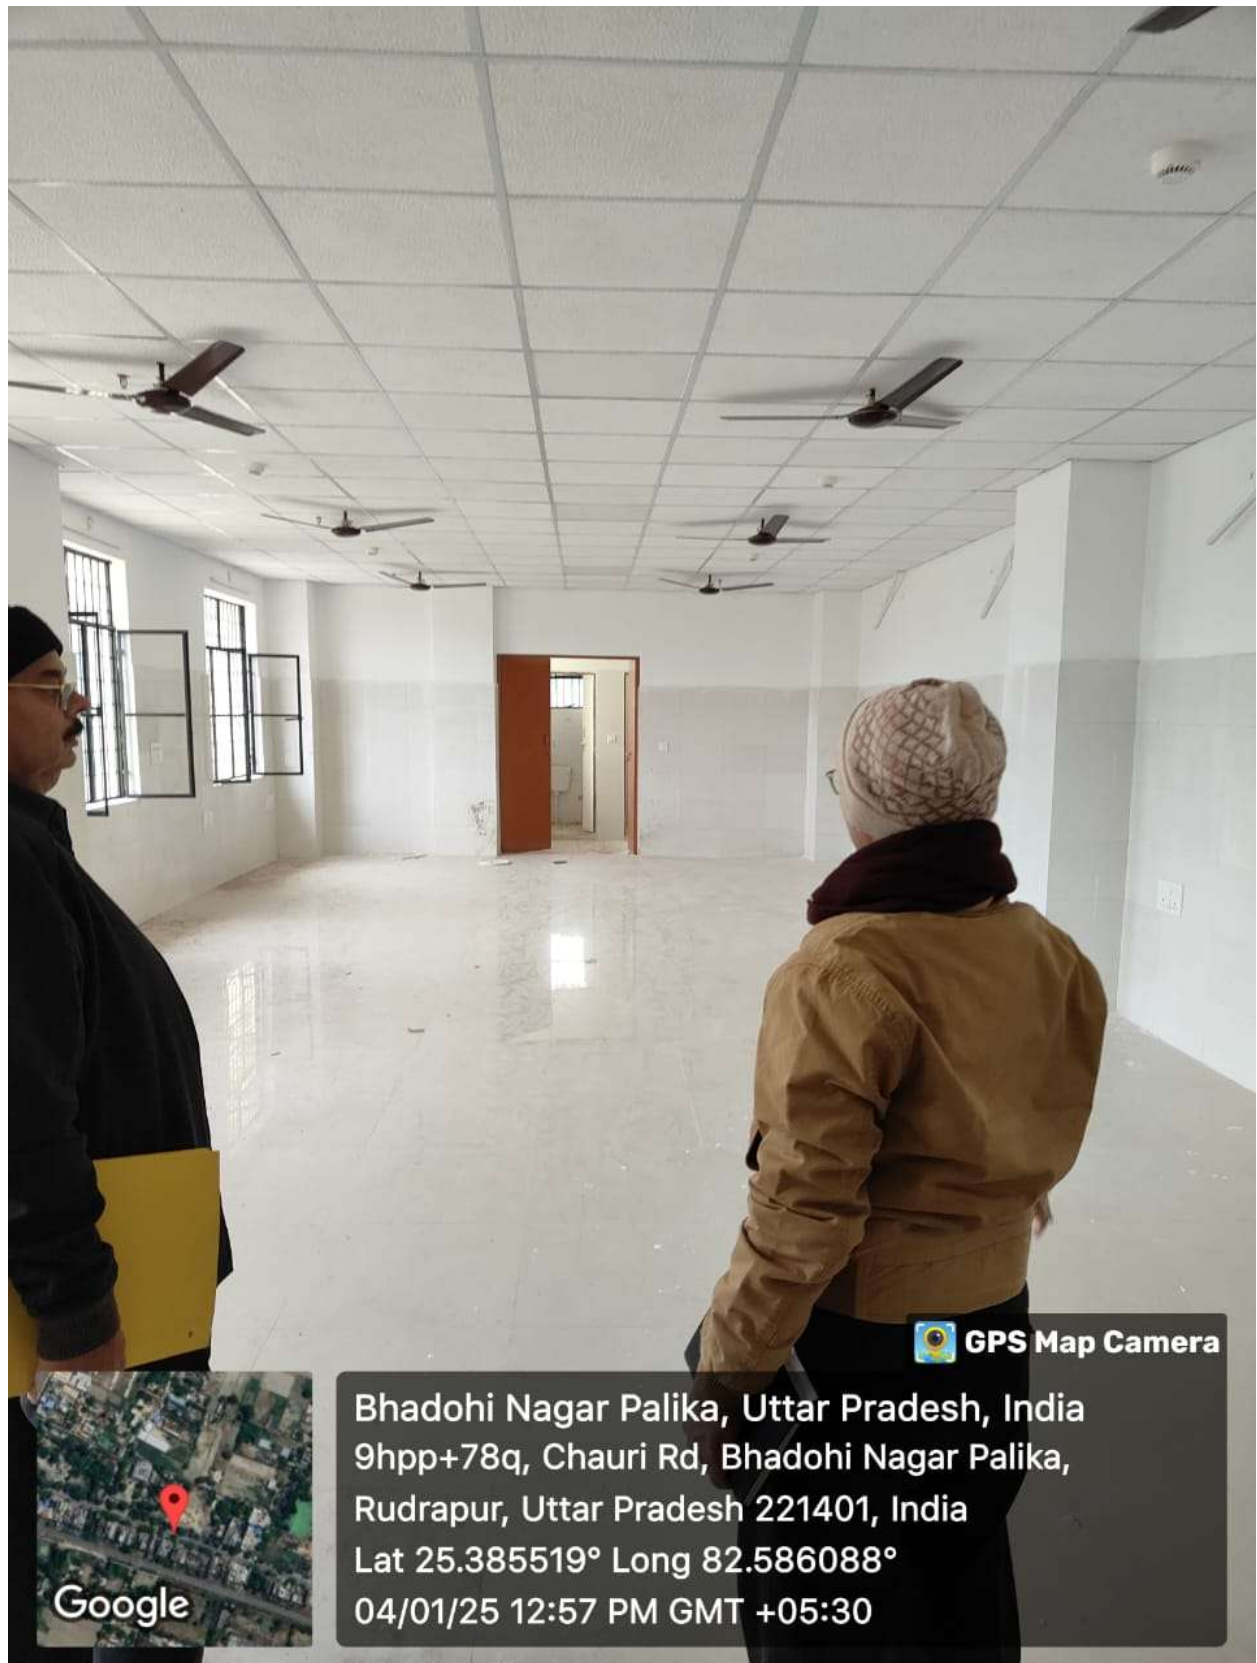
**Fig. 6:** Hospital Room

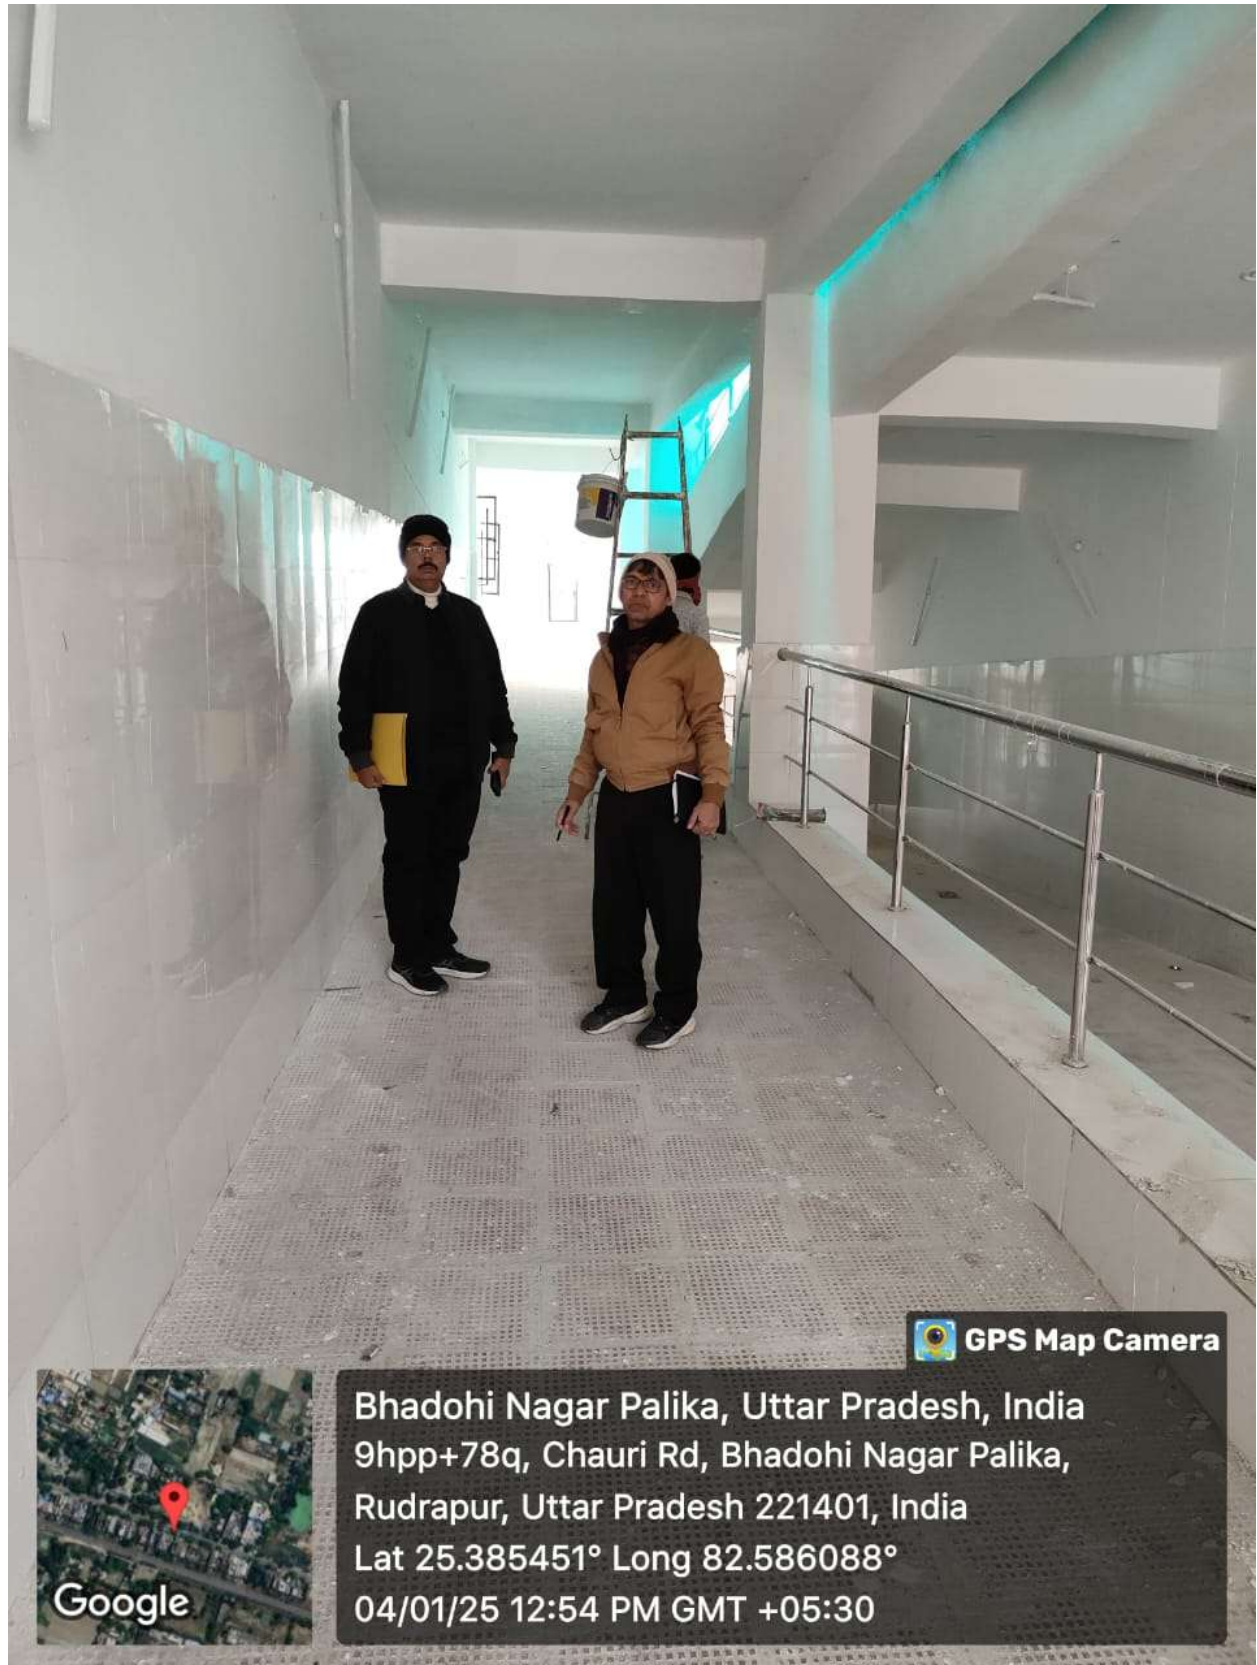
**Fig. 7:** Status of the ramp

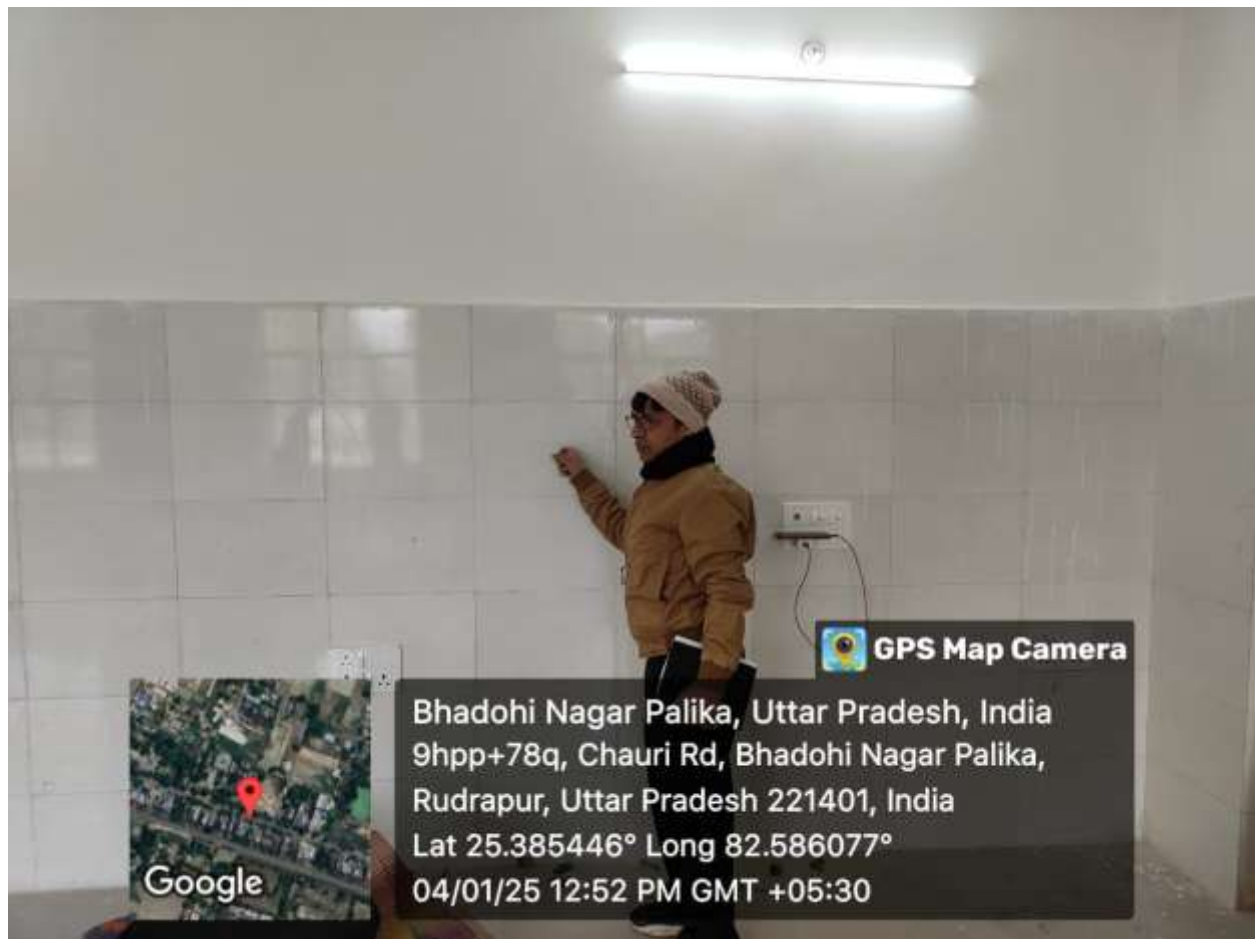
**Fig. 8:** Checking of the wall tiles

- Rough surfaces on walls and door panels should be properly finished.
- Gaps of the tiles should be grouted.
- Fittings of the toilets should be properly fixed.
- Campus should be properly cleaned before handover.
