# Analysis Report on Wacker Neuson Gear Pump

TSQR-0586  
2026-6-29  
Prepared by: Wang Kuan  
Approved by:

Customer feedback failure mode: Gear pump oil leakage

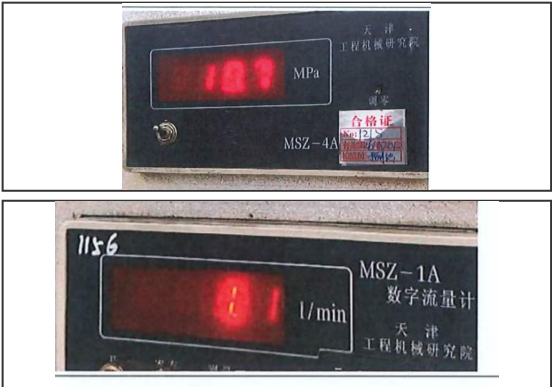
**Test bench flow confirmation:**

This gear pump cannot meet the test condition: **17.2 MPa**  
→ The factory test bench can no longer build up pressure.

Retest results show that the flow rate is significantly lower than the rated value.
