RE: Facility Inspection – Minor Deficiencies Noted
Big Creek Lake Dam Toe Berm and Drainage Improvements
NPDES Permit ALR10C6BZ
FID 311J-P6F8-9TD
Inspected 07/10/2025

Big Creek Lake Dam Toe Berm and Drainage
 Improvements : 311J-P6F8-9TD
 FOD NPDES Construction Stormwater Inspection Form

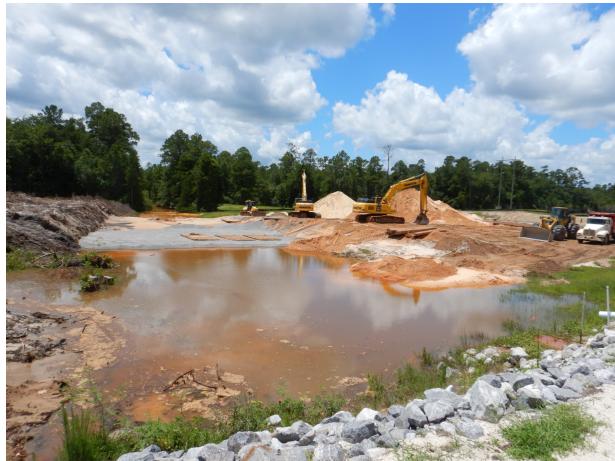
Overall

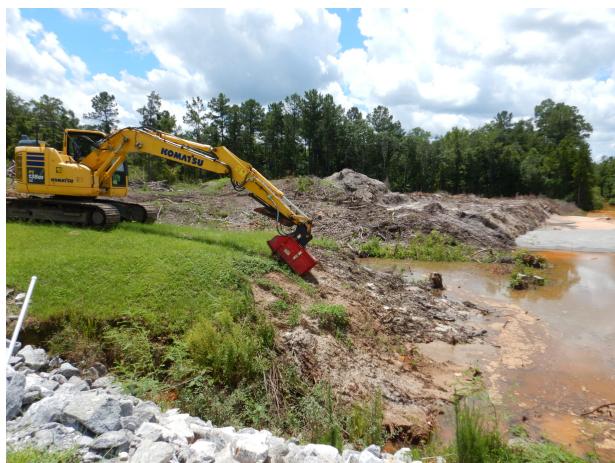
Overall

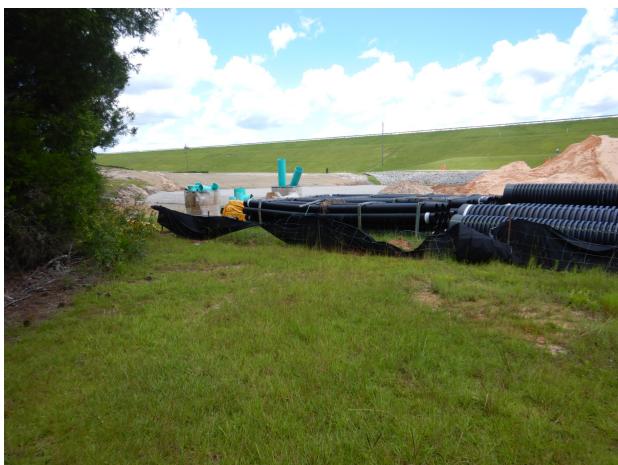
BMPs (silt fencing) did not appear to be properly implemented and/or maintained.

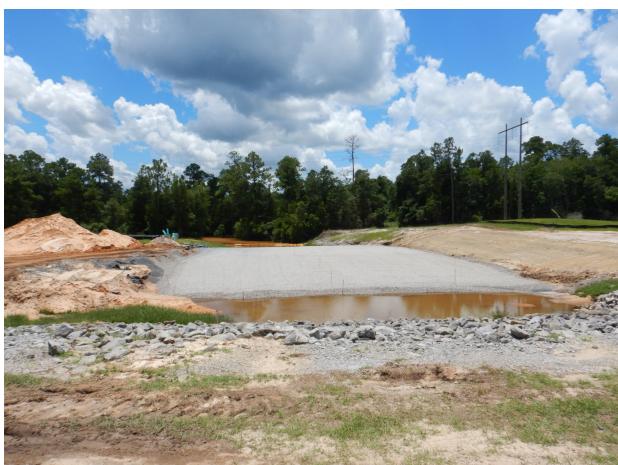
Overall

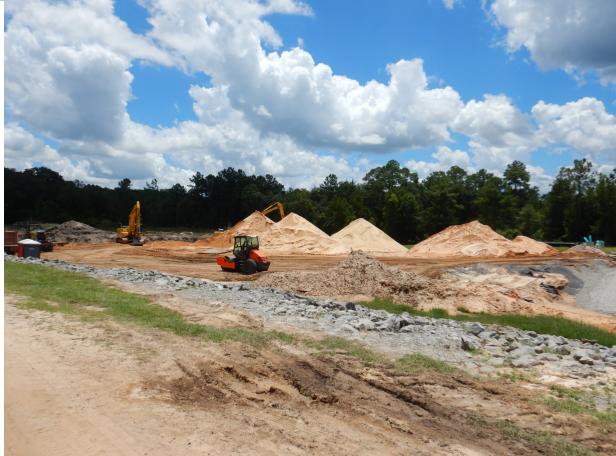
Overall

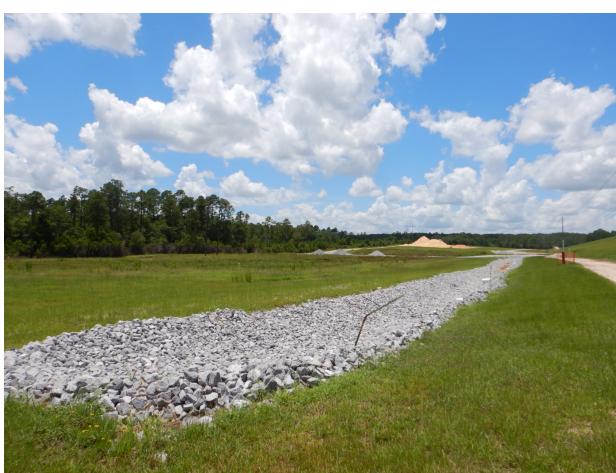
Overall

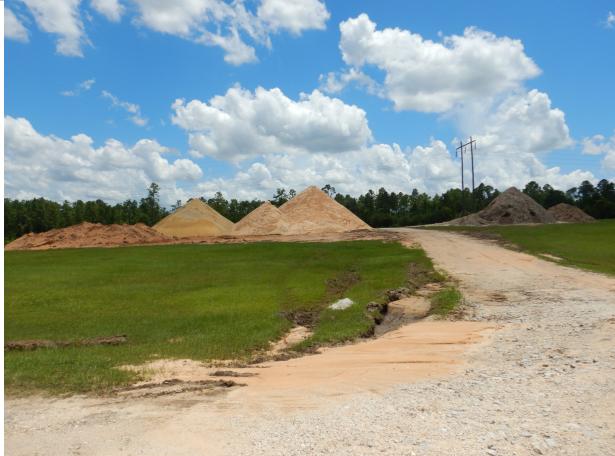
No structural BMPs observed around stockpiles.
Sedimentation observed.
Vegetative buffer observed.

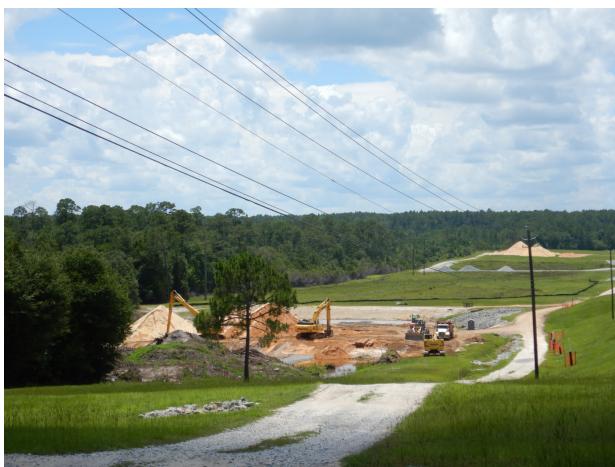
Overall

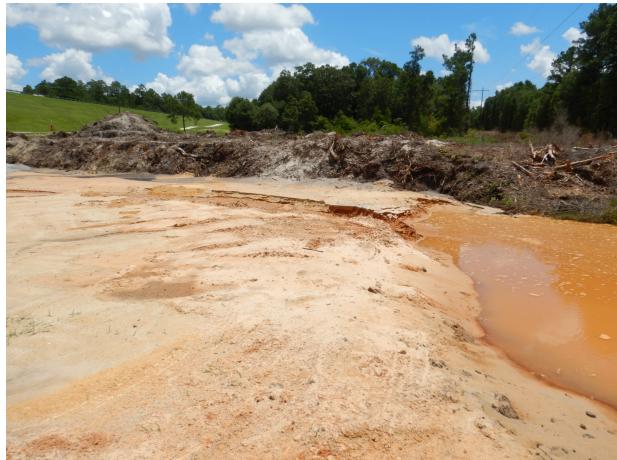
- 2.03. Was onsite sediment accumulation and/or onsite erosion, with potential water quality concerns, observed at the time of inspection? Yes No

Erosion
