Recommended Actions Summary Town of South Kingstown, RI

The Wood-Pawcatuck watershed is vulnerable to flood-related damages, as evidenced by the devastating flooding that occurred in 2010. The Wood-Pawcatuck Watershed Association, working with the watershed municipalities and partner agencies, has developed a watershed-based management plan to enhance the resiliency of the watershed communities to future flooding and protect river and stream ecosystems, including water quality and habitat. The following is a summary of key findings and recommendations of the watershed plan for the Town of South Kingstown.

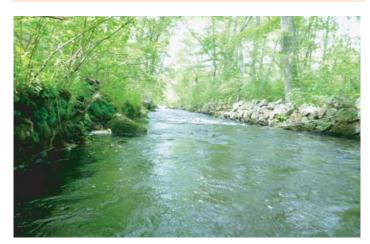
Granite-lined, straightened mill-race channel with restricted floodplain access, located downstream of Route 112.

- Remove granite blocks confining channel downstream of Route 112 to allow floodplain access; use granite blocks to build in-stream habitat structures
- Protect wetlands, including Indian Cedar Swamp, as well as stream connections to wetlands and floodplains
- Install log jams in select locations along the stream corridor to protect banks, create habitat, and reform meanders

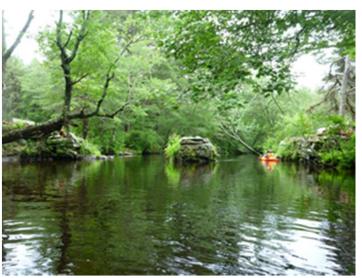
Straightened river channel and old bridge abutments

- Add wood cover structures along river banks (a.k.a. marginal wood cover) and wood to river to encourage meander formation and sediment storage within artificially straightened channel
- Area is popular for fly fishing
- Area is owned and managed by the Wood-Pawcatuck Watershed Association

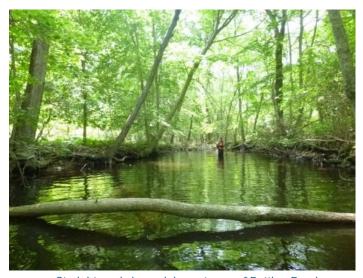
Straightened channel downstream of Puttker Road

- Protect corridor from encroachment by development to protect valuable archaeological sites and areas with good habitat potential
- Install log jams along channel margins to encourage meander formation downstream of Puttker Road and thereby reduce flood impacts
