Comparing seismic performances of single-span RC frames with and without wing wall retrofitting by shaking table tests

Lingxin Zhang ^{a,b}, Caiquan Wang ^c, Yongsheng Chen ^{a,b,*}

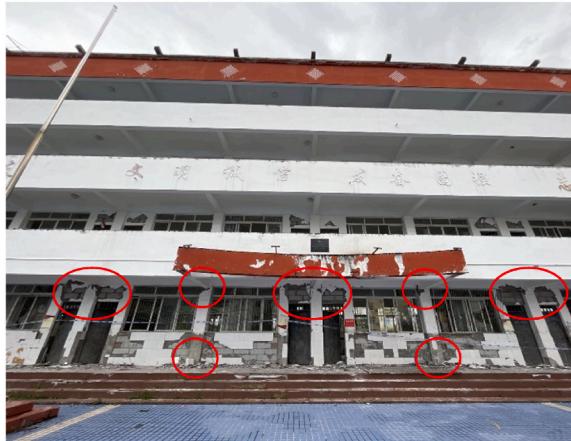
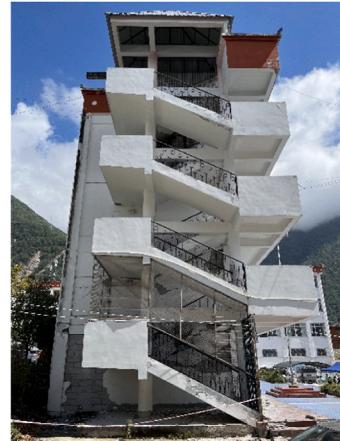
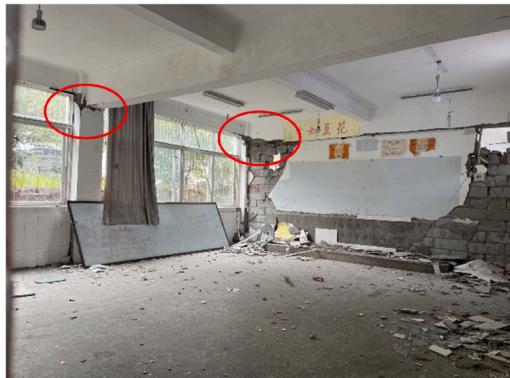
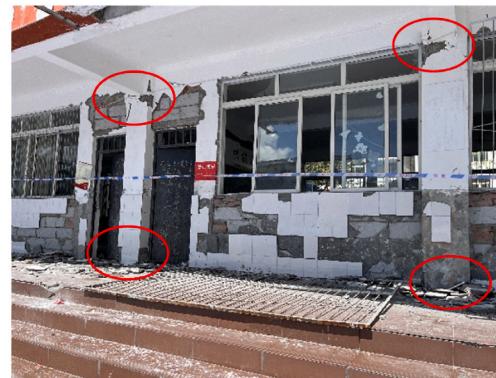
(a) Front view of the single span frame with severe

(b) Side view of the single span frame

(c) Internal damage of the classroom

(d) Crushed concrete at both ends of columns

Fig. 1. A sing-span RC frame damaged in Luding Ms 6.8 earthquake (2022) [5].

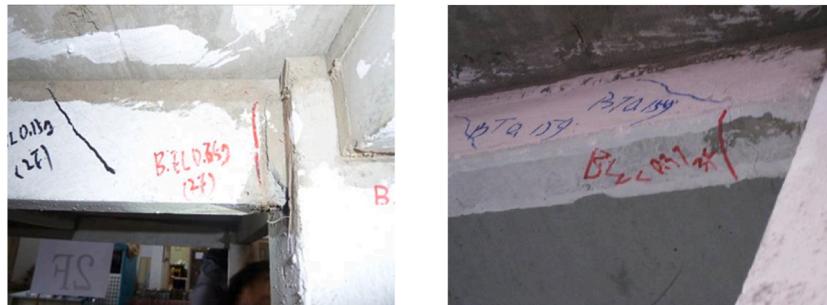
After the PGA of the excitation reached 0.30 g, Model-B suffered permanent/sustained damage. Vertical cracks at the beam end penetrated the joints on the second floor. The cracks at the bottom of the beam on the third floor widened and developed diagonally, see Fig. 15. In addition, cracks at the top end of the column on the third floor penetrated the joints with a small amount of spalling concrete, as shown in Fig. 16. The damage of Model-B was severe with $\bar{\theta}_m$ equal to 1/47. In contrast, for Model-A, a large number of cracks appeared in the beam-wing wall joints and developed towards the middle of the beams, and the side columns were slightly damaged, with a few tiny cracks, as shown in Figs. 17 and 18. The damage of Model-A was moderate with $\bar{\theta}_m$ equal to 1/69.

(a) Location at axis- A/② on 2nd floor (b) Location at axis- B/② on 3rd floor

Fig. 15. Cracks at the beam ends of the 2nd and 3rd storeys of the frame without retrofitting.

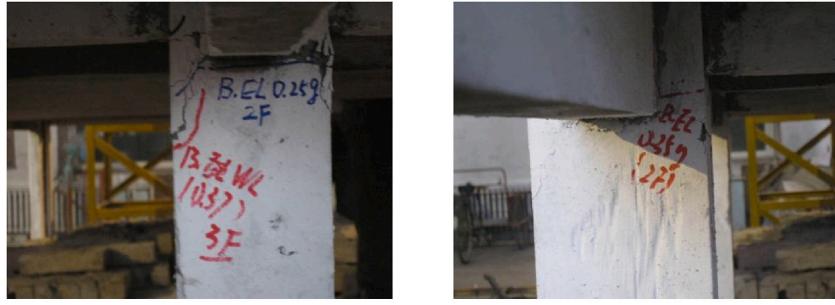
(a) Location at axis B/Ø on 2nd floor (b) Location at axis B/Ø on 2nd floor

Fig. 16. Spalling of concrete at the column top on the 2nd floor of the frame without retrofitting.

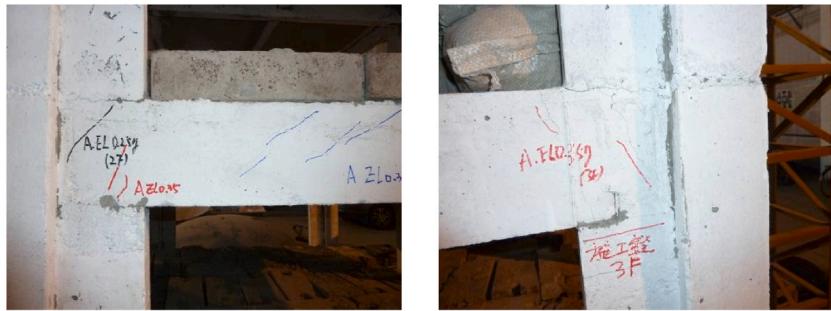
(a) Location at axis A-B/Ø on 2nd floor (b) Location at axis A/Ø on 3rd floor

Fig. 17. Cracks on the beam and its ends on 2nd and 3rd floors of the frame with retrofitting.

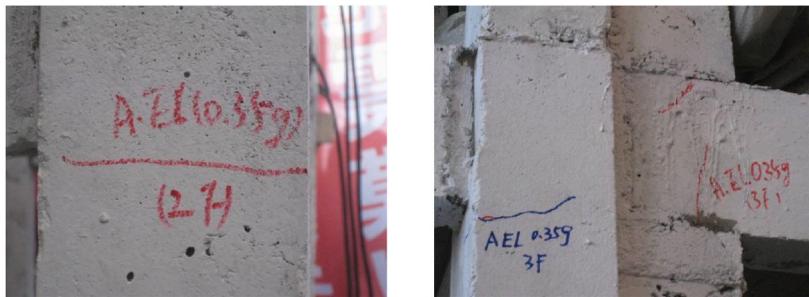
(a) Location at axis A/Ø on 2nd floor (b) Location at axis B/Ø on 3rd floor

Fig. 18. Cracks in the side column ends on 2nd and 3rd floors of the frame with retrofitting.

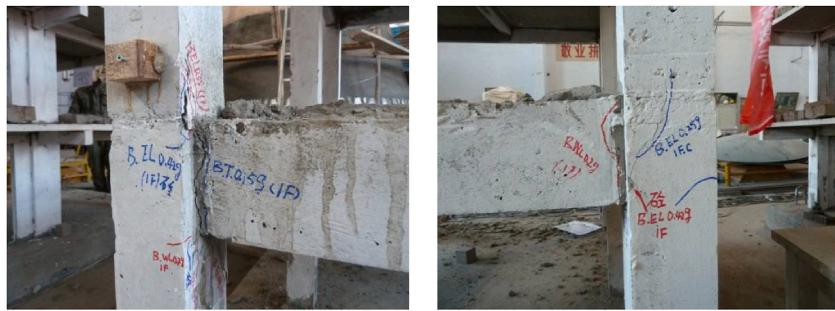
When the PGA of El Centro and Taft were equal to 0.40 g, the damage of Model-B became critical. The beams on the first and second floors suffered serious damage, and penetrating cracks appeared at most of the beam ends, as shown in Figs. 19 and 20. The concrete was crushed at the top ends of the side columns on the first and second floors and the middle columns on the second and third floors. Model-B was in collapse damage state with $\bar{\theta}_m$ reached 1/26. In contrast, many cracks in Model-A propagated from the beam ends to the mid-span and were evenly distributed, as shown in Fig. 21. Obvious destruction on the construction joints between beam and wing walls can be observed, as is seen in Fig. 22. Model-A was in severe damage state, and $\bar{\theta}_m$ reached 1/49.

(a) Joints at axis- A/① on 1st floor (b) Joints at axis- A/③ on 1st floor

Fig. 19. Destruction in the joints and beam-ends of Model-B.

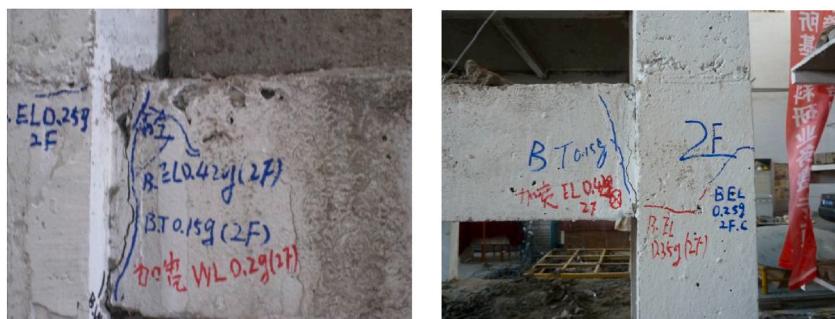
(a) Joints at axis- A/① on 2nd floor (b) Joints at axis- A/③ on 2nd floor

Fig. 20. Penetrating cracks on the beam-ends of Model-B.

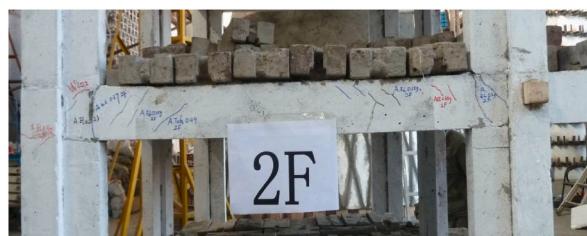
Fig. 21. Evenly distributed cracks on Model-A.

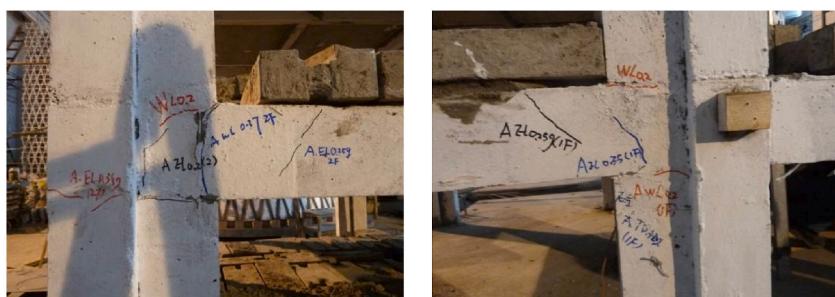
Fig. 22. Severe destruction on the connection between beam and wing wall of Model-A.
