Esk River flood content damage assessment

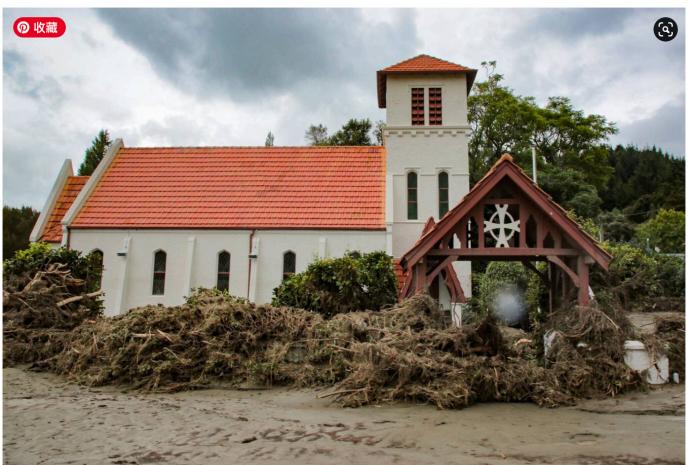
ESKDALE WAR MEMORIAL CHURCH

Eskdale War Memorial Church is still standing following the flooding. Photo / Warren Buckland
