## BPC01 Profiled Foam Closures

31 August 2024

Version 1

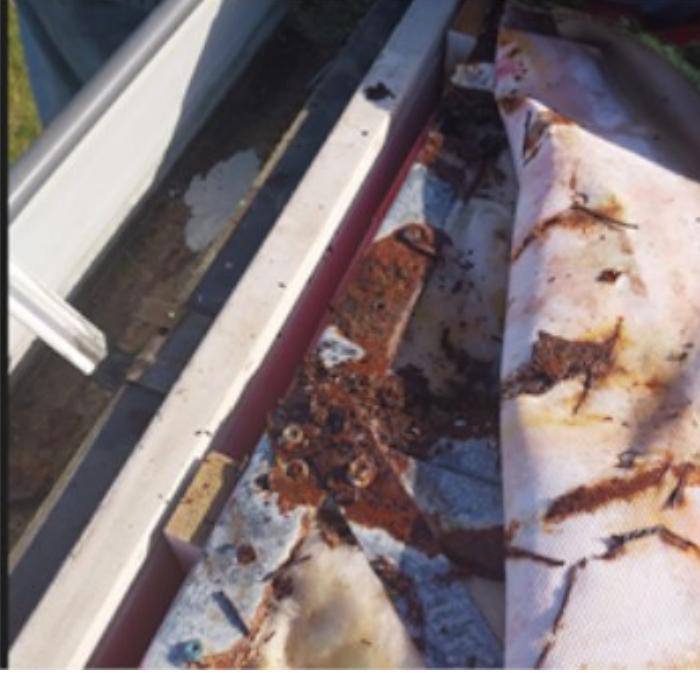
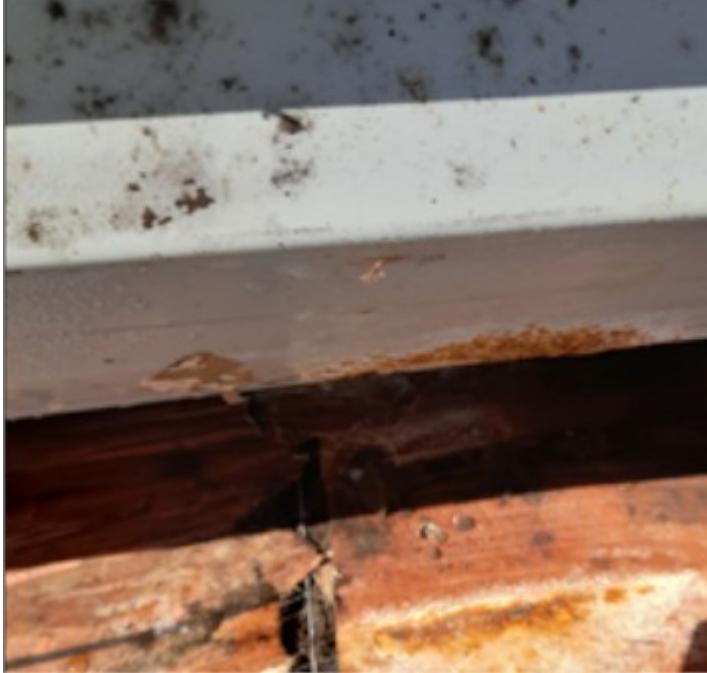
Where they are not required for weathertightness, we recommend against profiled foam closures, because they restrict ventilation. For example, in a dwelling the use of foam closures can result in the build-up of excessive internal moisture causing mould and corrosion, in a freight depot ventilation can help dissipate corrosive and unhealthy vehicle emissions. In all buildings they can contribute to exaggerated time of wetness of the underside of the sheet and purlins, causing premature failure of the roof and structure.

Failure caused by internal moisture	Roofing Failure and Mould caused by internal moisture after 14 years.

While there are valid arguments for using profiled closures in specific cladding situations as mentioned above, or for an atmosphere-controlled low energy building, as a rule they should be avoided wherever possible. Details showing profiled foam should be re-considered, in many cases that is as simple as simply removing the foam. For vermin exclusion at the eaves, an eaves comb will provide a durable and more effective solution.
