## 1. CORE INSPECTION METADATA

| Primary Finding | DENT |
| Severity Layer | HIGH |

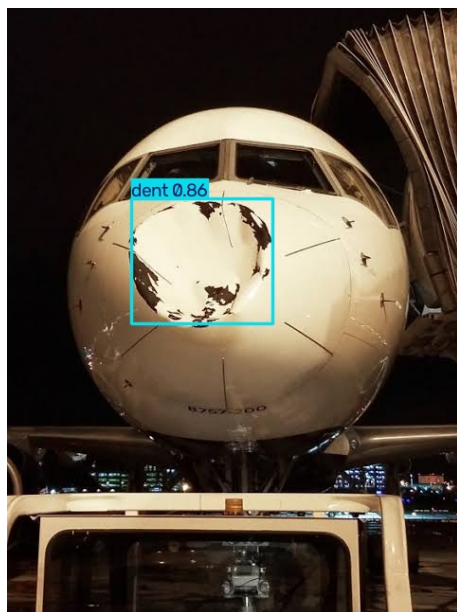
Fig 1. AI-annotated structural imagery overlay.

| ID | DEFECT CLASS | CONFIDENCE | SEVERITY | BOUNDING BOX [X, Y, W, H] |
|---|---|---|---|---|
| 01 | DENT | 86.0% | HIGH | [0.430, 0.418, 0.310, 0.207] |

- 1 Isolate the damaged area**  
Clearly mark and isolate the high-severity dent on the aircraft's surface to define the extent of the repair needed.
- 2 Remove the dent**  
Carefully remove the dented metal using appropriate tools, ensuring not to cause additional damage to the surrounding area.
- 3 Prepare the surface**  
Clean and prepare the area where the dent was removed, ensuring it is free from debris and ready for repair.
- 4 Apply the repair material**  
Select the same type and thickness of metal used in the original construction and apply it to the prepared area, following the manufacturer's guidelines for curing or setting.
- 5 Finish and inspect the repair**  
Once the repair material has set, finish the repair to match the surrounding area's texture and inspect the repair to ensure it meets the required strength and appearance standards.
