## 1. CORE INSPECTION METADATA

| Primary Finding | DENT |

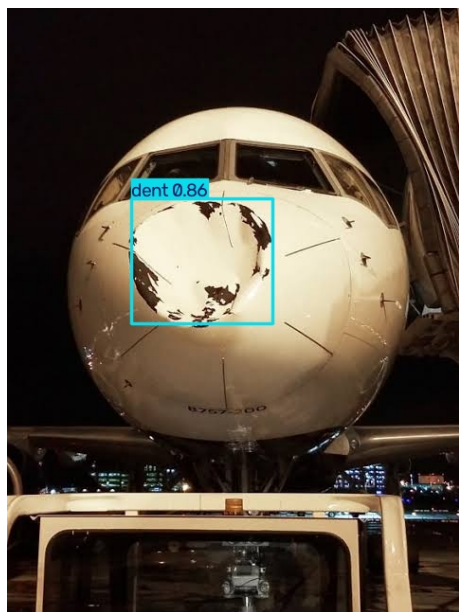
Fig 1. AI-annotated structural imagery overlay.

| ID | DEFECT CLASS | CONFIDENCE | SEVERITY | BOUNDING BOX [X, Y, W, H] |
|---|---|---|---|---|
| 01 | DENT | 86.0% | HIGH | [0.430, 0.418, 0.310, 0.207] |

- 1 Step 1**  
Isolate the damaged dented area to prevent further stress and potential damage to surrounding aircraft skin.
- 2 Step 2**  
Remove any loose or damaged material from the dented area to prepare for the repair process.
- 3 Step 3**  
Apply a suitable material of the same type and thickness as the original aircraft skin to the dented area, ensuring it is compatible with the aircraft's structure.
- 4 Step 4**  
Shape the applied material to conform precisely to the original contour of the aircraft skin, using specialized tools to avoid introducing new stresses or altering the resonant frequency.
- 5 Step 5**  
Allow the repaired area to cool down and stabilize under controlled conditions, ensuring the repair is sustainable under operational stresses.
