Merserize Makinesinde Tespit Edilen Kumas Hatalari

Tarih: 17.2.2023

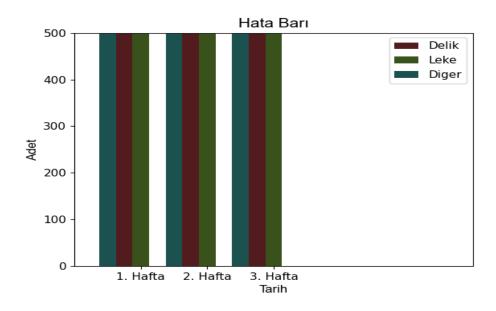
13.1.2023-17.2.2023'leri arasinda hata tespit turleri;

13.1.2023-23.1.2023'leri arasinda tespit edilen Delik ve Leke sayisi: 13727-951 (Adet)

24.1.2023-7.2.2023'leri arasinda tespit edilen Delik ve Leke sayisi: 35459-929 (Adet)

8.2.2023-17.2.2023'leri arasinda tespit edilen Delik ve Leke sayisi: 14681-727 (Adet)

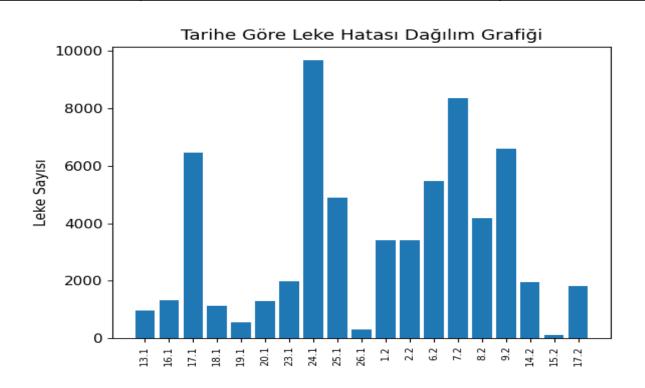
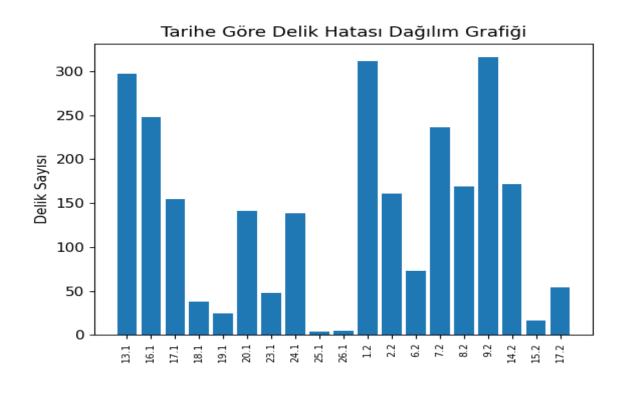
Merserize Makinesinde Tespit Edilen Kumas Hatalari
