Merserize Makinesinde Tespit Edilen Kumas Hatalari

Tarih: 14.9.2023

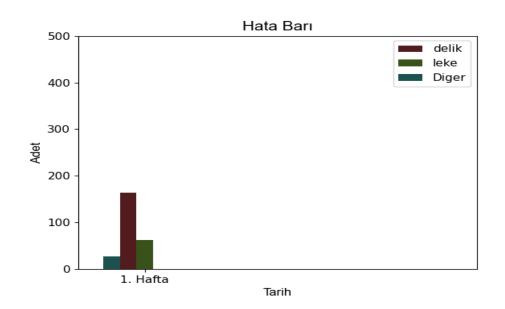
14.9.2023-14.9.2023'leri arasinda hata tespit turleri;

14.9.2023-14.9.2023'leri arasinda tespit edilen Delik ve Leke sayisi: 164-62 (Adet)

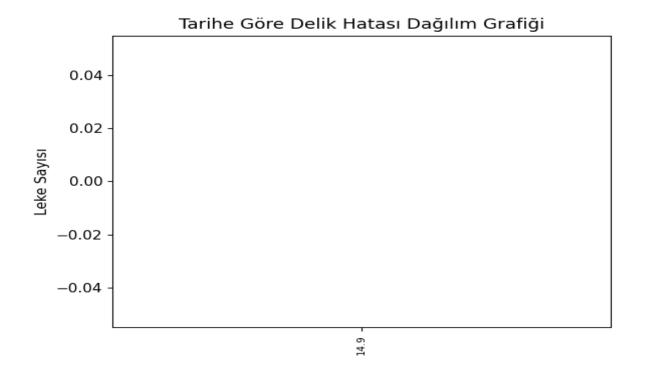
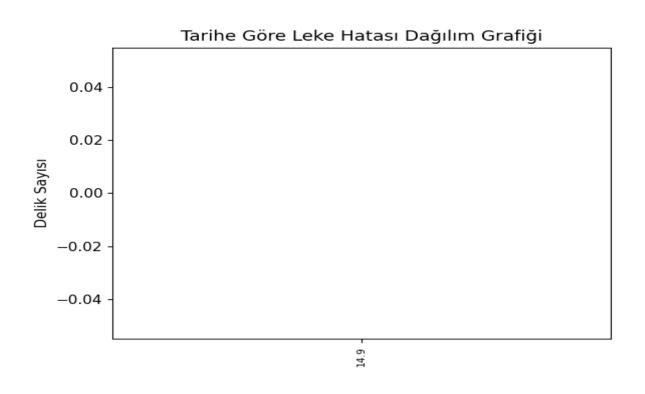
Dok No:1	Kalite No:SATEN(IS
Hatanin Yatay Konumu(cm)	101
Hatanin Geldigi Metre(m)	0
Hata Eni(mm)	168.65
Hata Boyu(mm)	45.12
Hata Alani(mm2)	7609.49
Hata Sinifi	iplik
Hatanin Geldigi Tarih	14.9.2023
