On the Out-of-Sync TDC Module on the HMS Chambers

Carlos Yero

August 28 2018

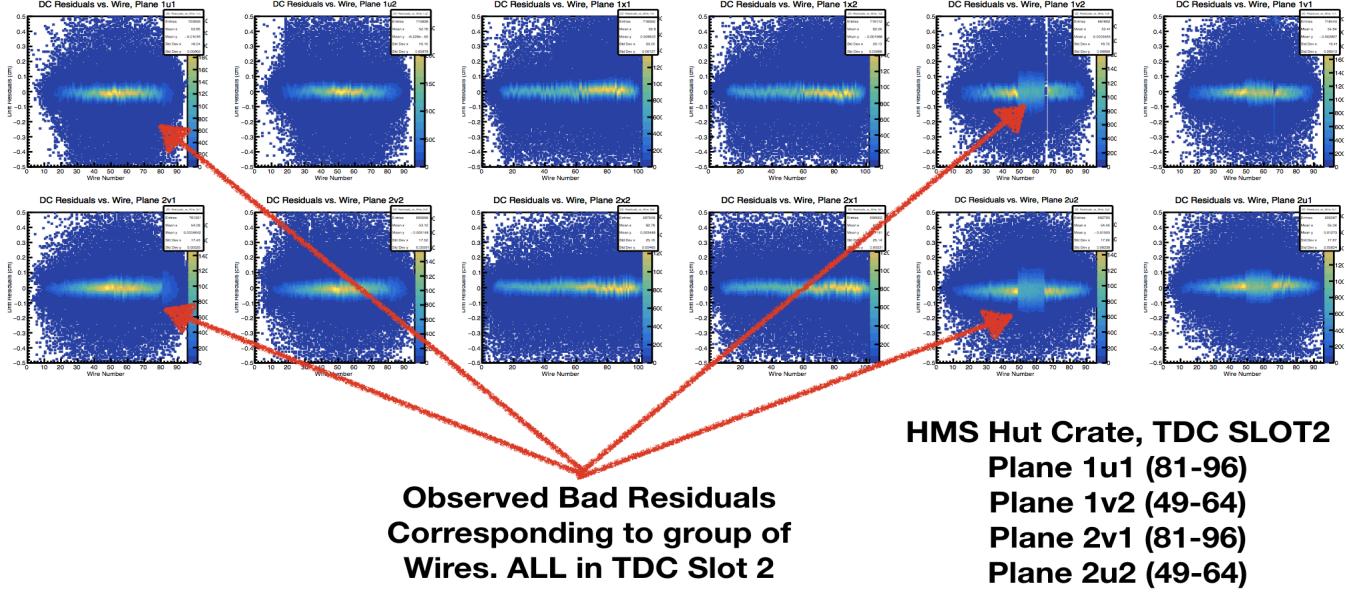
Figure 2: Correlation of Residuals vs. Wire Number for all 12 planes. Four wire groups stand out from the rest, with a noticeable smearing. The adjacent planes are affected by this smearing as well, even though they are NOT part of the problematic TDC.

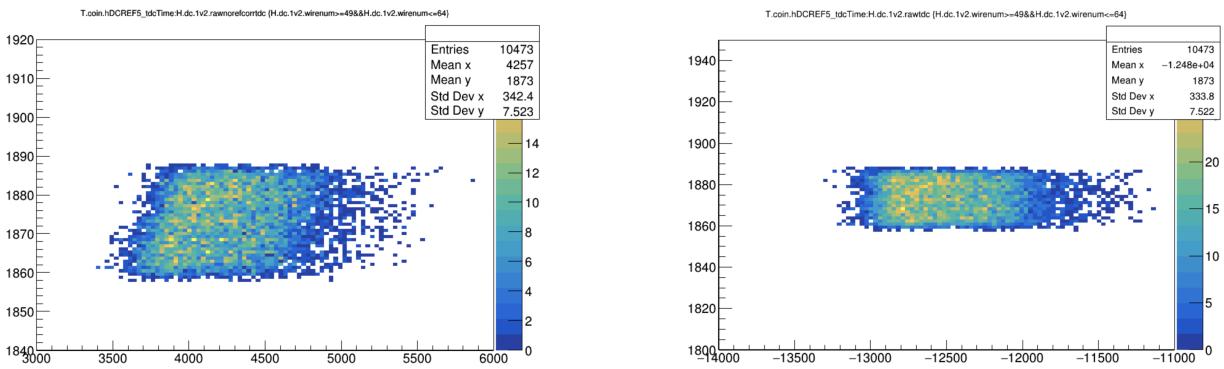
(a) TDC Slot 2 Reference Time vs. Raw Uncorrected TDC Time for wire group 1V2 (49-64)

(b) TDC Slot 2 Reference Time vs. Raw Corrected TDC Time for wire group 1V2 (49-64)

Figure 4: Results of HMS singles (DAQ in Coincidence Mode) cosmic run 4437 to verify that adding the new reference time to TDC Slot 2 fixes the problem. The subfigures above show the correlation between the newly added reference time and raw TDC Time from a group of wires in TDC Slot 2. As shown in subfigure (b), the correlation between the new reference time and raw TDC time is NOT present when the raw time is reference time corrected.

As a temporary solution (until we replace the TDC module), it was decided that a copy of the reference time should be fed independently to the bad TDC module. This way, the TDC can synchronize with its own reference time, as opposed to receiving an alternate copy from the trigger interface (TI) module. This modification was done on hardware on July 30, 2018. See Log Entry <https://logbooks.jlab.org/entry/3583094>.

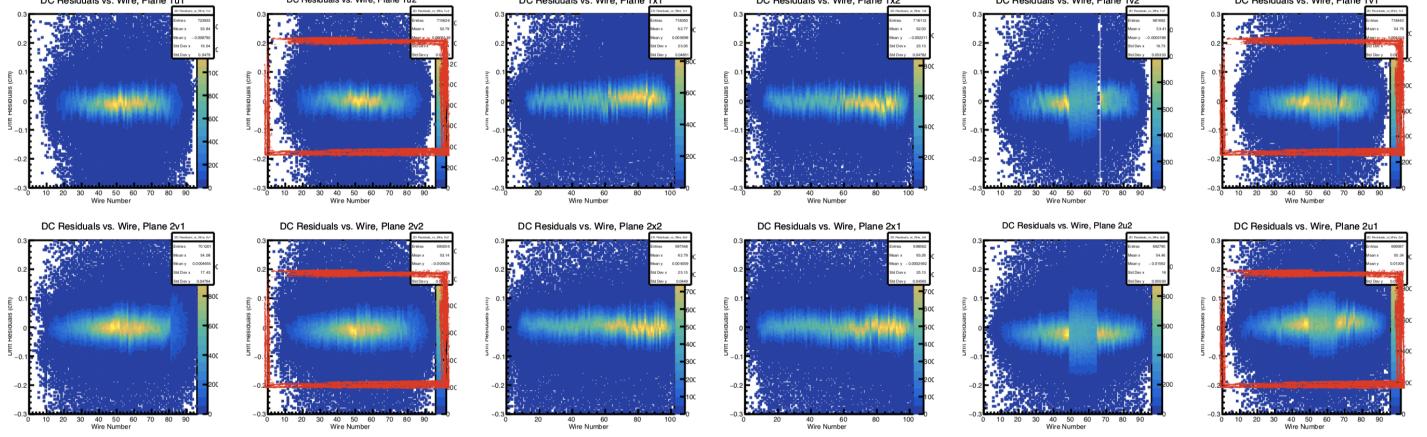
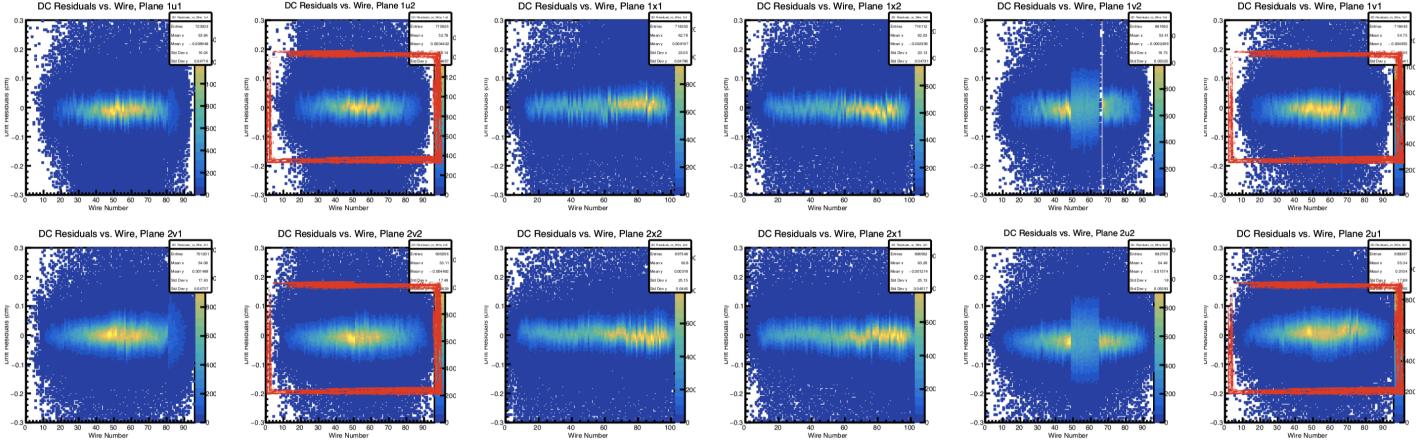
(a) Residuals vs. Wire Number for all Chamber planes, with sigma-per-wire flag OFF.

(b) Residuals vs. Wire Number for all Chamber planes, with sigma-per-wire flag ON.

Figure 6: Residuals vs. Wire Number for all Chamber planes. The **RED BOXES** highlight the group of wires that were affected, but had nothing to do with the out-of-sync TDCs wire groups.

In subfigure (b), when a sigma of 0.06 was applied to the bad groups (Planes 1u1, 1v2, 2v1, 2u2), the adjacent planes (highlighted in **RED**) wire residuals improved significantly. This is due to the fact that less weight (larger $\sigma(\sigma)$) was given to the affected group of wires.

this smearing, since they depend heavily on their adjacent partners (U,V planes) for the (x,y) coordinate determination from tracking. To minimize this effect, the Hall C source code *hcana* was modified to read in the sigma parameters on a per-wire basis, if a certain flag is set. Originally, the sigma parameters were read on a per-plane basis, and were assigned a value of 0.02 by default. If the sigma-per-wire flag is set, then the sigma parameter values are read on a wire-by-wire basis, and the wire groups associated with the Out-of-Sync TDC are assigned a sigma of 0.06, while the rest are assigned a value of 0.02 so that during the track-fitting algorithm, if a track passes through one of these groups, they will have a smaller contribution (or weight) to the fit. The results are shown in Figures 6.
