# Discussion On the Out-of-Sync TDC Module from the HMS Chambers

Carlos Yero

August 29 2018

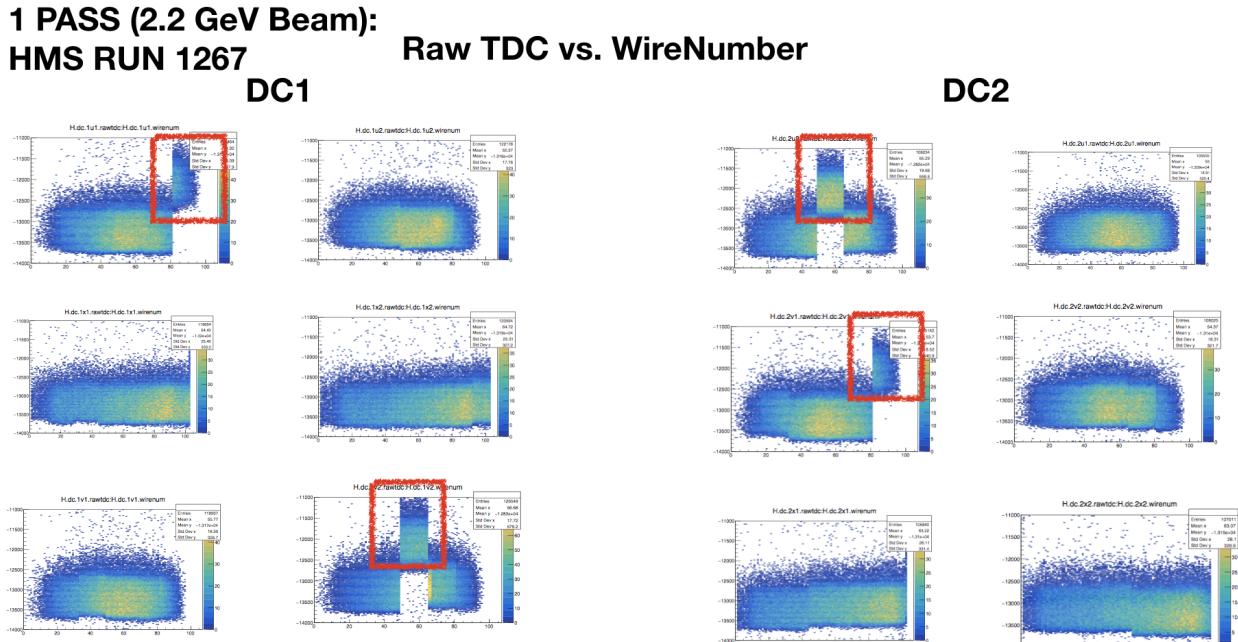
**1 PASS (2.2 GeV Beam):  
HMS RUN 1267**

**Figure 1:** The Raw TDC vs. Wire Number Correlations for all 12 planes. An offset of  $\sim 1000$  Channels ( $\sim 100$  ns) is observed in wire groups of four distinct planes.

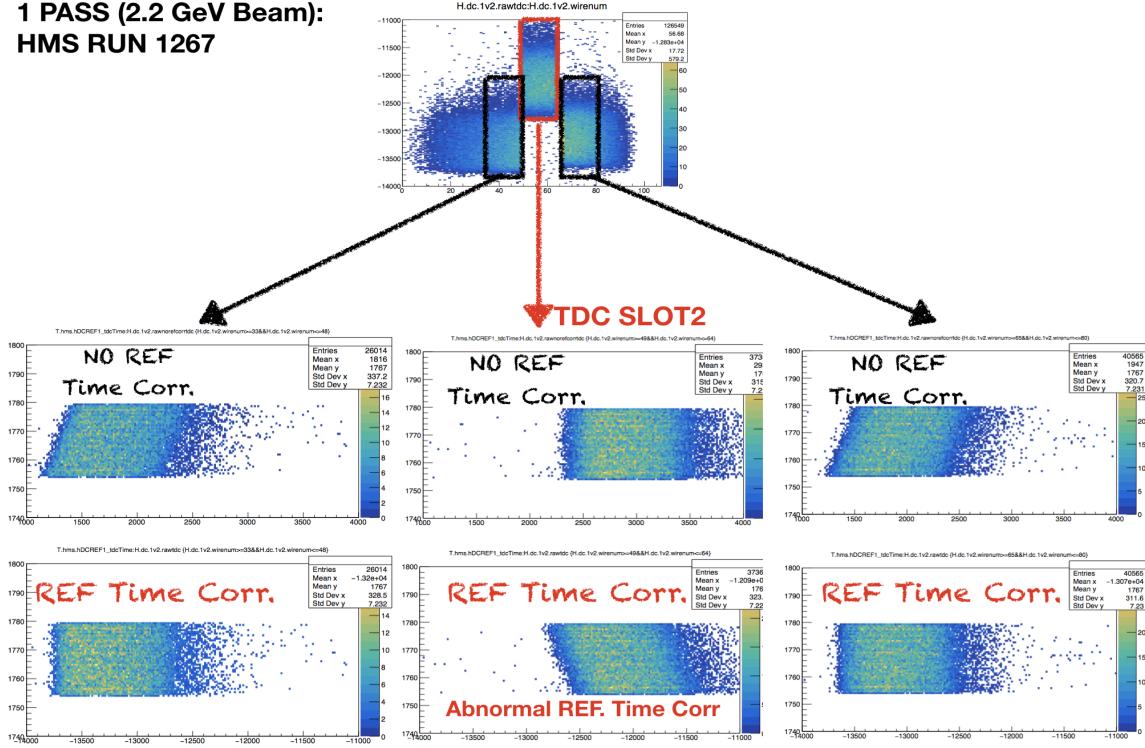
**Figure 3:** Correlation between the HMS DC reference time and the raw TDC times. The DC 1, V'-Plane raw TDC vs. Wire Number is shown. Adjacent wirgroups which are NOT in TDC Slot 2 are compared to the TDC Slot 2 wire group before and after applying the reference time correction to the TDC time.

The figure above is determinant in this study, as it shows the correlation of the reference time with the raw TDC time before and after applying the reference time correction. As expected from a normal TDC, when tdc times are reference time subtracted, the correlation disappears. However, in TDC Slot 2, the reference time and raw tdc time appear to be correlated, which is an indication that its copy of the reference time is Out-of-Sync with the rest of the modules.

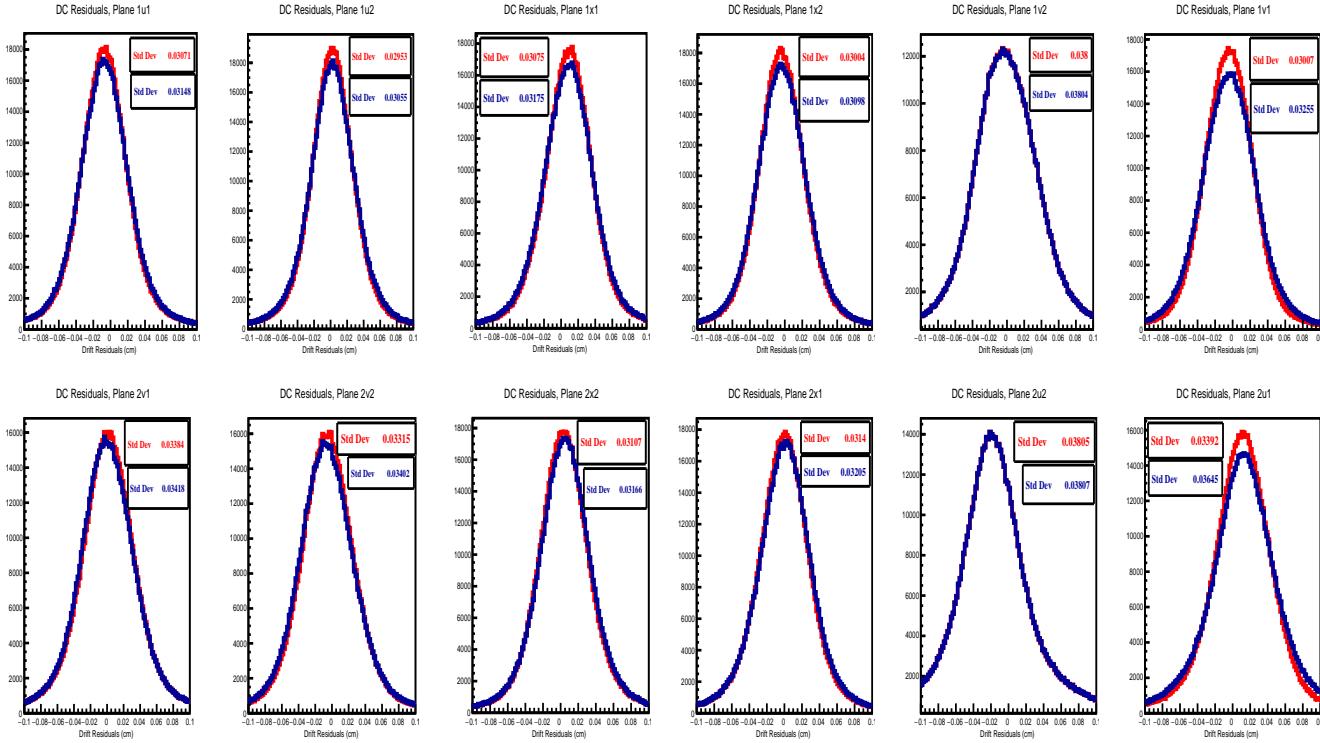
The plane residuals, however, did not have much improvement after increasing the weight factor. At most, there was a  $25 \mu\text{m}$  improvement in the Standard Deviation. See Figure 7

**Figure 7:** Plane residuals with the sigma-per-wire flag ON (RED) and OFF (BLUE)
