# Discussion On the Out-of-Sync TDC Module from the HMS Chambers

Carlos Yero

August 29 2018

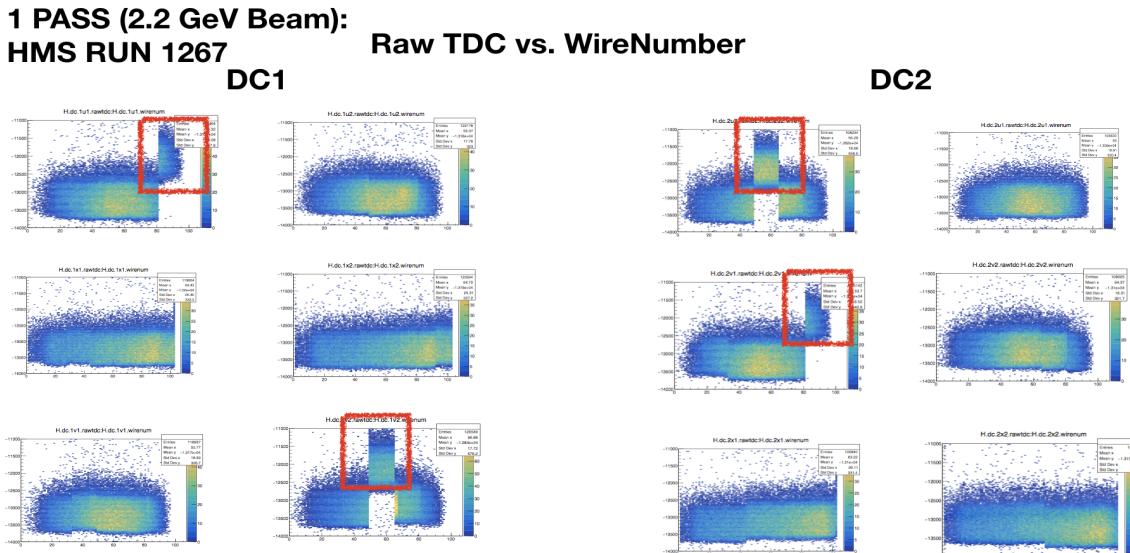
Figure 1 shows the Drift Chamber raw TDC times vs. Wire Number for all 12 planes. In four of the planes, a  $\sim 100$  ns drift for certain groups of wires can clearly be observed. This was the first indication, but NOT with absolute certainty, that the TDC module to which these four groups were connected to was problematic.

**Figure 1:** The Raw TDC vs. Wire Number Correlations for all 12 planes. An offset of  $\sim 1000$  Channels ( $\sim 100$  ns) is observed in wire groups of four distinct planes.

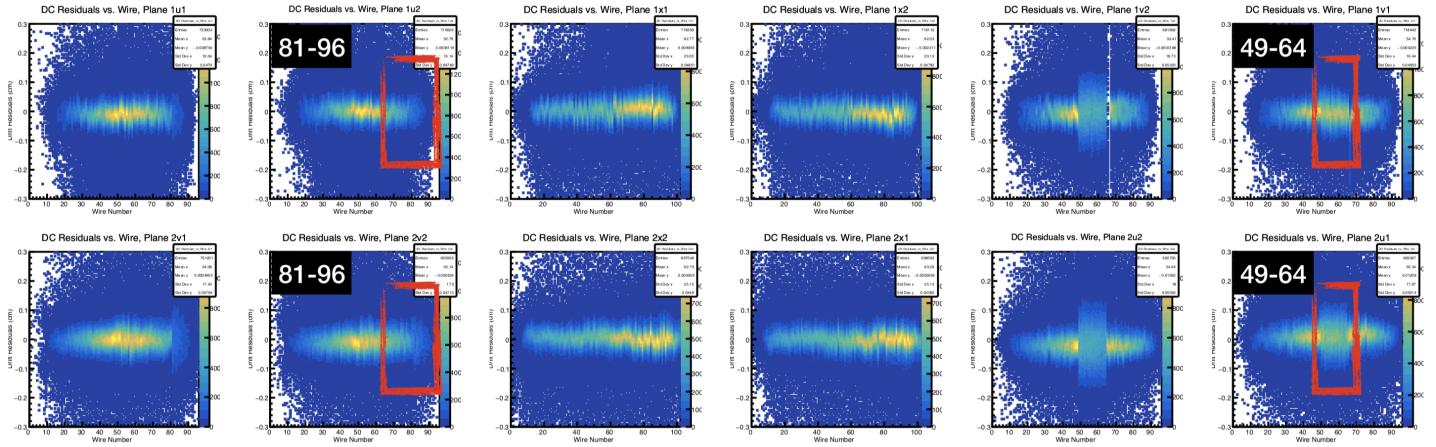
The group of wires that were affected by the TDC synchronization issue cannot be restored to normal, so their residuals will remain significantly smeared out. Fortunately, two of the groups are located at the edge of each chamber, so they have minimal impact. The other two groups, even though they are near the center of the chamber, they are in different chambers, so tracking in NOT severely affected. The group of wires in adjacent planes are affected (See Figure 2) by this smearing, since they depend heavily on their adjacent partners (U,V planes) for the (x,y) coordinate determination from tracking. To minimize this effect, the Hall C source code *hcana* was modified to read in the sigma parameters on a per-wire basis, if a certain flag is set. Originally, the sigma parameters were read on a per-plane basis, and were assigned a value of 0.02 by default. If the sigma-per-wire flag is set, then the sigma parameter values are read on a wire-by-wire basis, and the wire groups associated with the Out-of-Sync TDC are assigned a sigma of 0.06, while the rest are assigned a value of 0.02 so that during the track-fitting algorithm, if a track passes through one of these groups, they will have a smaller contribution (or weight) to the fit. The results are shown in Figures 6.

(a) Residuals vs. Wire Number for all Chamber planes, with sigma-per-wire flag OFF.

**Figure 6:** Residuals vs. Wire Number for all Chamber planes. The **RED BOXES** highlight the group of wires that were affected, but had nothing to do with the out-of-sync TDCs wire groups.

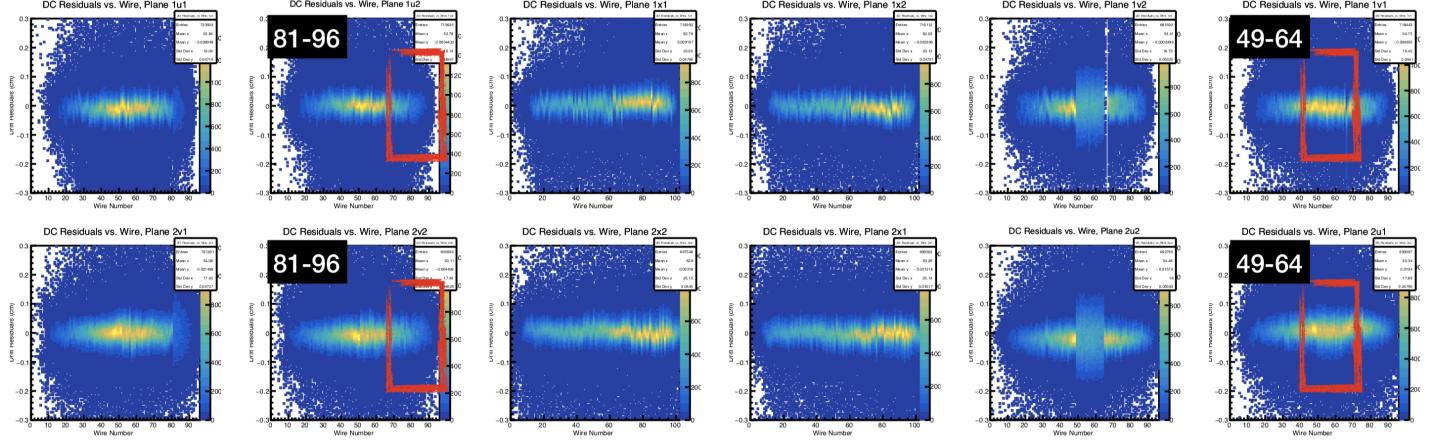
(b) Residuals vs. Wire Number for all Chamber planes, with sigma-per-wire flag ON.

In subfigure (b), when a sigma of 0.06 was applied to the bad groups (Planes 1u1, 1v2, 2v1, 2u2), the adjacent planes (highlighted in RED) wire residuals improved significantly. This is due to the fact that less weight (larger  $\sigma(\sigma)$ ) was given to the affected group of wires. To quantify by how much the group residuals highlighted in Figure 6 have improved, I plotted the 1D-projection of such wire groups. There seemed to be a noticeable improvement with up to  $\sim$

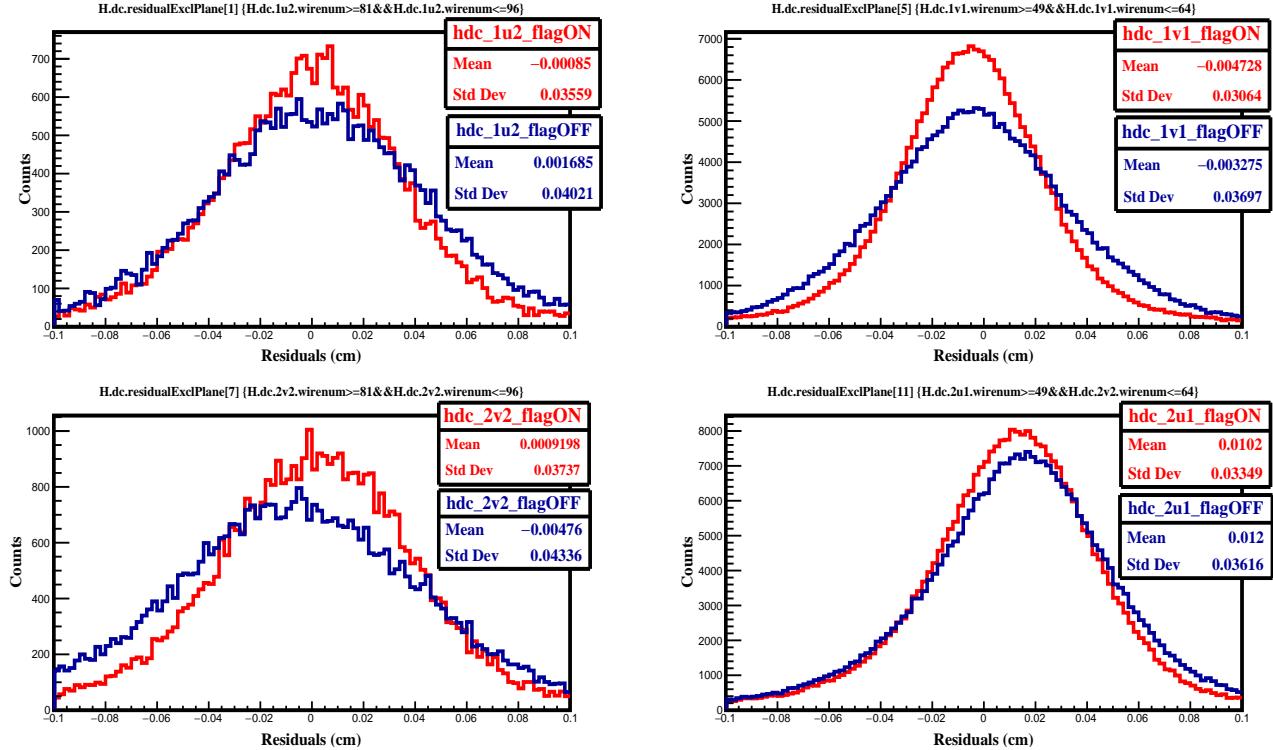
$60 \mu\text{m}$  in the residuals. See Figure 7 below.

Figure 7: Residuals of highlighted wire groups in Figure 6

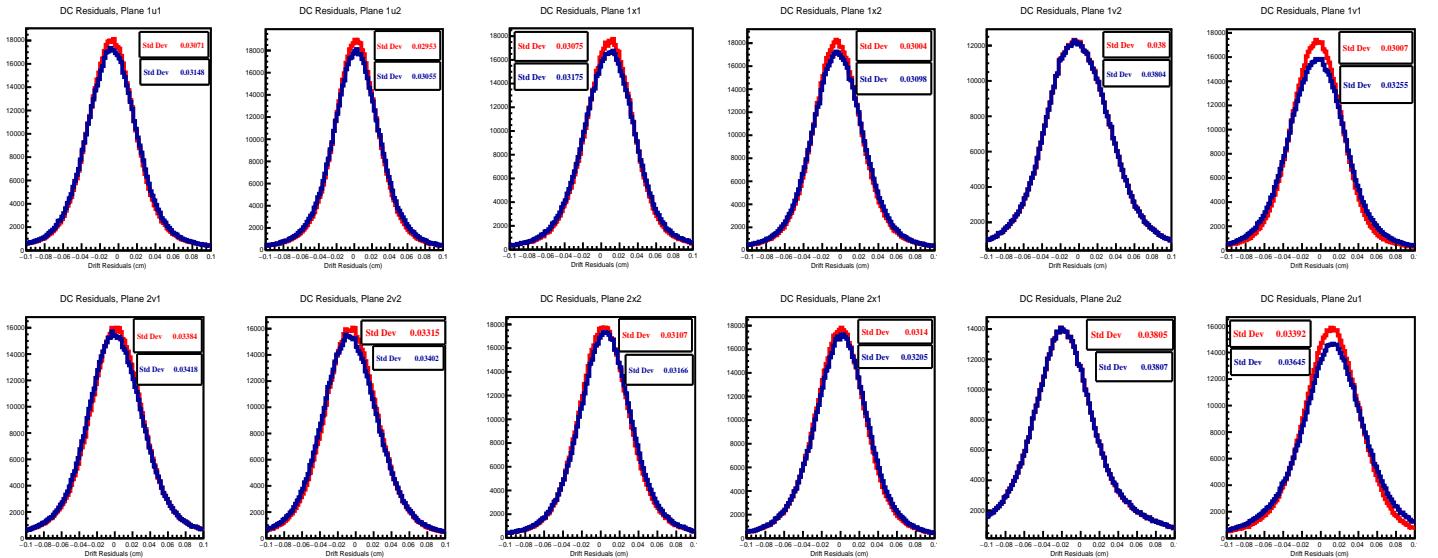
The plane residuals, however, did not have much improvement after increasing the weight factor. At most, there was a  $25 \mu\text{m}$  improvement in the Standard Deviation. See Figure 8

Figure 8: Plane residuals with the sigma-per-wire flag ON (RED) and OFF (BLUE)
