Discussion On the Out-of-Sync TDC Module from the HMS Chambers

Carlos Yero

August 29 2018

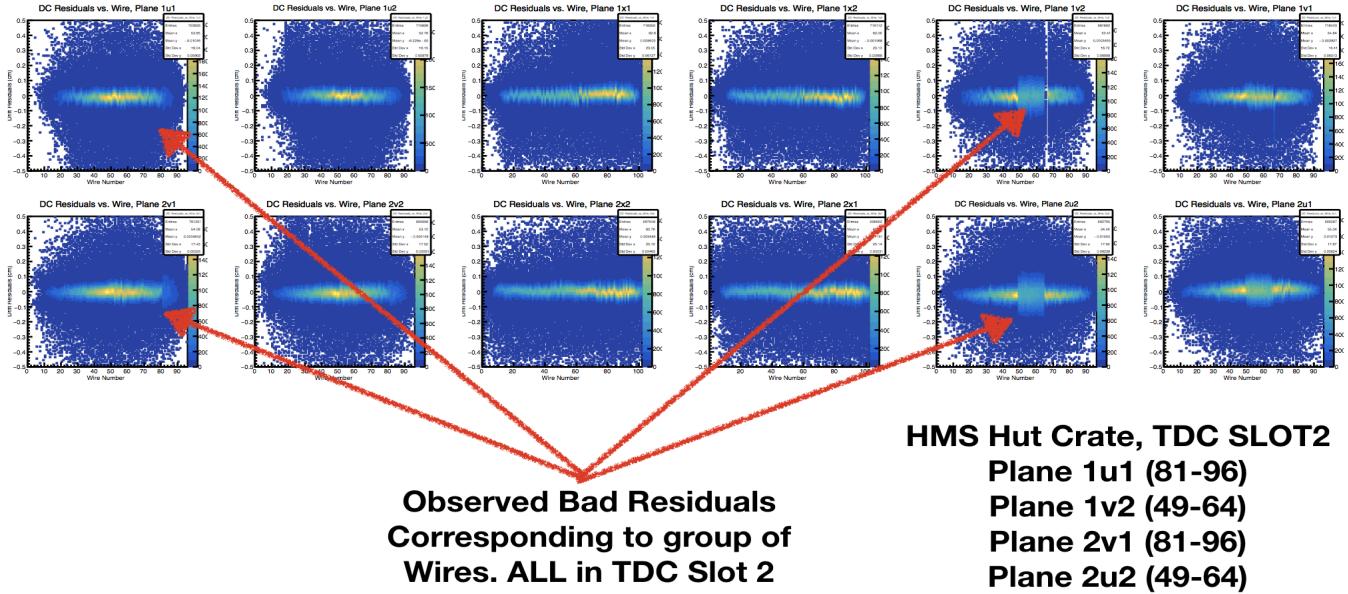
In Figure 2, the residuals for the tracks are plotted as a function of wire number. It can be clearly observed that the same four groups mentioned in Figure 1 have smeared out residuals. At this point, I started to consider this issue seriously, as it was NOT simply drifted times which could be fixed in software, but now the tracking had been affected.

Figure 2: Correlation of Residuals vs. Wire Number for all 12 planes. Four wire groups stand out from the rest, with a noticeable smearing. The adjacent planes are affected by this smearing as well, even though they are NOT part of the problematic TDC.

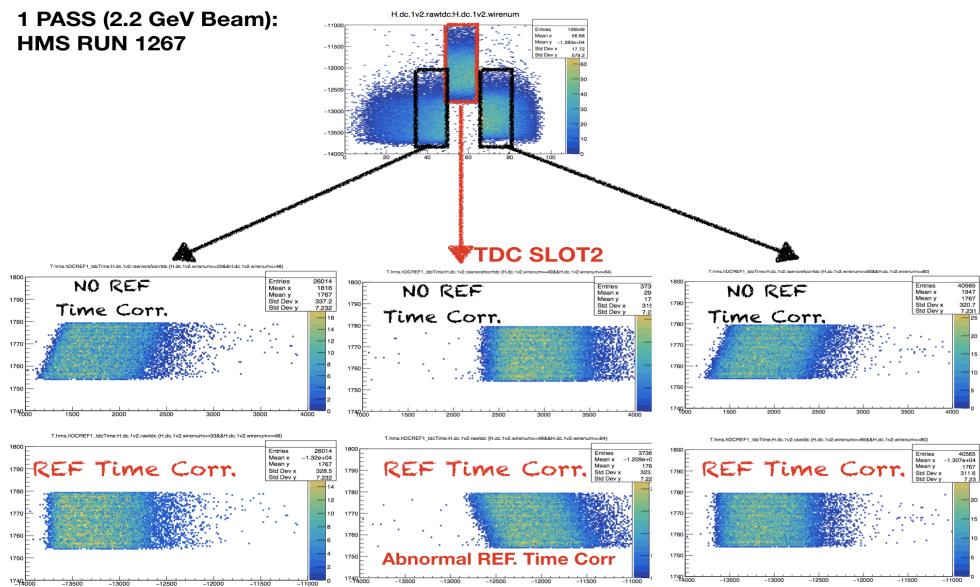
Figure 3: Correlation between the HMS DC reference time and the raw TDC times. The DC 1, V'-Plane raw TDC vs. Wire Number is shown. Adjacent wirgroups which are NOT in TDC Slot 2 are compared to the TDC Slot 2 wire group before and after applying the reference time correction to the raw TDC time.

Figure 3 is determinant in this study, as it shows the correlation of the reference time with the raw TDC time before and after applying the reference time correction. As expected from a normal TDC, when tdc times are reference time subtracted, the correlation disappears. However, in TDC Slot 2, the reference time and raw tdc time appear to be correlated, which is an indication that its copy of the reference time is Out-of-Sync with the rest of the modules.

As a temporary solution (until we replace the TDC module), it was decided that a copy of the reference time should be fed independently to the bad TDC module. This way, the TDC can synchronize with its own reference time, as opposed to receiving an alternate copy from the trigger interface (TI) module. This modification was done on hardware on July 30, 2018. See Log Enrty <https://logbooks.jlab.org/entry/3583094>.

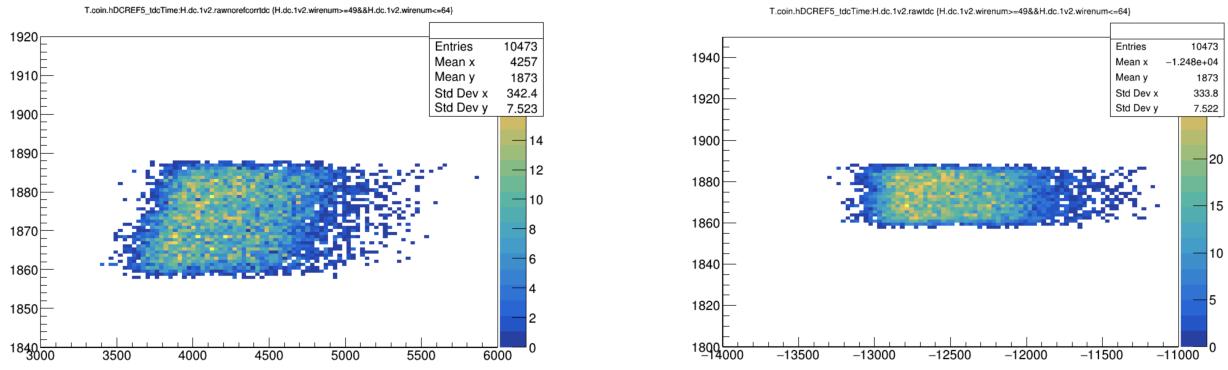
(a) TDC Slot 2 Reference Time vs. Raw Uncorrected TDC Time for wire group 1V2 (49-64)

(b) TDC Slot 2 Reference Time vs. Raw Corrected TDC Time for wire group 1V2 (49-64)

Figure 4: Results of HMS singles (DAQ in Coincidence Mode) cosmic run 4437 to verify that adding the new reference time to TDC Slot 2 fixes the problem. The subfigures above show the correlation between the newly added reference time and raw TDC Time from a group of wires in TDC Slot 2. As shown in subfigure (b), the correlation between the new reference time and raw TDC time is NOT present when the raw time is reference time corrected.

To demonstrate that the new reference time added fixed the issue, I decided to take an HMS singles (DAQ in Coincidence Mode) cosmic run to prove that when the new reference time was subtracted from the raw TDC time, the correlation that was present originally, dissappeared. This was indeed what happened, as observed in Figure 4.
