# Annual Inspection Report

1400 Alderpath Ave. Torrance, CA 90503

May 2026

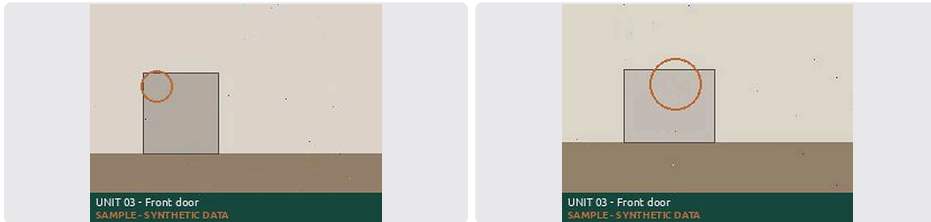
### ● Front Door REPAIR

The unit number is missing from the front door.

| PRIORITY | UNIT | ITEM | ACTION | DETAIL |
|---|---|---|---|---|
| Low | 03 | Front Door | Repair | The unit number is missing from the front door. |

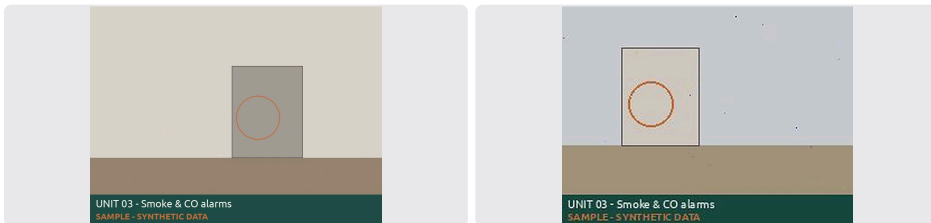
### ● Smoke / CO Alarms REPLACE

The carbon monoxide alarm is chirping on a low battery.

| PRIORITY | UNIT | ITEM | ACTION | DETAIL |
|---|---|---|---|---|
| High | 03 | Smoke / CO Alarms | Replace | The carbon monoxide alarm is chirping on a low battery. |

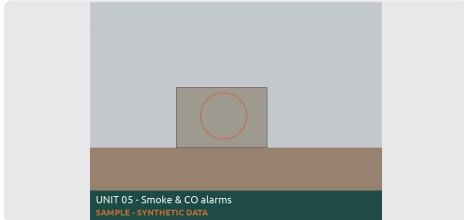
### ● Smoke / CO Alarms REPLACE

Smoke detectors are missing from the hallway.

| PRIORITY | UNIT | ITEM | ACTION | DETAIL |
|---|---|---|---|---|
| High | 05 | Smoke / CO Alarms | Replace | Smoke detectors are missing from the hallway. |

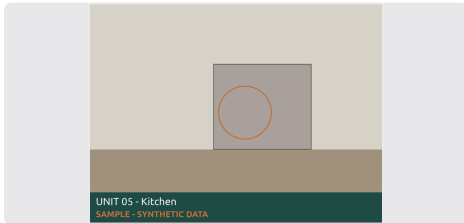
### ● Kitchen REPAIR

Several kitchen cabinet hinges are loose.

| PRIORITY | UNIT | ITEM | ACTION | DETAIL |
|---|---|---|---|---|
| Low | 05 | Kitchen | Repair | Several kitchen cabinet hinges are loose. |

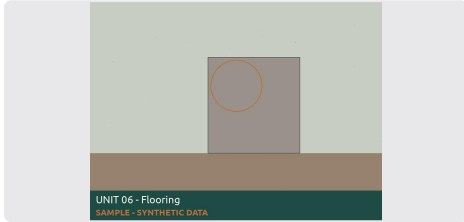
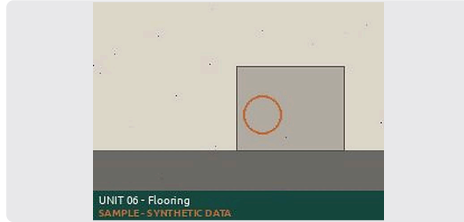
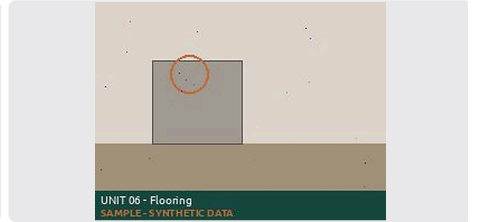
### ● Flooring REPAIR

The carpet tack strip is missing screws.

| PRIORITY | UNIT | ITEM | ACTION | DETAIL |
|---|---|---|---|---|
| Low | 06 | Flooring | Repair | The carpet tack strip is missing screws. |

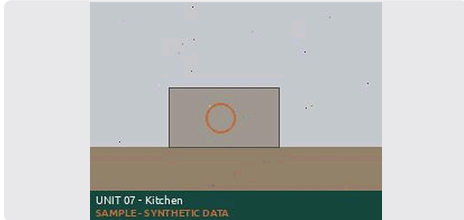
### ● Kitchen REPAIR

A kitchen drawer is damaged.

| PRIORITY | UNIT | ITEM | ACTION | DETAIL |
|---|---|---|---|---|
| Low | 07 | Kitchen | Repair | A kitchen drawer is damaged. |

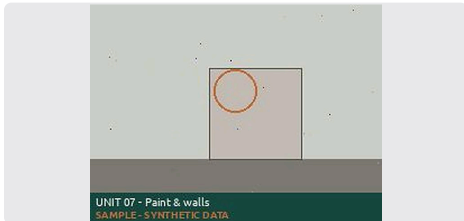
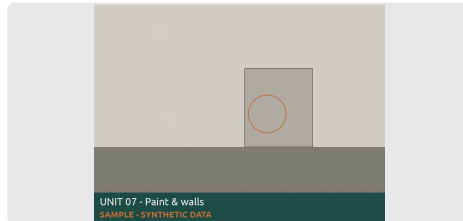
### ● Paint & Walls REPAIR

The drywall in the dining room, behind the kitchen wall, is damaged.

| PRIORITY | UNIT | ITEM | ACTION | DETAIL |
|---|---|---|---|---|
| Medium | 07 | Paint & Walls | Repair | The drywall in the dining room, behind the kitchen wall, is damaged. |

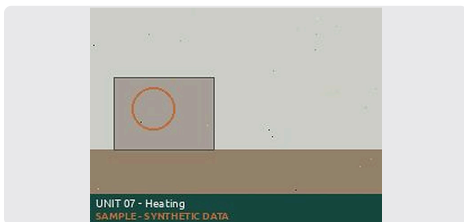
### ● HVAC REPAIR

The control knob on the living room wall heater is broken.

| PRIORITY | UNIT | ITEM | ACTION | DETAIL |
|---|---|---|---|---|
| Medium | 07 | HVAC | Repair | The control knob on the living room wall heater is broken. |

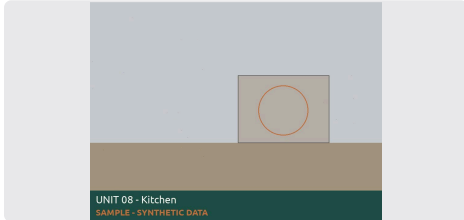
### ● Kitchen REPAIR

Several kitchen cabinet hinges are loose.

| PRIORITY | UNIT | ITEM | ACTION | DETAIL |
|---|---|---|---|---|
| Low | 08 | Kitchen | Repair | Several kitchen cabinet hinges are loose. |

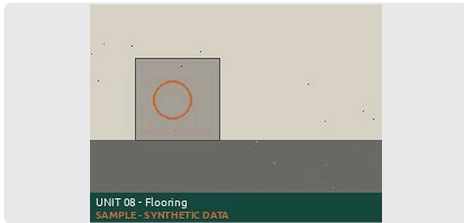
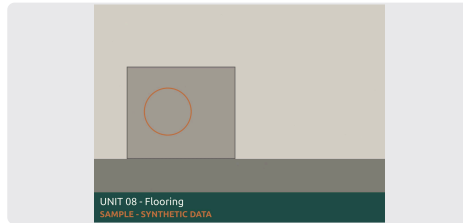
### ● Flooring REPAIR

The hallway floor is damaged.

| PRIORITY | UNIT | ITEM | ACTION | DETAIL |
|---|---|---|---|---|
| Medium | 08 | Flooring | Repair | The hallway floor is damaged. |

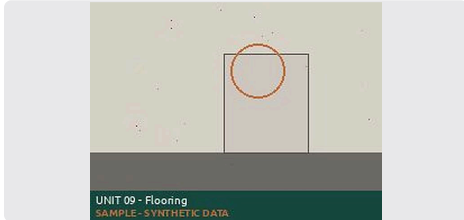
### ● Flooring REPAIR

Floor planks are lifting in the living room.

| PRIORITY | UNIT | ITEM | ACTION | DETAIL |
|---|---|---|---|---|
| Medium | 09 | Flooring | Repair | Floor planks are lifting in the living room. |

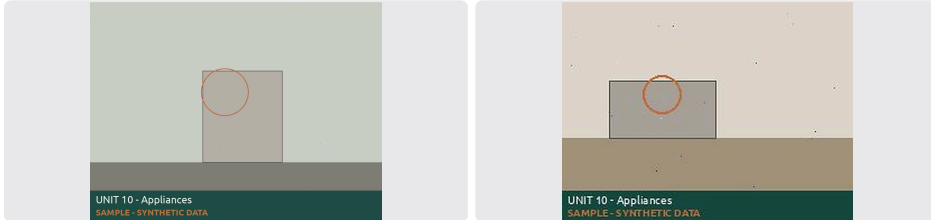
## ● Appliances REPAIR

The burners on the right side of the stove do not turn on.

| PRIORITY | UNIT | ITEM | ACTION | DETAIL |
|---|---|---|---|---|
| Medium | 10 | Appliances | Repair | The burners on the right side of the stove do not turn on. |

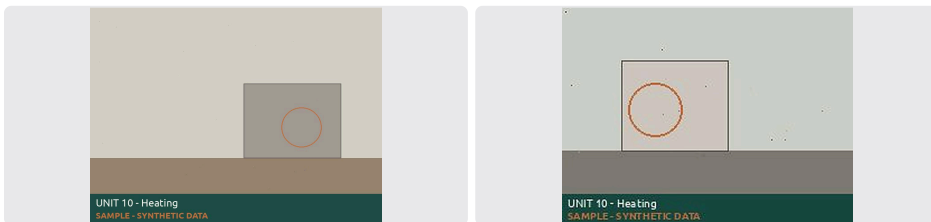
## ● HVAC REPAIR

The control knob on the living room wall heater is broken.

| PRIORITY | UNIT | ITEM | ACTION | DETAIL |
|---|---|---|---|---|
| Medium | 10 | HVAC | Repair | The control knob on the living room wall heater is broken. |

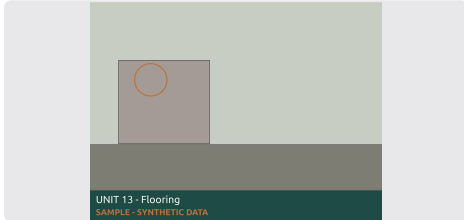
### ● Flooring REPAIR

Floor planks are lifting in the living room.

| PRIORITY | UNIT | ITEM | ACTION | DETAIL |
|---|---|---|---|---|
| Medium | 13 | Flooring | Repair | Floor planks are lifting in the living room. |

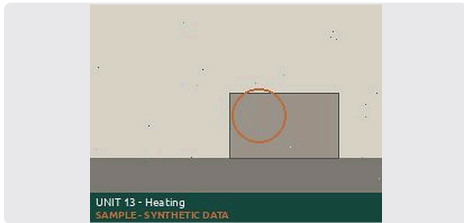
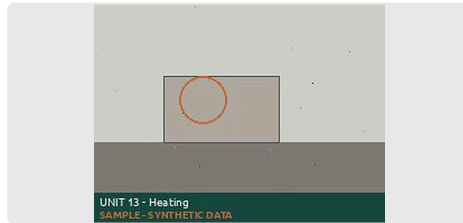
### ● HVAC REPAIR

The control knob on the living room wall heater is broken.

| PRIORITY | UNIT | ITEM | ACTION | DETAIL |
|---|---|---|---|---|
| Medium | 13 | HVAC | Repair | The control knob on the living room wall heater is broken. |

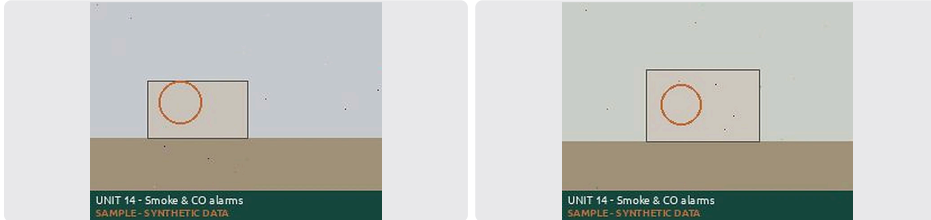
### ● Smoke / CO Alarms REPLACE

The carbon monoxide alarm is chirping on a low battery.

| PRIORITY | UNIT | ITEM | ACTION | DETAIL |
|---|---|---|---|---|
| High | 14 | Smoke / CO Alarms | Replace | The carbon monoxide alarm is chirping on a low battery. |

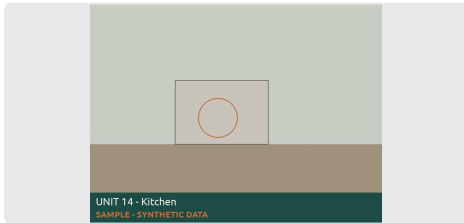
### ● Kitchen REPAIR

A kitchen drawer is damaged.

| PRIORITY | UNIT | ITEM | ACTION | DETAIL |
|---|---|---|---|---|
| Low | 14 | Kitchen | Repair | A kitchen drawer is damaged. |

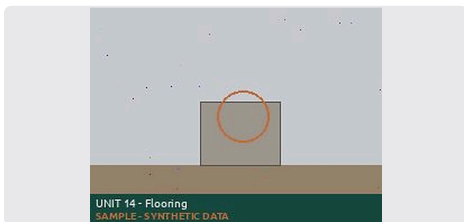
### ● Flooring REPAIR

Floor planks are lifting in the living room.

| PRIORITY | UNIT | ITEM | ACTION | DETAIL |
|---|---|---|---|---|
| Medium | 14 | Flooring | Repair | Floor planks are lifting in the living room. |

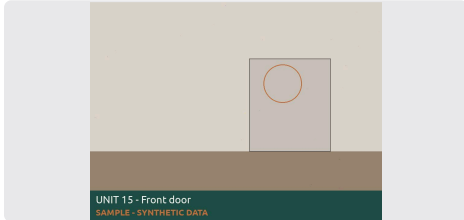
### ● Front Door REPAIR

The unit number is missing from the front door.

| PRIORITY | UNIT | ITEM | ACTION | DETAIL |
|---|---|---|---|---|
| Low | 15 | Front Door | Repair | The unit number is missing from the front door. |

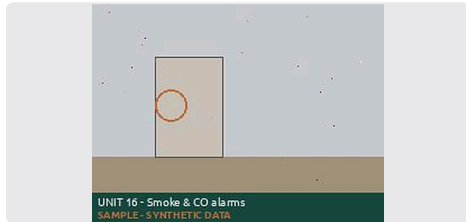
### ● Smoke / CO Alarms REPLACE

The carbon monoxide alarm is chirping on a low battery.

| PRIORITY | UNIT | ITEM | ACTION | DETAIL |
|---|---|---|---|---|
| High | 16 | Smoke / CO Alarms | Replace | The carbon monoxide alarm is chirping on a low battery. |

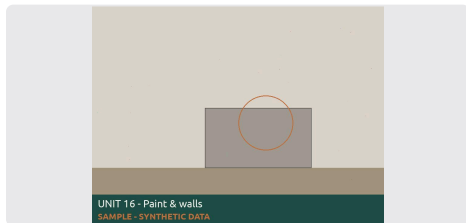
### ● Paint & Walls REPAIR

The dining room ceiling fan is broken and is not secured to its mount.

| PRIORITY | UNIT | ITEM | ACTION | DETAIL |
|---|---|---|---|---|
| High | 16 | Paint & Walls | Repair | The dining room ceiling fan is broken and is not secured to its mount. |

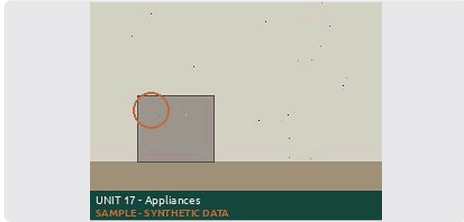
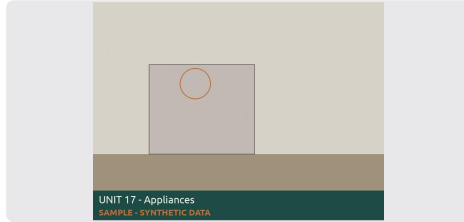
### ● Appliances REPAIR

The refrigerator door seal is torn.

| PRIORITY | UNIT | ITEM | ACTION | DETAIL |
|---|---|---|---|---|
| Medium | 17 | Appliances | Repair | The refrigerator door seal is torn. |

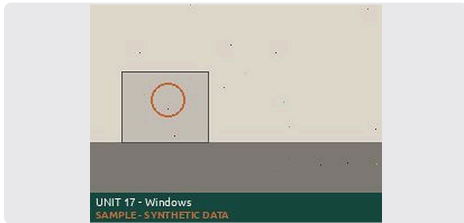
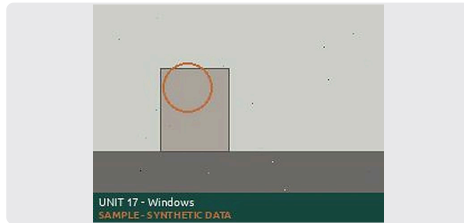
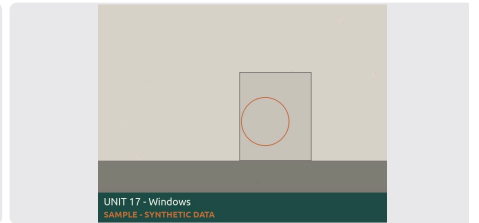
### ● Windows REPAIR

The bedroom window does not stay open on its own.

| PRIORITY | UNIT | ITEM | ACTION | DETAIL |
|---|---|---|---|---|
| Medium | 17 | Windows | Repair | The bedroom window does not stay open on its own. |

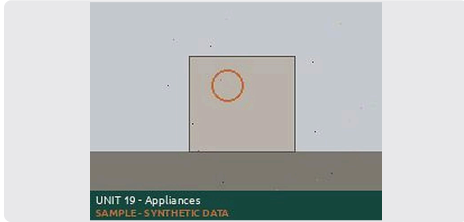
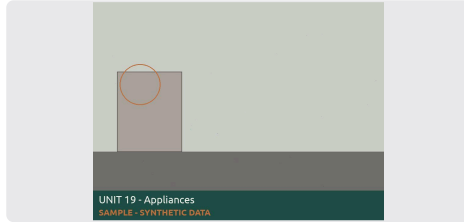
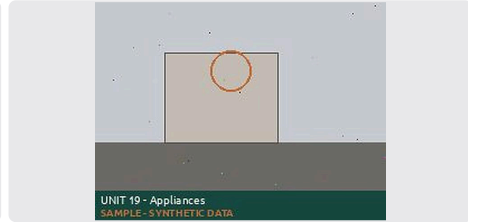
## ● Appliances REPAIR

The burners on the right side of the stove do not turn on.

| PRIORITY | UNIT | ITEM | ACTION | DETAIL |
|---|---|---|---|---|
| Medium | 19 | Appliances | Repair | The burners on the right side of the stove do not turn on. |

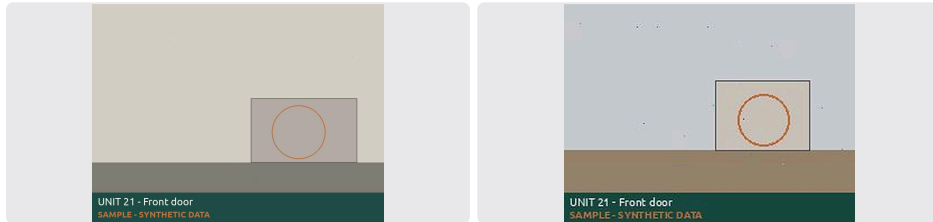
## ● Front Door REPAIR

The unit number is missing from the front door.

| PRIORITY | UNIT | ITEM | ACTION | DETAIL |
|---|---|---|---|---|
| Low | 21 | Front Door | Repair | The unit number is missing from the front door. |

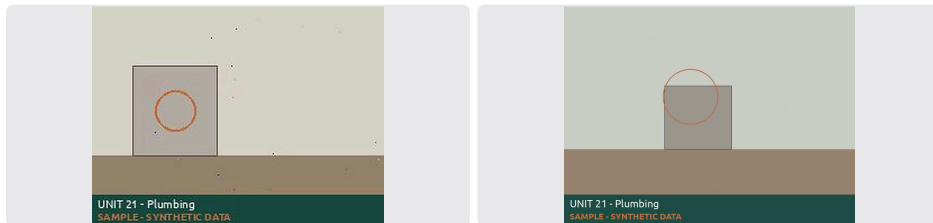
## ● Plumbing REPAIR

The garbage disposal does not run, and the bathtub and bathroom sink are missing drain strainers.

| PRIORITY | UNIT | ITEM | ACTION | DETAIL |
|---|---|---|---|---|
| Medium | 21 | Plumbing | Repair | The garbage disposal does not run, and the bathtub and bathroom sink are missing drain strainers. |

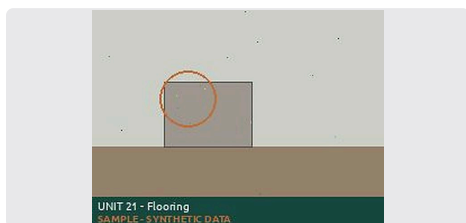
## ● Flooring REPAIR

The carpet tack strip is missing screws.

| PRIORITY | UNIT | ITEM | ACTION | DETAIL |
|---|---|---|---|---|
| Low | 21 | Flooring | Repair | The carpet tack strip is missing screws. |

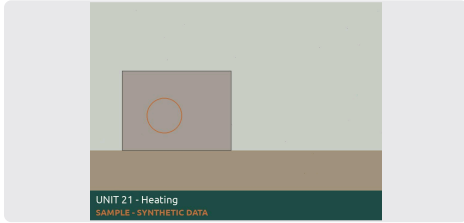
## ● HVAC REPAIR

The water heater closet is blocked by stored boxes.

| PRIORITY | UNIT | ITEM | ACTION | DETAIL |
|---|---|---|---|---|
| High | 21 | HVAC | Repair | The water heater closet is blocked by stored boxes. |

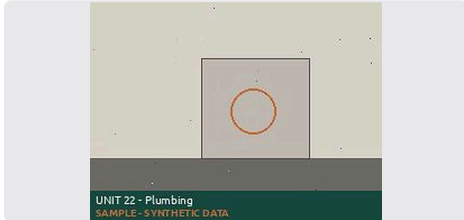
### ● Plumbing REPAIR

The tub spout in the hallway bathroom is missing caulk where it meets the wall.

| PRIORITY | UNIT | ITEM | ACTION | DETAIL |
|---|---|---|---|---|
| Medium | 22 | Plumbing | Repair | The tub spout in the hallway bathroom is missing caulk where it meets the wall. |

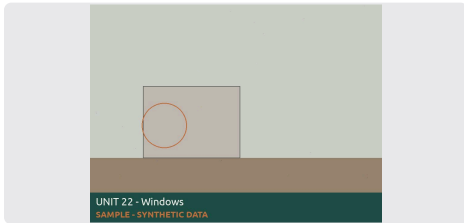
### ● Windows REPAIR

The kitchen window screen is damaged.

| PRIORITY | UNIT | ITEM | ACTION | DETAIL |
|---|---|---|---|---|
| Low | 22 | Windows | Repair | The kitchen window screen is damaged. |

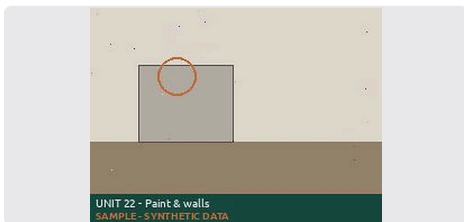
### ● Paint & Walls REPAIR

The dining room ceiling fan is broken and is not secured to its mount.

| PRIORITY | UNIT | ITEM | ACTION | DETAIL |
|---|---|---|---|---|
| High | 22 | Paint & Walls | Repair | The dining room ceiling fan is broken and is not secured to its mount. |

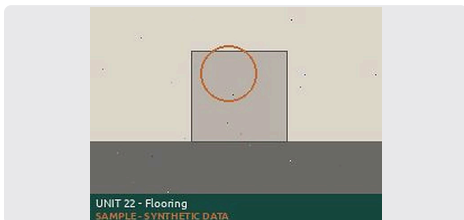
### ● Flooring REPAIR

The carpet tack strip is missing screws.

| PRIORITY | UNIT | ITEM | ACTION | DETAIL |
|---|---|---|---|---|
| Low | 22 | Flooring | Repair | The carpet tack strip is missing screws. |

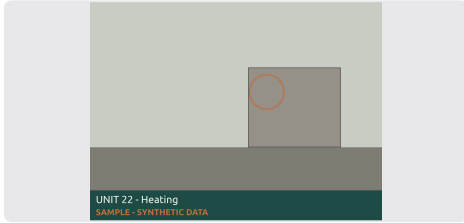
## ● HVAC REPAIR

The control knob on the living room wall heater is broken.

| PRIORITY | UNIT | ITEM | ACTION | DETAIL |
|---|---|---|---|---|
| Medium | 22 | HVAC | Repair | The control knob on the living room wall heater is broken. |

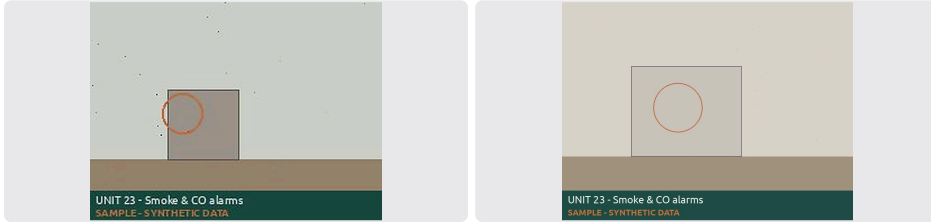
### ● Smoke / CO Alarms REPLACE

Smoke detectors are missing throughout the unit.

| PRIORITY | UNIT | ITEM | ACTION | DETAIL |
|---|---|---|---|---|
| High | 23 | Smoke / CO Alarms | Replace | Smoke detectors are missing throughout the unit. |

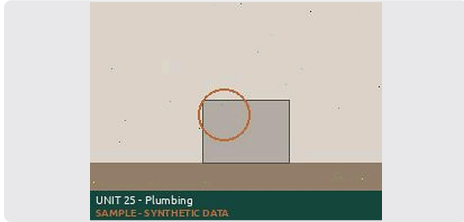
### ● Plumbing REPAIR

The bathroom sink drains slowly.

| PRIORITY | UNIT | ITEM | ACTION | DETAIL |
|---|---|---|---|---|
| Low | 25 | Plumbing | Repair | The bathroom sink drains slowly. |

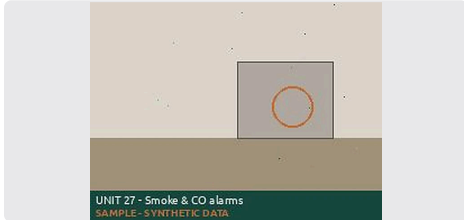
### ● Smoke / CO Alarms REPLACE

Smoke detectors are missing from the hallway.

| PRIORITY | UNIT | ITEM | ACTION | DETAIL |
|---|---|---|---|---|
| High | 27 | Smoke / CO Alarms | Replace | Smoke detectors are missing from the hallway. |

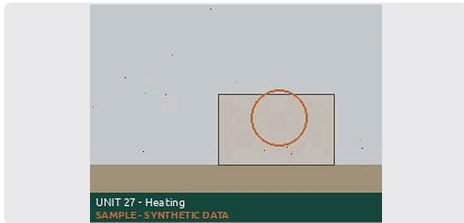
### ● HVAC REPAIR

The control knob on the living room wall heater is broken.

| PRIORITY | UNIT | ITEM | ACTION | DETAIL |
|---|---|---|---|---|
| Medium | 27 | HVAC | Repair | The control knob on the living room wall heater is broken. |

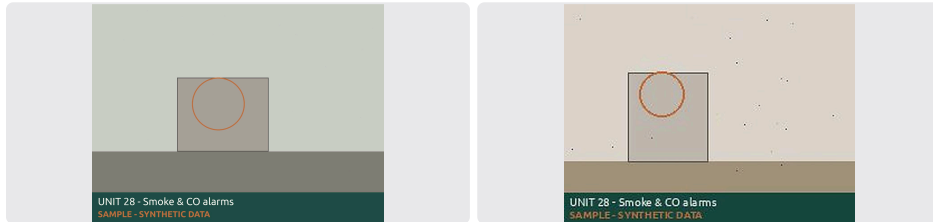
### ● Smoke / CO Alarms REPLACE

The carbon monoxide alarm is chirping on a low battery.

| PRIORITY | UNIT | ITEM | ACTION | DETAIL |
|---|---|---|---|---|
| High | 28 | Smoke / CO Alarms | Replace | The carbon monoxide alarm is chirping on a low battery. |
