# Urban Change Intelligence Agent — Case Report

Total cases reviewed: 6

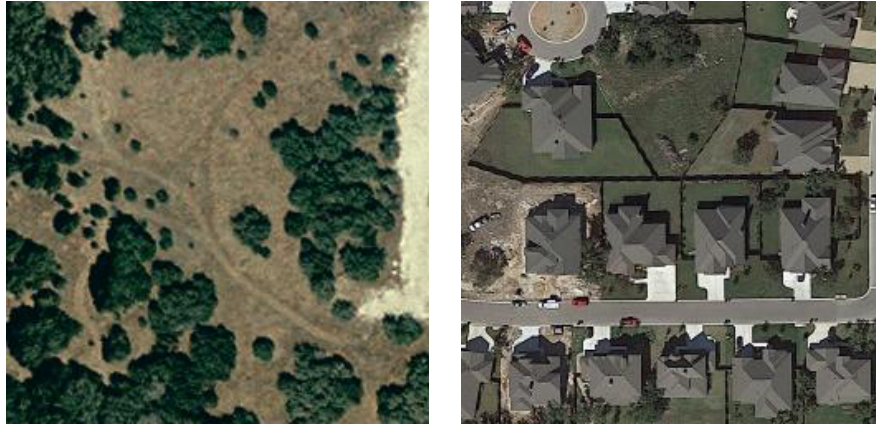
*test\_2\_0000\_0000 — ESCALATE (98% confidence)*

Change: The land transformed from an undeveloped, sparsely wooded area with bare soil and scattered trees into a residential subdivision featuring multiple new houses, paved roads, driveways, and landscaped lots.

Environmental notes: Significant vegetation and tree cover was clearly lost, with natural scrubland and woodland converted to a residential subdivision featuring multiple homes, roads, and paved surfaces. This represents a near-complete transformation of undeveloped land to hardened urban surfaces, though this is a rough visual estimate based on satellite imagery alone.

Reason: A major unauthorized residential subdivision has been constructed with no permit of any kind on file, representing large-scale illegal development requiring immediate escalation.

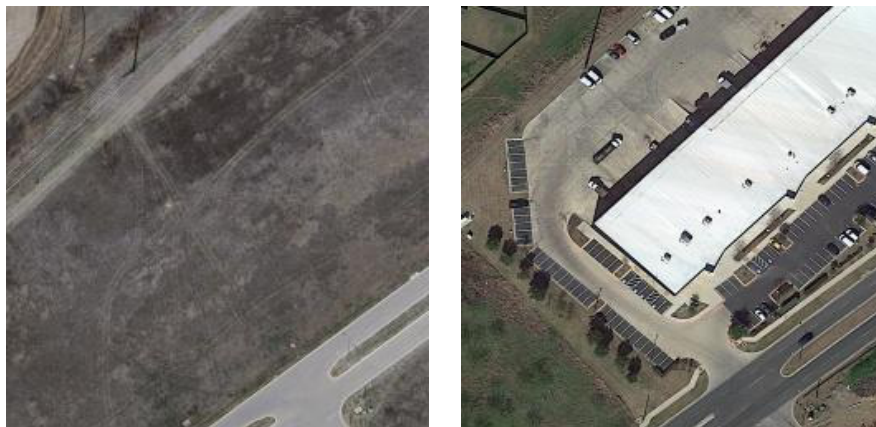
***test\_102\_0512\_0000 — FLAG\_FOR\_REVIEW (72% confidence)***

Change: A large commercial/industrial warehouse or distribution building was constructed on the previously vacant, undeveloped land. The development also includes a substantial parking lot, access roads, and associated infrastructure surrounding the building.

Environmental notes: The before image shows largely bare/scrubby undeveloped land with minimal vegetation, which has been converted to a large warehouse building with extensive parking and pavement in the after image; vegetation loss appears minimal given the already sparse cover, but significant soil sealing and impervious surface creation has occurred. This is a rough visual estimate based on satellite imagery alone.

Reason: A new construction permit application is on file for commercial use on this parcel, which aligns with the detected warehouse development, but the permit status is still pending with no issue date, meaning construction has begun without an approved permit.

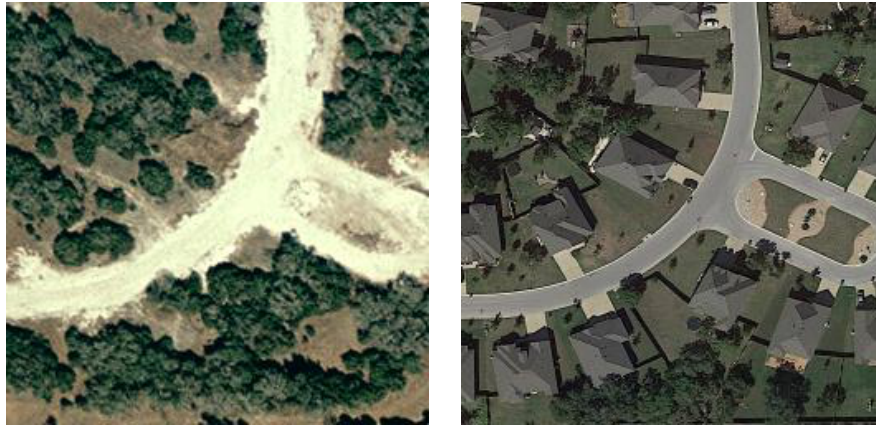
**test\_2\_0000\_0512 — ESCALATE (99% confidence)**

Change: The area was completely transformed from a natural landscape with a winding dry riverbed/sandy wash surrounded by trees into a residential subdivision with multiple houses, paved roads, driveways, and landscaped lots.

Environmental notes: Significant vegetation and tree cover was lost, with natural undeveloped land featuring a sandy riverbed/wash and surrounding forest converted to a residential subdivision with roads, rooftops, and paved surfaces. This represents a near-complete transformation of a natural landscape to hardened urban infrastructure, though this is a rough visual estimate based on satellite imagery alone.

Reason: A major transformation of natural land into a full residential subdivision with roads, houses, and infrastructure has occurred with absolutely no permit on file, representing a severe unauthorized development requiring immediate escalation.

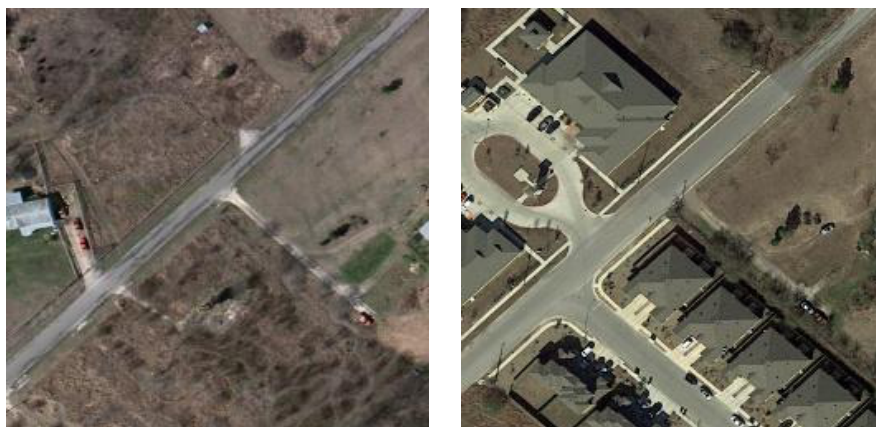
**test\_121\_0768\_0256 — ESCALATE (82% confidence)**

Change: The previously undeveloped/rural land with a simple road intersection has been transformed into a large-scale development featuring multiple buildings, parking lots, paved roads, and what appears to be a residential or mixed-use complex with several structures of varying sizes.

Environmental notes: Significant vegetation and scrubland were cleared to construct multiple buildings, parking lots, and paved roadways, representing a substantial conversion of natural land to impervious

surfaces. This is a rough visual estimate, but the loss of natural cover appears extensive across most of the parcel.

Reason: A large-scale development with multiple buildings and infrastructure has been constructed on previously undeveloped land, but the only permit on file is a pending (not approved) building \*extension\* permit, which does not authorize new large-scale ground-up construction, making this high-severity unauthorized development requiring urgent escalation.
