## Takachar Hot Test (In-Depth) Documentation

This is the 1st point of hot test documentation listed below. An overview of all test data, parameters, and takeaways can be found at point 4.

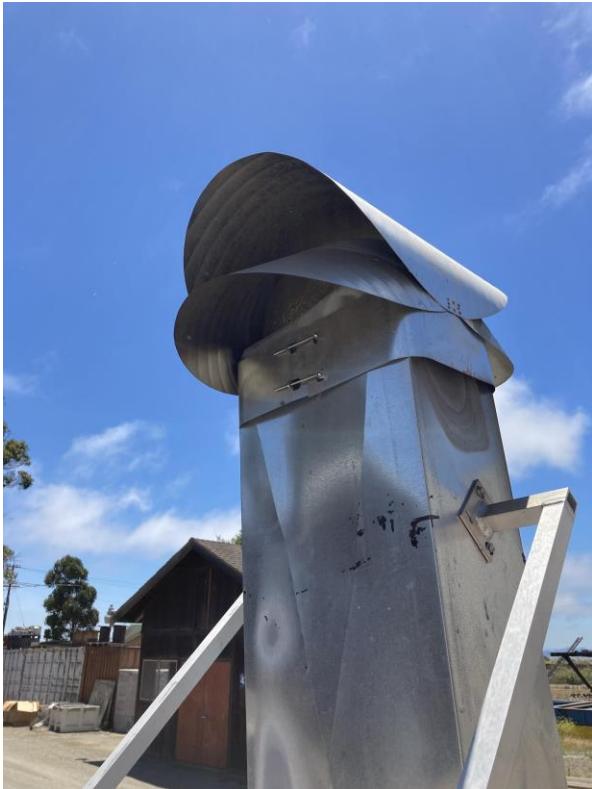
- Reduced smoke, but noticeable particulates

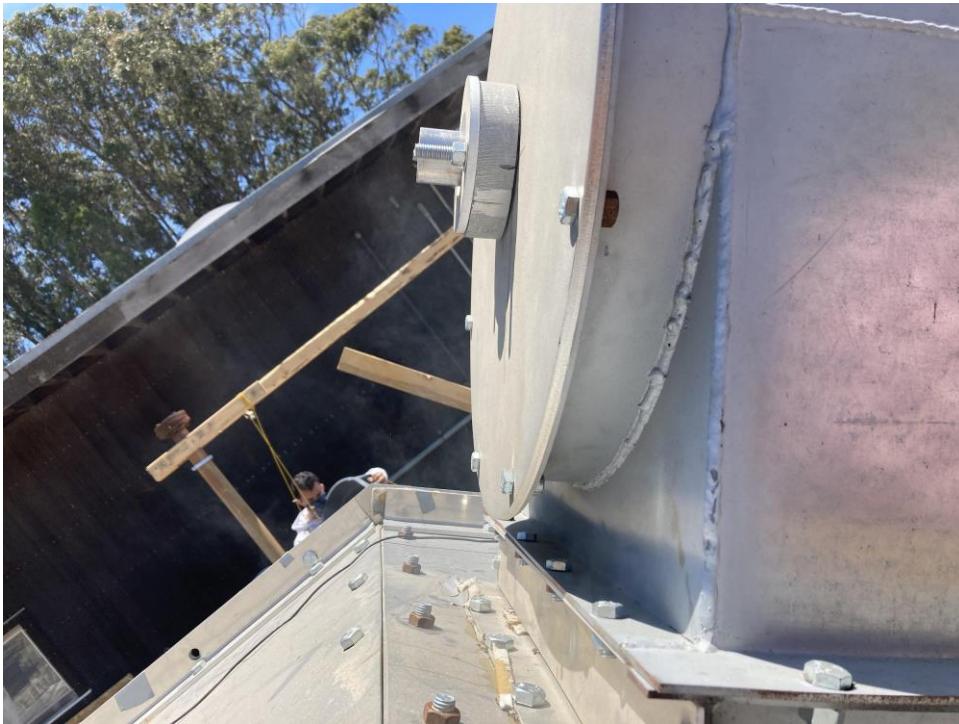
- Some smoke escaping from char box initially

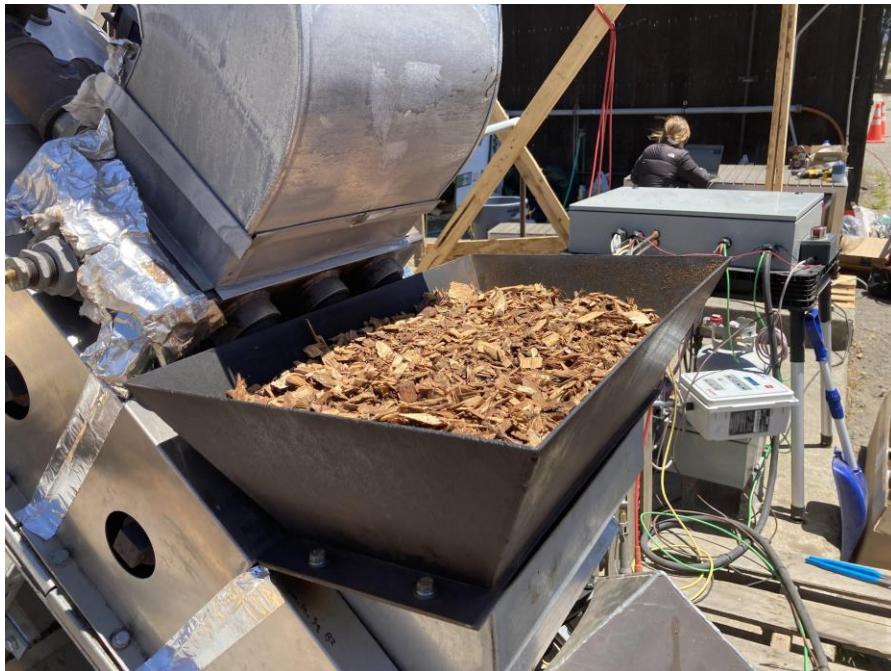
- Minimal smoke from hopper

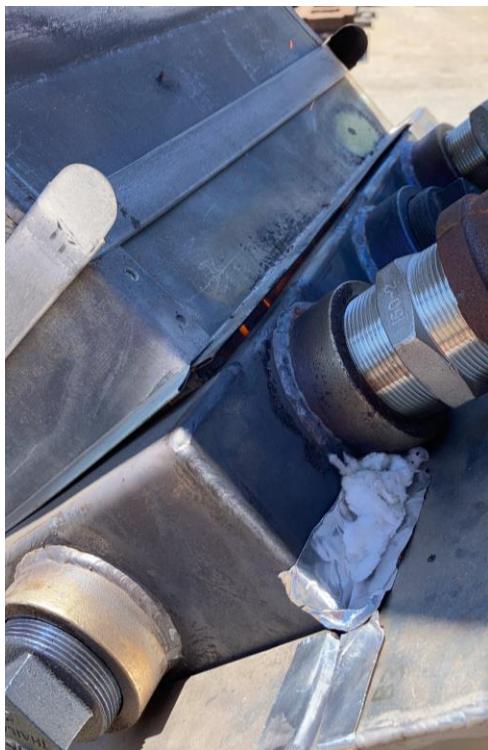
- Chimney came unseated

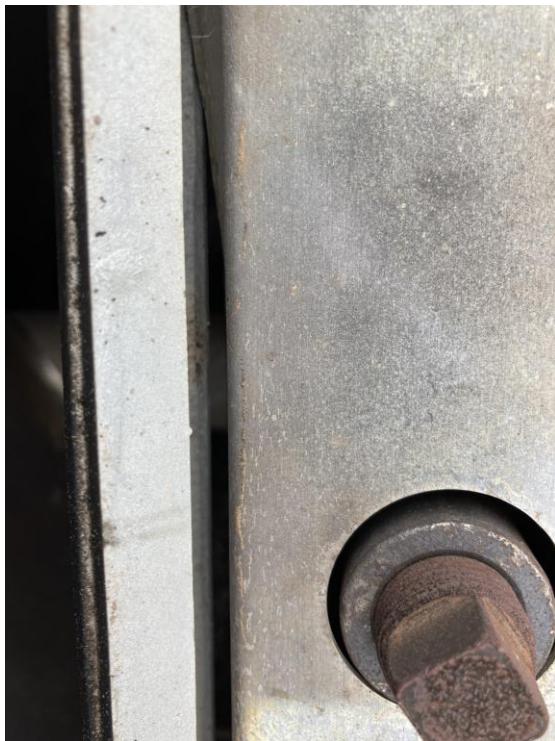
- Deforming metals due to thermal expansion - dissimilar metals and unequal expansion coefficients

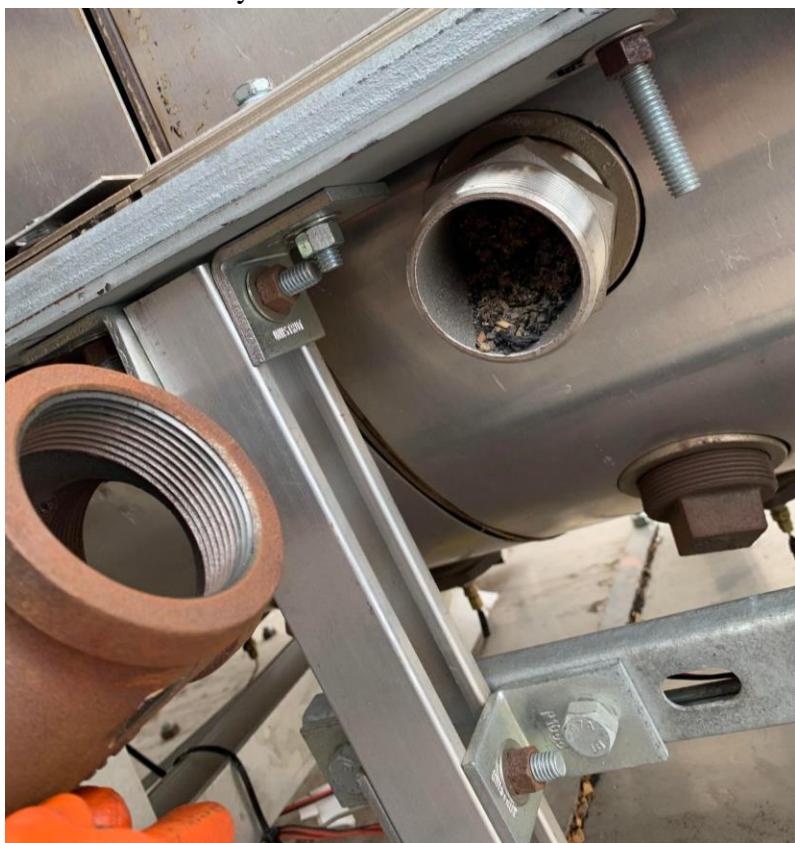
- Blower inlet seemed to be partially blocked by char/biomass

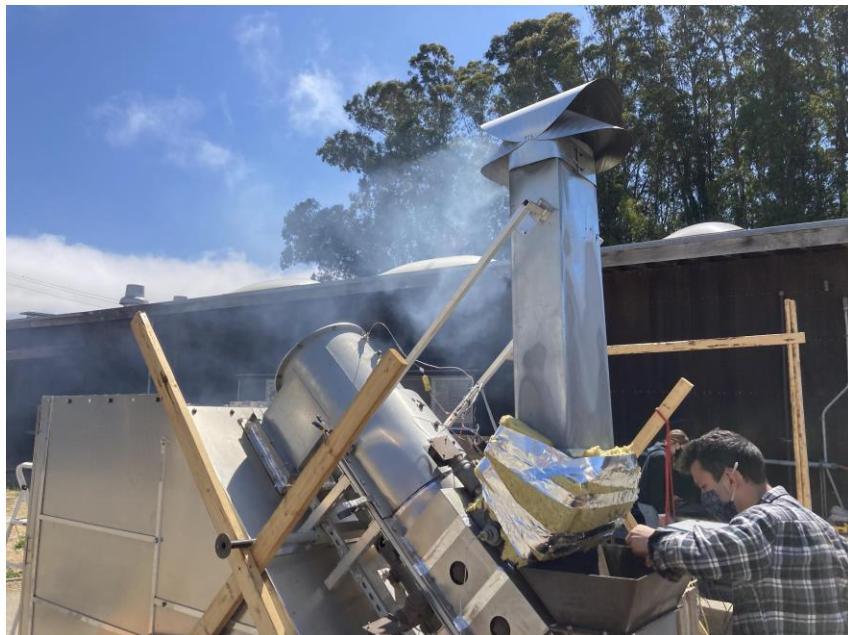
- Smoke emissions during ramp up

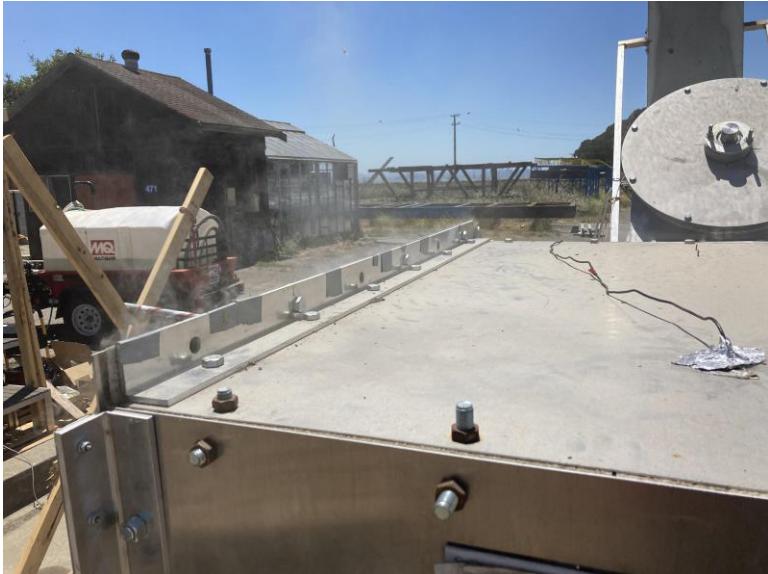
- Significant smoke and fumes of melting plastic from char box

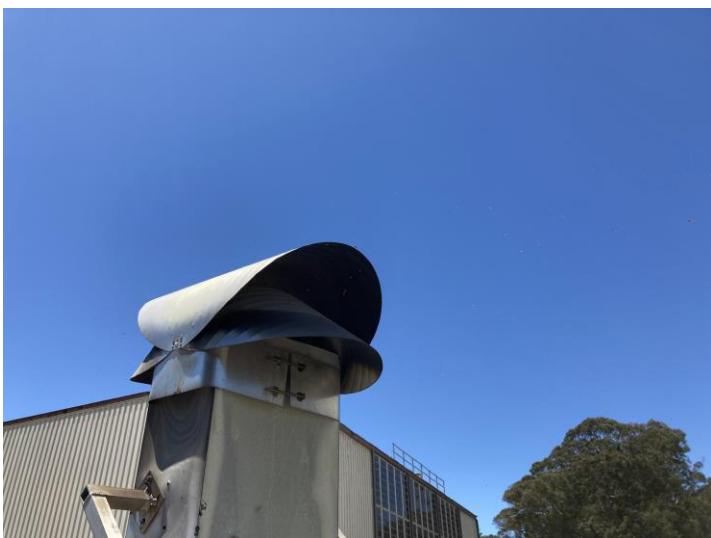
- These embers are a safety hazard for both the environment around the reactor as well as those working close to the reactor.
- At one point during the test, we also saw flames coming out of the top of the chimney and so we increased the secondary blowers to 6500 and reduced the primary blowers to 3000.

- Red hot embers emitting from chimney. Flames also visible at times beneath calling.

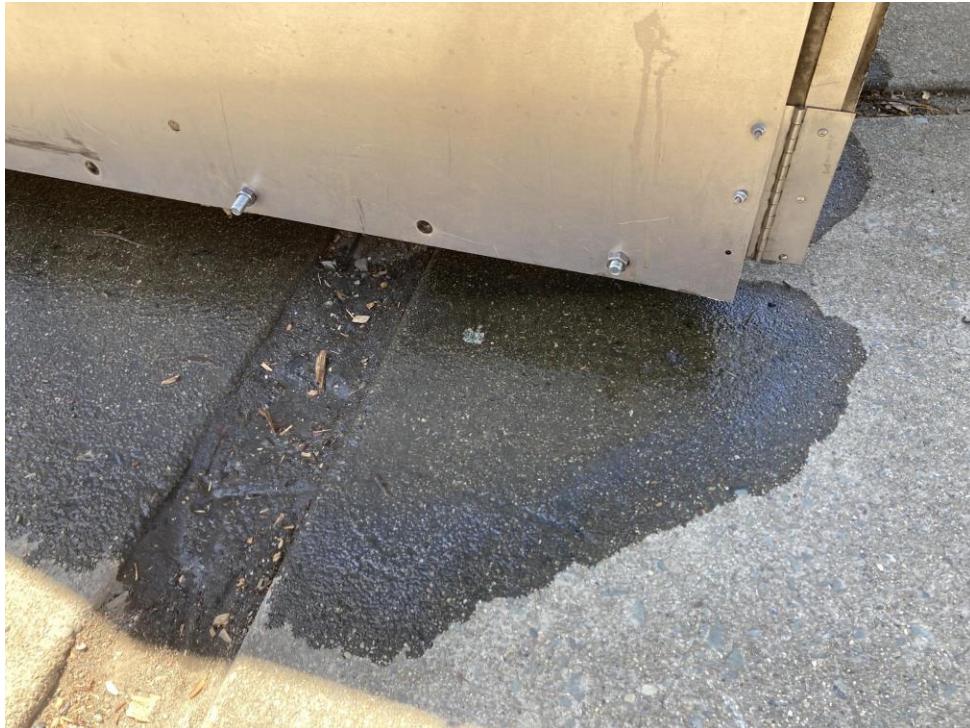
- Unknown liquid dripping from char box. Cold to the touch (accidentally dripped on Ryan)

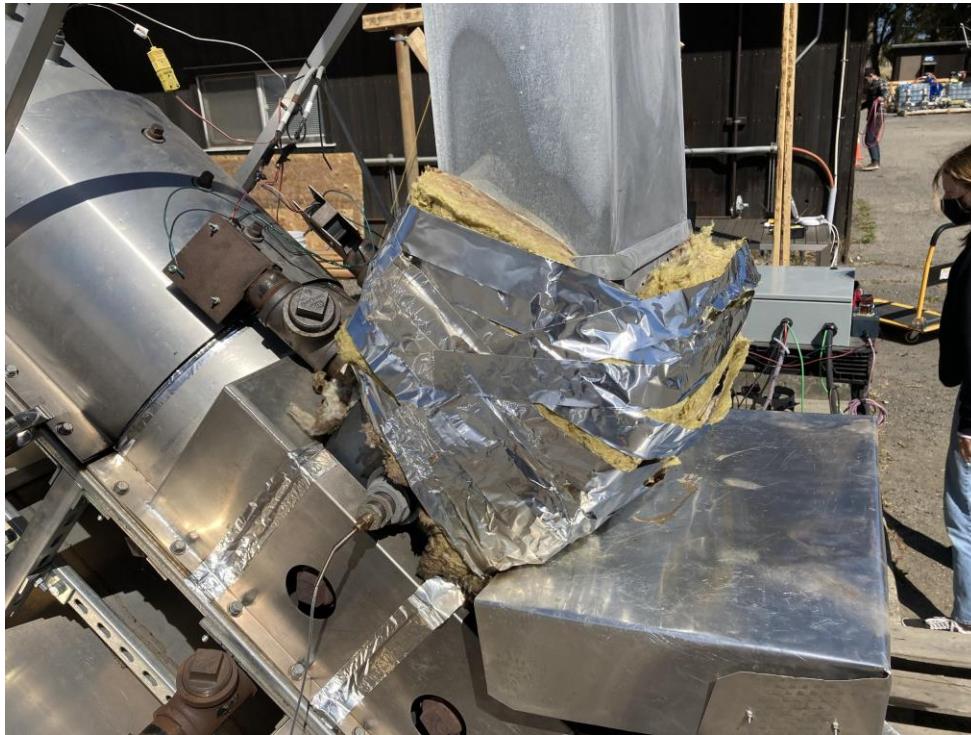
- Improved insulation at chimney

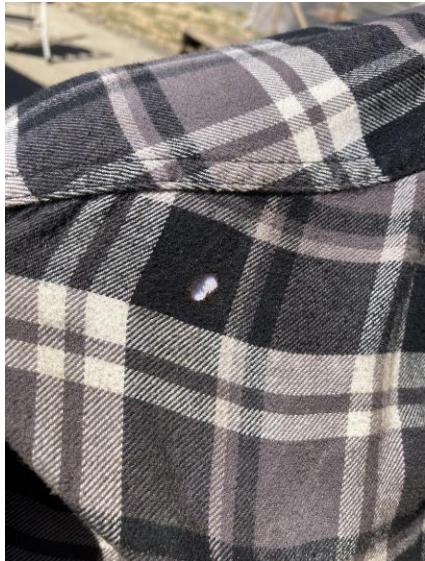
- Embers from reactor melting clothing and burning skin - safety hazard!

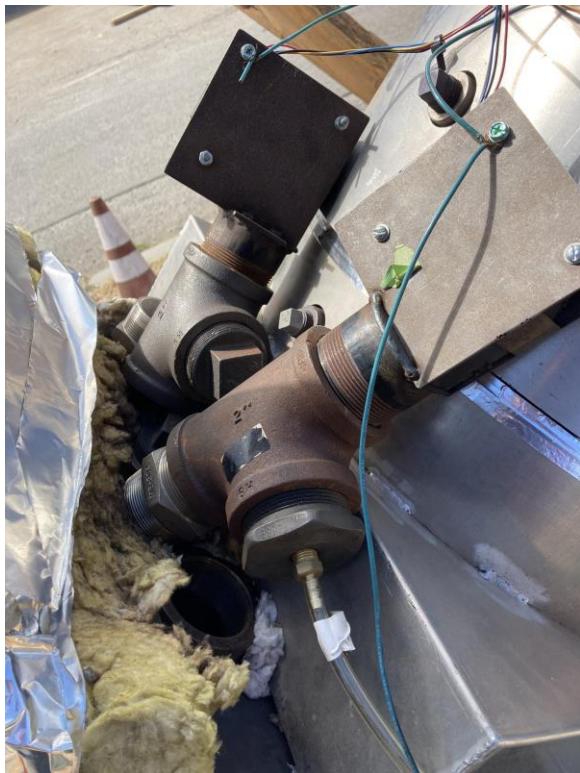
- Removed secondary blowers before leaving to avoid heat damage

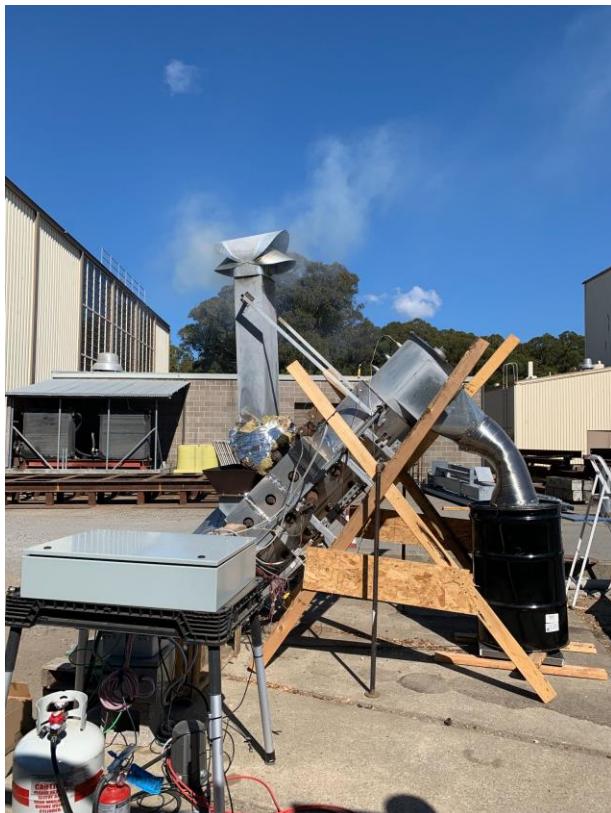
- Smoke from the chimney

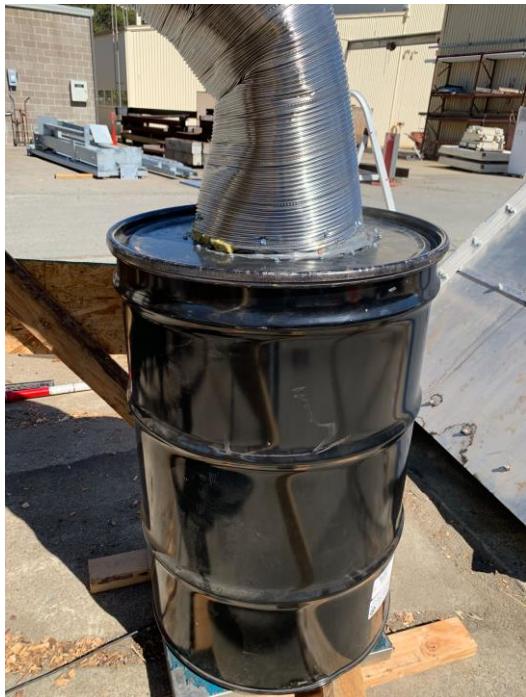
- Smoke coming out of small gaps of cooling mechanism

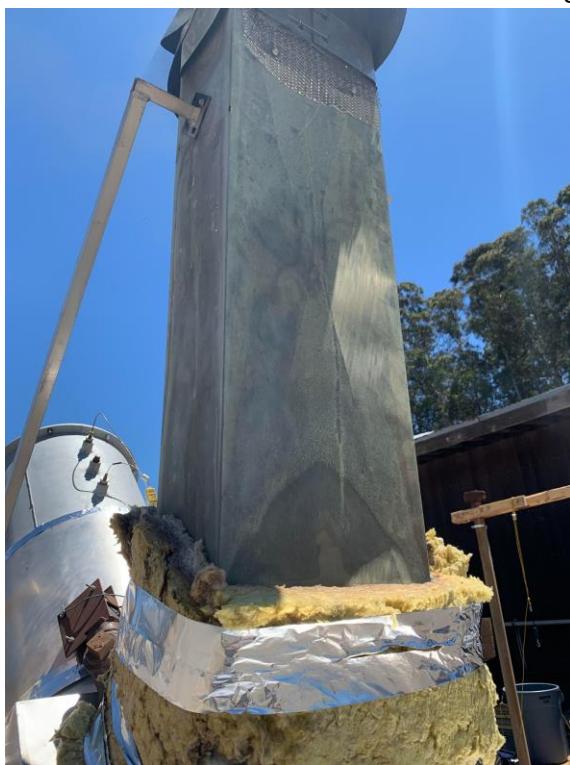
- We also did not observe any smoke leaking out of the reactor or oil drum tubing.
- During this test, the chimney became very hot and started turning green in color.

- Chimney changing colors

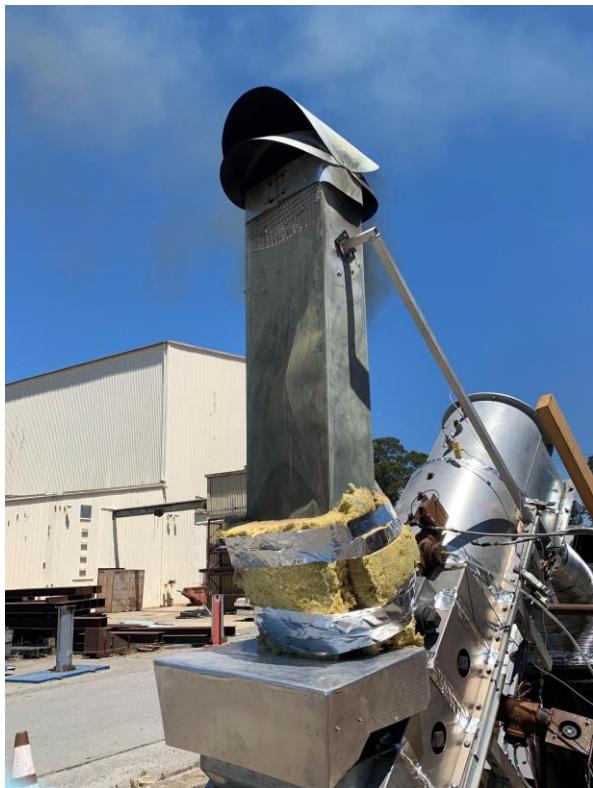
- Black smoke from chimney

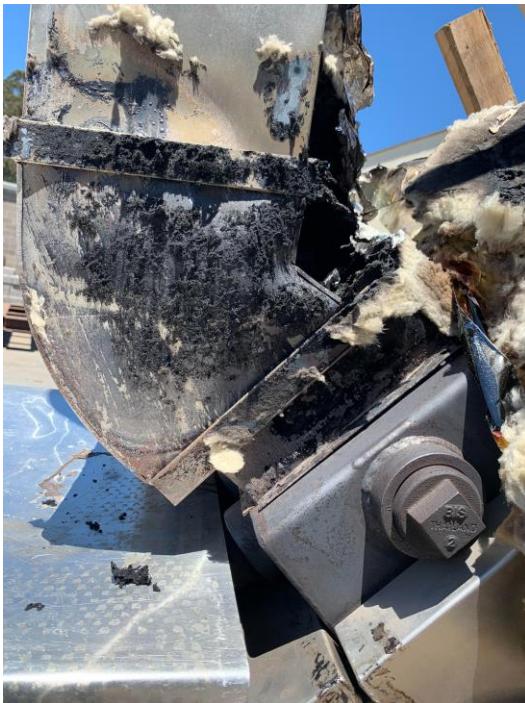
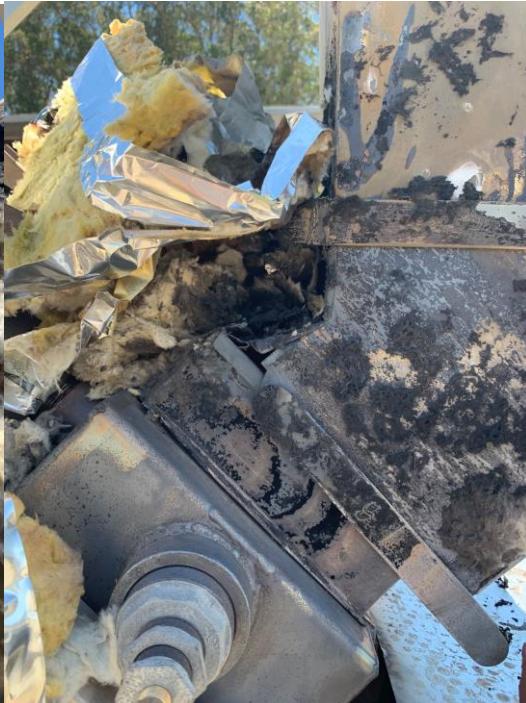
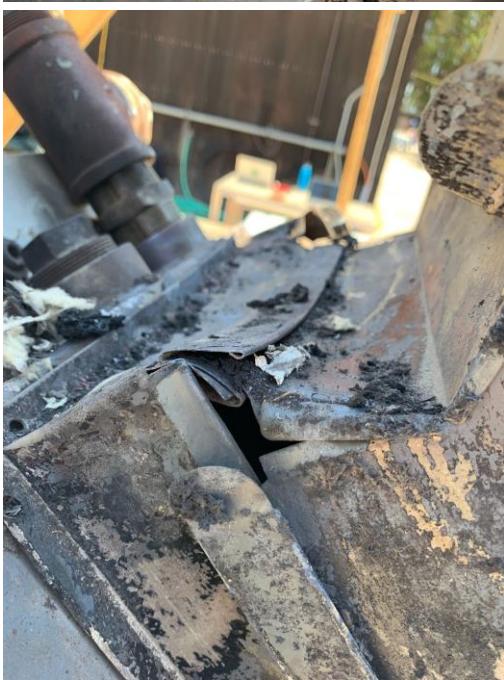
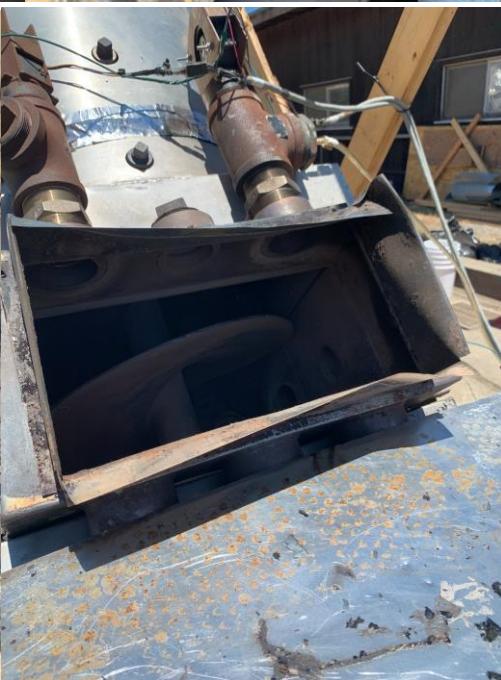
- Upon seeing the flames, we turned off the motor and doused the flame with water as well as a fire extinguisher. This killed the flame.
  - We suspect that the fire may have been seeping through holes between the chimney and the adapter, which we think may have been caused by corrosion and stress.

- Chimney base after shut down (we think most of this damage is due to corrosion and stress)

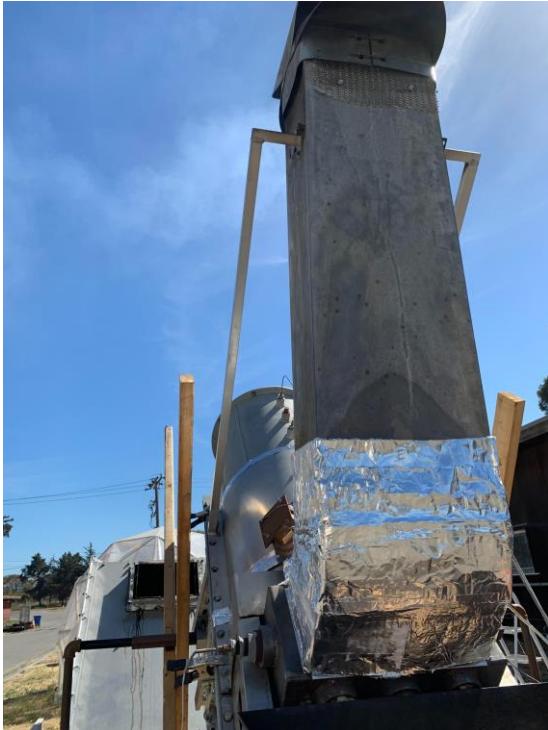
- Smoke from the chimney while trying to start the fire

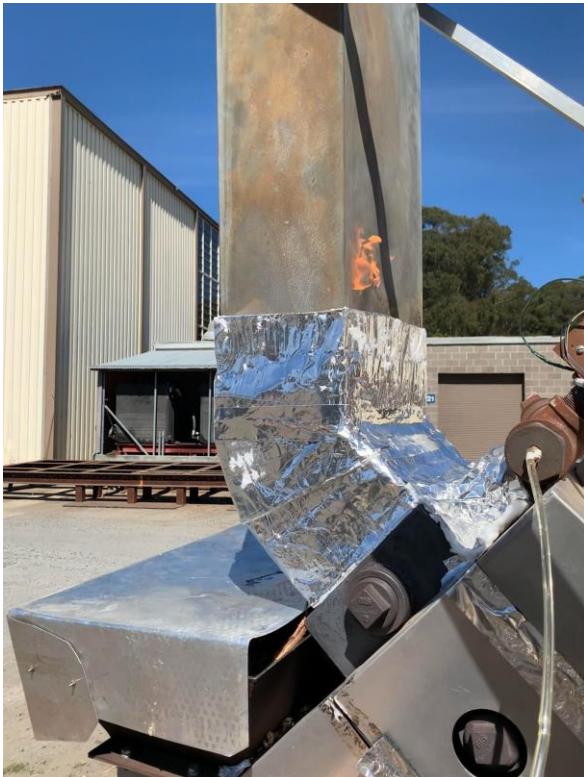
- About 20 min after getting the motor going again, we noticed flames coming out of the bottom of the chimney and black smoke coming from the top of the chimney and so we increased the secondary blowers, which caused the flames to increase. Once we lowered the speed of the secondary blowers, the flames seemed to die down a bit.

- These flames could have also been caused by the transfer of heat from the chimney (which was less insulated than in previous tests) to the hopper lid, which then caused the biomass inside to catch on fire.

- Flame at bottom of the chimney
- Flame near hopper

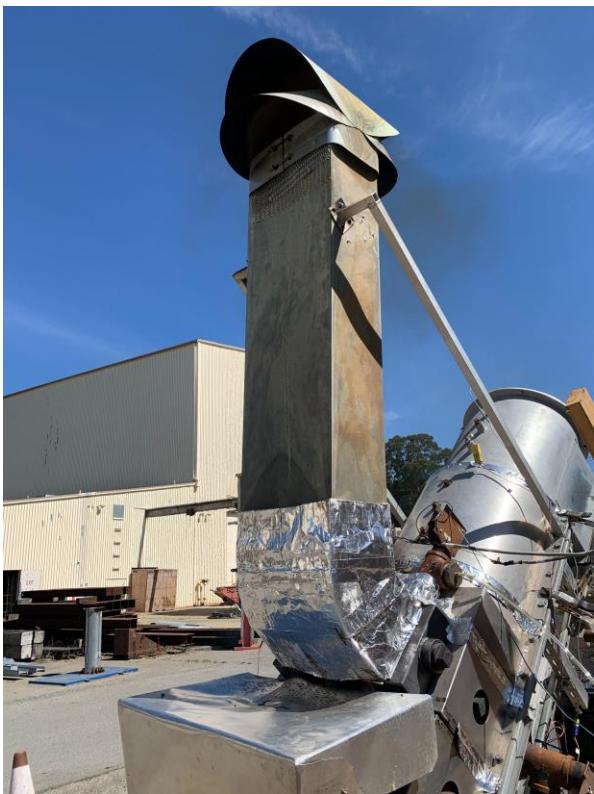
- Chimney discoloration

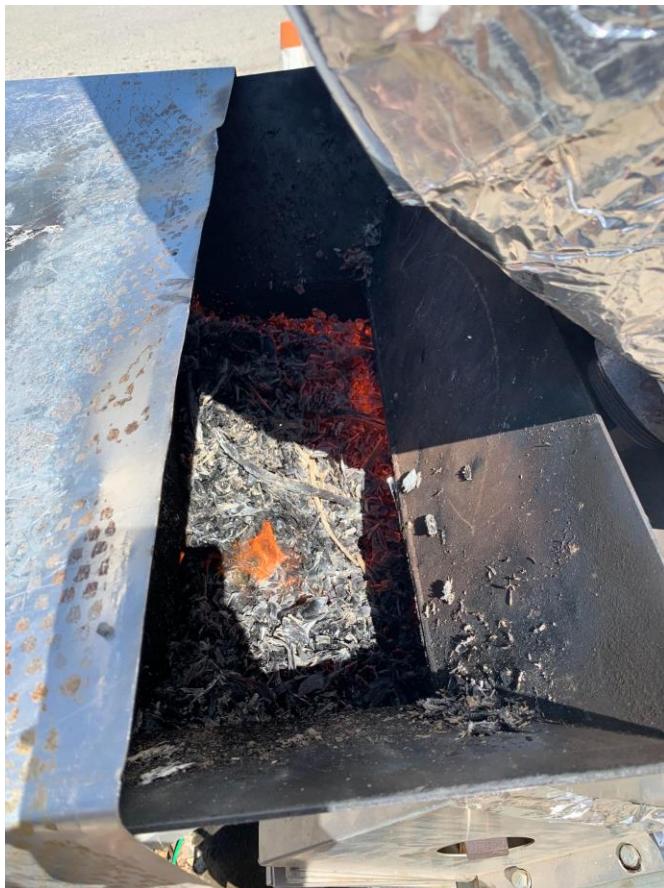
- Fire in hopper

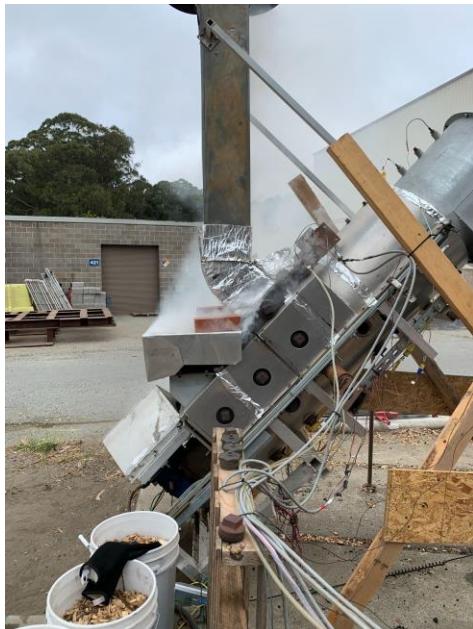
- As we were reigniting the fire, there was smoke coming out of the top and bottom of the chimney.
  - During this time, we also noticed smoke leaking through some of the cracks in the output chute as well as the hopper and some openings between different parts of the reactor.

- Smoke from hopper

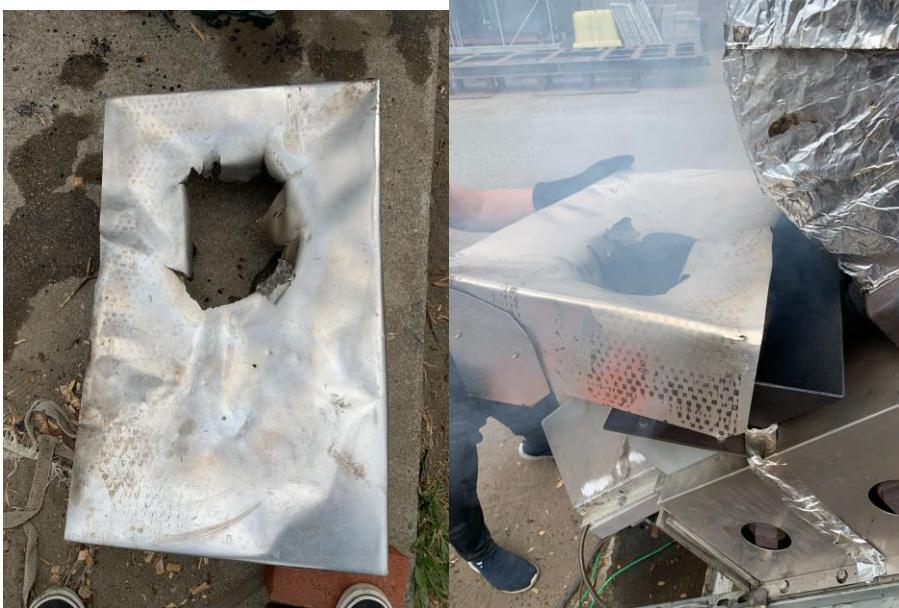
- Around this time, we disconnected the laptop from the PLC, which caused the blowers to ramp up to max RPM. The increase in blower speed led to an intense fire in the hopper, which burned a hole through the hopper lid.

- Hole in hopper lid

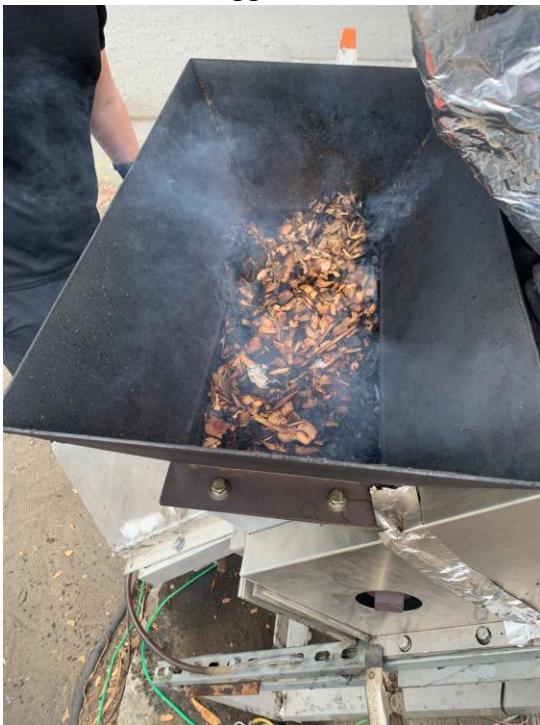
- Charred biomass in hopper

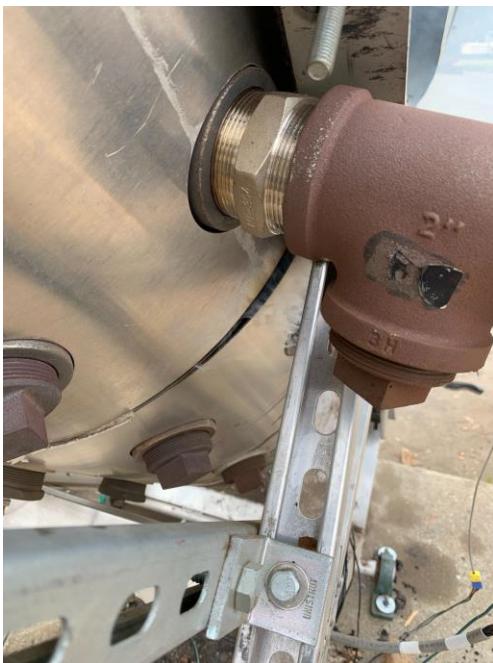
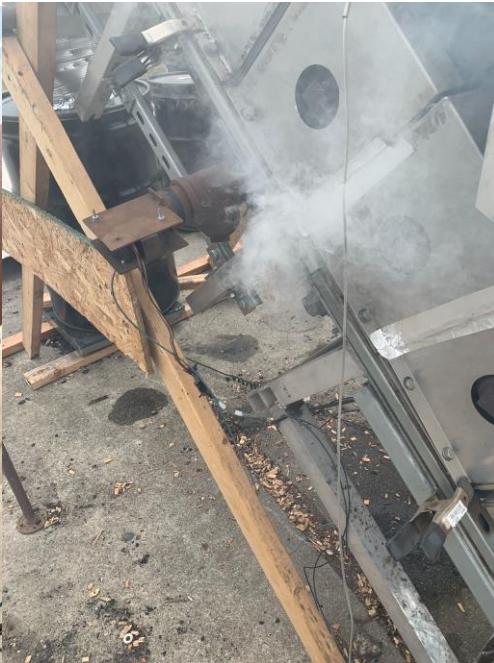
- Smoke from side of reactor

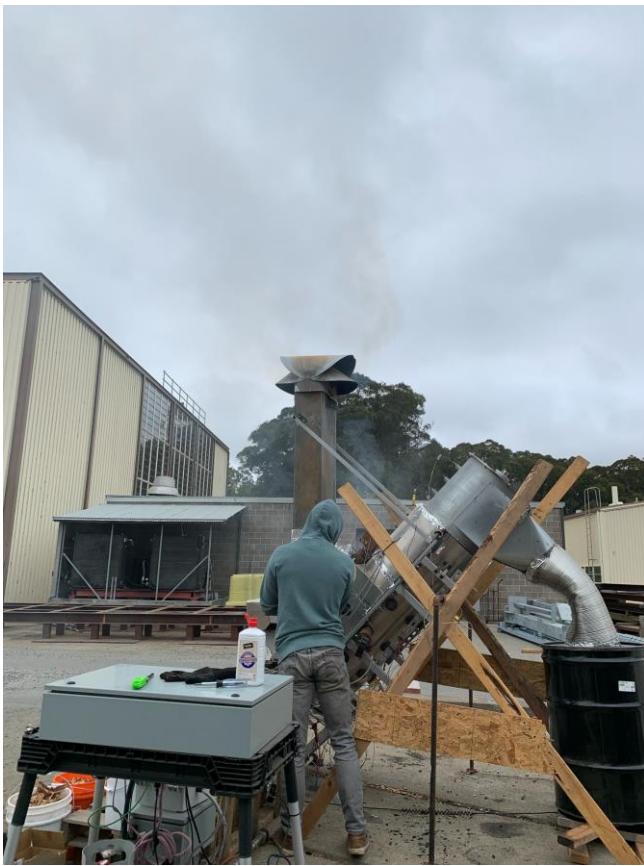
- Dark smoke from chimney

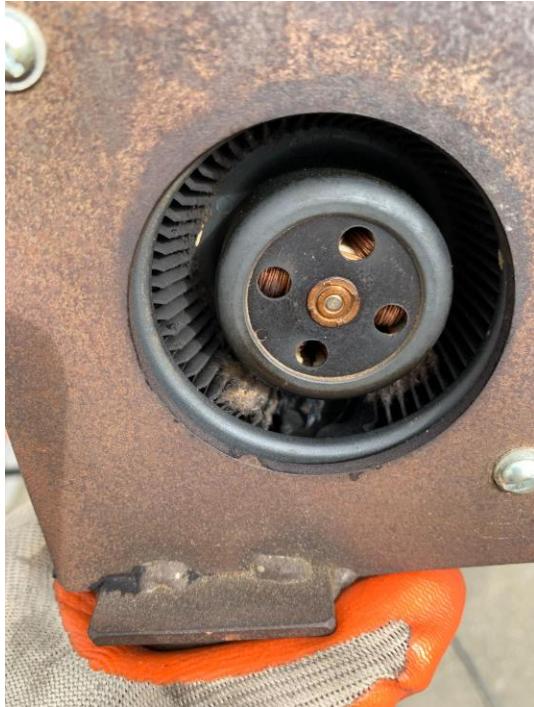
- At this point, we shut off the breaker for the blowers, which caused the secondary blowers to melt and malfunction.
  - We then disconnected all the blowers and plugged their holes.

- Burned out blowers

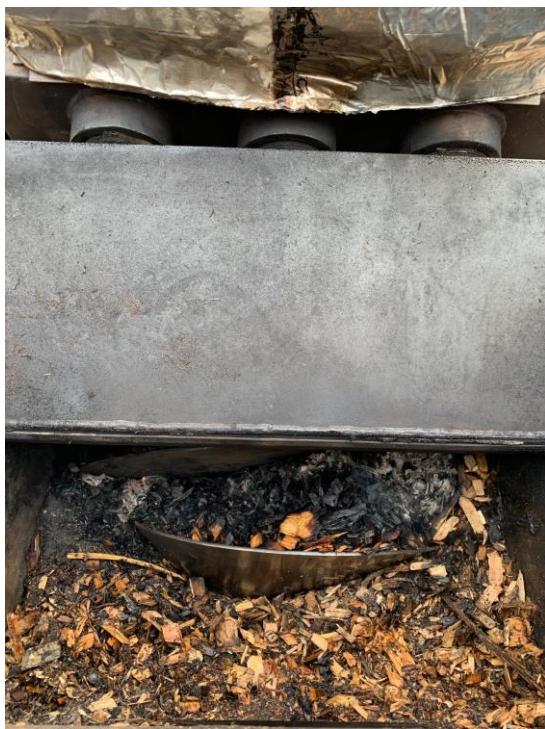
- We also realized that the auger had been moving backwards and so the auger was bent out of place.
- After this, we stopped the hot test.

- Bent auger

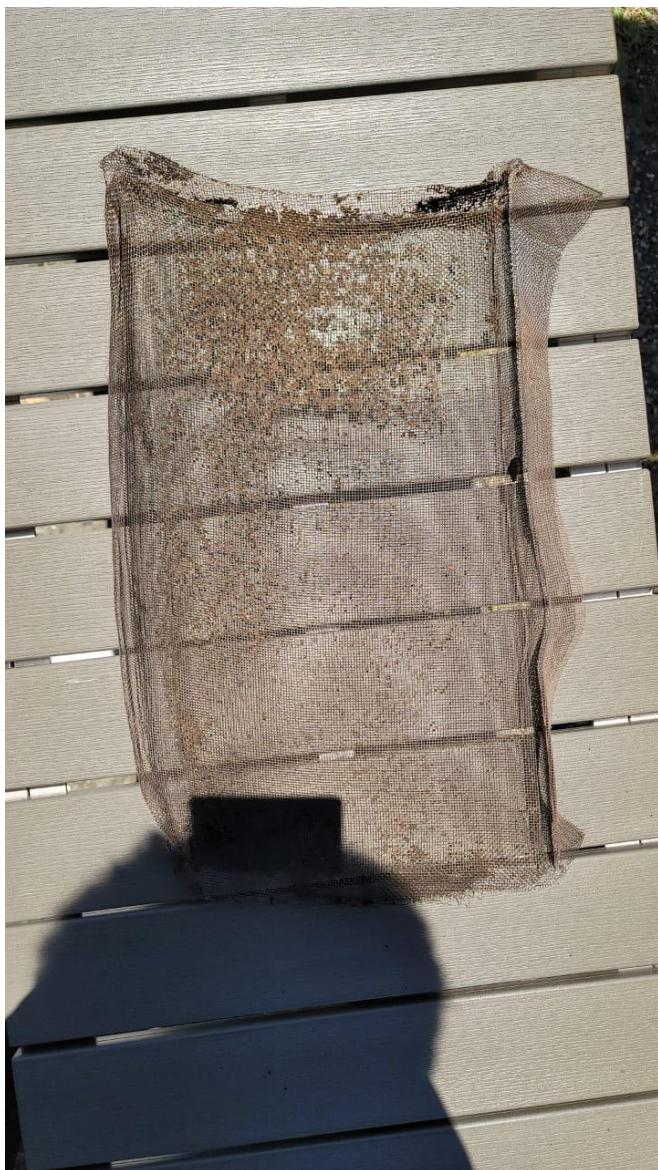
- Mesh from inside chimney

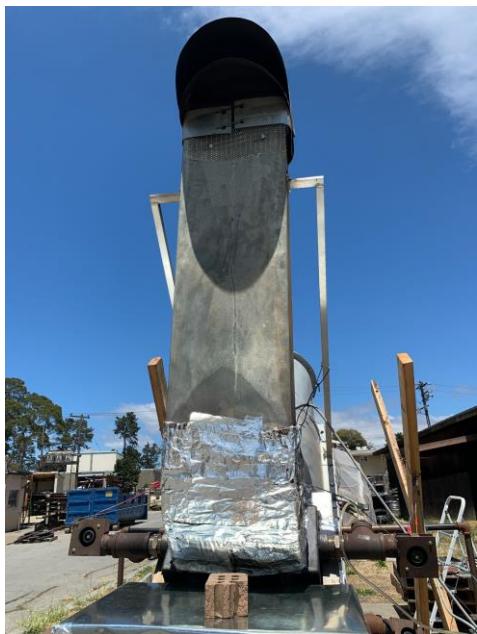
- Chimney changing color

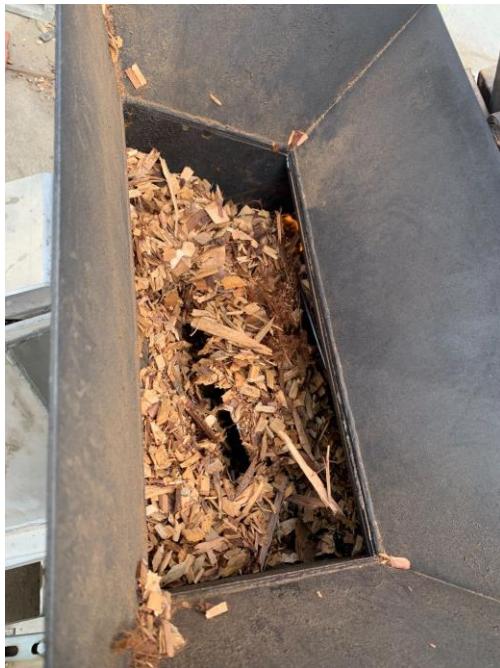
- We also noticed some flames leaking through the cracks in the bottom of the chimney and so we turned down the blowers.
- Throughout the test, we noticed a flame at the base of the hopper ; however, it never caught the entire hopper on fire and we never saw significant smoke from the hopper.

- Small fire at base of hopper

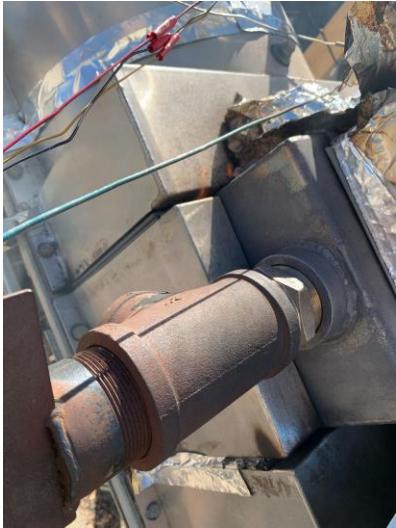
- Fire coming from gap in between reactor pieces

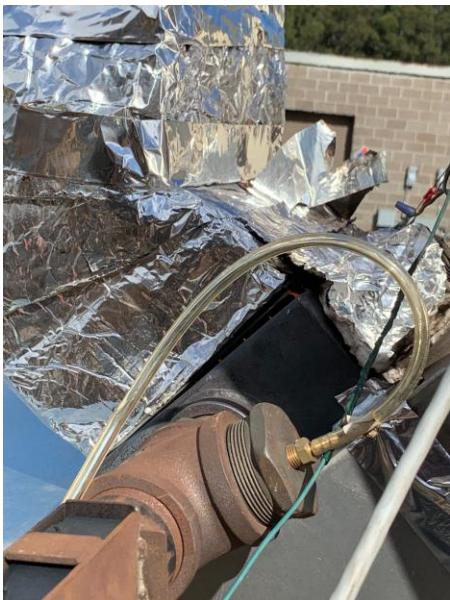
- Gap at base of chimney

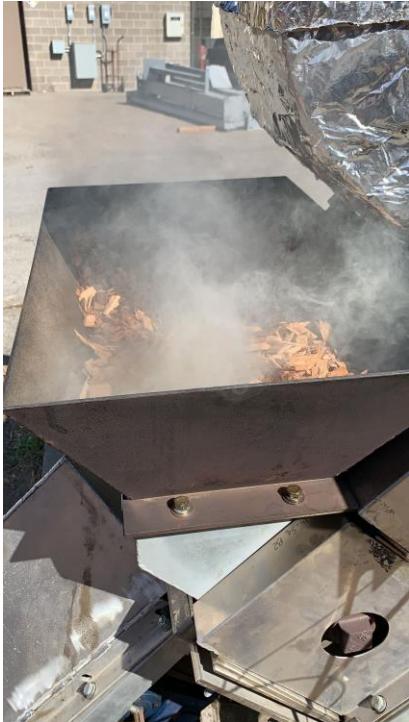
- Smoke from hopper

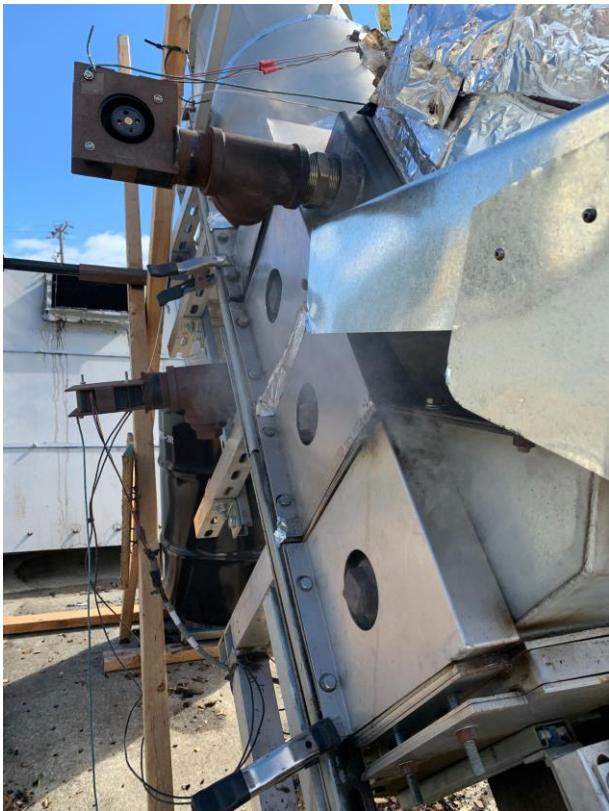
- Smoke from side of reactor

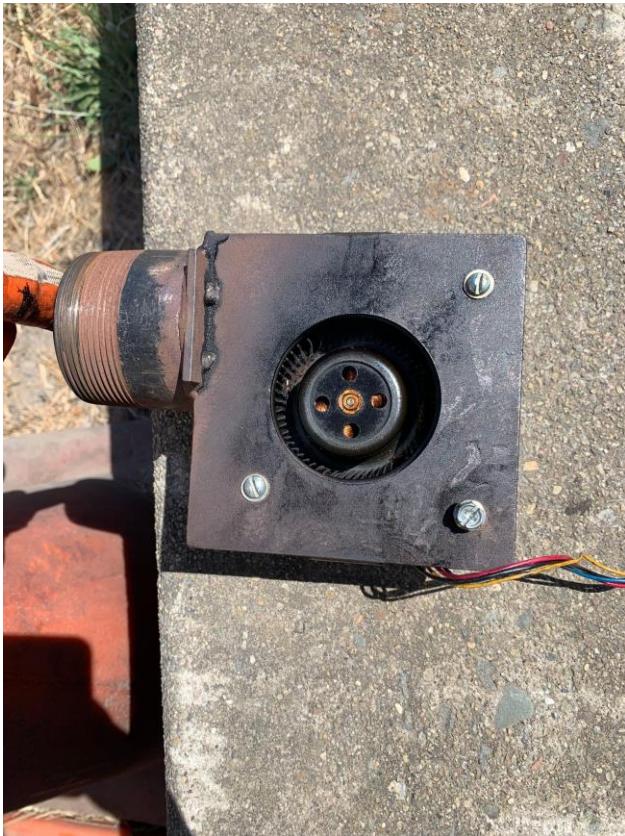
- At one point, we noticed that the left primary blower stopped running and was smoking significantly so we unplugged it and stopped the test.
  - We think the connection to the blower may have failed, causing it to stop spinning.

- Burned blower

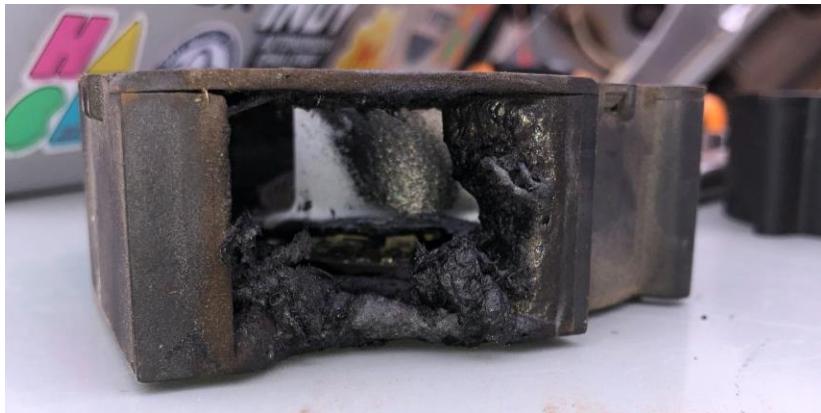
- After lighting the fire on (on the hole of the main blower), blower melted due to installing it before turning it on, causing hot smoke to rush out to the fan

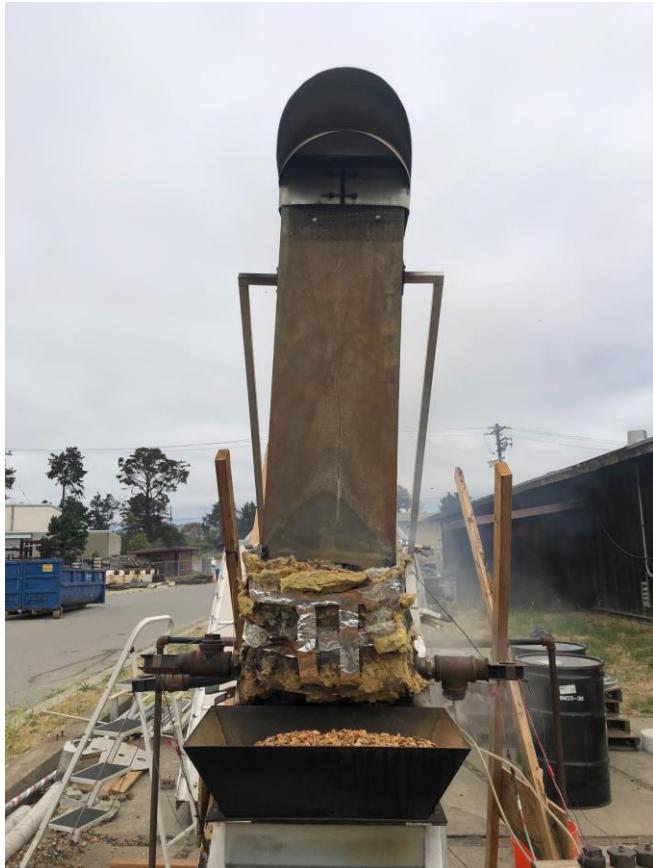
- The chimney is bent and oxidized; we should wait until a new chimney is installed before doing another hot test

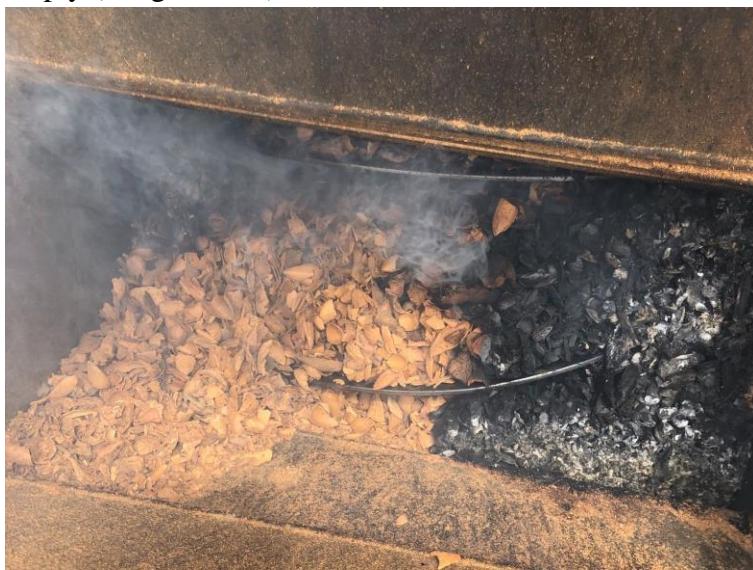
- 30 minutes after the last fuel feed, the chimney has cooled down to < 100 °C.
- However, the auger was stuck. We did not know when it happened, but the feeder is not empty (image below)

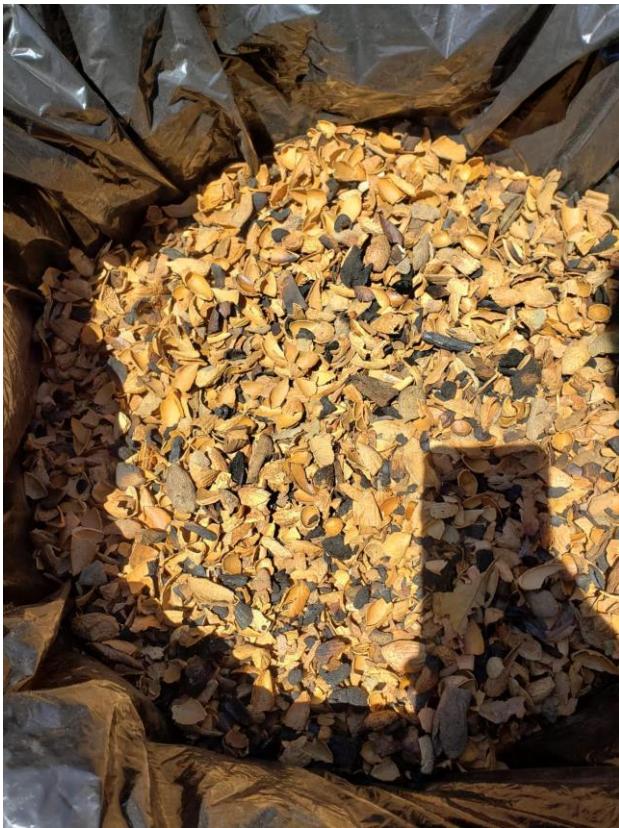
- The test was stopped due to the blower malfunction.
- The resulting output are uncharred almond shells with a hint of charred ones, which are most likely the results of the multiple attempts at lighting the fuel.

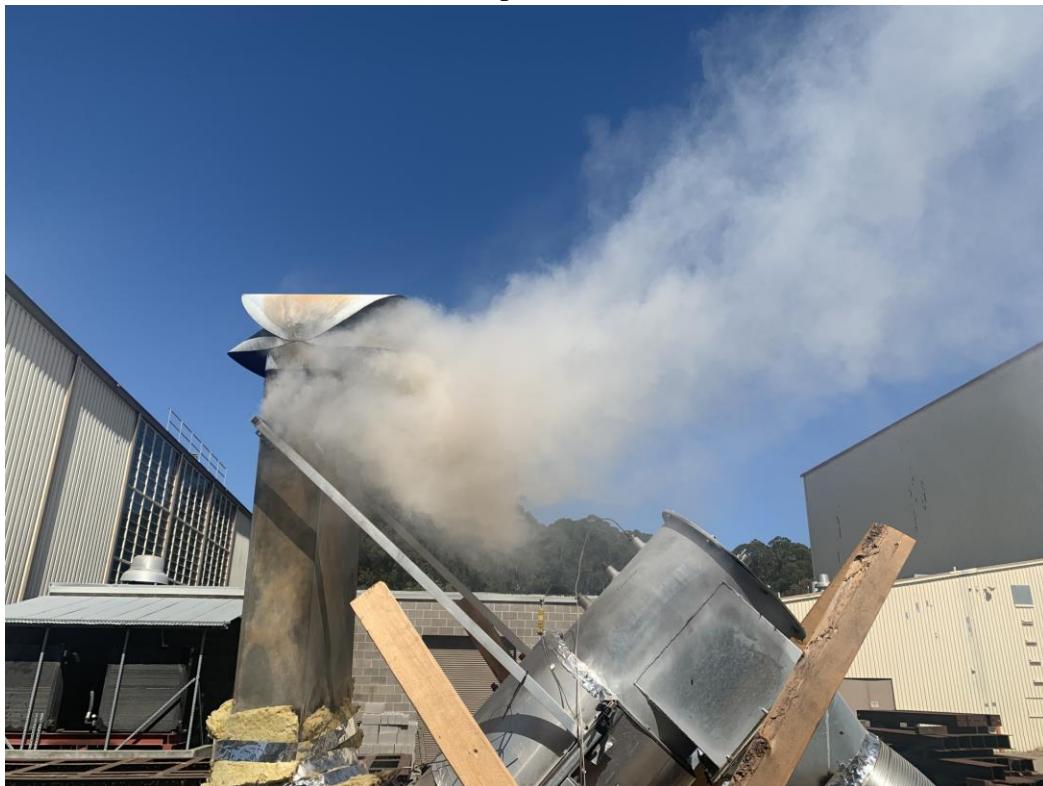
- At 10:34, the primaries and secondaries were cranked up to 3500 and 5000 respectively to try to clear the smoke plume pictured below. At around 10:40, the smoke out of the top of the chimney started to noticeably decrease. After about 20 minutes at these high blower speeds, the smoke had decreased, so both the blowers were lowered back down to 2000 at 11:03.

- In the future, starting the test with higher blower speeds may help to reach temperature and clear up a thick smoke plume, and then the blowers can be lowered to the desired speed.

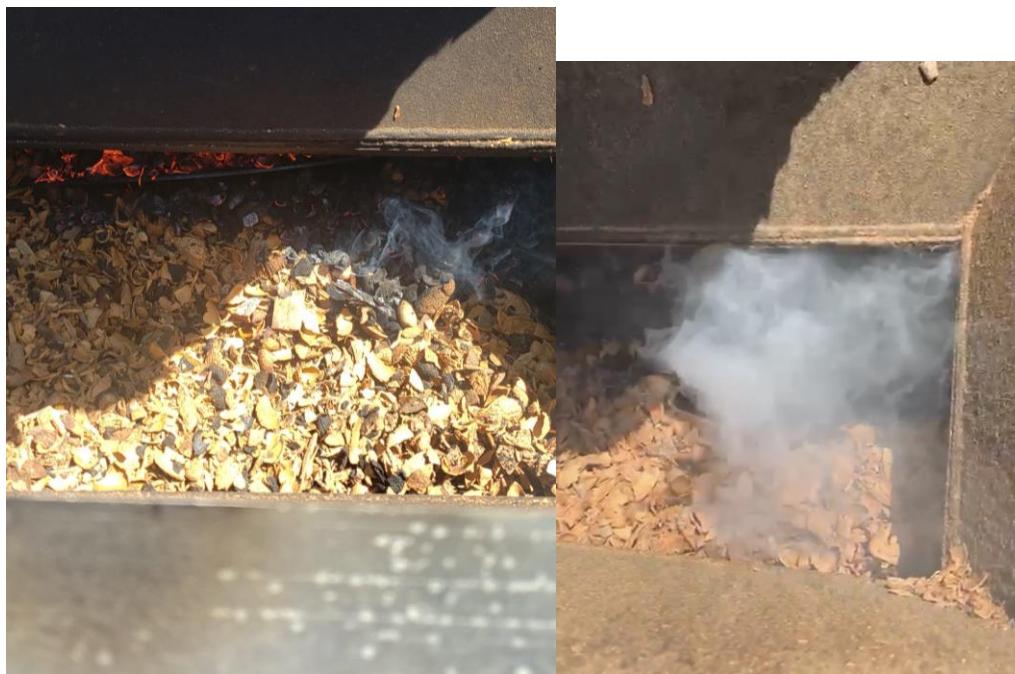
- At 11:28, we switched to fresh buckets of almond shells for the rest of the test (Steady state was noted at 11:31).
  - During this time, the primaries and secondaries both started at 2000. Embers and some charred bits were seen at the base of the auger in the feeder along with smoke from the feeder.
