## Takachar Hot Test (In-Depth) Documentation

This is the 1st point of hot test documentation listed below. An overview of all test data, parameters, and takeaways can be found at point 4.

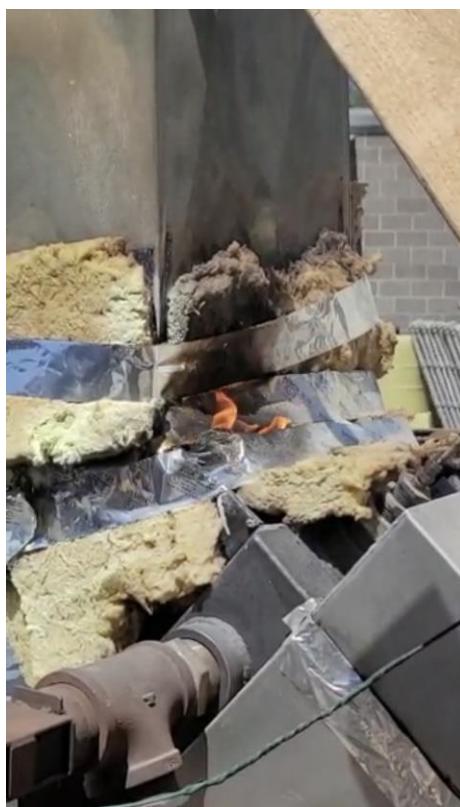
- At 11:33, an open flame was observed in the feeder and a bucket of almond shells was used to quench the fire. In the future, the feeder level should be maintained as full as possible during testing.
- At 11:39, there were flames at the base of the chimney. The extinguisher was used.

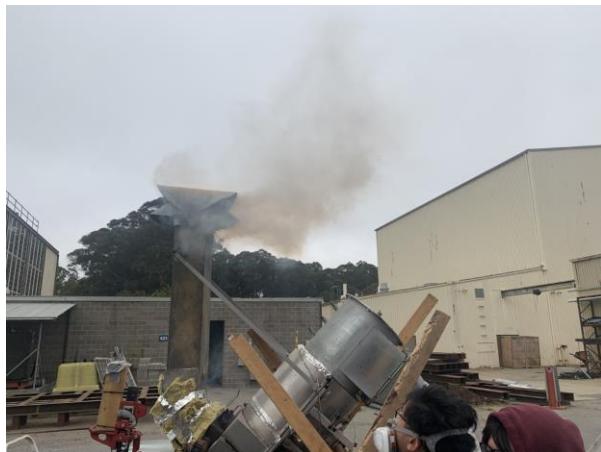
- The goal of this test is to attempt the first test using rice hull, determine the best way to light the material, and observe any differences between rice hull and almond shells. This test should also look at the new chute elbow/damper system.
- The test started with about 28 lbs of wood chips in order to heat up the reactor.
  - There was immediate smoke out of the base of the chimney and light colored smoke out of the top of the chimney.
  - About 10 minutes later, the smoke out of the chimney darkened (pictured below), so the secondary blowers were ramped from 4000 to 5000 rpm. The smoke out of the top of the chimney seemed to improve.

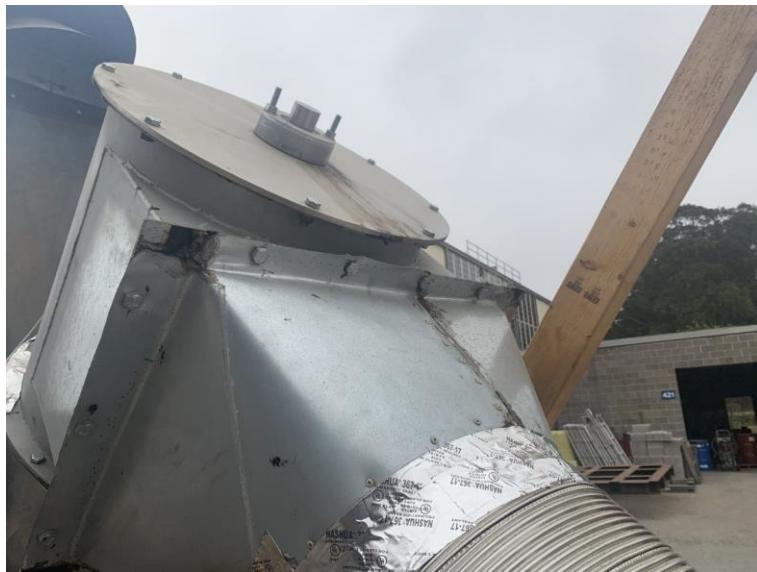
- There was also smoke coming out of the feeder when the biomass level dropped to just above the screw along with smoke out of the lid of the drum and the chute connections. There was also a new smoke leak from the corners of the connection of the chute to the main body of the bioreactor (difficult to see smoke in picture but can see corners where it's leaking).

- What to do next: Remove spacer/damper system to prevent extra openings at the base of the chimney, address leakage of smoke by the chute (use clamps on drum during next hot test, seal holes on interface of chute/body of reactor), order new chimney, aim to start next test with primary blowers at 5000 and secondary at 2500 to obtain good smoke plume before ramping down

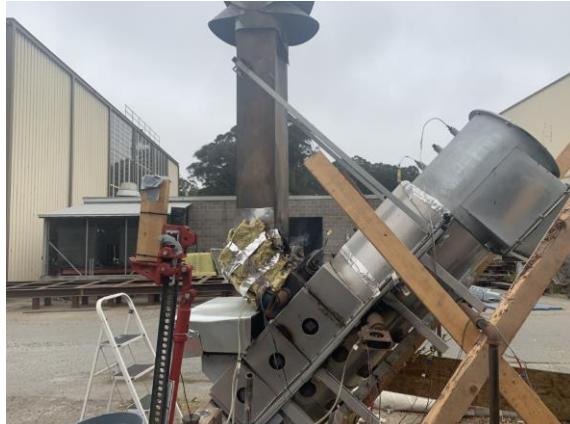
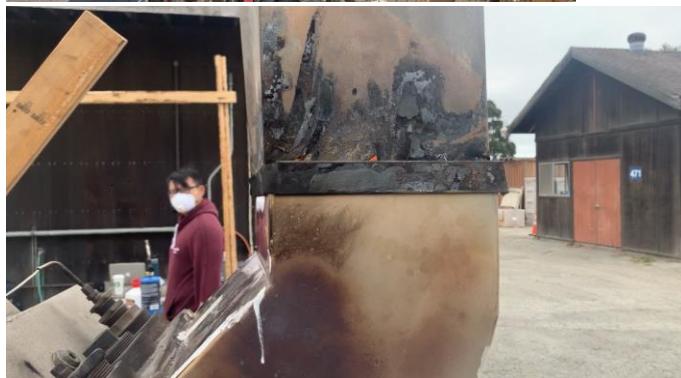
- We then transitioned to the rice hull for a little over 20 lbs worth.
  - The smoke was not noticeably dark during this time, but there was still smoke out of the feeder and previously mentioned chute connections.
- The fire went out, so we then transitioned back to wood chips to continue heating up the reactor to temperature before continuing with the rice hull.
  - The chimney base started making cracking noises, but there was no visible smoke out of the top (just by the base). A fire started on the insulation at the base of the chimney. The fire burnt through the insulation and stopped, but flames were seen within the chimney (pictured below). The damper was also removed.

- Takeaways: Ramping the blowers up to 5000 seemed to prevent a dark smoke plume from the top of the chimney in comparison to the plume of the last almond shell test. There were noticeable new holes at the base of the chimney due to corrosion and the new damper system which may have led to the fire. The new elbow held up well even with the flames in the chimney. There are also still points struggling with leakage of smoke near the chute system. The fire extinguisher was not filled and ready for this fire -- it may be helpful to have a safety checklist before tests to prevent oversights like this in the future.

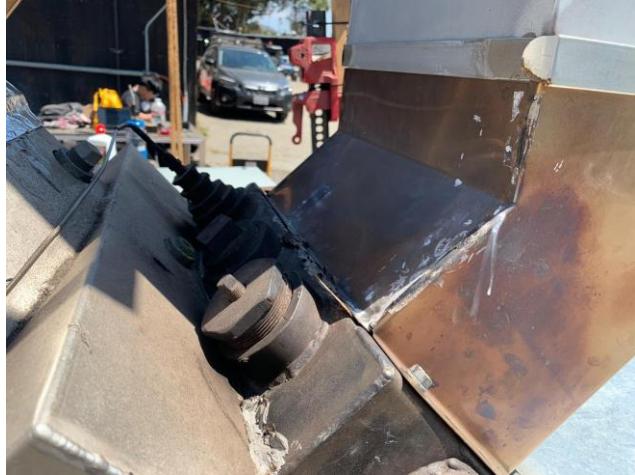
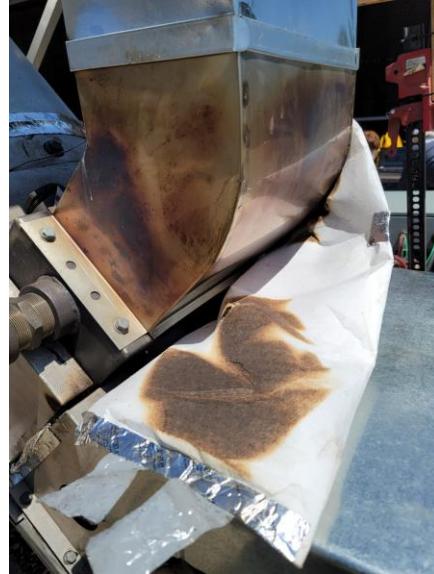
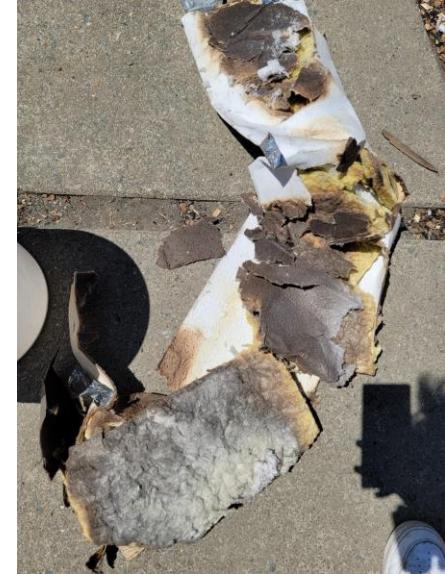
At 2:07 ash started coming out of the top of the chimney, and at 2:08 the gasket wrapped around the elbow started to burn. Over the next 5 minutes the gasket was retaped around the chimney but wouldn't stay on so it was completely removed from the chimney, as shown in the pictures below:

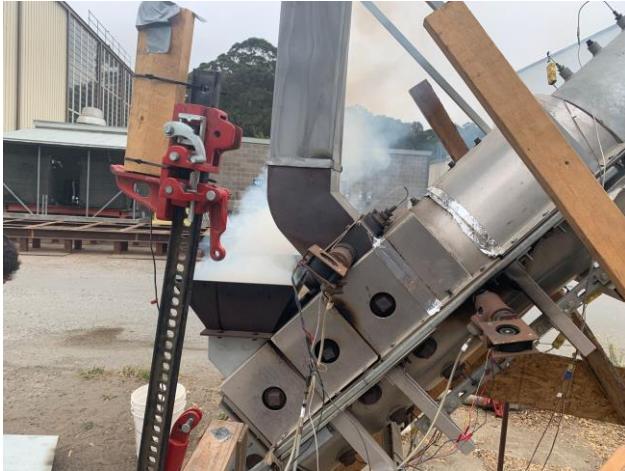
- The goal of this test is to test the newly installed finer mesh at the chimney outlet to see how well it prevents escaping ash, while keeping blower speeds the same as the previous hot test. There is also a focus on the openings at the base of the chimney and whether the added caulking and gasket prevented leaks in that area.
- Smoke out of feeder:

- The result of this hot test was as expected. The fine mesh causes additional positive pressure which ends up causing a lot of smoke to come out of the feeder. We would need to use a different mesh (medium mesh) in future tests in order to prevent smoke coming out of the feeder.

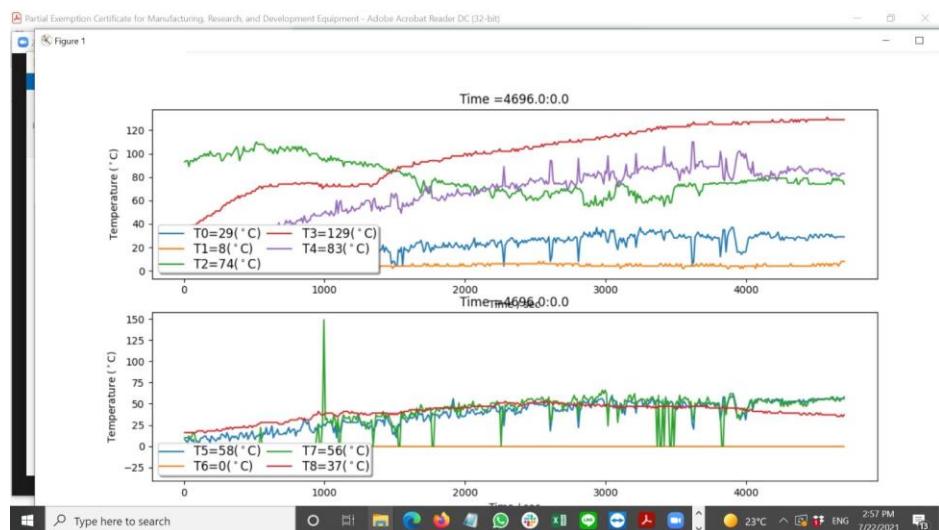
- This test was using the stronger indian motor for the first time and returned to woodchips
- The first problem was the auger stopping sporadically. Further investigation found that this was a bad cable for the engage wire
- While running the test it would sometimes trip the breaker, but also once stalled without tripping the breaker indicating the 8A limit is too low to prevent damage to the gearbox
- As the auger kept stalling we realized that the biomass coming out was not charred and that there was nearly 110 lbs of biomass potentially stuck in the reactor
- This was odd because the reactor was still hot. To prevent damaging the auger more we shut down the reaction and let the rest of the biomass burn off

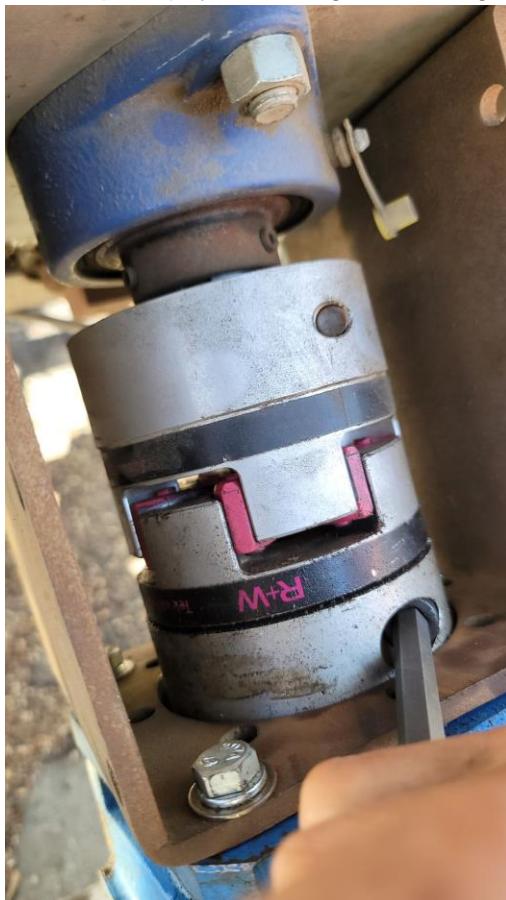
Incorrect Assembly

- We found an effective way of starting the fire for woodchips. First stop the auger and then add some lighter fluid inside of the reactor, then light the fire using a lighter or a blowtorch. Then, add more lighter fluid before holding the blowers and subjecting it to the flame. Use 2500 RPM to keep the fire alive. After 1 to 2 minutes, fasten the blowers back to the reactor and let the fire spread for another 2 minutes before starting the auger again.
- We had some issues with the gearbox where its coupling appears to be squeezed, and so we stopped the auger and fixed this issue. We realigned and reinstalled the assembly promptly and the gearbox/auger was fixed.

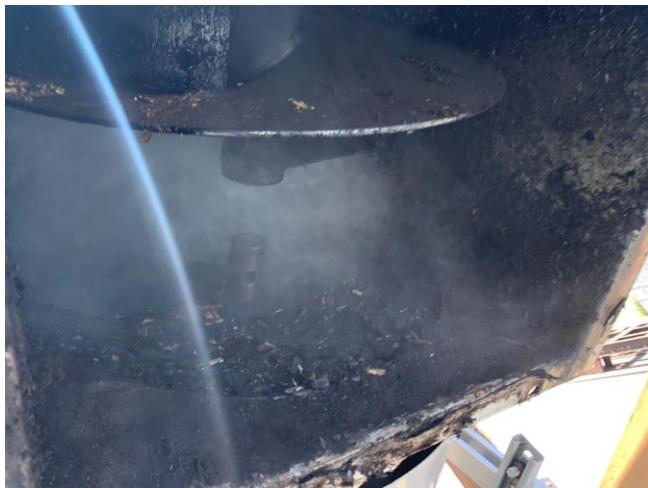
Disconnected auger

- Although, there was another issue we came across during the test, where the top section of the auger was disconnected from the rest of the auger. This may be due to a loose bolt coming off or because the bolts were sheared off, due to the malfunctioning spherical bearing that got stuck and accumulated biomass at the top.

- Before conducting another test, we need to remove the damaged spherical bearing, install a new one on the top protruding shaft of the auger, identify the cause of the bolt detachment, rebolting the disconnected auger section, and then identify the cause of this issue and document it.

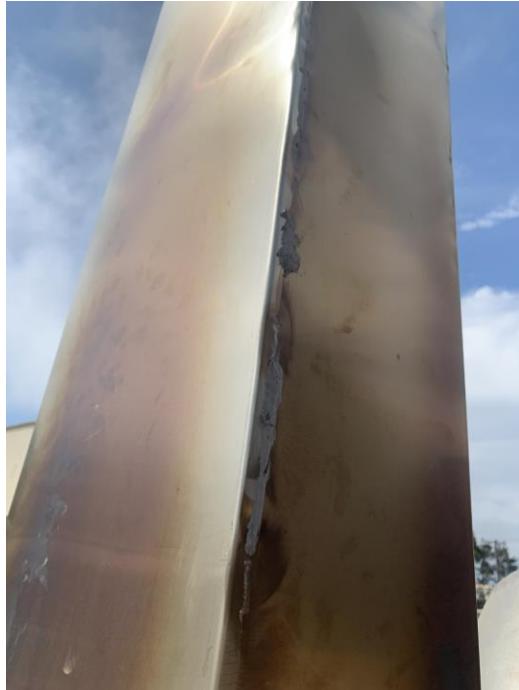
- Motor 6 RPM
- The goal of this test is to reach a steady state and help determine the blower speed at which we can maintain no smoke from the feeder. For this test, blower speeds of 1500 rpm for both primary and secondary were tested.
- There was intermittent dark smoke out of the chimney before steady state was reached.
- Steady state was reached and maintained for about 30 minutes. No smoke was observed out of the feeder.
- Smoke leaks were seen at the corners of the chimney and out of the collar around the bearing.
  - The corners of the chimney were addressed with caulk during the test and saw no more leakage after that.

- The leakage from the bearing should be addressed using aluminum tape before the next test.
- At the end of the test, the biomass in the feeder dropped below the blade and a flame was seen in the feeder. The flame was put out with water.
- Steady State Char:

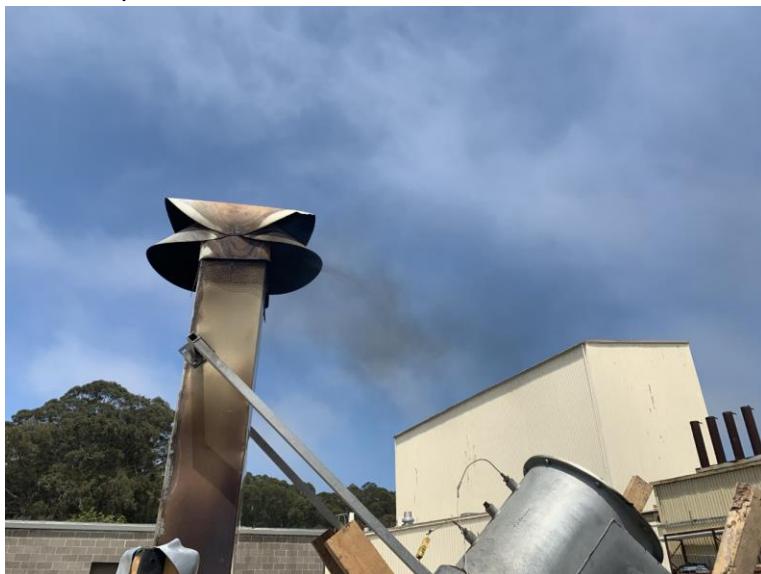
- The goal of this test was to get a basepoint for coconut shells and reach a steady state. The blowers were kept constant at 1500 rpm. Steady state was observed with the auger at both 6 and 8 rpm.
- The plugs were stuck in the normal primary blower inlets before starting the test.  
The primary blowers were moved to the inlet two below the secondary blowers initially.  
Once the reactor got hot we were able to remove the plugs and move the primary blowers back to the original spot.
- Dark colored smoke was observed out of chimney when warming up the reactor with wood chips

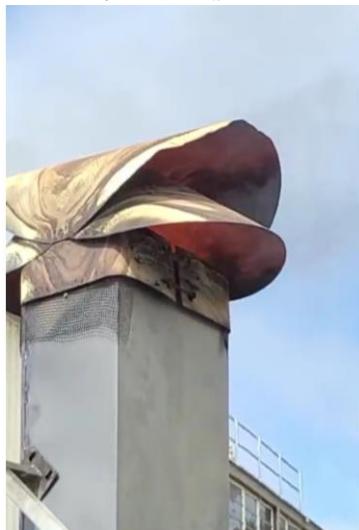
Chimney flame (primaries 3000, secondaries 6000):

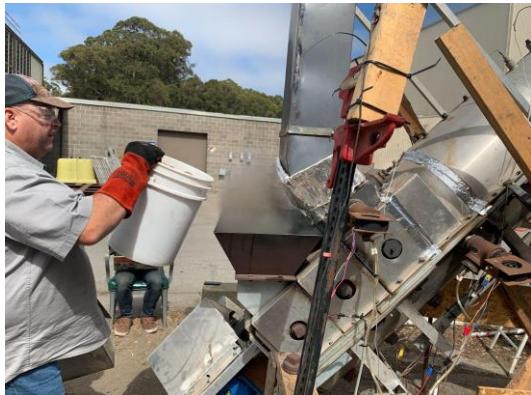
Feeder smoke (primaries 3000, secondaries 8700):

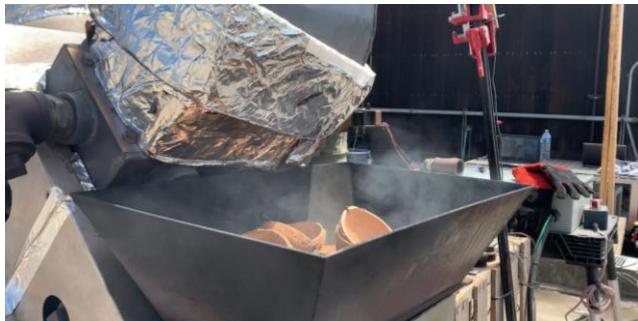
- There was a consistent leak in the chute throughout the test, with smoke coming from the areas where the chute connected to the reactor, where the chute connected to the drum lid, the plastic wrapping, and where the plastic wrapping connected to the chute.

Leakage points (side of reactor and flame at base of chimney):

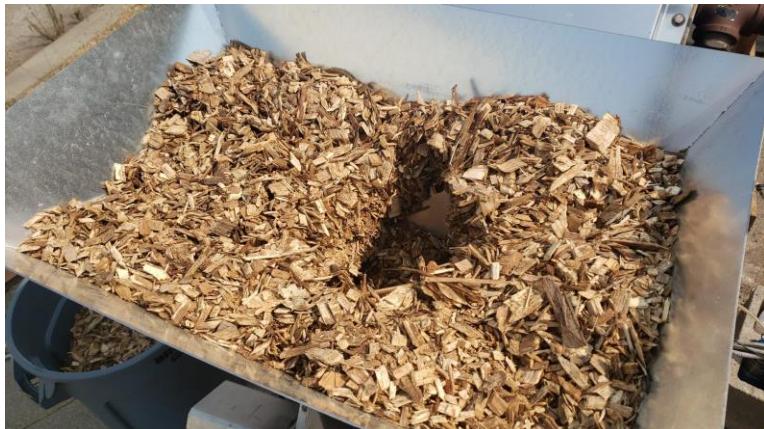
The large hopper significantly reduced the work needed to load the hopper significantly. Two on the hot test had as much down time as working time. However, there is lots of arching as seen above.

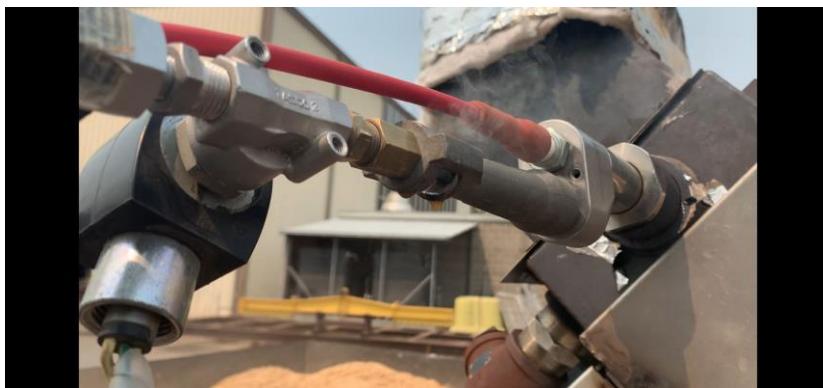
- One place we noted smoke from the open joint on the igniter (where it mixes gas and air?)

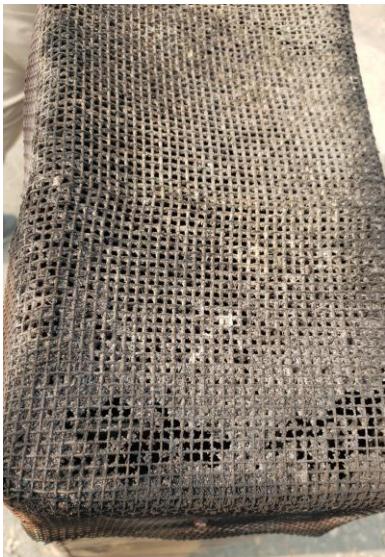
clogged medium mesh from 8/19

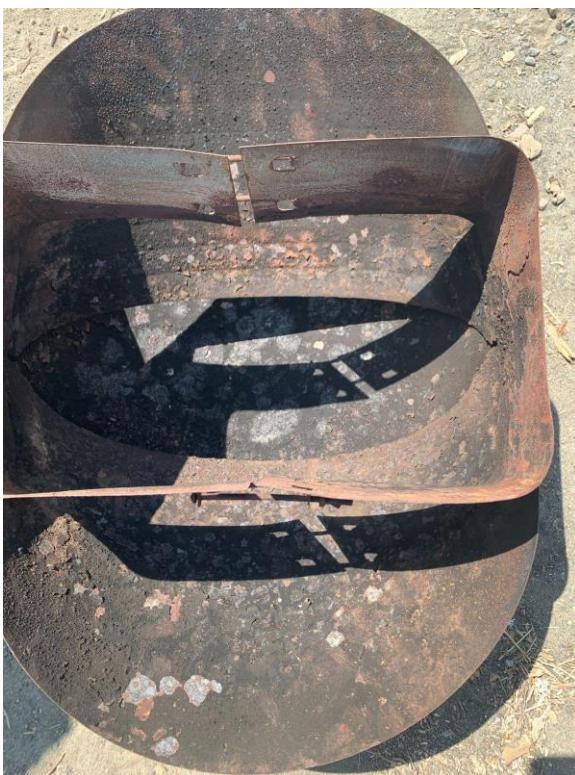
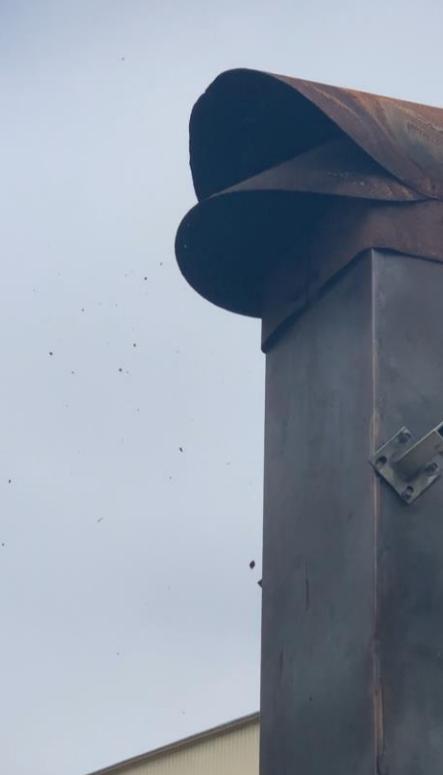
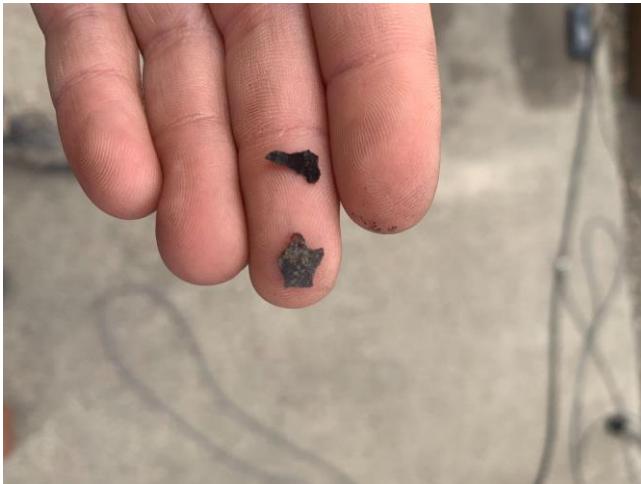
- The goal of this test was to determine whether or not fine mesh solved the ash problem that we had been experiencing in previous rice hull tests.
- We initially had some problems lighting the fire, probably due to a lighter fluid shortage and because we were lighting rice hulls directly instead of warming up the reactor with wood chips first.
- Primaries were set to 2500, secondaries set to idle, Profire turned on, and auger at 6.
- Once the reactor was warm, massive chunks of ash-looking material started shooting out of the top of the chimney. Because we had fine mesh on, we think it was coming from the chimney cap.

- Test was shut down soon after, with Profire still on, blowers at idle, and auger at 10.
- Key takeaways:
  - Some difficulty keeping rice hulls lit
  - Minimal smoke, but test may not have been long enough to determine whether or not fine mesh helps with smoke
  - Some ash, some chimney cap flakes were a serious problem

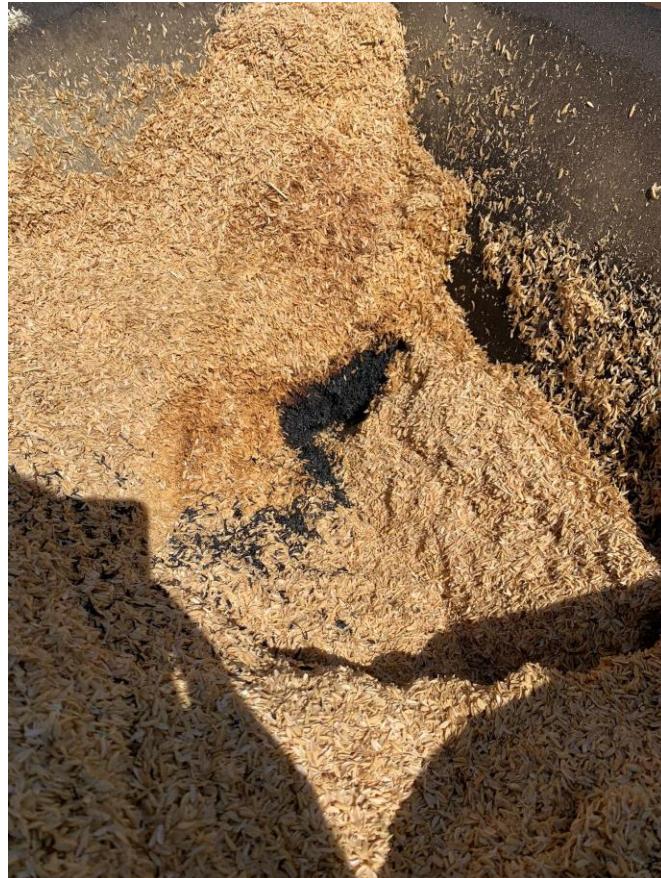
- After 20 minutes with the secondaries at 6500 the right-side secondary (closest to shed) melted and so the test had to be stopped. Blowers were idled; Profire was put in but would not start so was taken back out and the inlet was plugged; auger was set to 10 to run rice hulls through reactor quickly; un-charred rice hulls were shoveled out of hopper and a region of completely charred hulls were seen in the feeder; feeder cover and damper were put on/in.

- Heavy feeder smoke and the charred region in the hopper (shown above) also noticed.
- The two above notes suggest that the combustion zone was lower in the reactor than expected - close to the hopper - we think that the reaction may have been occurring below the primaries, and then when the hot rice hulls reached the combustor they spiked its temperature but rapidly cooled such that the combustor temperature dropped to the 300s. This could either be caused by the high secondaries blowing out the reaction or the hulls could have gone through complete combustion and were already cooling when they got to the combustor region. We don't think that complete combustion was occurring because the output rice hulls were not well-charred.

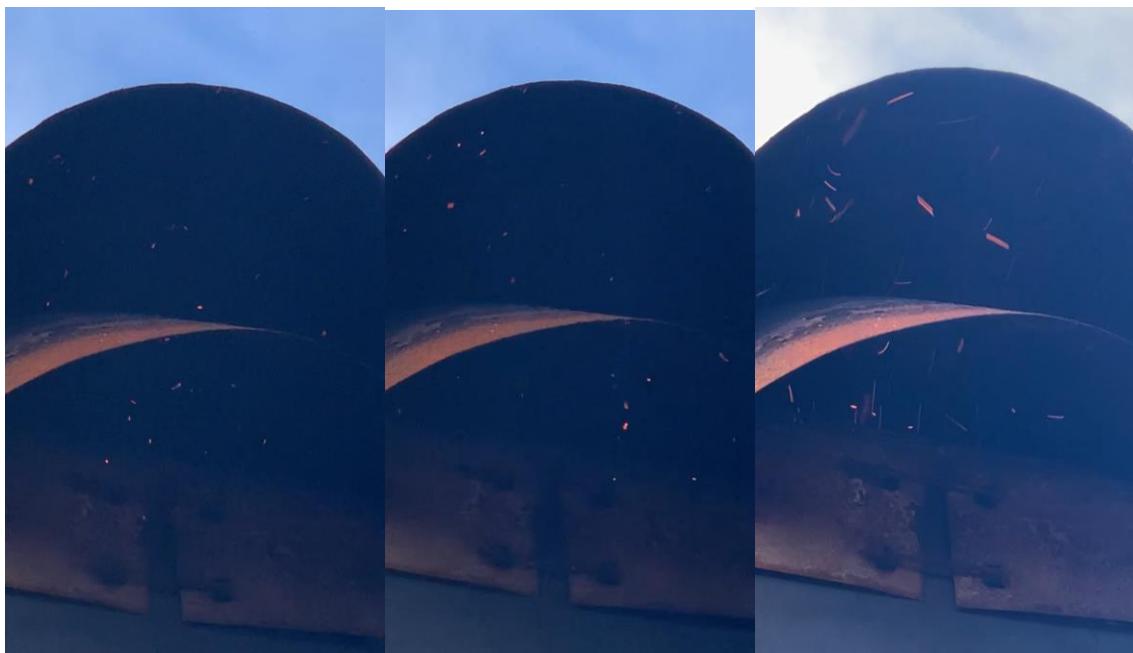
- We also had more difficulty with biomass getting stuck in the chute
  - A hole was burned into the chute where it was sitting

- Replace chute
- Address ember and ash issue from chimney

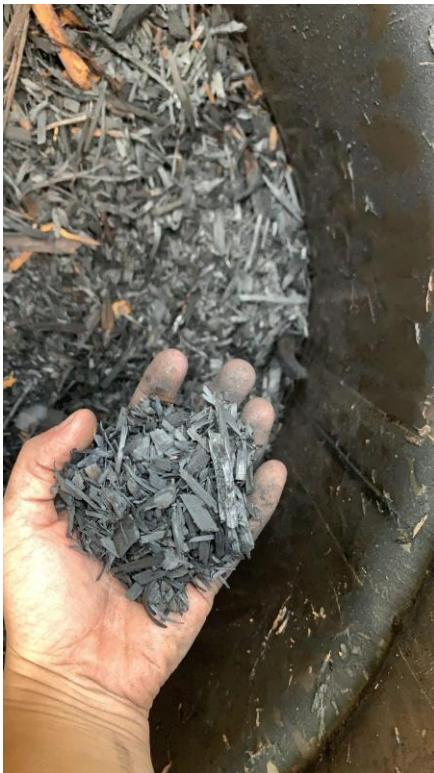
- The char produced was consistently charred with slightly larger pieces than the previous test. (uncharred pieces are from the shutdown period)

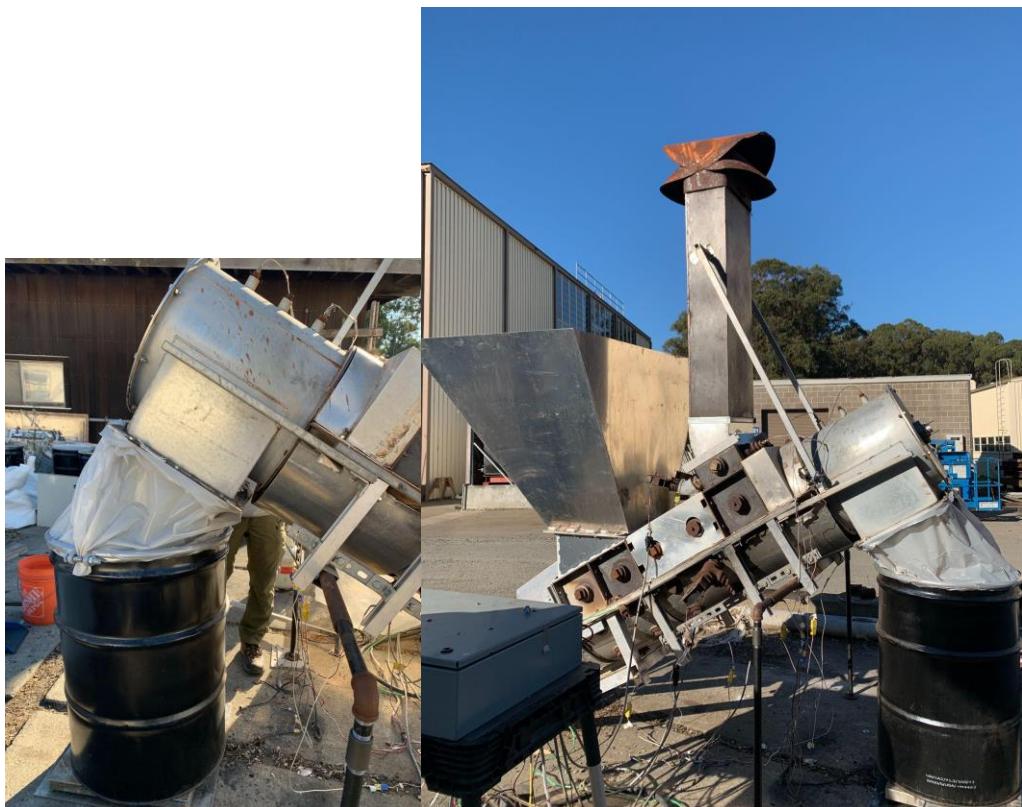
- First test back at RFS with Reactor Configuration C (30 degree). The old chute did not work with the height of the oil drum so a temporary plastic was installed for the sake of hot testing (see below)

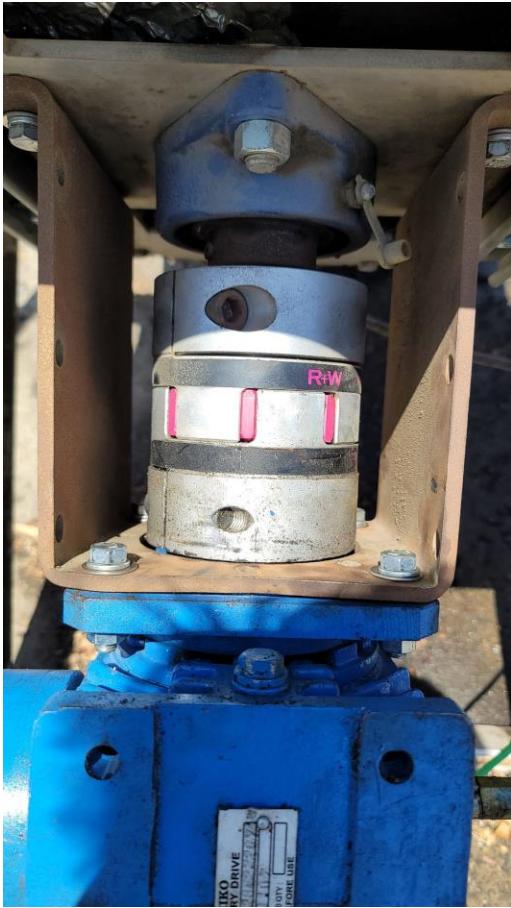
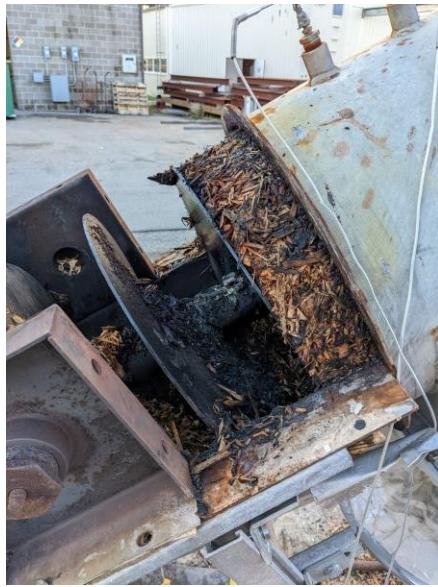
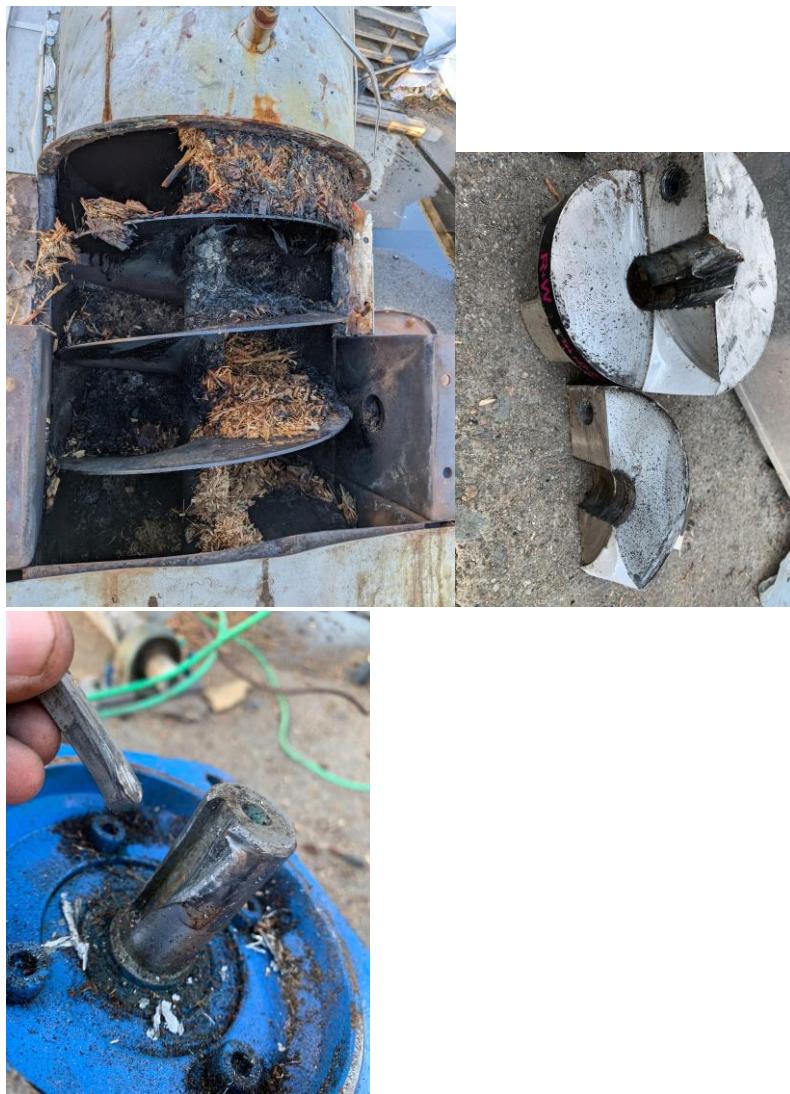
- The flow into the oil drum was much improved at the 30 degree angle. The biomass that made it to the end fell freely into the drum. However, it did not seem to improve much mobility for feeding or throughout the body of the reactor for PG&E chips in particular. We saw considerable compaction and larger sticks getting stuck between the auger blades and the wall of the reactor at the top portion of the reactor where it switches from rectangular to circular top. The sticks getting stuck seem to be due to discontinuities within the auger blade. The sticks will fall between those gaps making it easier for the auger blade to run over it and get stuck. This resulted in complete failure of the coupling and distortion of the gearbox output shaft for this test.

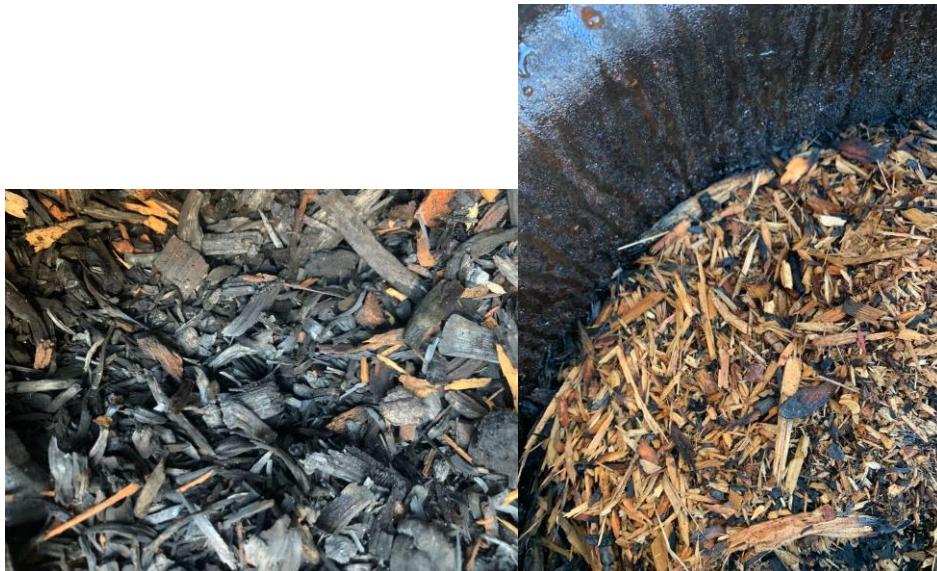
- Another Important thing to note from this test was the fact that even with a raging fire in the body the PGE chips were too wet to maintain a significant reaction and get any charring.
  - The moisture and drop in temperature also resulted in a severe smoke issue from the chimney. In comparison, we didn't have really any smoke during start up with the tan oak or JDSF chipped chips. Smoke only started once the PGE chips got into the combustion zone.
  - A fire could be sustained for the PGE chips at 6 rpm but when we increased to 8 or 10 the fire would immediately die out.
  - May help to try a slower speed in the future for moist biomass
- Complete charring was seen for the tan oak and JDSF chips (left) as seen below but any PGE chips (right) that made it through were almost completely uncharred.

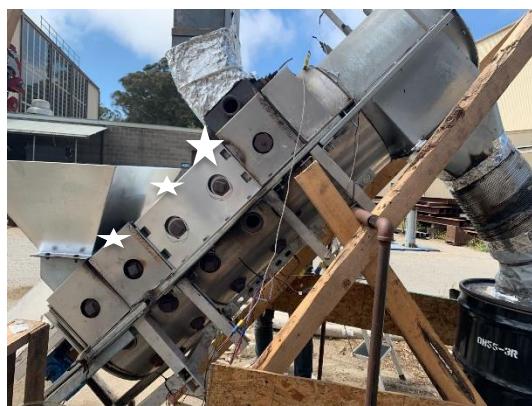
During the test there was ash, then eventually hot embers, followed by flames coming from the cracks of the hopper mostly the area were the hopper and combustion chamber meet facing the sky.

As the test continued to get very hot there was an attempt to decrease it by lowering the blowers to 3000/4000. After this was done flames started coming out of the system cracks in 3 places:

When the blowers were raised back to 4000/5000 the flames eventually went out.
