# Incident ( 16 Sep) Report for NaviX AI Microgrid

Date: 16/09/25

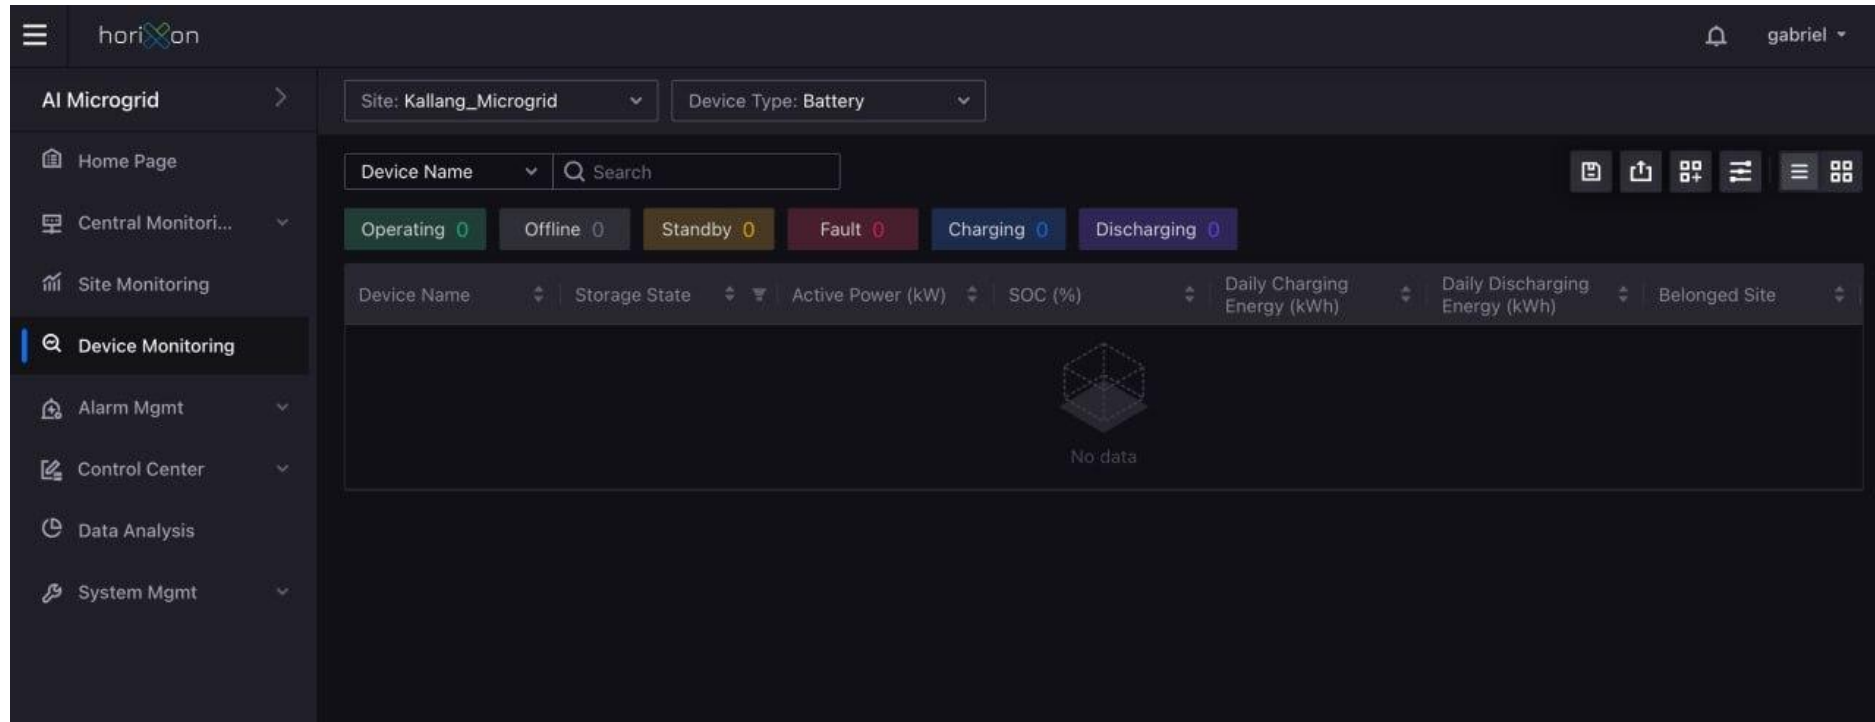
On 16 Sept 2025, 1601, NaviX requested support for the following issue:

1. Missing Data on charting tool

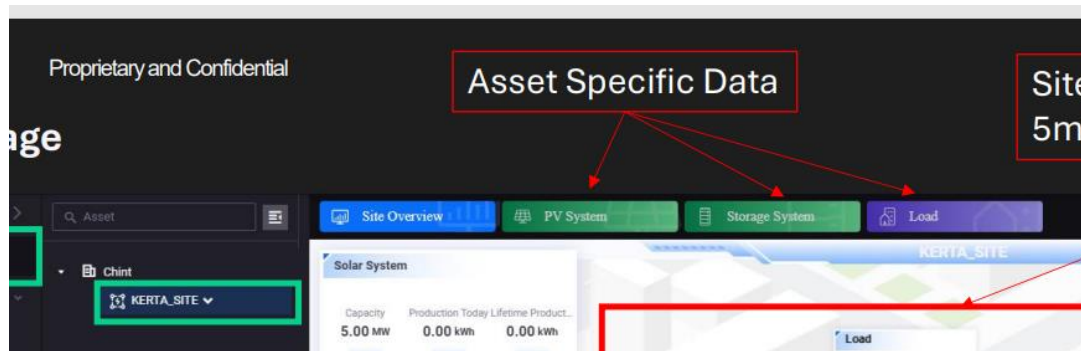
After checking, Univers identified one other issue present:

1. Missing Assets on EnFlex platform

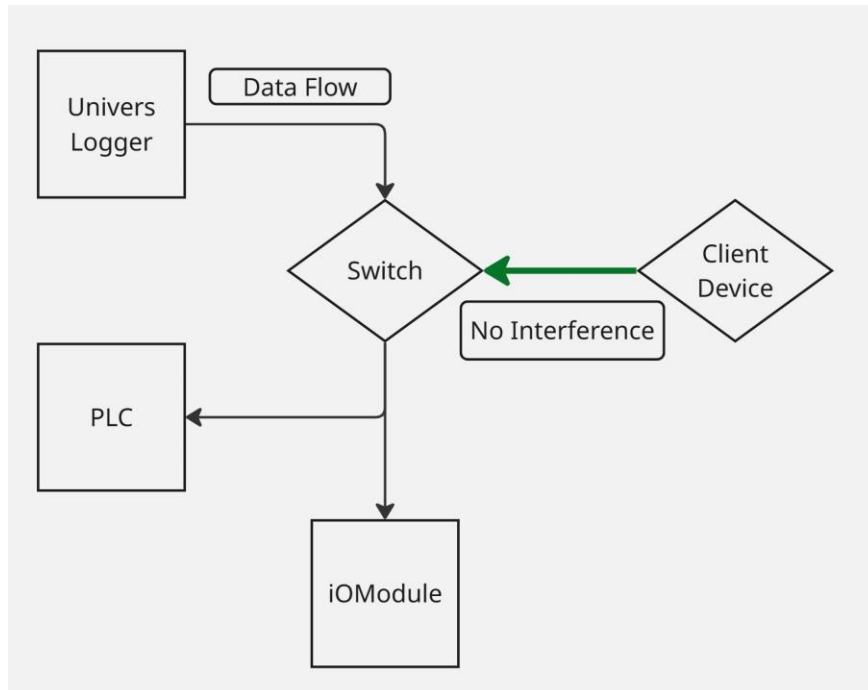
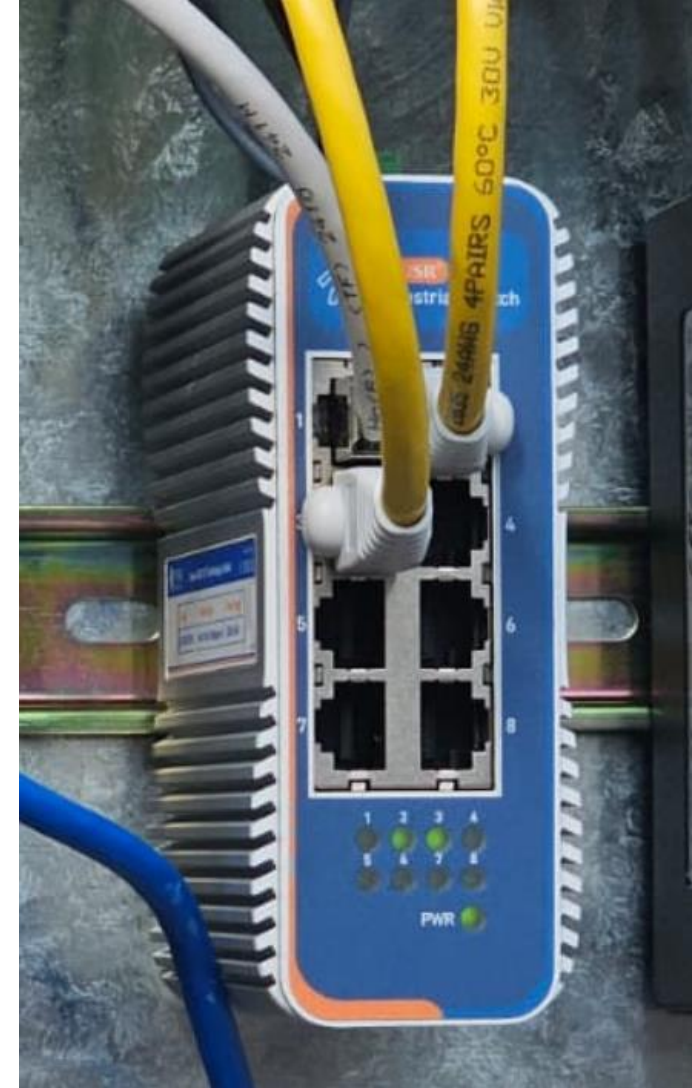
Network architecture:

1. All Modbus TCP connections are first connected to the blue switch
2. Logger is connected to blue switch to access data

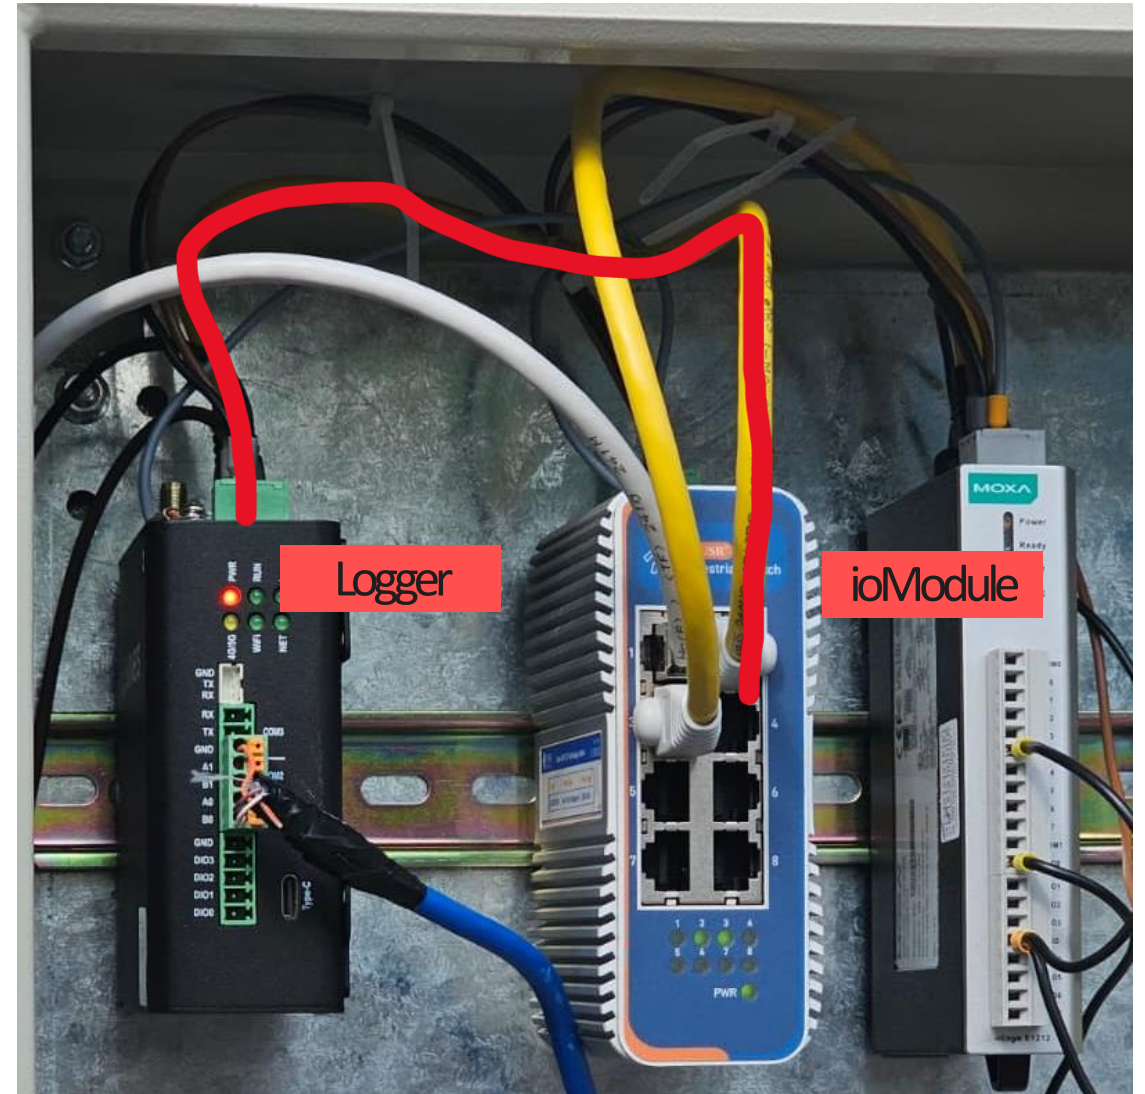
During delivery, devices were connected accordingly
