Field Safety Notice

2018-05-14 | MSA-2018-001-IU |

Subject: Volista bracket detachment

Products affected: All Getinge Volista cupolas of model Access, StandOP, Triop and Quicklock made until December 2016

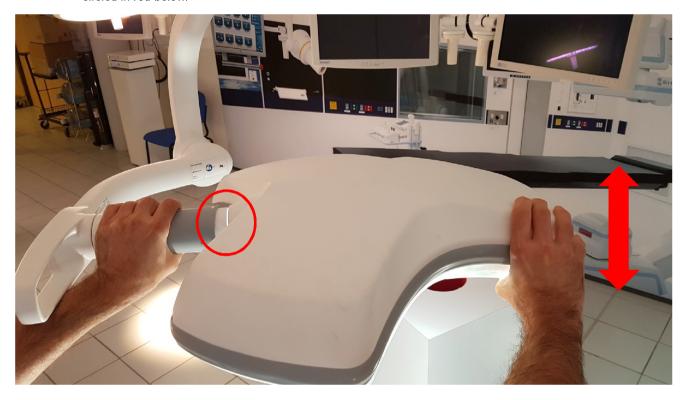
Under certain conditions, we have identified that an issue might prevent the device from performing as intended. It was established that, with some of the manufactured units, a screw has been forgotten on the racket of the cupola on some devices in production or that the screws have loosened over the course of life. As a consequence the light head shaft could break and the cupola could detach itself when manipulated and be held only by its cables. It appears such event is more likely to happen mainly during maintenance, cleaning and surgery preparation.

Hold the cupola with both hands (as shown in the picture below), and check for play by trying to move the cupola up and down (as shown by the arrow). If there is play in the cupola, you will feel it in the zone circled in red below.

If you detect play in the cupola, please cease to use the device and inform your local Getinge representatives immediately.

Getinge will initiate a field action of all affected device units. You will be contacted by your Getinge sales or service representative to plan for the update of your device.
