# BP394/832 MBL

Jun 2, 2026

**Project Name**  
First Punch

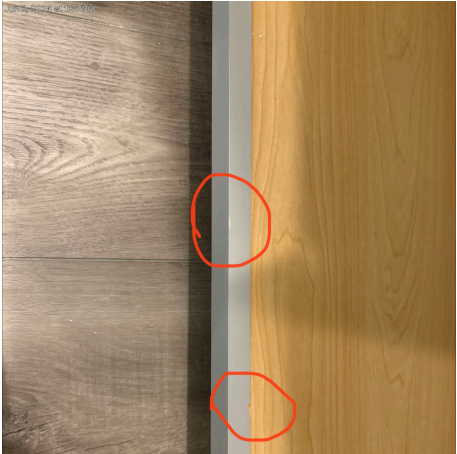
**Issue #**  
2

**Issue**  
Touch up face frame guest hall bath with fill stick and touch up pen

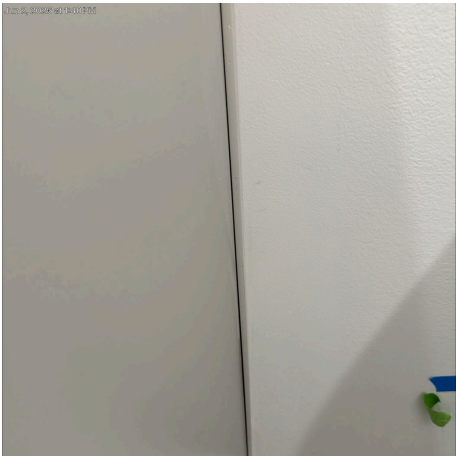
**Issue #**  
3

**Issue**  
Scribe bowing right side guest hall bath

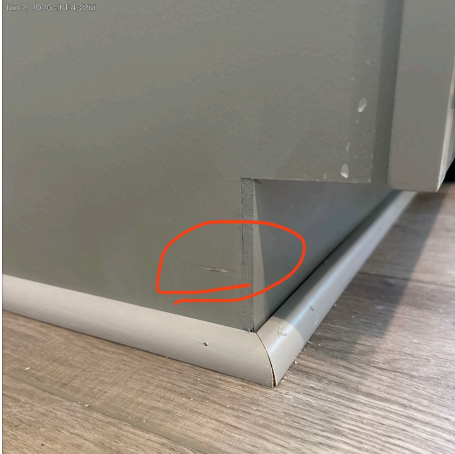
| <b>Issue #</b><br>5 | <b>Issue</b><br>Skin starting to delaminate left end of section at fridge opening | |

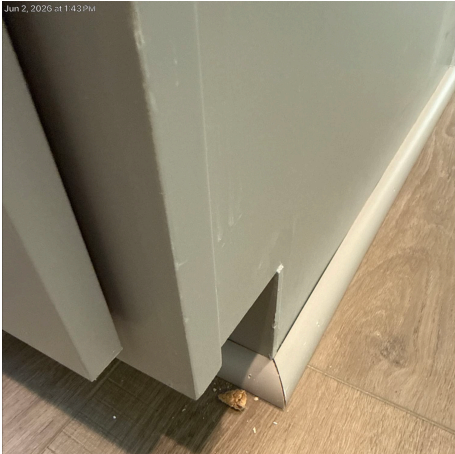
| <b>Issue #</b><br>6 | <b>Issue</b><br>Toe kick overcut at island | |

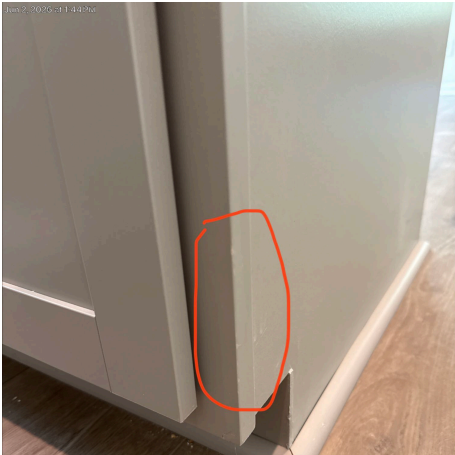
| <b>Issue #</b><br>7 | <b>Issue</b><br>Touch up right side of faceframe looking to back door | |

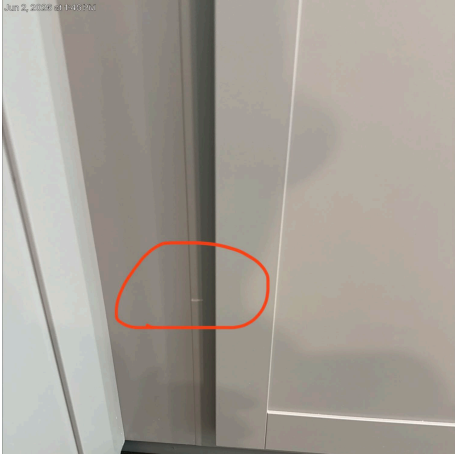
| <b>Issue #</b><br>9 | <b>Issue</b><br>Touch up lower left of sink | |

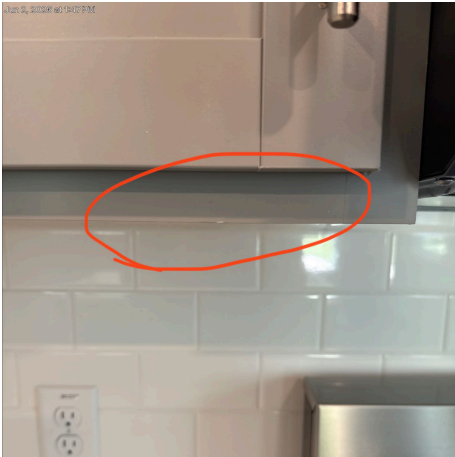
| <b>Issue #</b><br>12 | <b>Issue</b><br>Touch up face frame left of microwave | |

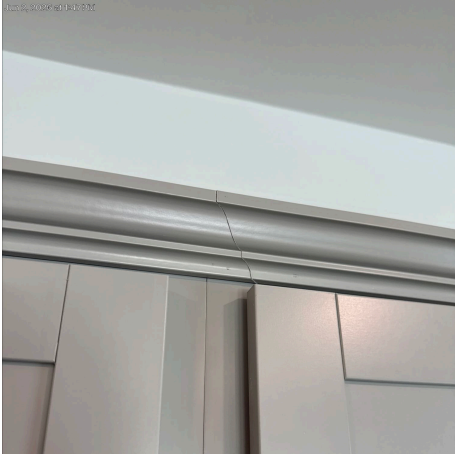
| <b>Issue #</b><br>13 | <b>Issue</b><br>Seam crown better | |

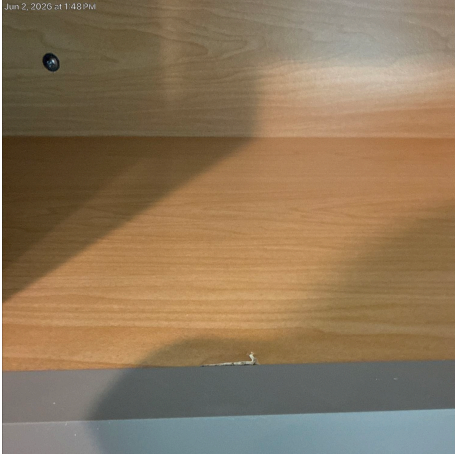
| <b>Issue #</b><br>14 | <b>Issue</b><br>Lower skin issue right cabinet beside microwave | |

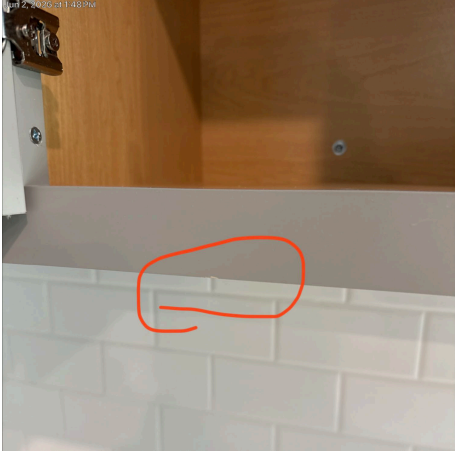
| <b>Issue #</b><br>15 | <b>Issue</b><br>Touch up face upper cab left of sink | |

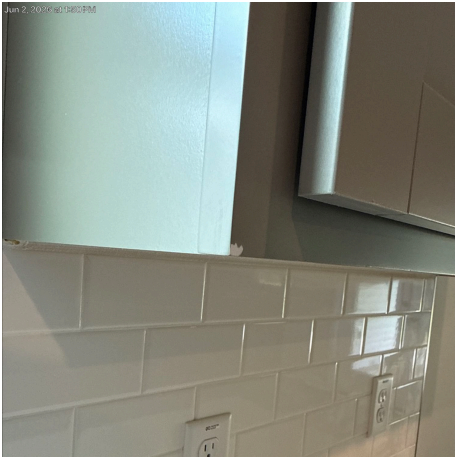
| <b>Issue #</b><br>16 | <b>Issue</b><br>Corner of face frame delaminating right upper beside sink | |

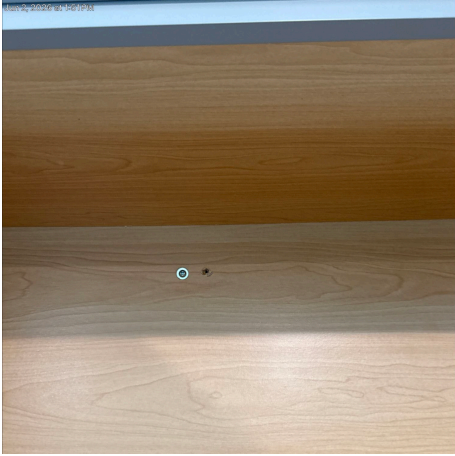
| <b>Issue #</b><br>17 | <b>Issue</b><br>Fix miss drill upper above dishwasher | |

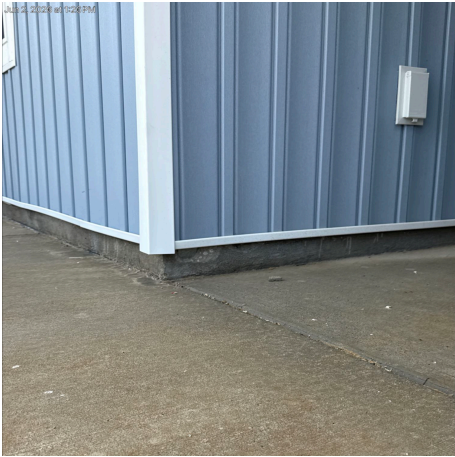
| <b>Issue #</b><br>19 | <b>Issue</b><br>Parge front left corner of entry way | |

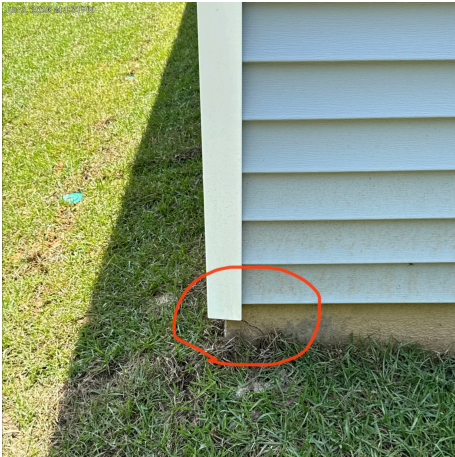
| <b>Issue #</b><br>20 | <b>Issue</b><br>Parge crack right rear elevation. | |

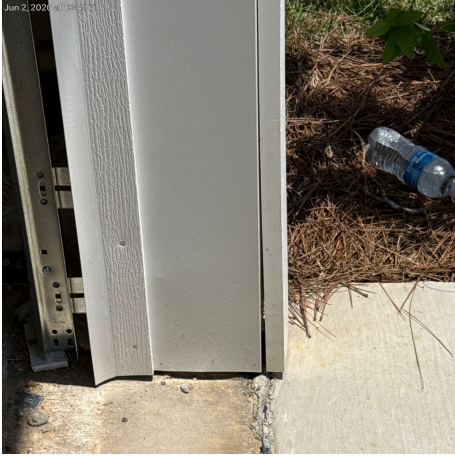
| <b>Issue #</b><br>21 | <b>Issue</b><br>Additional nails needs right side of garage trim lower | |

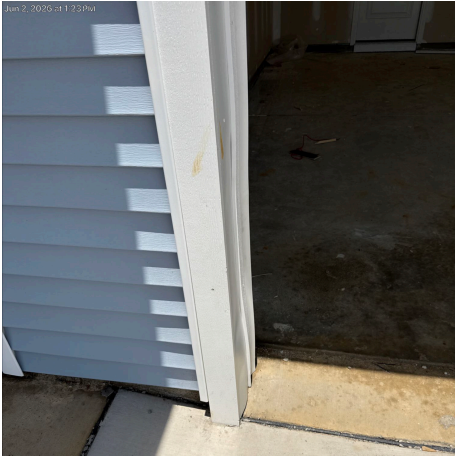
| <b>Issue #</b><br>22 | <b>Issue</b><br>Garage fascia metal is wavy, causing garage seal to be wavy | |

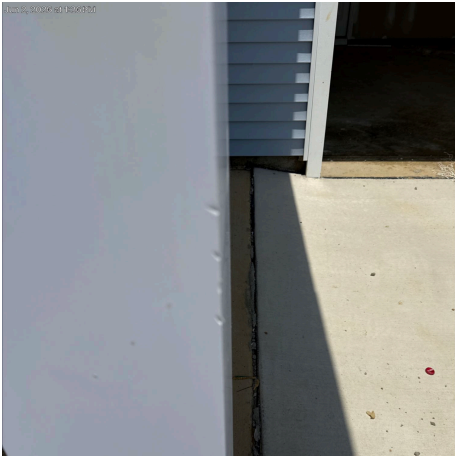
| <b>Issue #</b><br>23 | <b>Issue</b><br>Repair gouges in post front porch far right | |

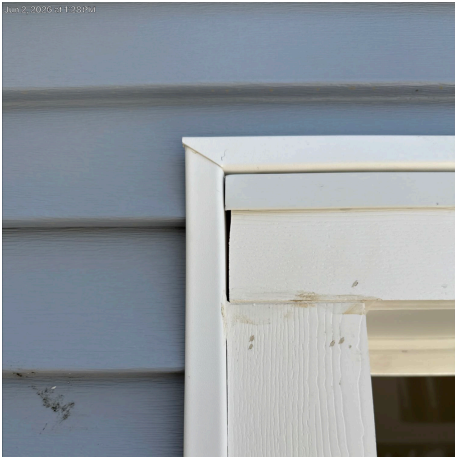
| <b>Issue #</b><br>24 | <b>Issue</b><br>Touch ups need at poor cut top of garage trim | |

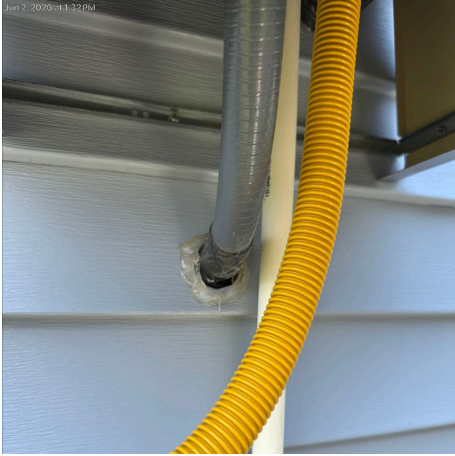
| <b>Issue #</b><br>25 | <b>Issue</b><br>Seal whip at tankless | |

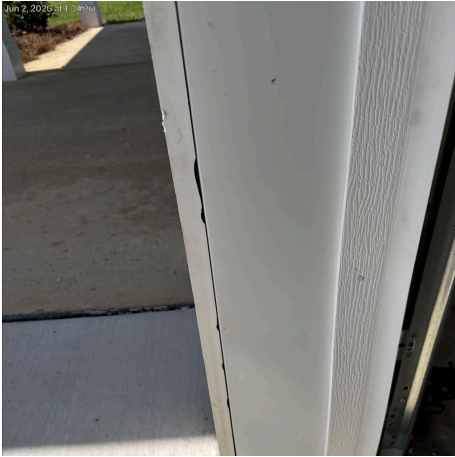
| <b>Issue #</b><br>26 | <b>Issue</b><br>Poor cuts/damaged trim at garage door left side | |

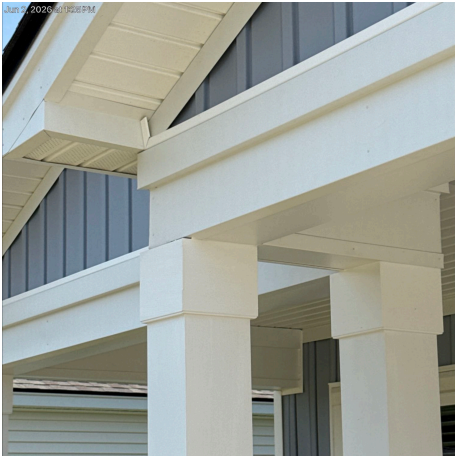
| <b>Issue #</b><br>27 | <b>Issue</b><br>Caulk touch ups at tops of front porch post | |

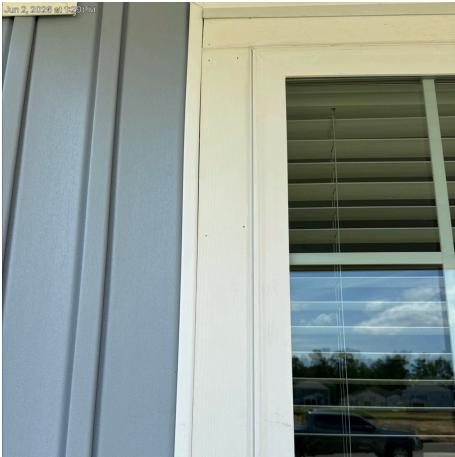
| <b>Issue #</b><br>28 | <b>Issue</b><br>Paint touch up nail holes at front windows | |

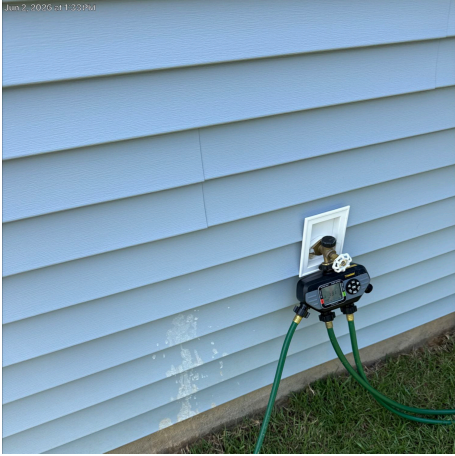
| <b>Issue #</b><br>29 | <b>Issue</b><br>Clean washed off paint off right right front hose bib | |

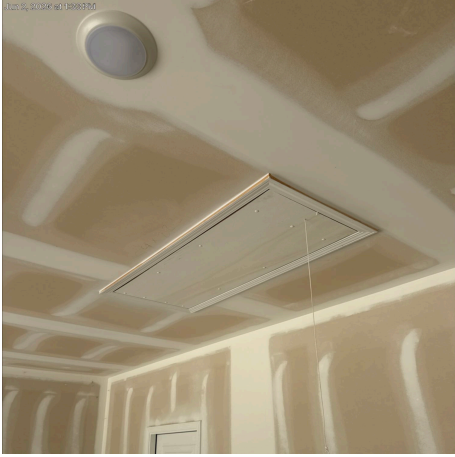
| <b>Issue #</b><br>30 | <b>Issue</b><br>Paint sides of PDS and second coat of PDS | |

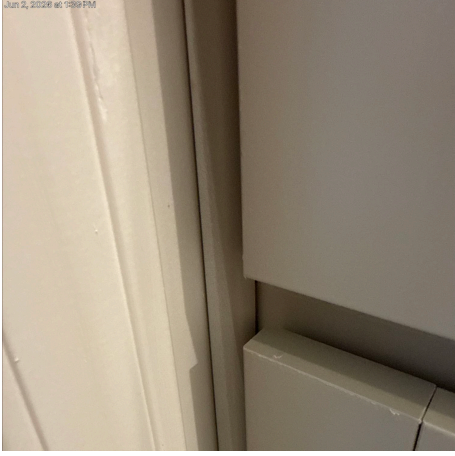
| <b>Issue #</b><br>31 | <b>Issue</b><br>Try to remove paint overspray off scribe at guest hall bath | |

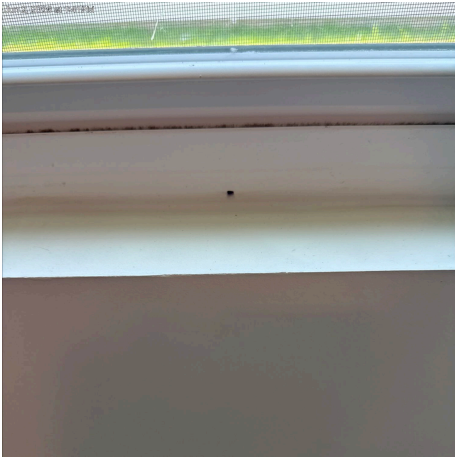
| <b>Issue #</b><br>32 | <b>Issue</b><br>Caulk void touch up at middle left bedroom window | |

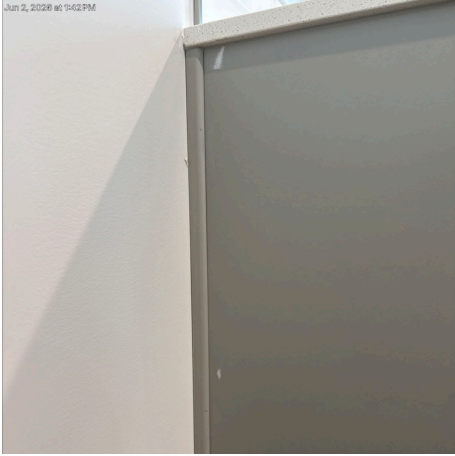
| <b>Issue #</b><br>33 | <b>Issue</b><br>Remove paint over spray off left end of cabinets at fridge opening | |

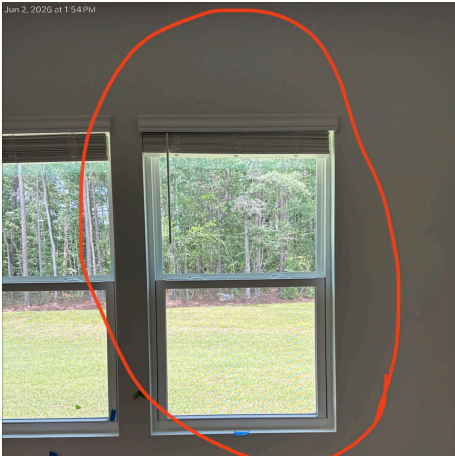
| <b>Issue #</b><br>37 | <b>Issue</b><br>Right window in living area squealing when operating please adjust | |

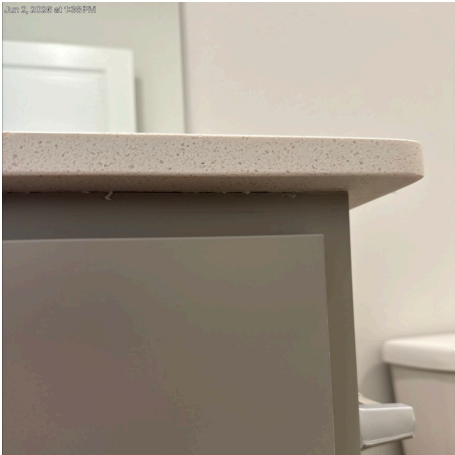
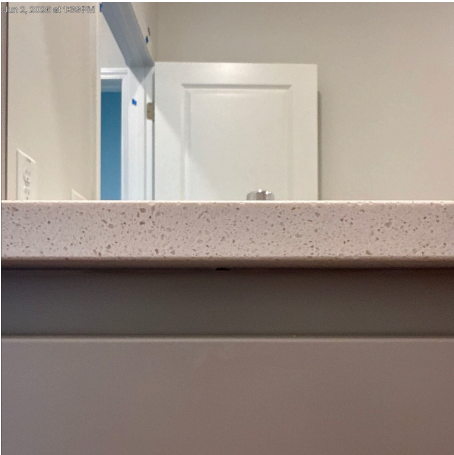
| <b>Issue #</b><br>39 | <b>Issue</b><br>Silicone touch ups needed at tops to cabinets hall bath | |

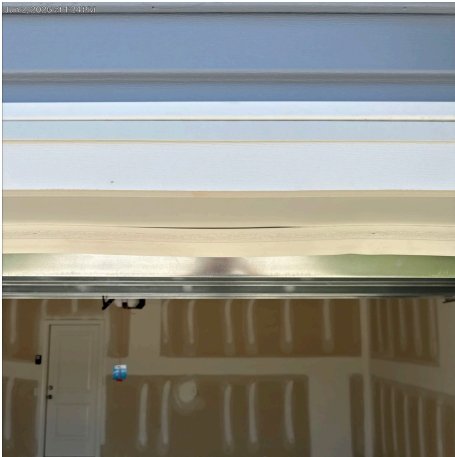
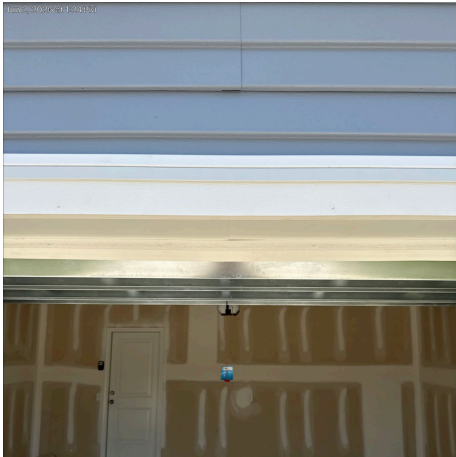
40

Garage trim/seal needs more nails, dipping in places across the top

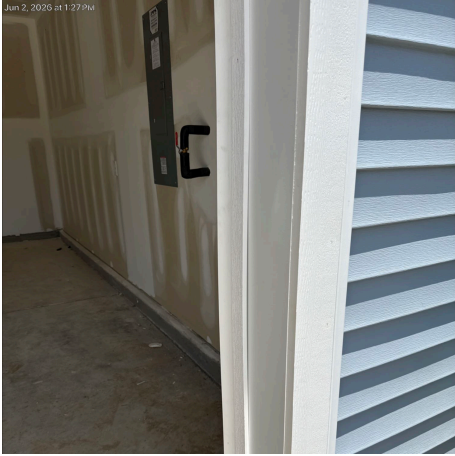
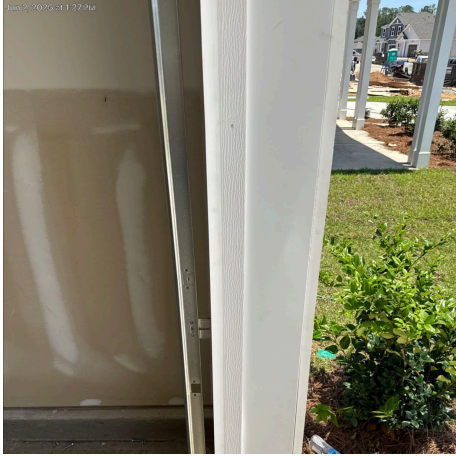
41

Right side of garage trim/seals needs another nail

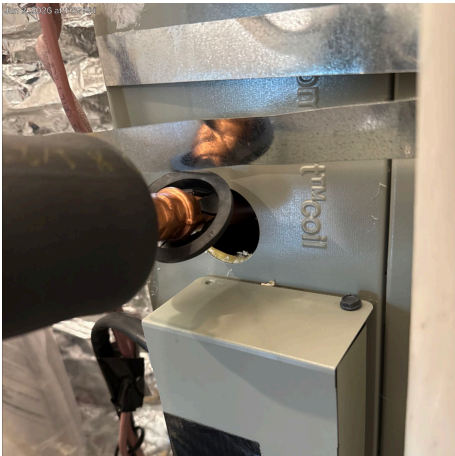
42

Seal not properly installed

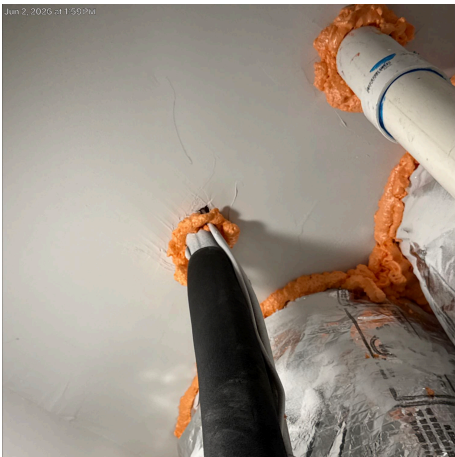
43

Foam gaps where lineset comes through

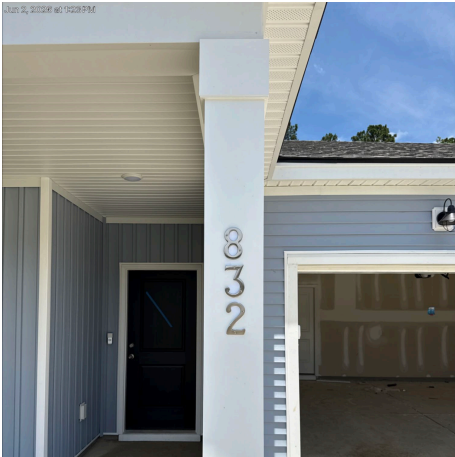
| <b>Issue #</b><br>44 | <b>Issue</b><br>House numbers are slanted,<br>please install straight | |

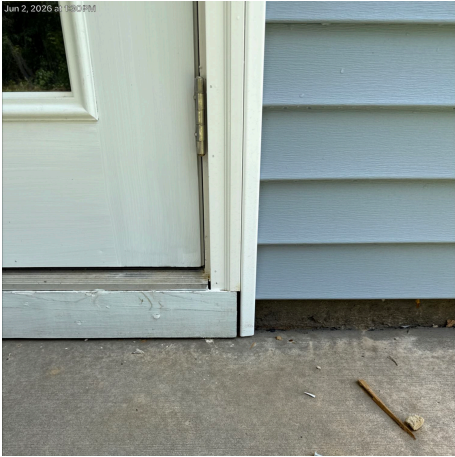
| <b>Issue #</b><br>46 | <b>Issue</b><br>T-support short cut at rear patio<br>door | |

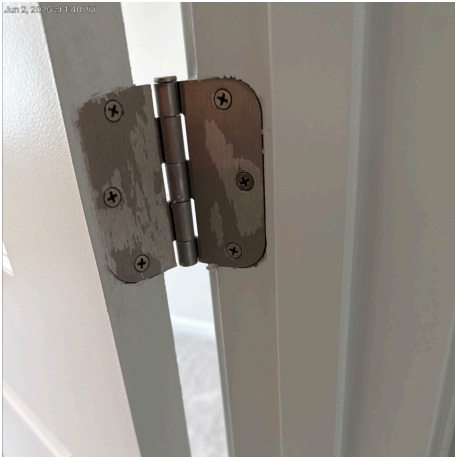
| <b>Issue #</b><br>48 | <b>Issue</b><br>Defective hinges middle left bedroom. Replace all 3 look like the photo | |

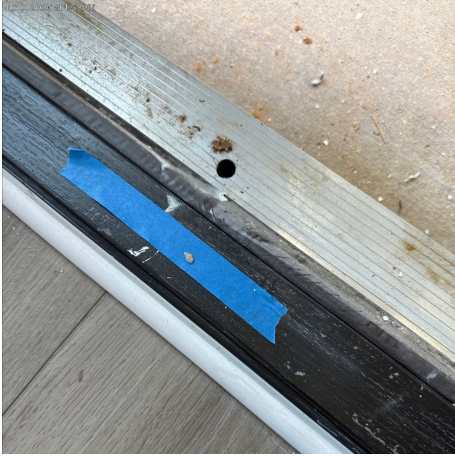
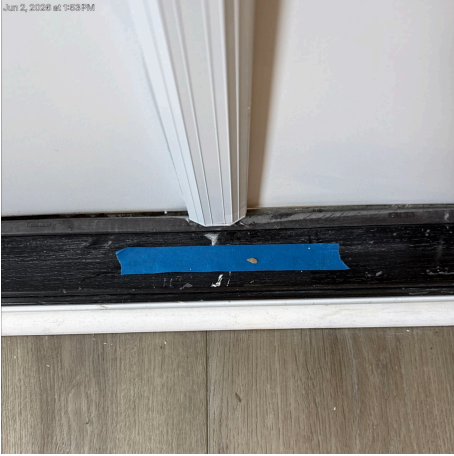
| <b>Issue #</b><br>49 | <b>Issue</b><br>Hole for lower pin of double doors over drilled causing door to move and rattle and not seal tight | | |

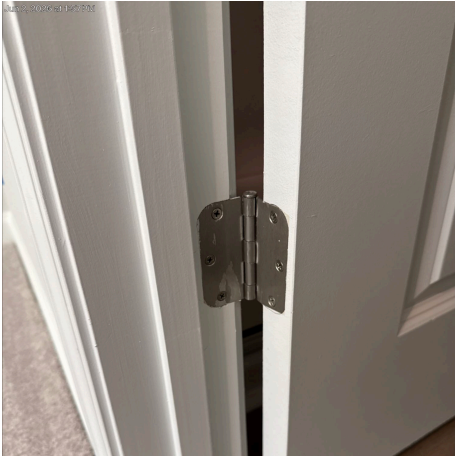
| <b>Issue #</b><br>50 | <b>Issue</b><br>Lower hinge defective owners bathroom door | |
