# The Hubble Space Telescope Optical Systems Failure Report

November 1990

National Aeronautics and  
Space Administration

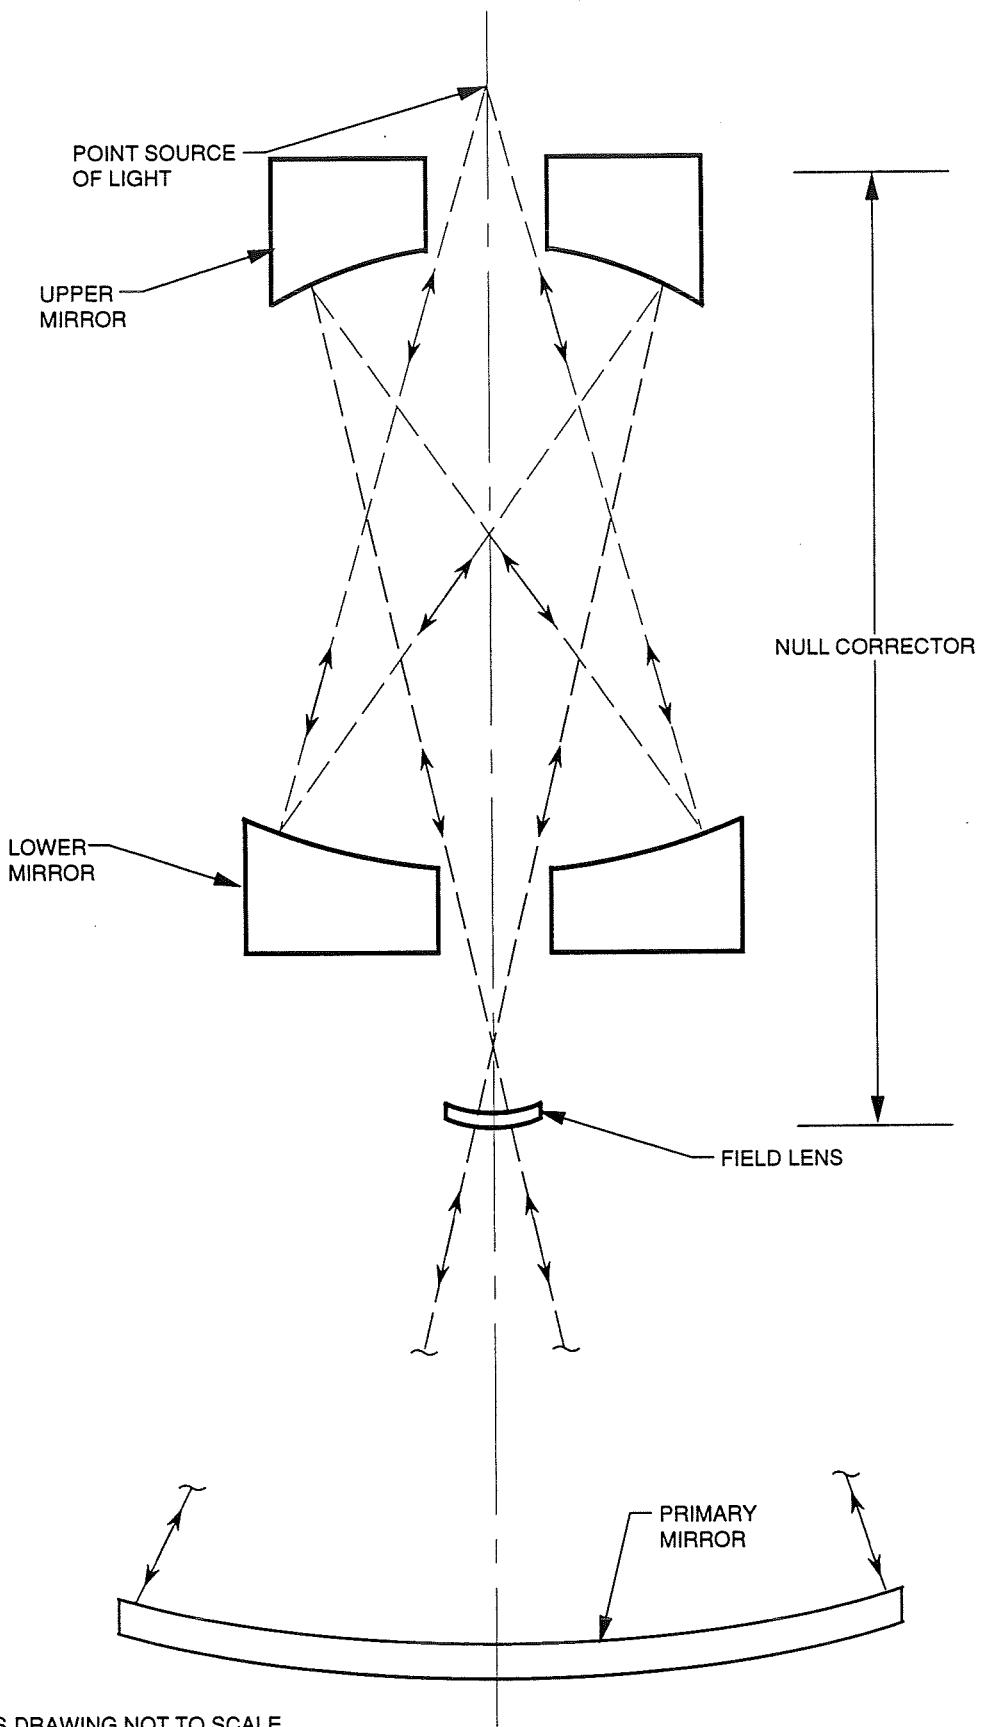
RNC was designed and built by the Perkin-Elmer Corporation for the HST Project. This unit had been preserved by the manufacturer exactly as it was during the manufacture of the mirror. When the Board measured the RNC, the lens was incorrectly spaced from the mirrors. Calculations of the effect of such displacement on the primary mirror show that the measured amount, 1.3 mm, accounts in detail for the amount and character of the observed image blurring.

**Figure 4-2. Reflective null corrector.**

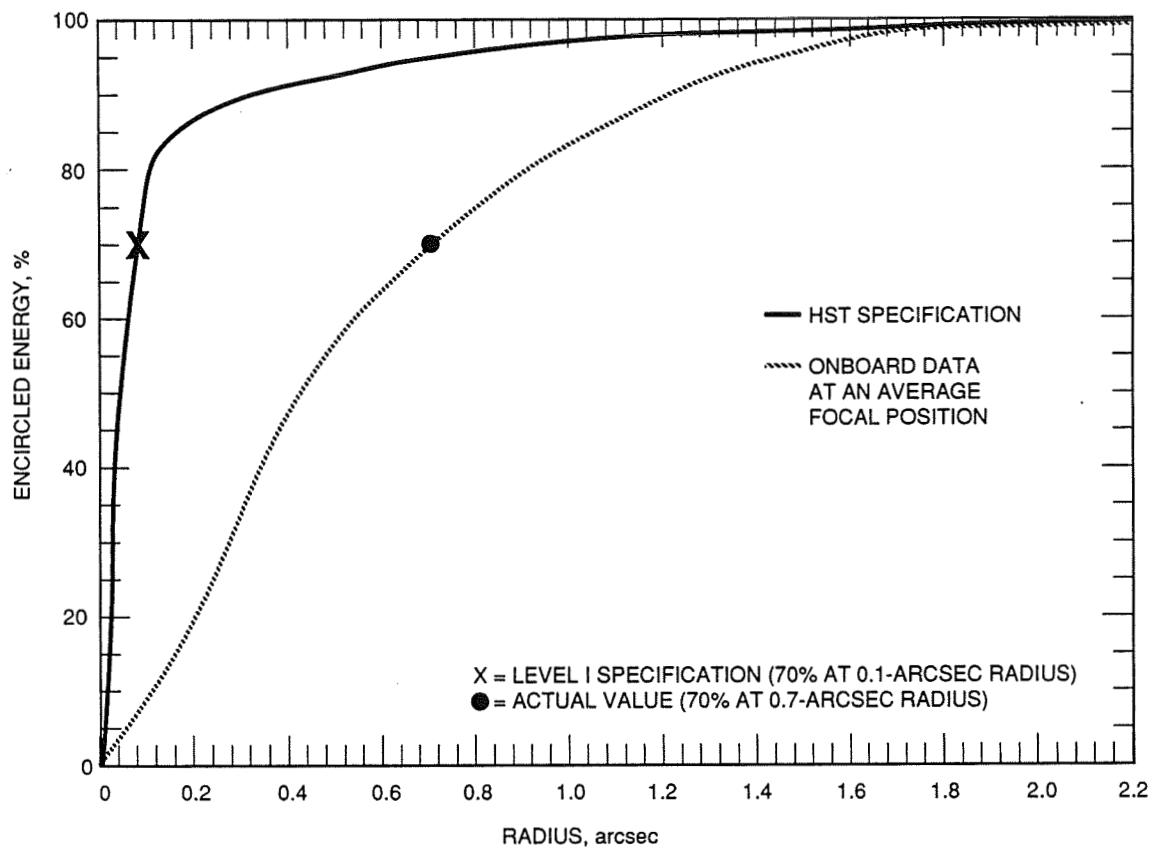
**Figure 5-1. Encircled energy versus arcsecond radius of image produced by the HST.**

The problem was initially detected when the "first light" images from both the Wide Field/Planetary Camera and the Faint Object Camera were analyzed and major defects were detected. Computer simulation of these images indicated that 0.5-wave rms wavefront spherical aberration at 547 nm existed in the telescope and not in the instruments. Further verification of the spherical aberration problem came from the wavefront sensors.

Both on-axis and off-axis data were analyzed in order to determine whether the primary mirror or the secondary mirror, or perhaps both mirrors, were flawed. Data taken by the wavefront sensors, the Wide Field/Planetary Camera, and the Faint Object Camera indicated a significant spherical aberration wavefront error. Although some coma appeared in the off-axis results taken by the fine guidance sensors, the amount of coma was small and the conclusion was reached that the primary source of image spreading is spherical aberration of the primary mirror.

Spherical aberration distorts a point source image (e.g., a distant star) by broadening the image and surrounding it with concentric diffraction rings. This broadening effect prevents distant, closely spaced objects from being separated in the image. A tutorial on spherical and coma aberration is given in Appendix C.

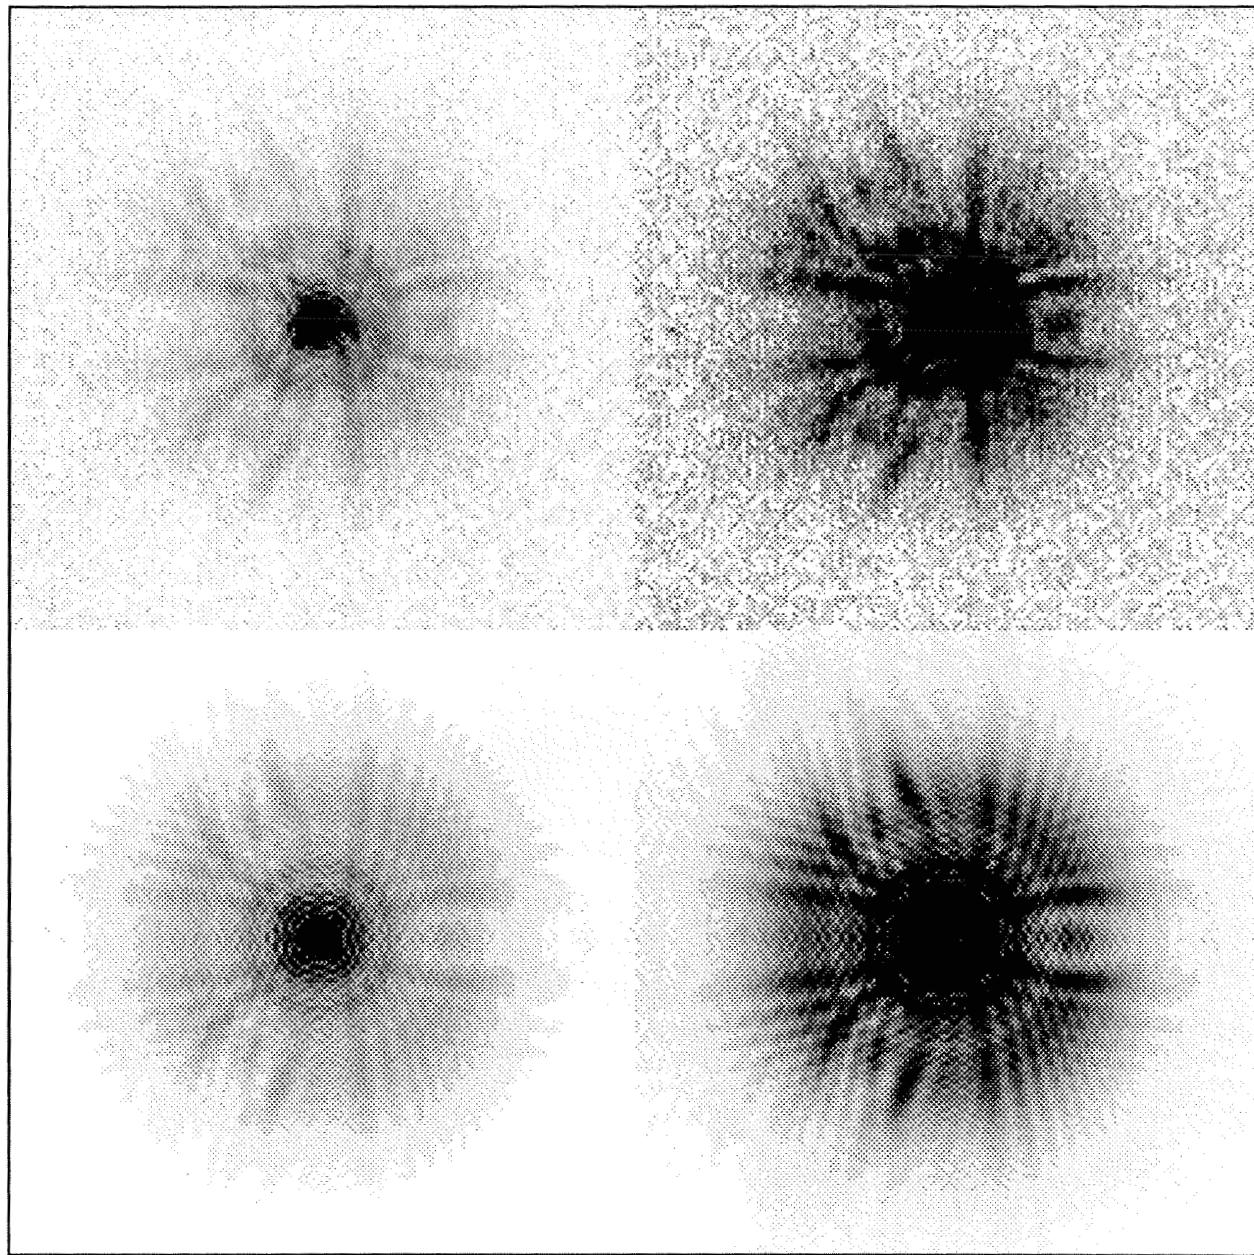
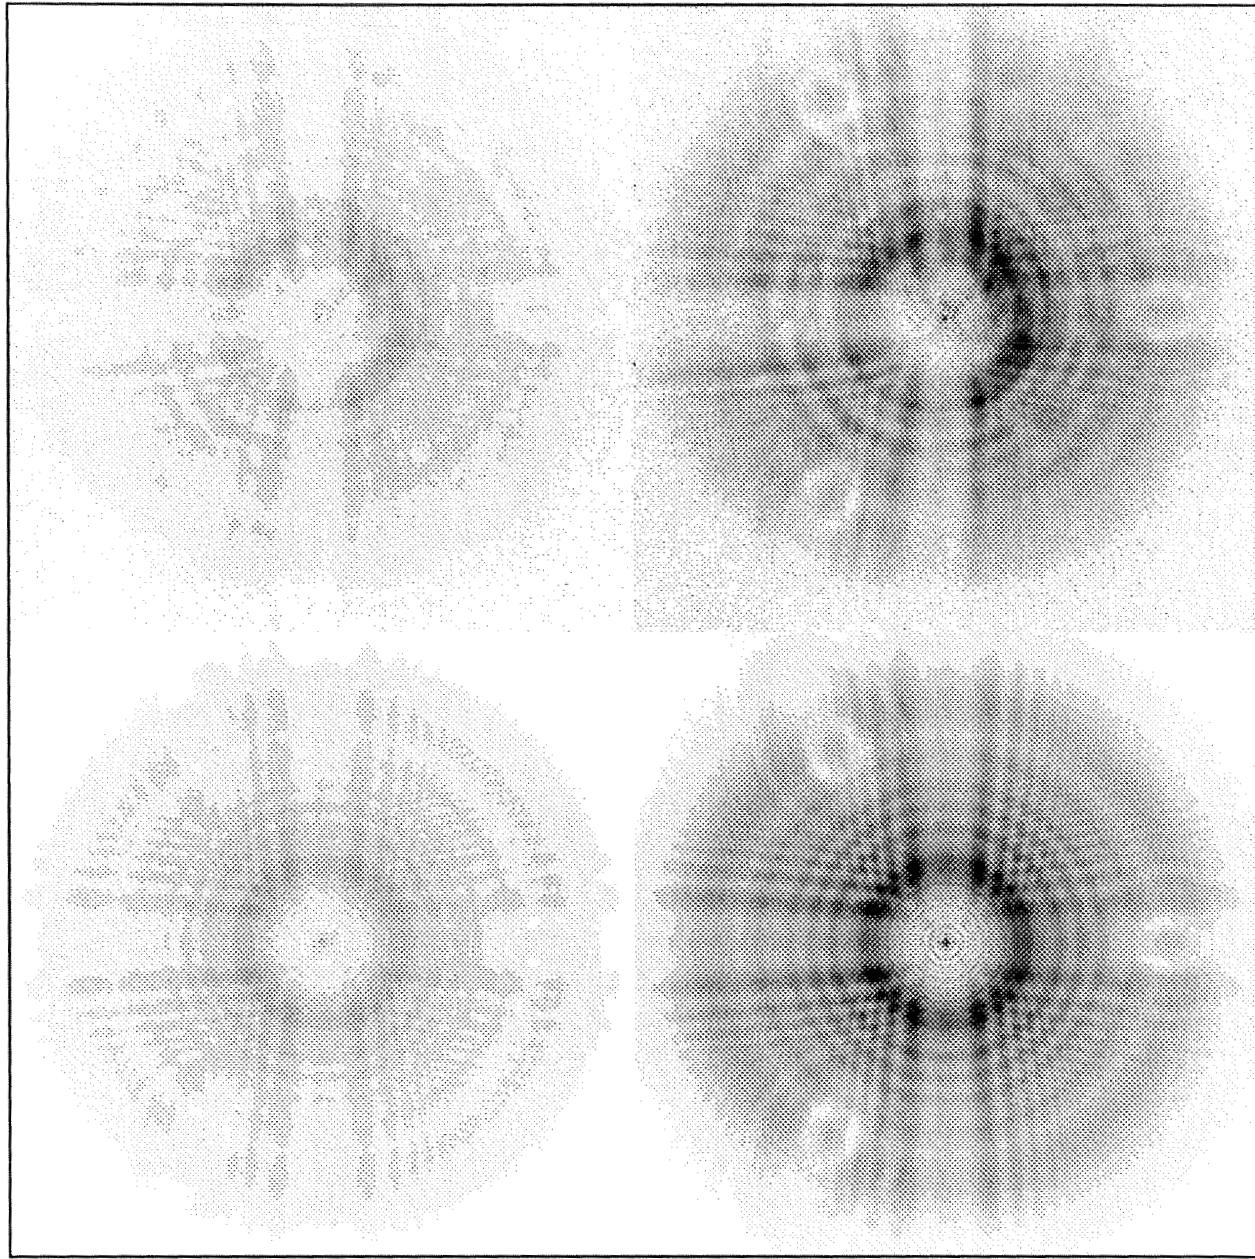
Figure 6-1. Planetary Camera images versus computer simulations. The images in the top frames were taken with the Planetary Camera; those in the bottom frames are computer simulations created using an optical model with 0.5-wave rms wavefront error at 547 nm.

(a) Recorded image of the PC5 star taken on June 14, 1990, with a  $0\text{-}\mu\text{m}$  inside focus.

(b) Recorded image of the PC5 star taken on June 21, 1990, with a -300- $\mu\text{m}$  inside focus.

Figure 6-1 (continued). The images in both (a) and (b) show a linear-intensity display on the left, and a logarithmic ("stretched") image display on the right. The focal position denotes the position of the secondary mirror. (Data were supplied by Dr. Jon Holtzman.)

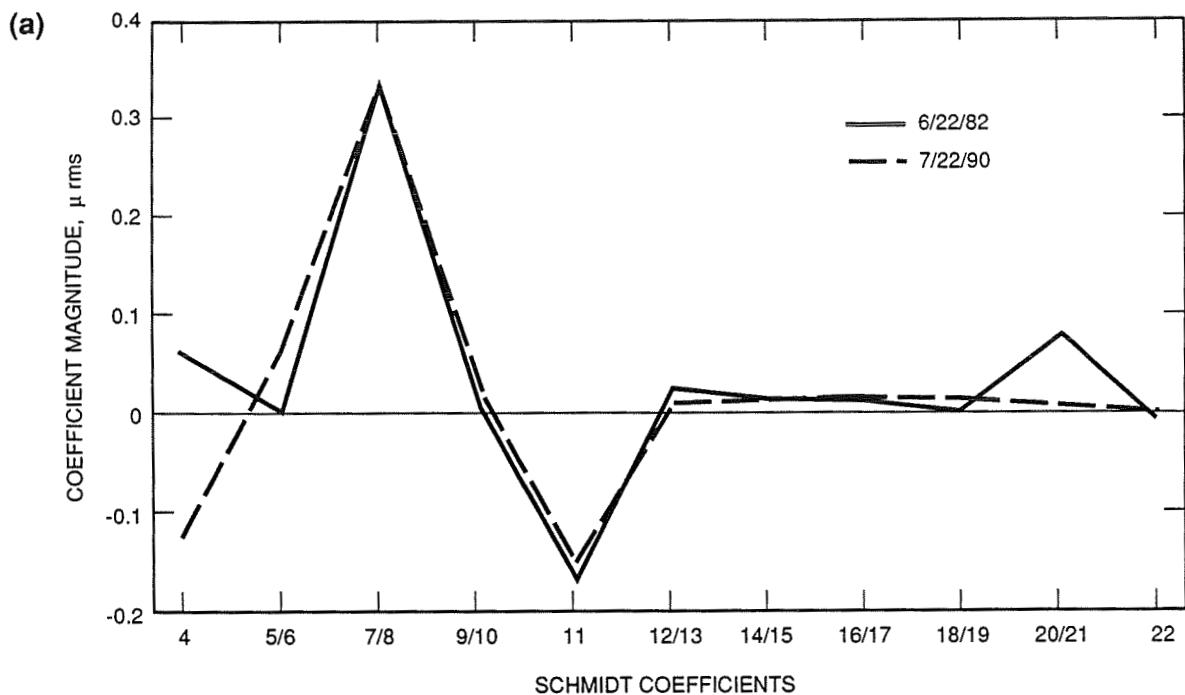
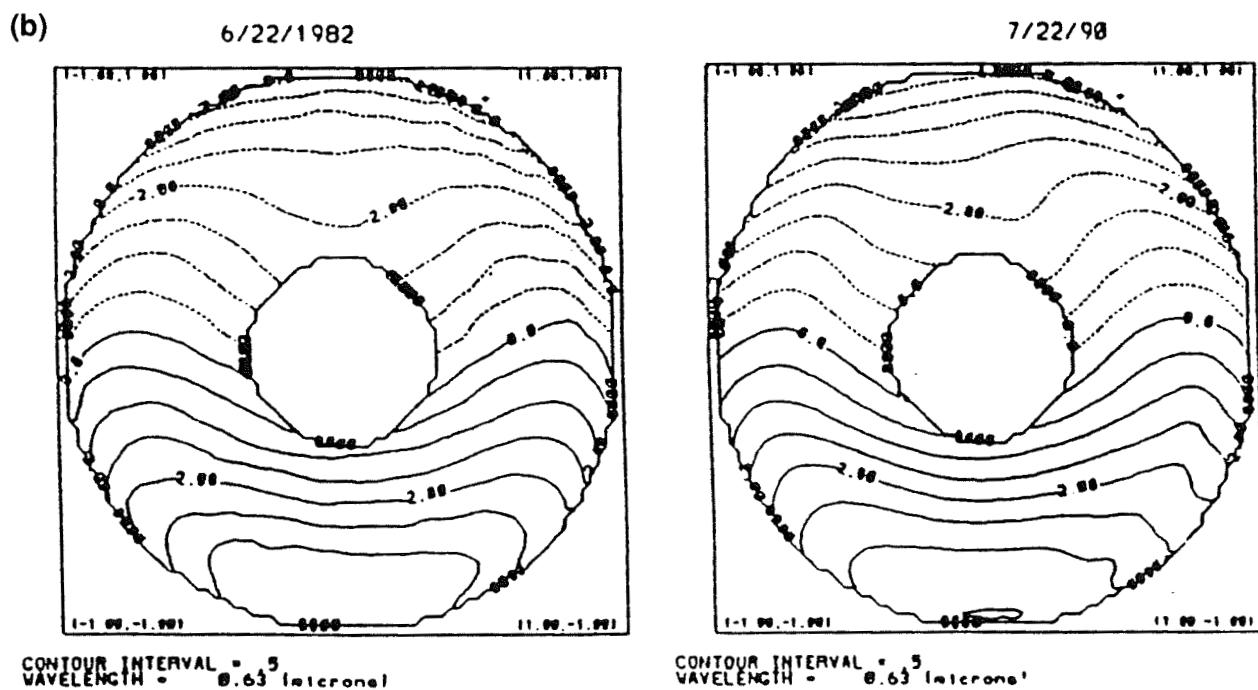
Unverifiable testimony raised the possibility of a waiver having been granted for an optical spacing error in the INC. During the current investigation, an error in the design calculations was discovered that produced a small amount of spherical aberration in the INC. An analysis of the "as-built" INC conducted for the investigation showed that the instrument had an accuracy to better than 0.14 wave.

The amount of spherical aberration introduced by the INC error is only a small amount compared to the amount of spherical aberration actually measured.

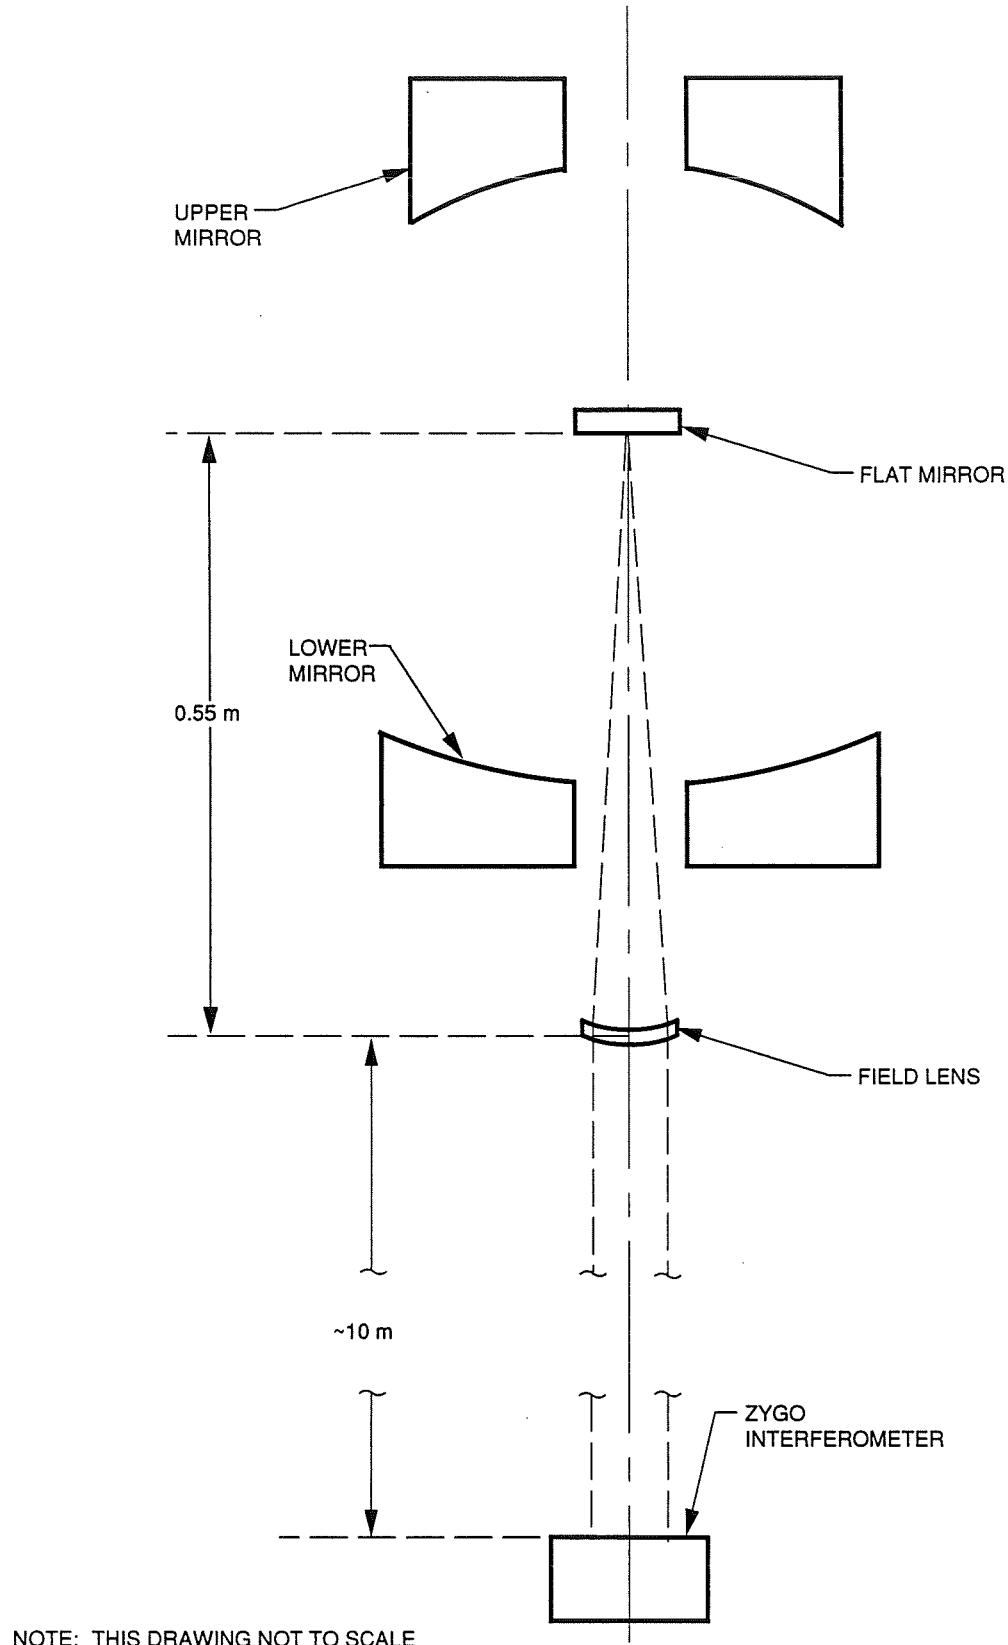
The optical element spacing was measured in 1990 by shining collimated light up through the field lens using a Zygo interferometer as the source, and by placing a flat mirror at the focus of the field lens (a distance of about 0.55 m above the lens). The correct position of the mirror was determined by using the interferometer to find the best focus (Figure 6-3). The distance from the flat mirror was then measured down to the vertex of the lower mirror using a fixture in the mirror hole for a reference. This measurement showed that the field lens was about 1.3 mm too far from the lower mirror. Both the direction and the magnitude of the spacing error correctly explained the spherical aberration observed in the HST image data. The spacings of the other optical elements in the RNC were measured and were found to be correct.

**Figure 6-3.** The 1990 spacing measurement between the field lens and the lower mirror of the reflective null corrector, using an optical test.

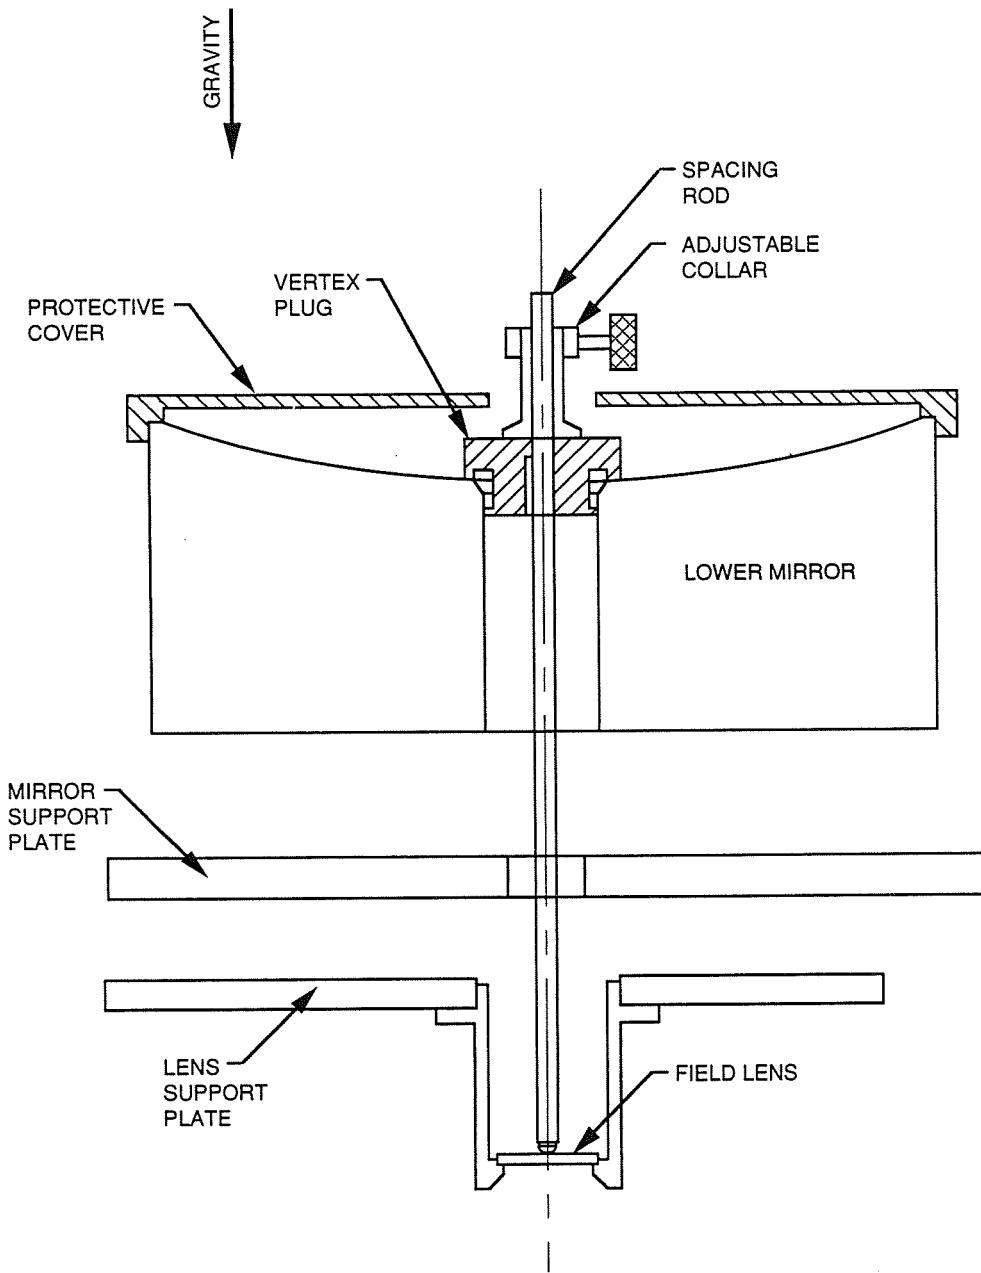
In addition to the optical test used to detect the field-lens spacing error, a direct physical measurement was made from the field lens to the vertex of the lower mirror (Figure 6-4). A lightweight spacing rod and a new vertex plug were made. The results verified the previously measured spacing error to  $\pm 0.1$  mm. More accurate measurements of the displacement error will be done at a later time, as this information is necessary for an accurate determination of a prescription for the recovery optics.

When the field lens position error (FLPE) is taken into account and applied in correcting the data taken with the RNC, it results in a mirror shape that would account for most of the error observed in the HST images. Also, the interferograms taken with the RvNC were reprocessed and corrected for the as-built data available for the RvNC. This independent set of data yields a mirror shape very close in value to the RNC/FLPE data. These data led the Board to conclude that the predominant source of error had been found and was caused by the field lens position error. (See Appendix E for the HST performance based on the as-built data.)

**Figure 6-4.** The 1990 spacing measurement between the lower mirror vertex and the field lens of the reflective null corrector, using a mechanical technique.

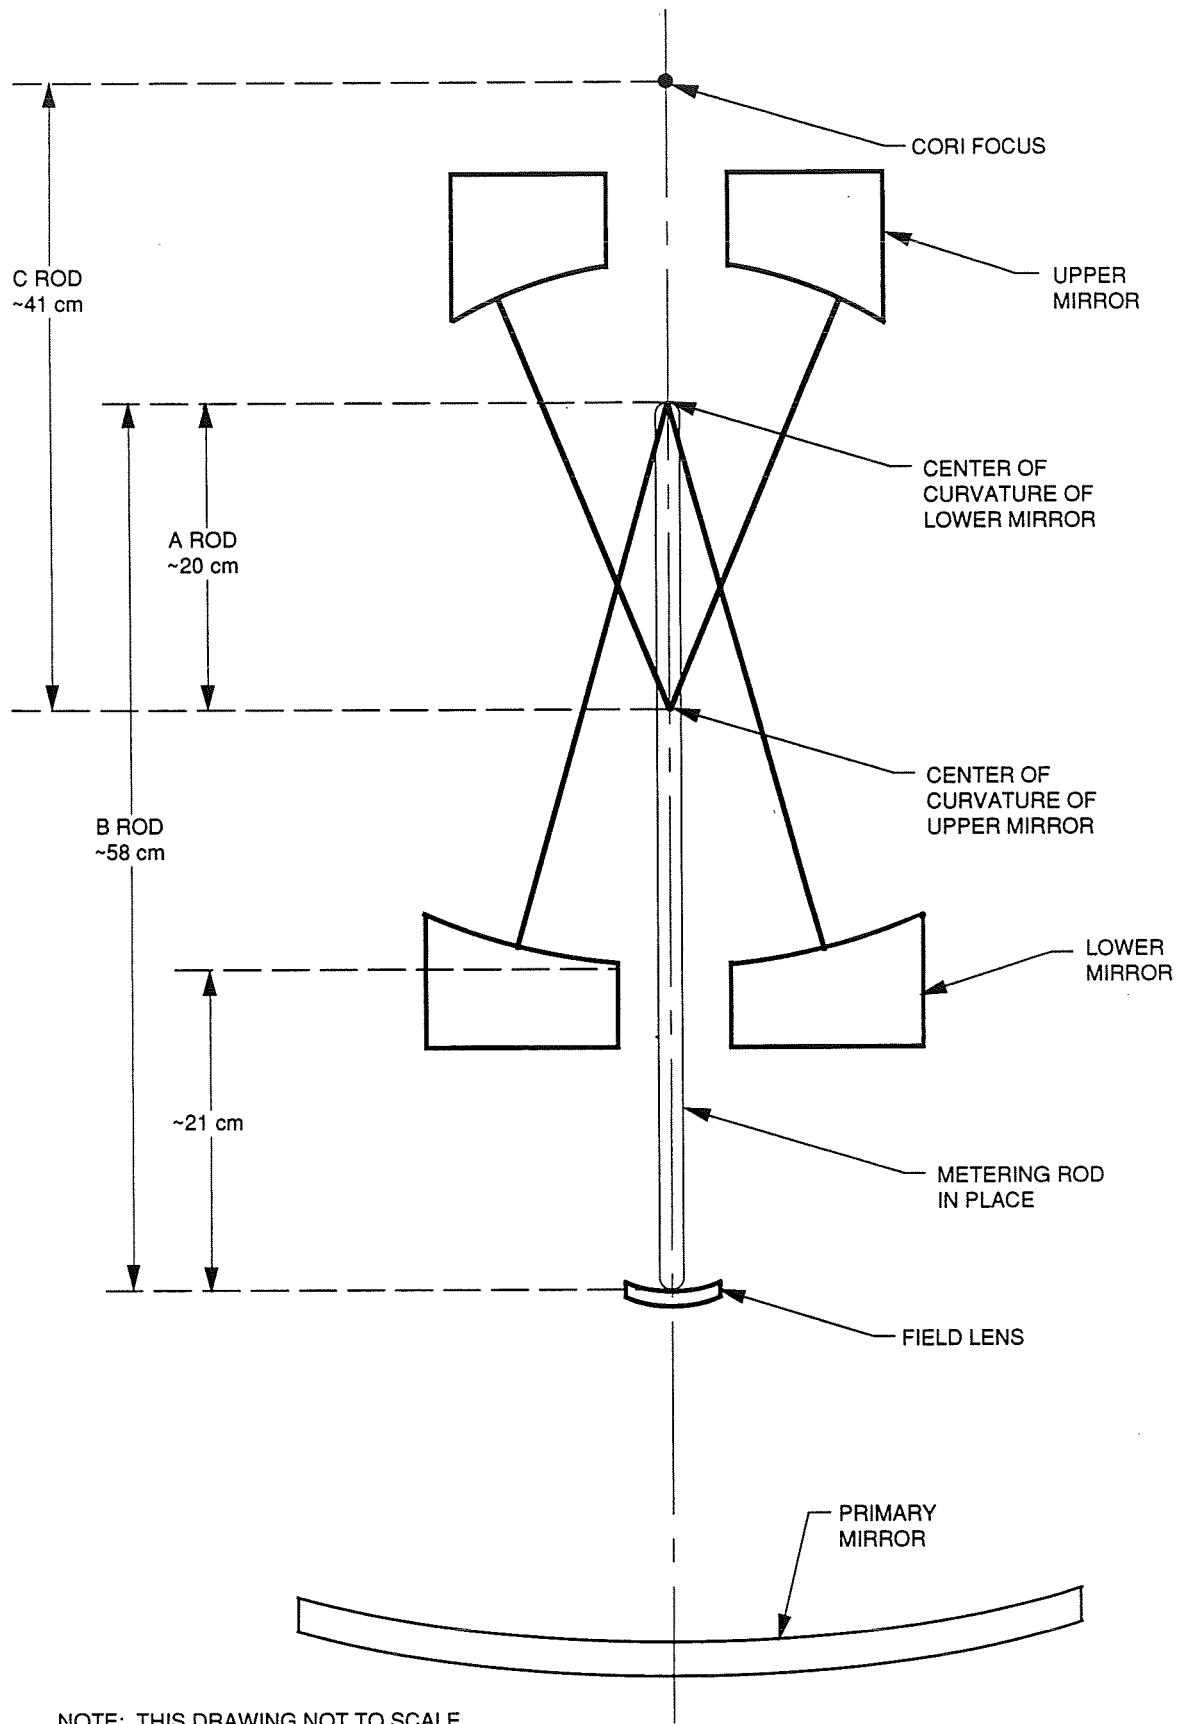
**Figure 7-1. Position of metering rods used to space optical elements in the reflective null corrector.**

At the beginning of the program to build the 2.4-m Hubble primary mirror, P-E modified the RNC that had been used in building a 1.5-m mirror prototype. This modification required adding a new field lens and respacing the optical elements to create the correct shape for the larger mirror. Figure 7-1 is a schematic of this RNC, including the positions of the metering rods used to set the optics.

There were three metering rods (labeled A, B, and C) made of Invar, a metal with a small temperature expansion coefficient. The ends of the metering rods were rounded and polished because the very precise positioning of the optics in the RNC used an interferometer, rather than a mechanical measurement. This procedure involved auto-reflecting a focused beam of light off the end of a rod and observing an interference pattern from the beam that came back on itself. Centering the light beam on the rod end was essential for the measurement. To prevent the metering rod from being misaligned laterally with respect to the interferometer axis, P-E decided to attach "field caps" to one end of the rod (Figures 7-2 and 7-3). The field caps were fitted over the rod ends and had a small aperture in the center to ensure centering of the rod on the beam.

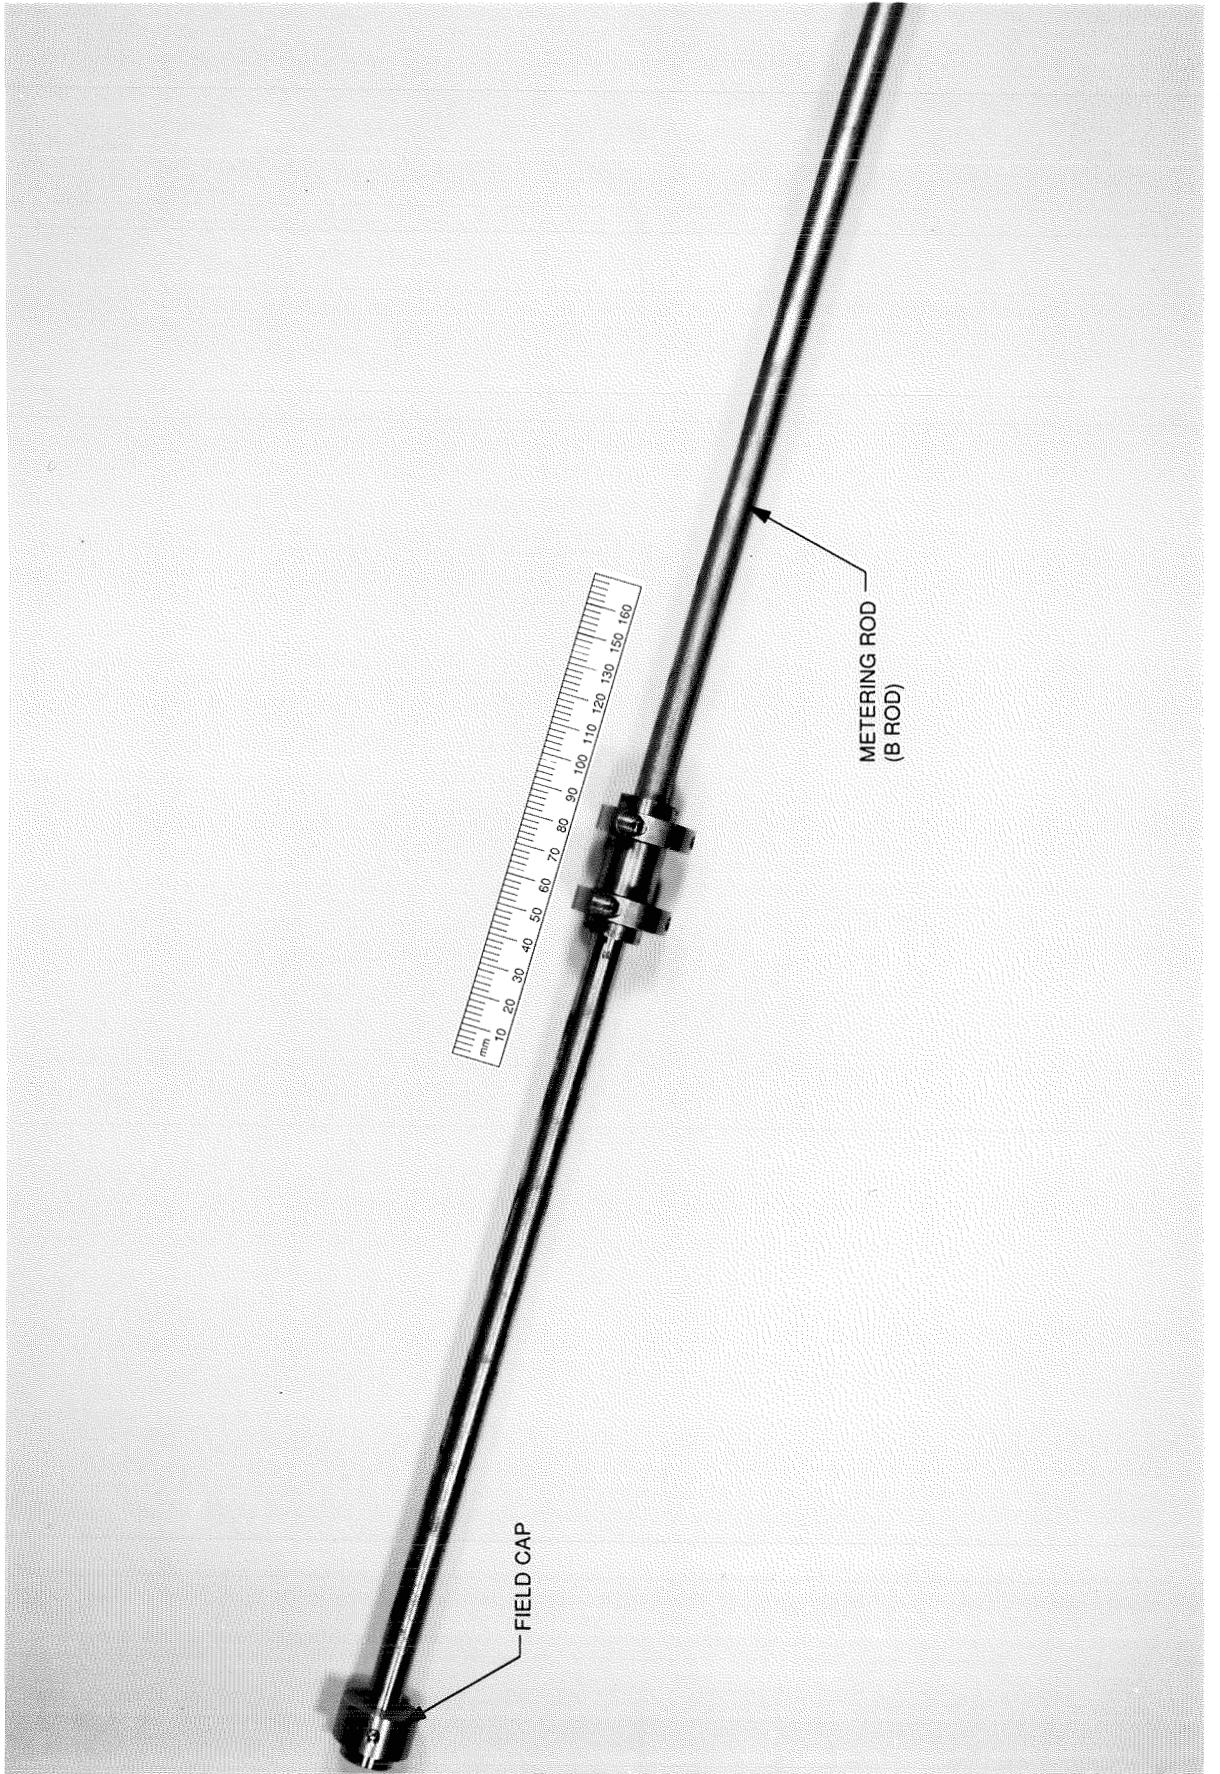
Figure 7-2. Metering rod (B rod) used to space the field lens and the center of curvature of the lower mirror in the reflective null corrector.

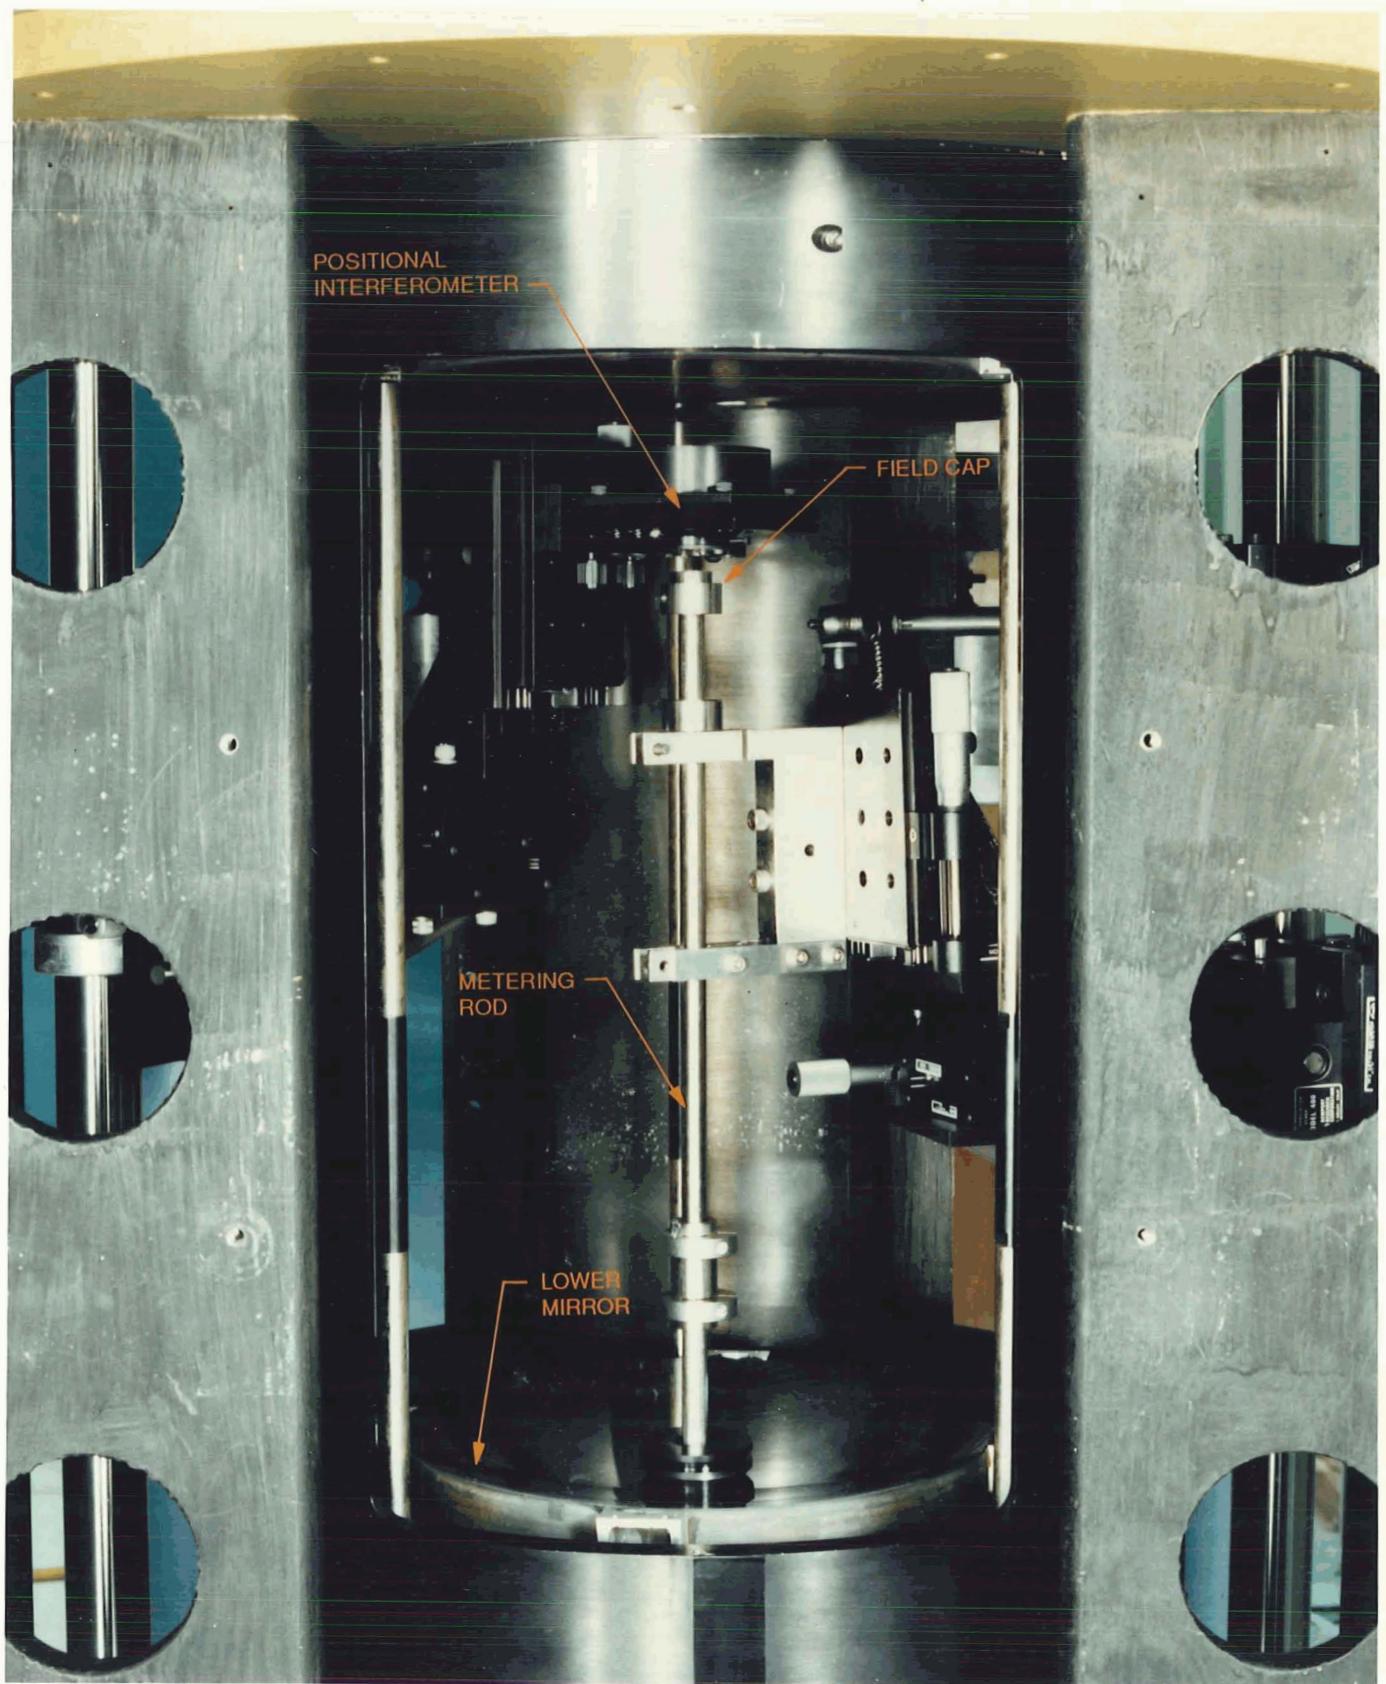
Figure 7-3. Metering rod in position between the field lens and the center of curvature of the lower mirror in the reflective null corrector.

The top surface of the field cap was covered with nonreflecting material; however, some of this material had, apparently inadvertently, broken away from a small area around the field cap aperture. It appears that the operator obtained reflection from the field cap where the nonreflecting material was absent, rather than the rod end, causing the 1.3-mm misspacing. A test performed in 1990 with the equipment showed that it was quite easy, even probable, to make this error with the configuration used. Figure 7-4 indicates how the displacement error occurred by reflecting light off the field cap, rather than the rod end, as designed. Figure 7-5 is a photograph of the field cap and shows the specular region around the aperture. (In this photograph, the broken-away coating appears darker than the surrounding region.)

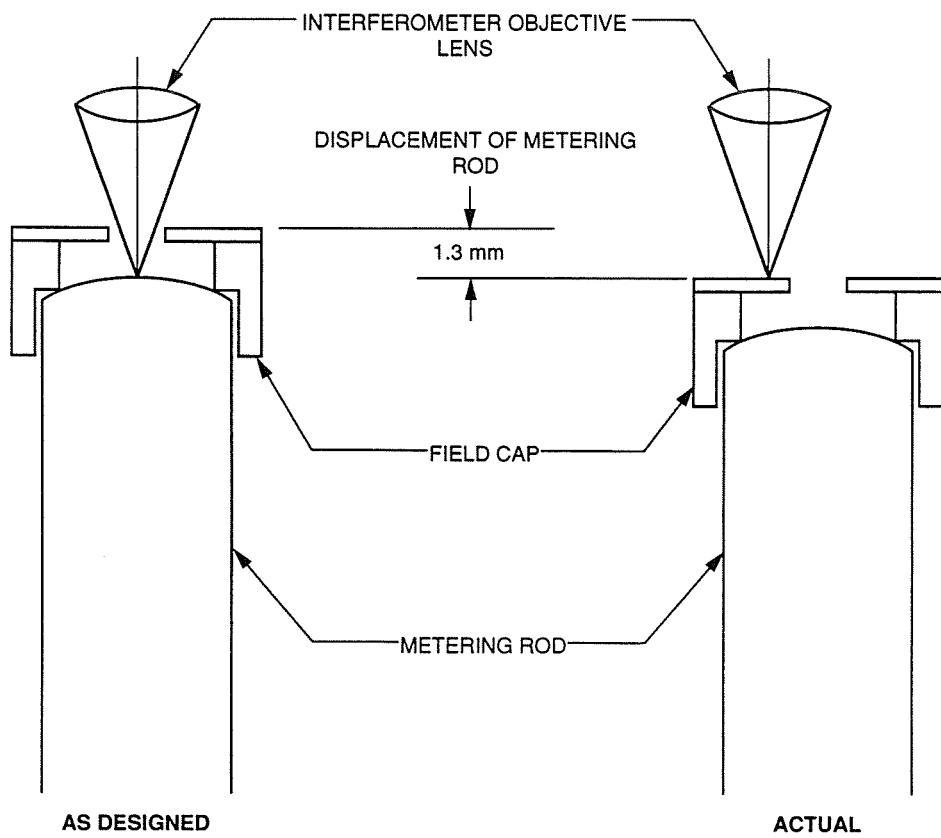
**Figure 7-4. Displacement due to the interferometer focusing on the field cap instead of the metering rod.**

With one end of the metering rod presumably located at the center of curvature of the lower RNC mirror, the field lens was then brought up to the end of rod B, but there was no adjustment left in the screws used for this positioning. More adjustment room was made by inserting spacers between the field lens and the lower mirror mounting plate. The adjustment mechanism was found not to be staked. Staking, i.e., securing the mechanism to prevent inadvertent movement, was a specified procedure. The final location of the field lens was then set with the addition of the spacers. As a result, the field lens was about 1.3 mm too far from its correct position relative to the lower mirror.

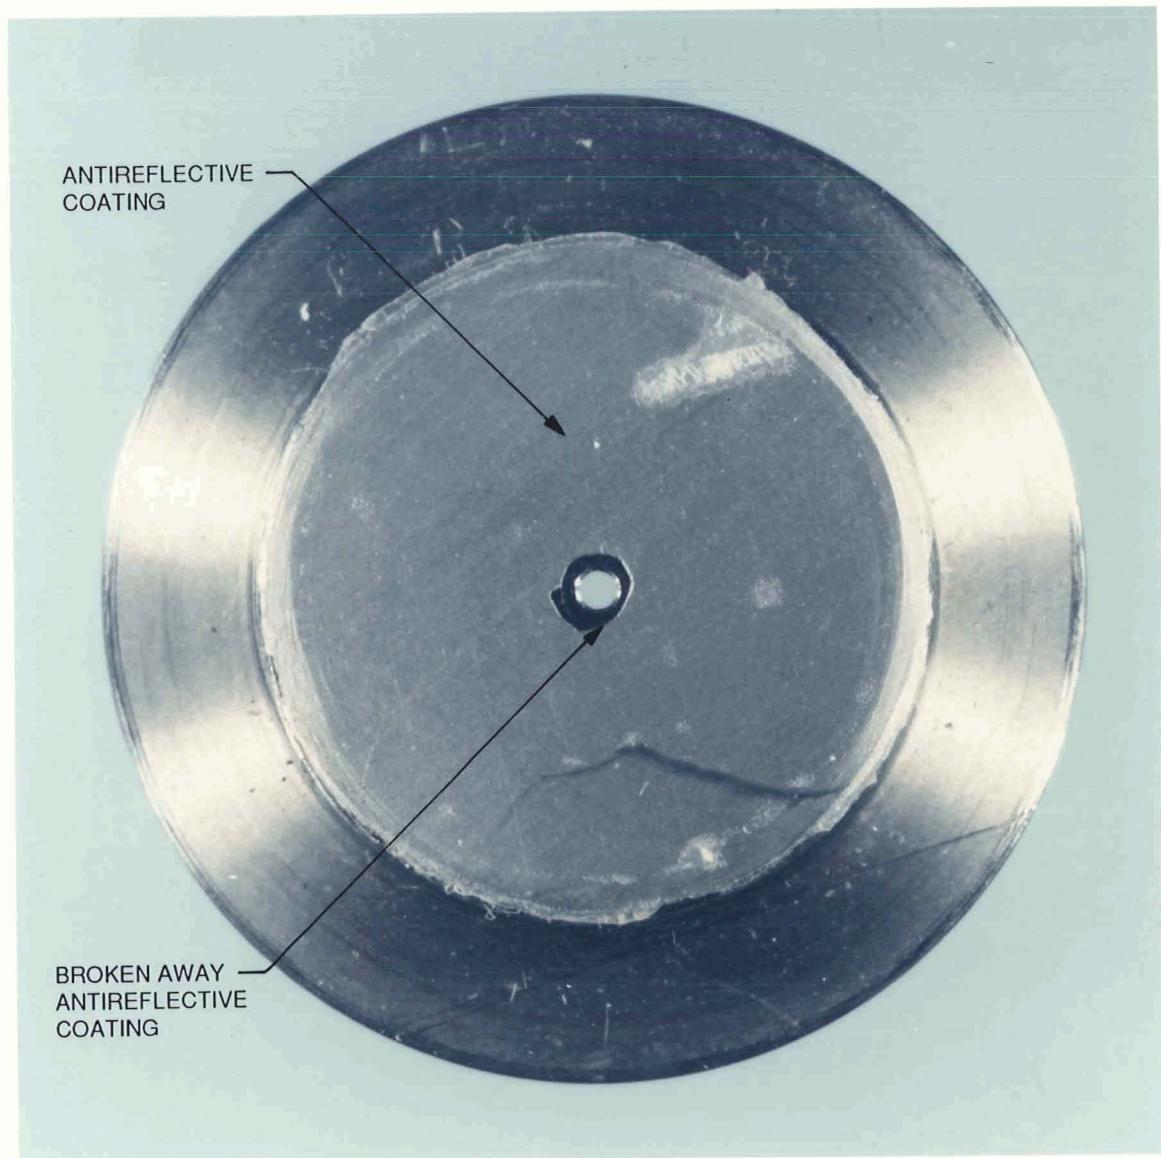
**Figure 7-5.** Top view of the field cap, showing the aperture and the area where the antireflective coating had broken away.
