# The Hubble Space Telescope Optical Systems Failure Report

November 1990

National Aeronautics and  
Space Administration

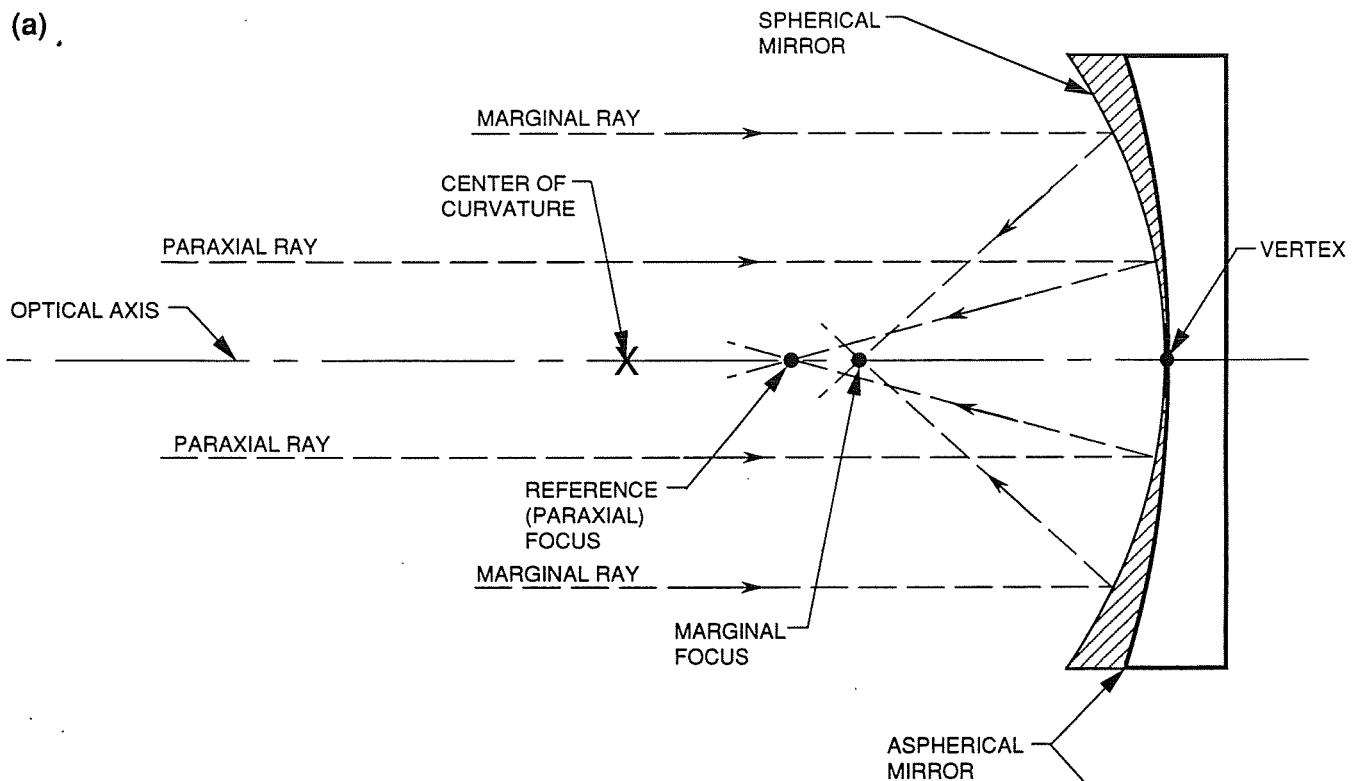
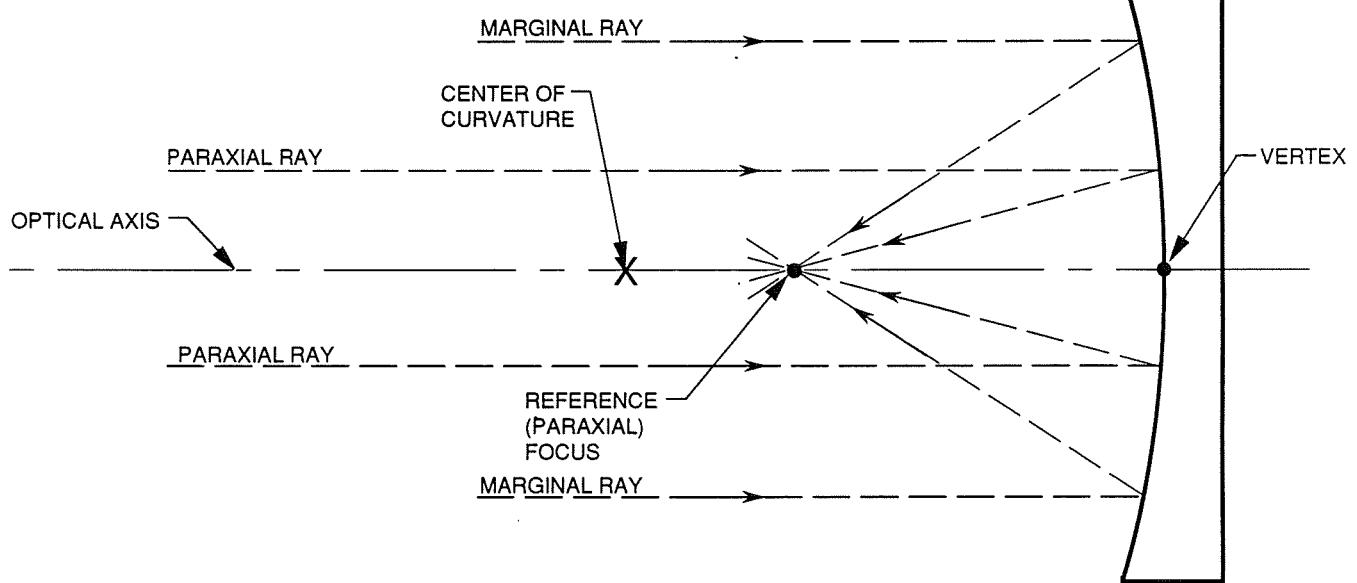
Figure C-1. Light-path comparison between spheric and aspheric mirrors.  
(a) The perfectly spherical mirror shows light reflecting to the two extreme foci, causing spherical aberration. (b) To remove this spherical aberration, an aspheric mirror is created by grinding down the edges of the mirror.

In the case of the HST, the "template" (the reflective null corrector) used to provide the reference surface for figuring the primary mirror, was not correct. In Figure C-4, we show an enlarged view of the marginal and paraxial rays as they converge in the vicinity of the vertex of the HST. Figure C-1 was used to show how the marginal focus could be superimposed on the paraxial focus by removing material. In the HST, too much material was removed from the outer edges of the primary mirror, and the marginal focus was moved to the right, past the paraxial focus. Since the marginal focus is to the right of the paraxial focus, the sign on the error is negative. Since more material than necessary was removed, the opticians call this situation "overcorrected" spherical aberration.

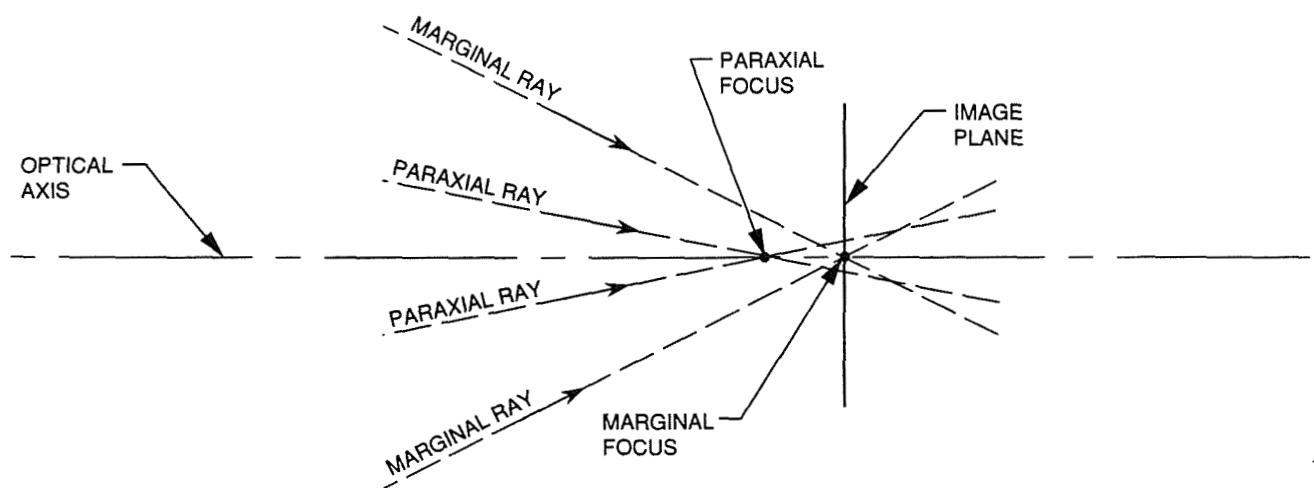
Figure C-4. Image-plane enlargement of the HST Ritchey-Chretien optical system. In the HST, too much material from the edges of the primary mirror was removed, and the marginal focus was moved past the paraxial focus. This is characteristic of an optical system overcorrected for spherical aberration.

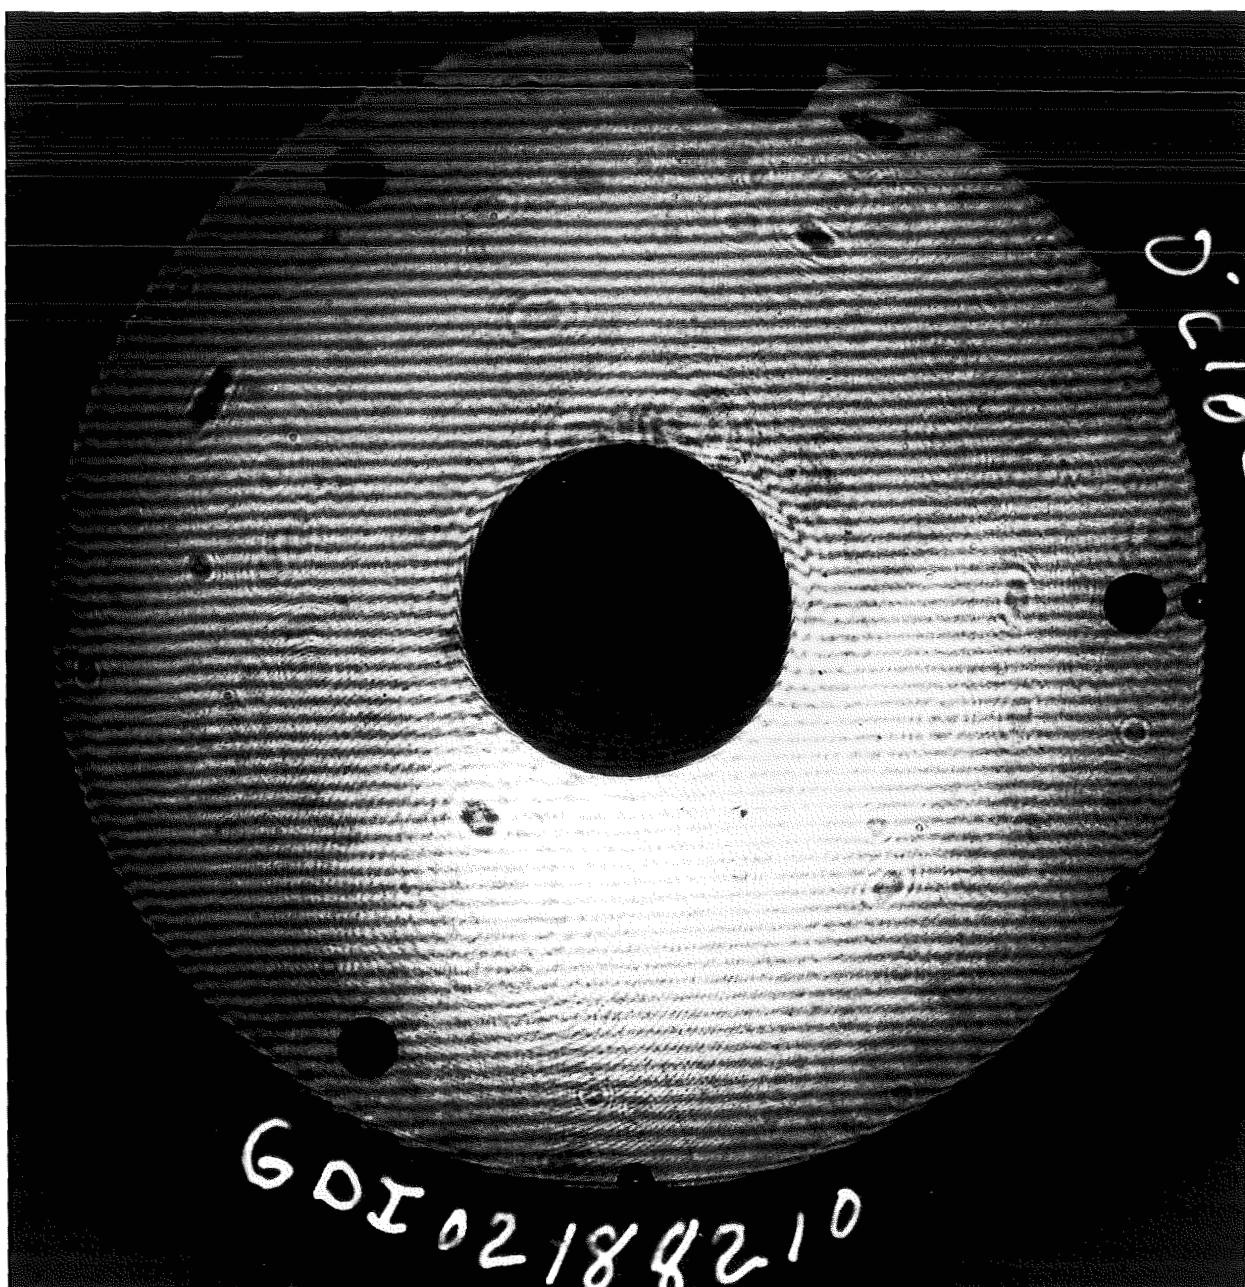
Figure D-1. RNC interferogram of the primary mirror, taken in February 1982.

This interferogram shows three circular obscurations that cover penetration holes in the mirror surface. The obscurations were not directly part of the mirror support system, but they covered catch plates that would keep the mirror from breaking loose of the mount and damaging portions of the space shuttle orbiter, should the shuttle have had to abort the flight and return to Earth in an emergency landing. The fringe pattern also indicates the presence of local, sharp surface errors that actually fall outside of the clear aperture being used in the telescope. The semicircular marks at the periphery are fiducials used to locate the aperture in the fringe digitization process. The other defects indicated in the picture are glass chips and marks attached to components in the reflective null corrector.

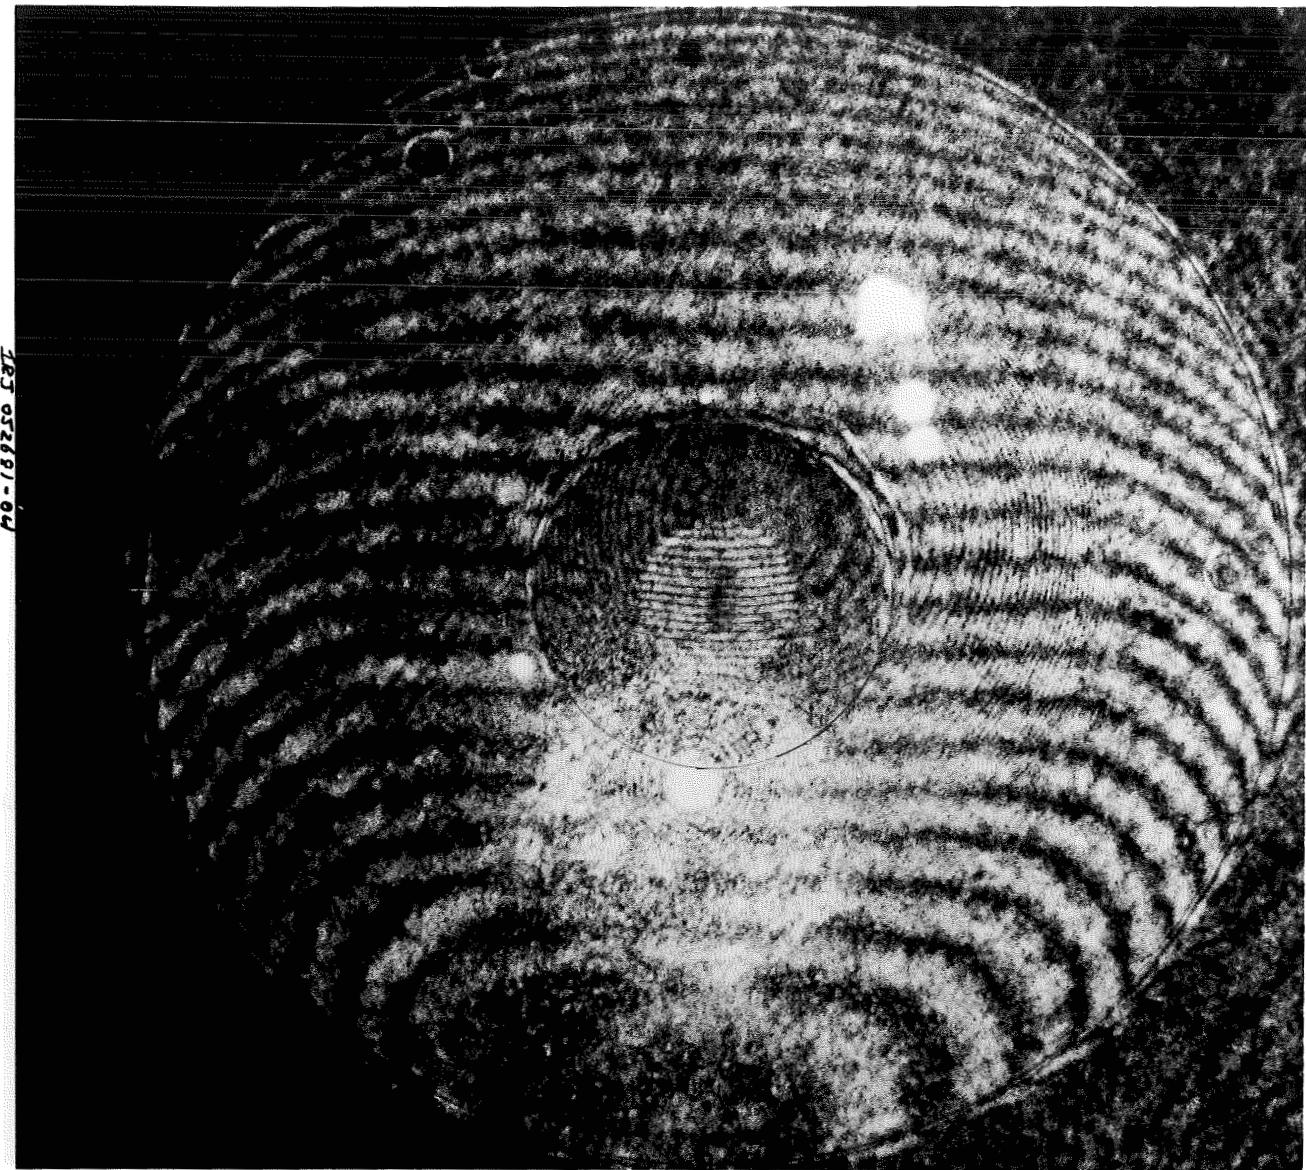
**Figure D-2. RvNC interferogram of the primary mirror, taken in May 1981.**

The consistency of the data from the INC and the RvNC indicates the presence of the error in the RNC. The excellent agreement of the INC data taken in 1981 and similar data taken in 1990 indicates the excellent stability of the RNC.

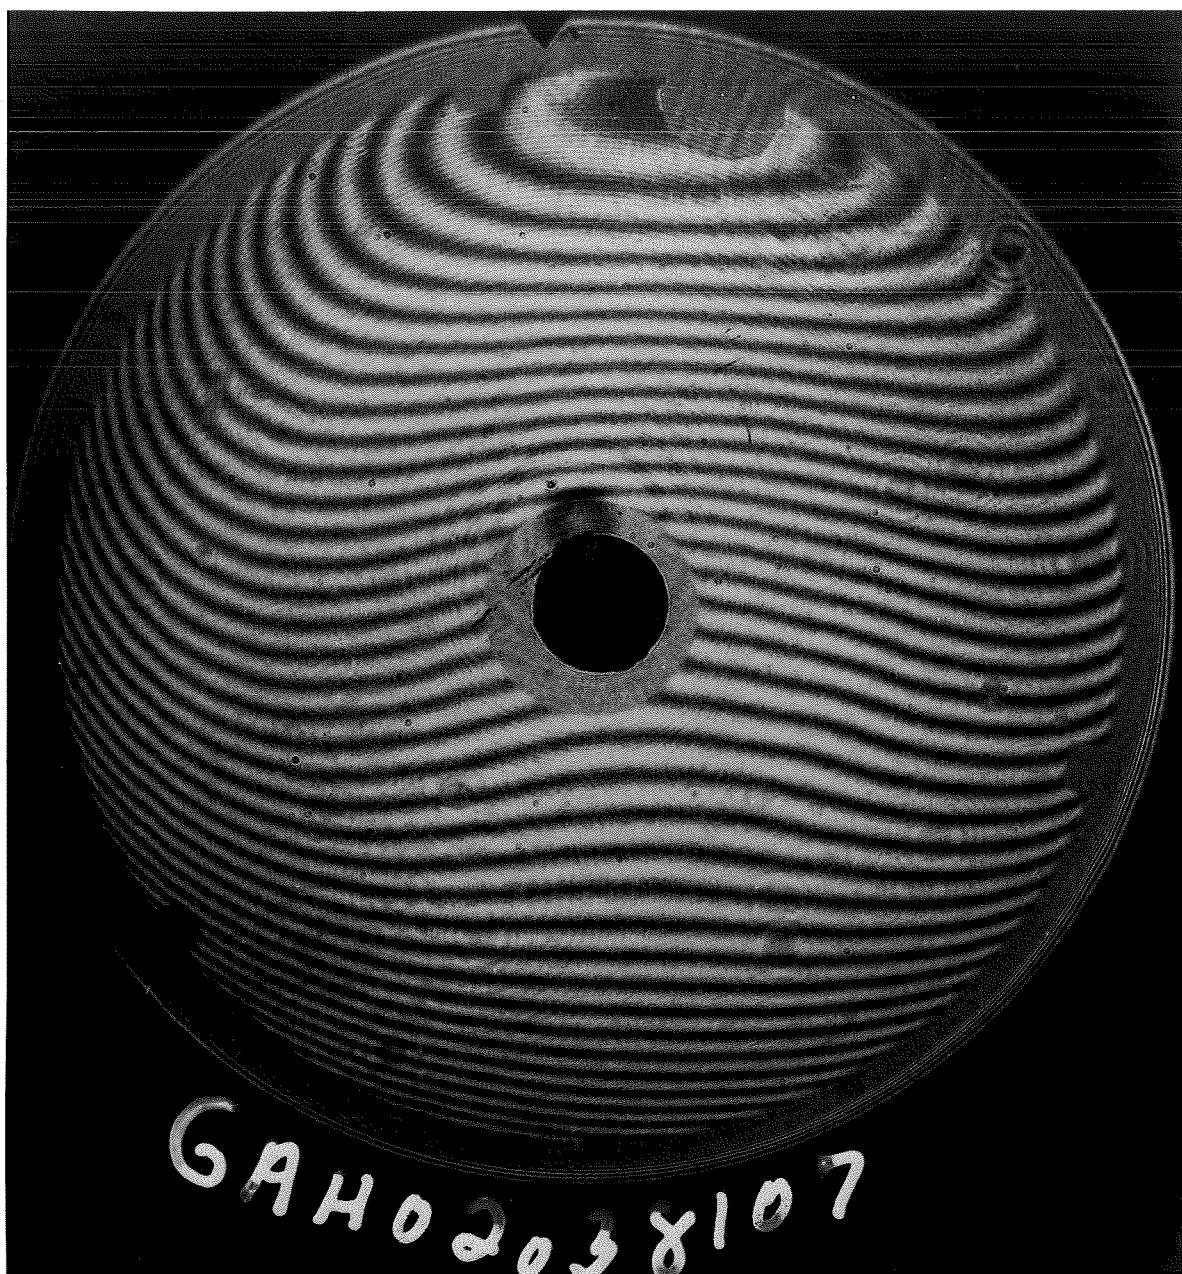
The final test data for the primary mirror, obtained using the reflective null corrector, indicated that the mirror exceeded the specifications. The Board found interferograms relating to the RvNC test (found in Appendix D), which indicated a surface-figure error of about the right magnitude and sign to explain the errors existing in the operational telescope. Since a perfectly polished mirror would have shown no error on either null corrector, it was evident to the Board that an error actually existed in the RNC.

**Figure D-3. INC interferogram of the reflective null corrector, taken in February 1981.**
