Overview				Site
Inspect No:	1033	Page:	1/1	AECOM - MIDLANDS HUB
Job No:	10012			
Customer:	AECOM			
Contact:	Rob Bewick	Date	21/03/2023	Drift Drive Crick Northamptonshire NN6 7GZ
Tel:	7553 226429

Client-ID	Make / Model	Serial No	ISI Equipment No
Vehicle wash	Vehicle Wash HGV		300244

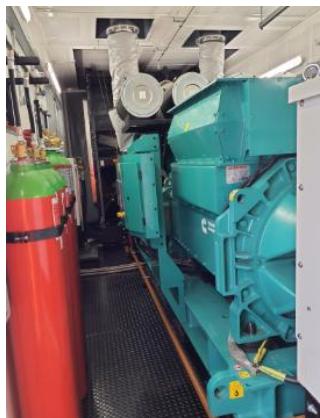
Asset Photograph	
Capture photograph of Asset, including asset number	See Photo 1
Hazard Priority and Findings	
Intolerable - Defects requiring immediate action	None
Substantial - Defects requiring attention within a time period	None
Moderate - Other defects requiring attention	None
Tolerable - Observations	Genset: Stamford HVSI804W2, S/n: C21B073097. Prime mover: Cummins QSK60-G23, engine no. 33226149

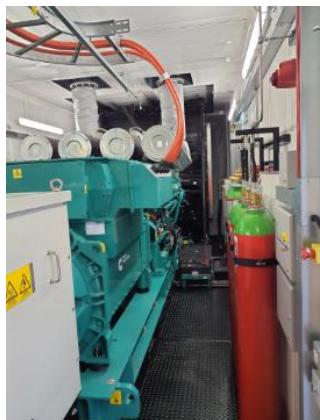
Asset Photograph	
Capture photograph of Asset, including asset number	See Photo 1
Hazard Priority and Findings	
Intolerable - Defects requiring immediate action	None
Substantial - Defects requiring attention within a time period	None
Moderate - Other defects requiring attention	None
Tolerable - Observations	Genset: Stamford HVSI804W2 s/n: C21G306259. Prime mover: Cummins QSK60-G23, engine no. 33226186

Fuel shut offs, emergency stop, remote fire suppression systems, guarding, signage, earthing and insulation all verified.

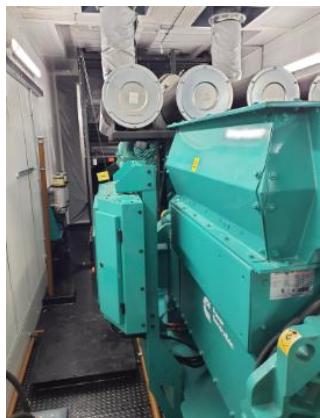
Asset Photograph	
Capture photograph of Asset, including asset number	See Photos 1 & 2
Hazard Priority and Findings	
Intolerable - Defects requiring immediate action	None
Substantial - Defects requiring attention within a time period	None
Moderate - Other defects requiring attention	None
Tolerable - Observations	Genset: Stamford HVSI804W2 s/n: C21B073096. Prime mover: QSK60-G23 engine no: 33226137

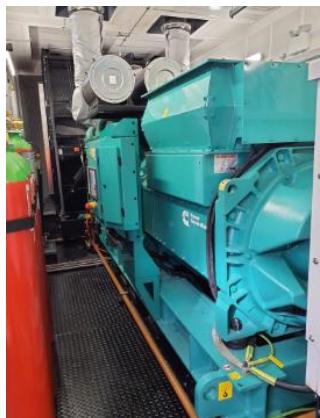
Asset Photograph	
Capture photograph of Asset, including asset number	See Photos 1 & 2
Hazard Priority and Findings	
Intolerable - Defects requiring immediate action	None
Substantial - Defects requiring attention within a time period	None
Moderate - Other defects requiring attention	None
Tolerable - Observations	Genset: Stamford HVSI804W2 s/n: C21G306260. Prime kover: Cummins QSK60-G23 engine no: 33226185

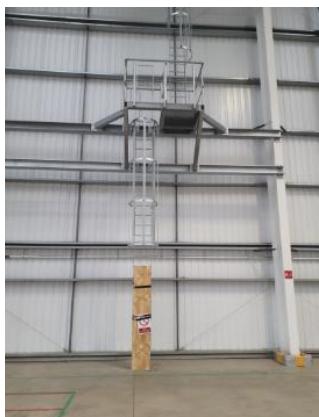
## Fail

Asset Photograph	
Capture photograph of Asset, including asset number	See Photo 1
Hazard Priority and Findings	
Intolerable - Defects requiring immediate action	Missing horizontal rungs at first rest platform. Installation is not compliant with BS4211
Substantial - Defects requiring attention within a time period	None
Moderate - Other defects requiring attention	None
Tolerable - Observations	None
