## Missing eye protection

AI-assisted photographic hazard assessment · Conveyor C3

| PLANT / UNIT<br><b>SSO Ranchi</b> | DEPARTMENT<br><b>Safety</b> | LOCATION<br><b>Conveyor C3</b> | DATE & TIME<br><b>03 Oct 2026, 11:48</b> |

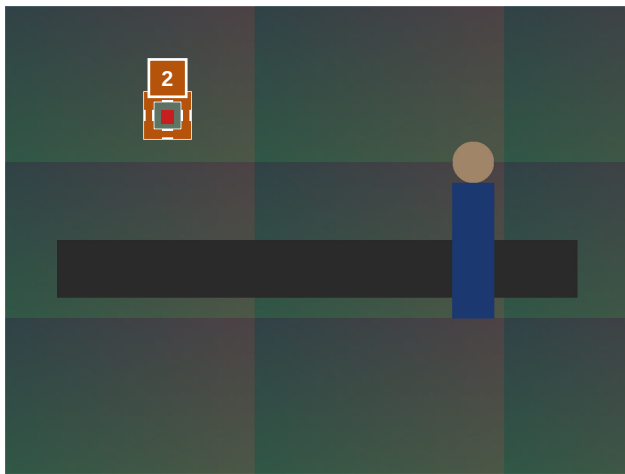
2 hazard(s) - 1 marked on photo, 1 not locatable in this view

Worker near running conveyor without eye protection; a small exposed item on the left.

| # | HAZARD | SEVERITY | DESCRIPTION | REGULATION | CORRECTIVE ACTION |
|---|---|---|---|---|---|
| 1 | Missing eye protection<br><i>not marked on photo</i> | <b>HIGH</b> | Worker beside the conveyor without goggles. | FA 1948 S35 | Issue goggles. |
| 2 | Exposed sharp item | <b>MEDIUM</b> | Small exposed item on the bench. | IS 14489 | Remove. |
