## Missing eye protection

AI-assisted photographic hazard assessment · Conveyor C3

| PLANT / UNIT<br><b>SSO Ranchi</b> | DEPARTMENT<br><b>Safety</b> | LOCATION<br><b>Conveyor C3</b> | DATE & TIME<br><b>03 Oct 2026, 11:48</b> |

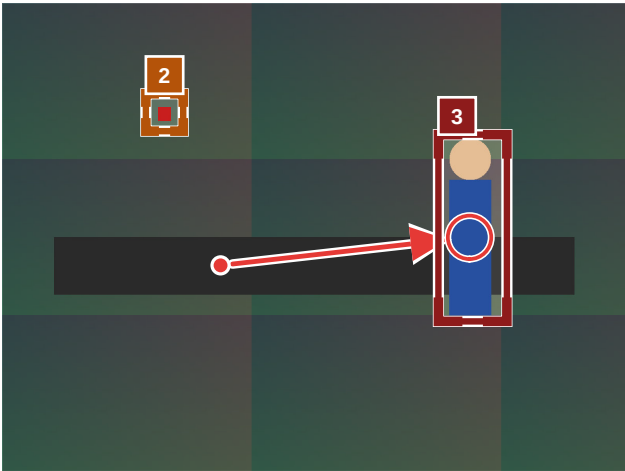
**LINE OF FIRE** (red arrow / dashed zone on photo)  
— 3 conveyor belt -> worker

3 hazard(s) - 2 marked on photo, 1 not locatable in this view

**SUMMARY**  
Worker near running conveyor without eye protection; a small exposed item on the left.

2  
Exposed sharp item

3  
Worker in line of fire of running

| # | HAZARD | SEVERITY | DESCRIPTION | REGULATION | CORRECTIVE ACTION |
|---|---|---|---|---|---|
| 1 | Missing eye protection<br><i>not marked on photo</i> | HIGH | Worker beside the conveyor without goggles. | FA 1948 S35 | Issue goggles. |
| 2 | Exposed sharp item | MEDIUM | Small exposed item on the bench. | IS 14489 | Remove. |
| 3 | Worker in line of fire of running conveyor<br><b>LINE OF FIRE</b> | CRITICAL | Worker standing next to the running conveyor belt nip point. | FA 1948 S21 | Guard the conveyor; barricade. |
