## AI Hazard Scan: Unsecured LPG cylinder on cart

AI-assisted photographic hazard assessment

## DSP - Durgapur Steel Plant

REF. 17911077

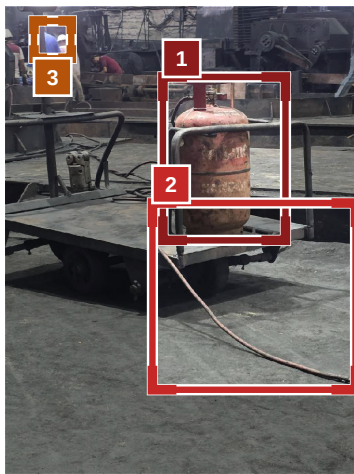
The image shows a rusty red LPG cylinder on a wheeled flatbed cart with a hose trailing across the floor. Workers are visible in the background near heavy machinery. The primary hazard is the unsecured transport of a pressurized gas cylinder on a mobile cart, with the hose draped across a walking area.

| # | HAZARD | SEVERITY | DESCRIPTION | REGULATION | CORRECTIVE ACTION |
|---|---|---|---|---|---|
| 1 | Unsecured LPG cylinder on cart | CRITICAL | Visible: A large, rusty red LPG cylinder stands on a flatbed wheeled cart, held only by a thin metal hoop frame. It is not chained, strapped, or bolted to the cart. If the cart moves or tips, the cylinder can fall, roll, or drag its hose, causing a gas leak or physical impact. | SMPV Rules 2016 Rule 14 | Immediately remove the cylinder from the cart, place it in an upright, chained, segregated storage rack, or use dedicated clamps/straps to secure it to the cart before any movement. |
| 2 | Hose trailing across walkway | HIGH | Visible: A long, flexible gas hose extends from the cylinder valve, drapes over the edge of the cart, and lies loose across the dark concrete floor, spanning towards the bottom right. This creates a severe trip hazard for workers moving between the foreground and background machinery. | FA 1948 S32 | Coil the excess hose neatly, secure it to the cart frame, and route any remaining length along the wall or designated conduit, ensuring no part lies across the active walking path. |
| 3 | Worker missing chin strap on helmet | MEDIUM | Visible: The worker in the blue shirt (mid-left background, id 2) wears a white hard hat, but the chin strap is not fastened under the chin. The strap is loose or missing, leaving the helmet vulnerable to falling off during a slip, trip, or impact. | IS 2925:1984 | Instruct the worker to fasten the chin strap securely under the jaw before entering the work area. Conduct a brief PPE compliance check for all personnel in the bay. |
