## AI Hazard Scan: Unsecured LPG cylinder on cart

AI-assisted photographic hazard assessment · Blast Furnace Road, Durgapur Steel Plant, Durgapur

## DSP - Durgapur Steel Plant

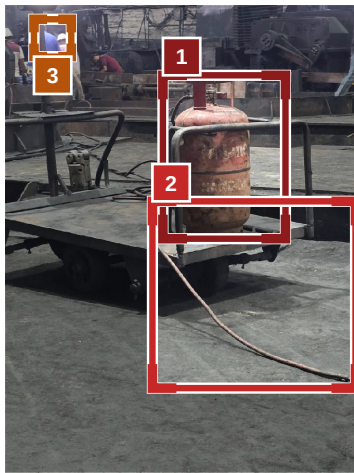
The image shows a rusty red LPG cylinder on a wheeled flatbed cart with a hose trailing across the floor. Workers are visible in the background near heavy machinery. The primary hazard is the unsecured transport of a pressurized gas cylinder on a mobile cart, with the hose draped across a walking area.

| # | HAZARD | SEVERITY | DESCRIPTION | REGULATION | CORRECTIVE ACTION |
|---|---|---|---|---|---|
| 1 | Unsecured LPG cylinder on cart | CRITICAL | Visible: A large, rusty red LPG cylinder stands on a flatbed wheeled cart, held only by a thin metal hoop frame. It is not chained, strapped, or bolted to the cart. If the cart moves or tips, the cylinder can fall, roll, or drag its hose, causing a gas leak or physical impact. | SMPV Rules 2016 Rule 14 | Immediately remove the cylinder from the cart, place it in an upright, chained, segregated storage rack, or use dedicated clamps/straps to secure it to the cart before any movement. |
| 2 | Hose trailing across walkway | HIGH | Visible: A long, flexible gas hose extends from the cylinder valve, drapes over the edge of the cart, and lies loose across the dark concrete floor, spanning towards the bottom right. This creates a severe trip hazard for workers moving between the foreground and background machinery. | FA 1948 S32 | Coil the excess hose neatly, secure it to the cart frame, and route any remaining length along the wall or designated conduit, ensuring no part lies across the active walking path. |
| 3 | Worker missing chin strap on helmet | MEDIUM | Visible: The worker in the blue shirt (mid-left background, id 2) wears a white hard hat, but the chin strap is not fastened under the chin. The strap is loose or missing, leaving the helmet vulnerable to falling off during a slip, trip, or impact. | IS 2925:1984 | Instruct the worker to fasten the chin strap securely under the jaw before entering the work area. Conduct a brief PPE compliance check for all personnel in the bay. |
