# WIND TURBINE INSPECTION REPORT

Autonomous Drone Inspection System

| Turbine ID | TRB-001 |

Overall Status: Moderate damage detected

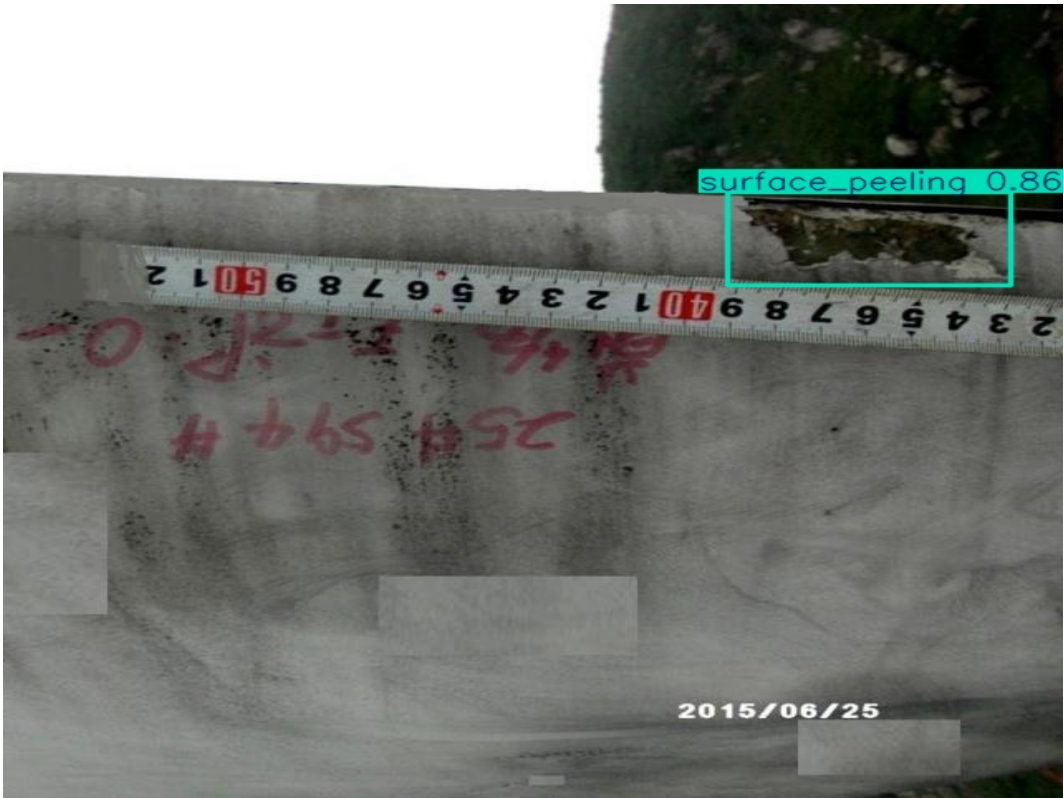
259\_jpg.rf.081ad309b23492e8a32df81c073f0b58.j  
pg

Score: 1.29 / 10

| Defect Type | Confidence | Bounding Box |
|---|---|---|
| surface_peeling | 85.7% | (438, 152) -> (609, 227) |

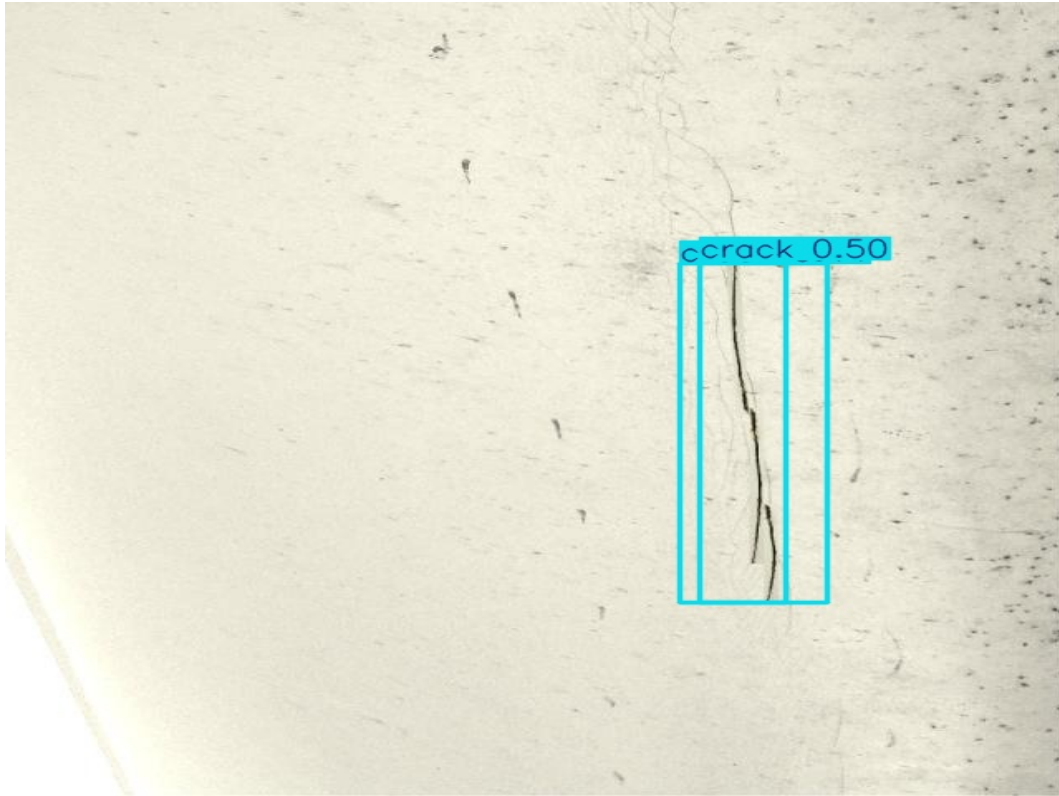
838\_jpg.rf.37ce3355ff5e427c21579c31b61f2ace.jp  
g

Score: 2.83 / 10

| Defect Type | Confidence | Bounding Box |
|---|---|---|
| crack | 50.5% | (419, 207) -> (472, 483) |
| crack | 44.0% | (408, 210) -> (496, 484) |

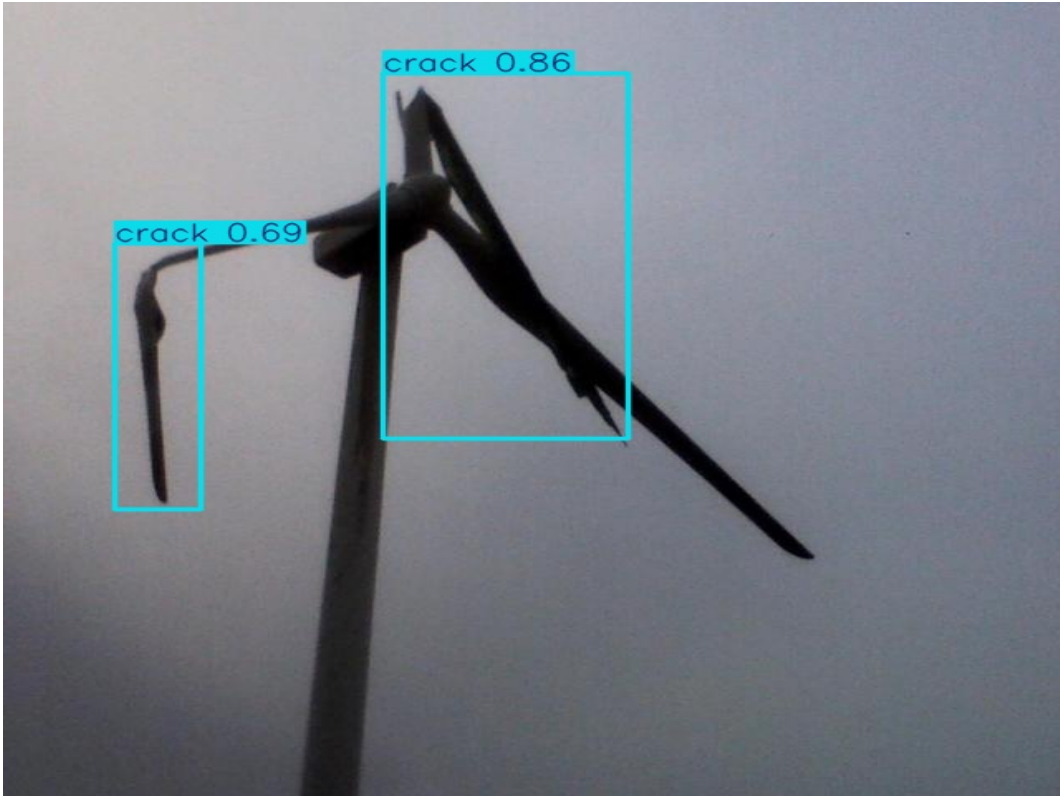
89\_jpg.rf.d79f8dd8d756a6eb057d208d43434fa1.jpg

Score: 4.64 / 10

| Defect Type | Confidence | Bounding Box |
|---|---|---|
| crack | 86.2% | (230, 57) -> (378, 352) |
| crack | 68.5% | (68, 194) -> (120, 409) |

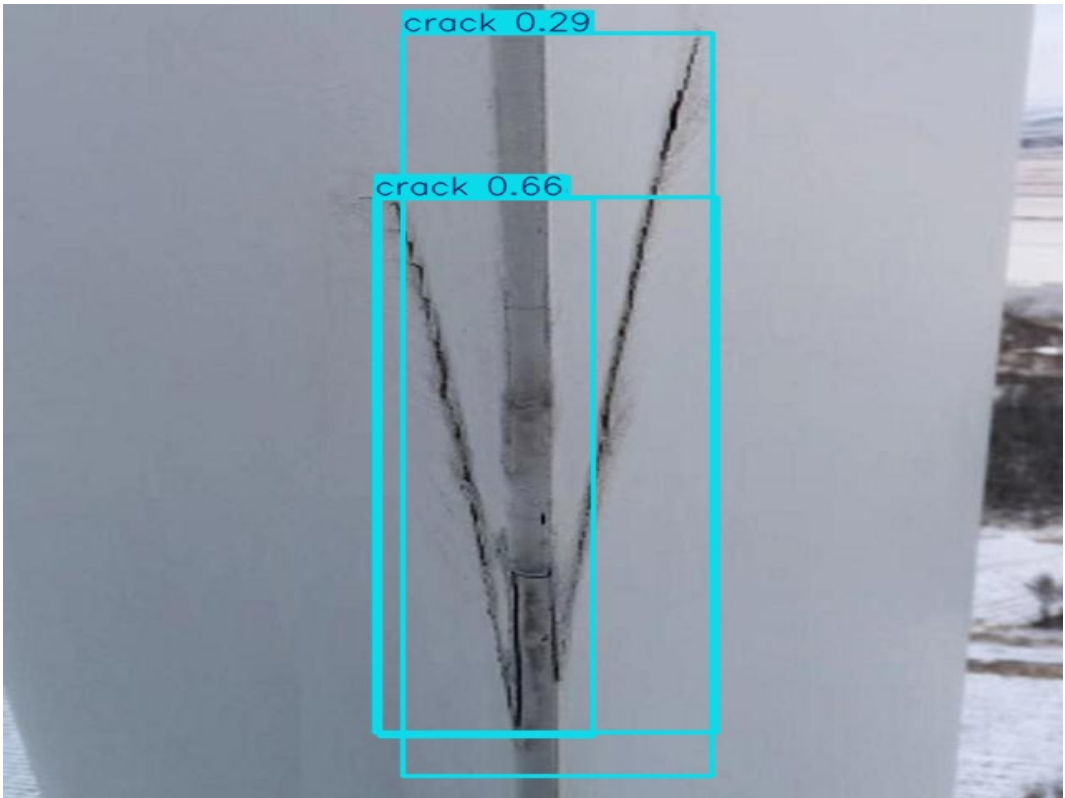
615\_jpg.rf.c190fbf68271cc43b47e2df2355fc061.jpg

Score: 4.54 / 10

| Defect Type | Confidence | Bounding Box |
|---|---|---|
| crack | 56.5% | (227, 156) -> (357, 590) |
| crack | 29.4% | (242, 24) -> (429, 621) |

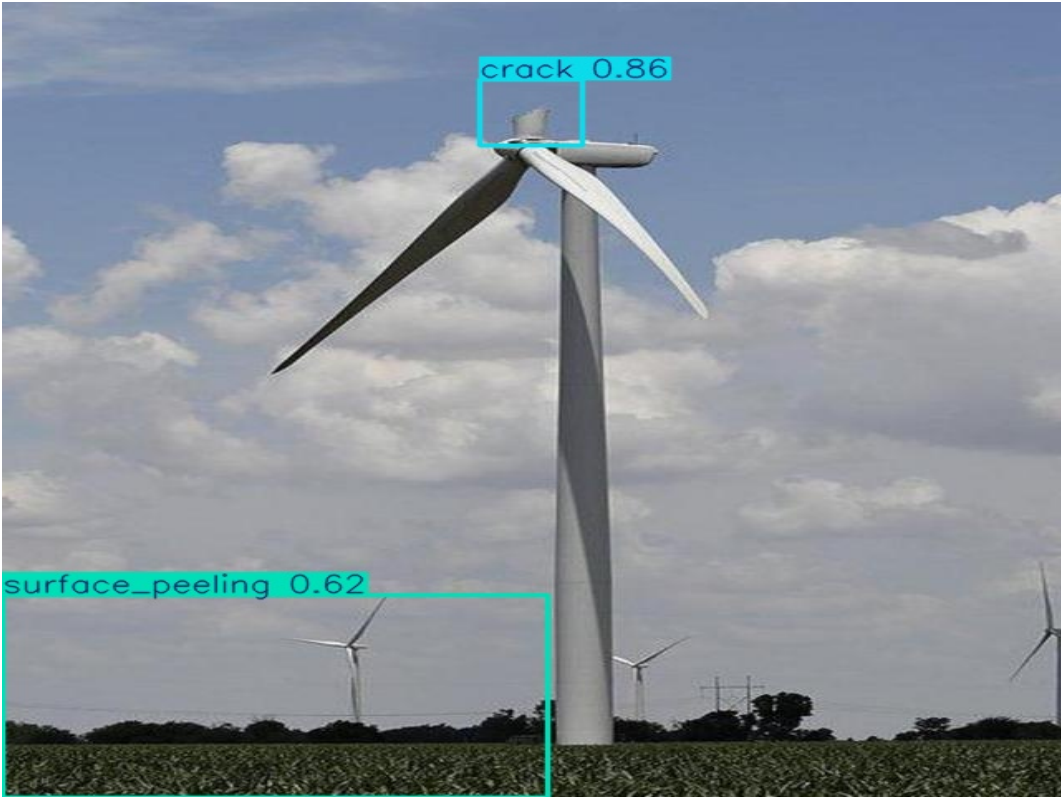
252\_jpg.rf.ff4834a1fbc83bc2d8bc36cac58db224.jpg

Score: 3.51 / 10

| Defect Type | Confidence | Bounding Box |
|---|---|---|
| crack | 85.7% | (288, 63) -> (350, 116) |
| surface_peeling | 62.4% | (0, 478) -> (330, 640) |

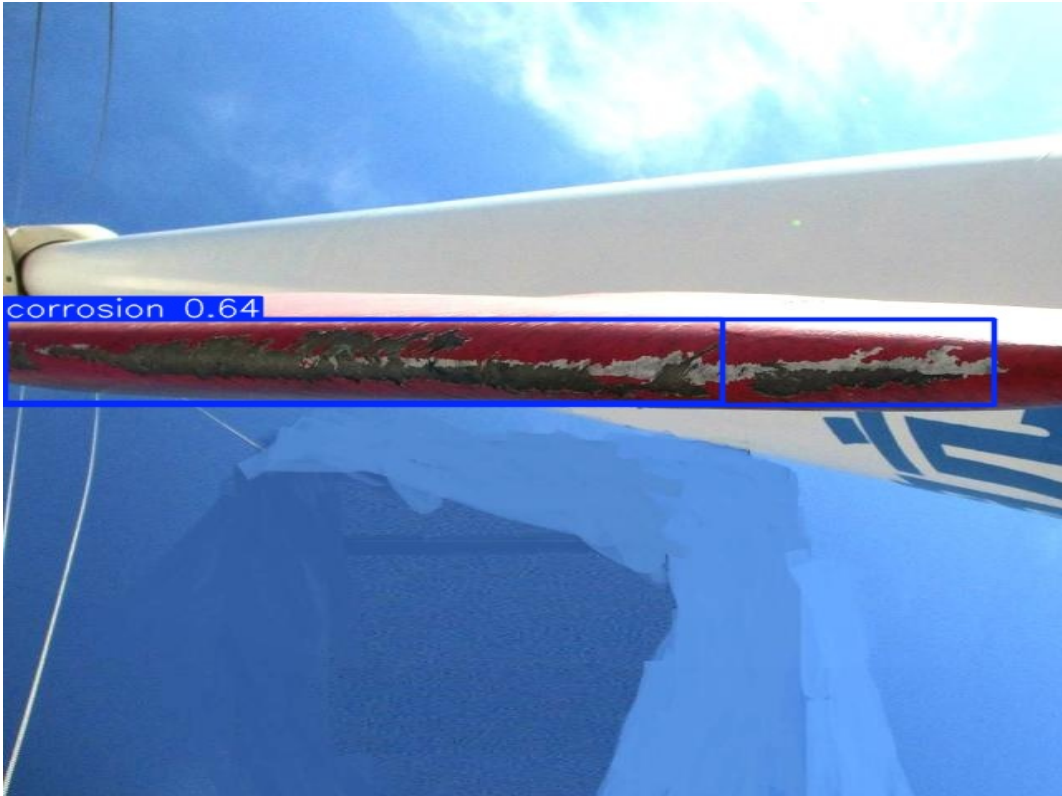
882\_jpg.rf.02d2d3ded834a4717897250516e9b66d.  
jpg

Score: 2.27 / 10

| Defect Type | Confidence | Bounding Box |
|---|---|---|
| corrosion | 64.4% | (1, 256) -> (435, 322) |
| corrosion | 49.2% | (0, 256) -> (599, 325) |

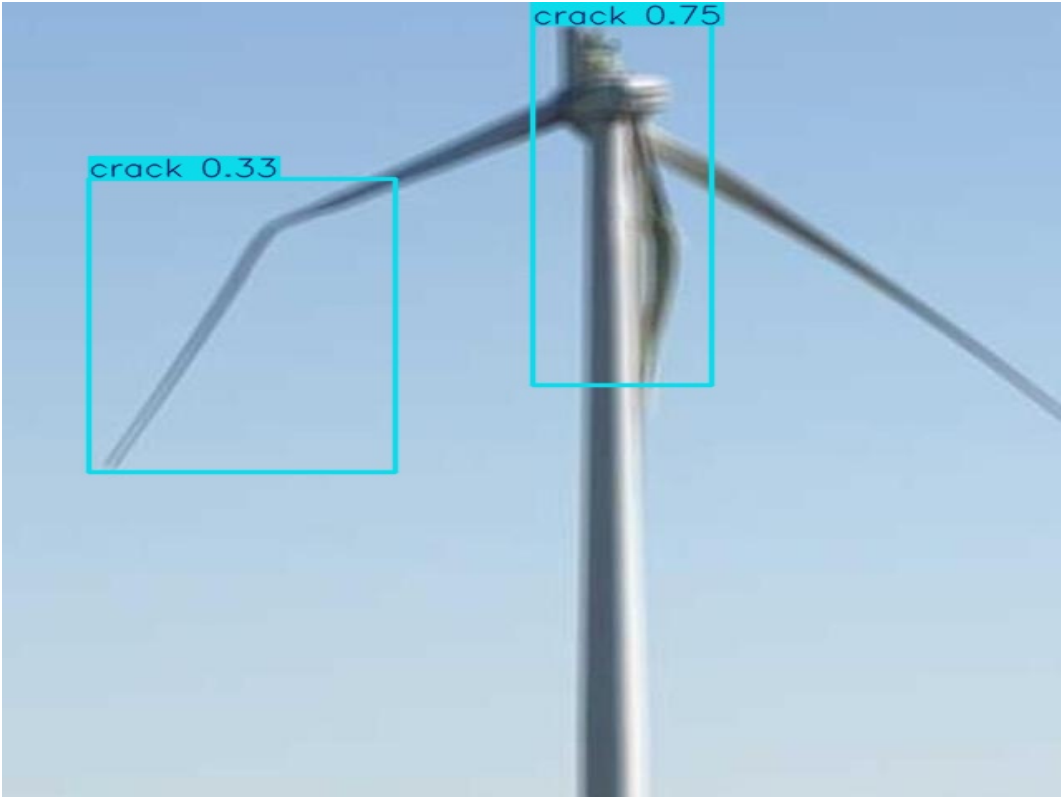
582\_jpg.rf.461894dea6de79ed41c33e8d344e1325.jpg

Score: 3.25 / 10

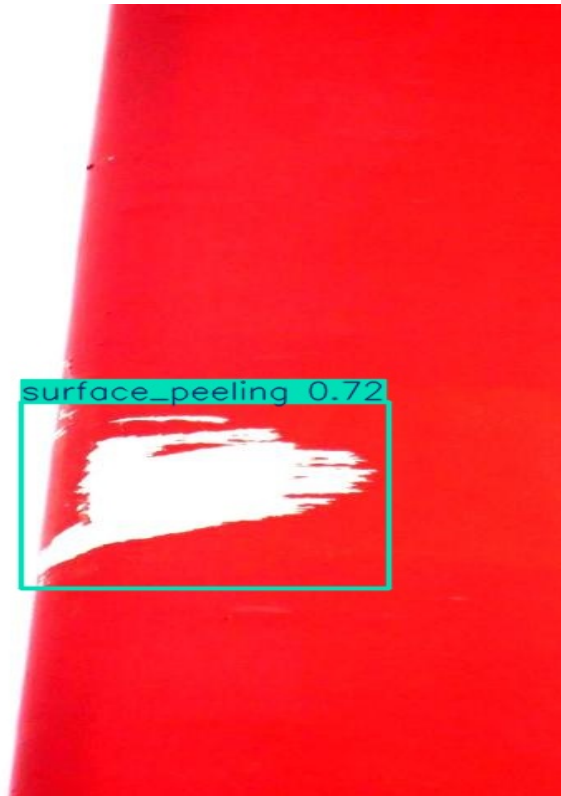
873\_jpg.rf.38c7240e4ab98b9b3b6d4972f645fb8a.jpg

Score: 1.08 / 10

Minor wear

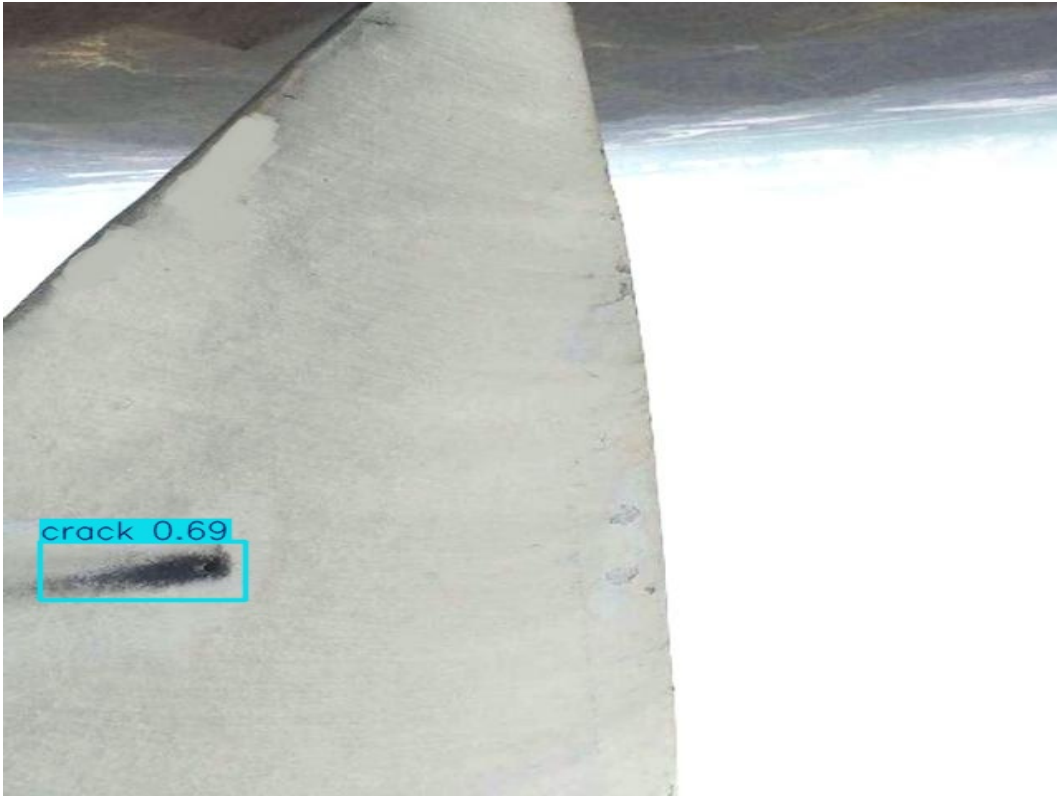
1006\_jpg.rf.6bf0d7ea8e3205f8cba24a8738a711d5.jpg

Score: 2.06 / 10

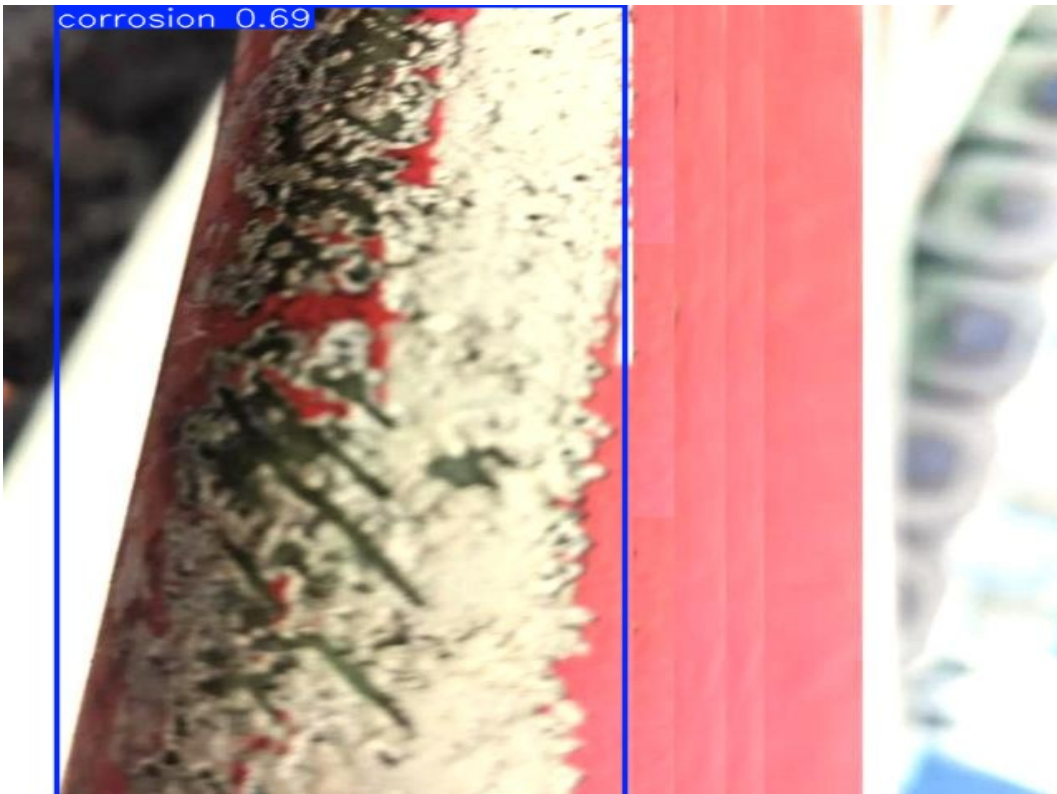
1043\_jpg.rf.629ecc948fc391175b036f808c48a6ce.  
jpg

Score: 1.39 / 10

Minor wear

| Defect Type | Confidence | Bounding Box |
|---|---|---|
| corrosion | 69.4% | (32, 0) -> (375, 639) |

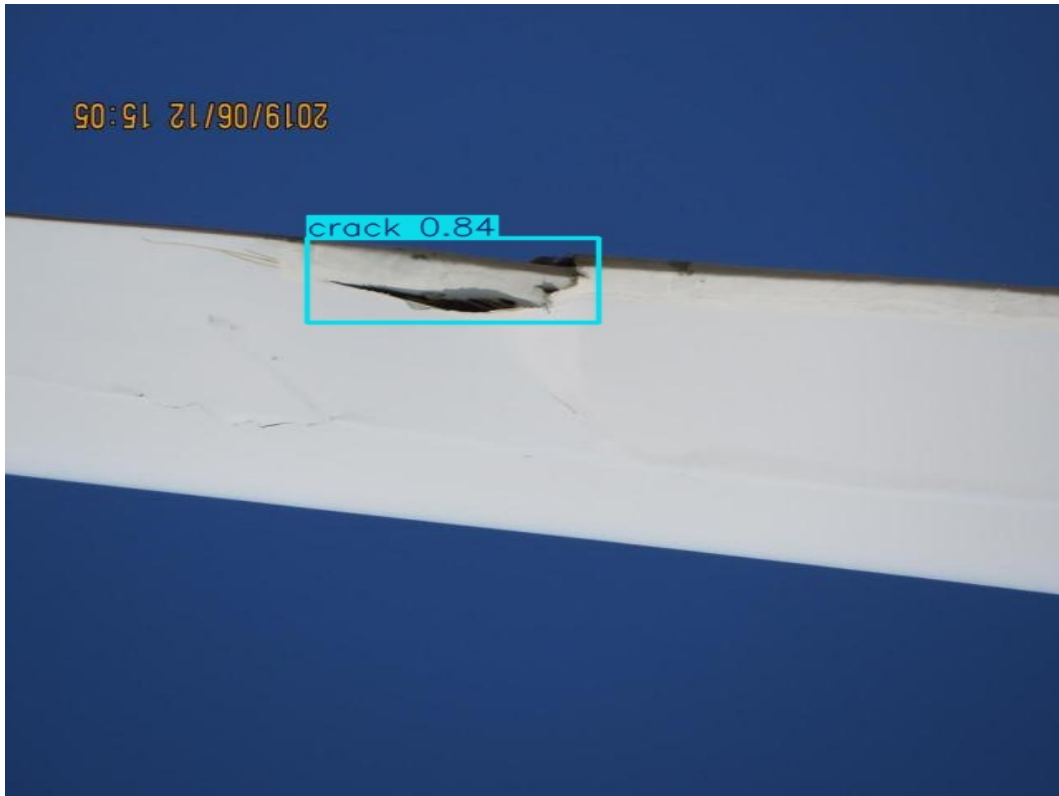
166\_jpg.rf.6ac17179a30cefdf25db529c5c09d98b.jpg

Score: 2.52 / 10

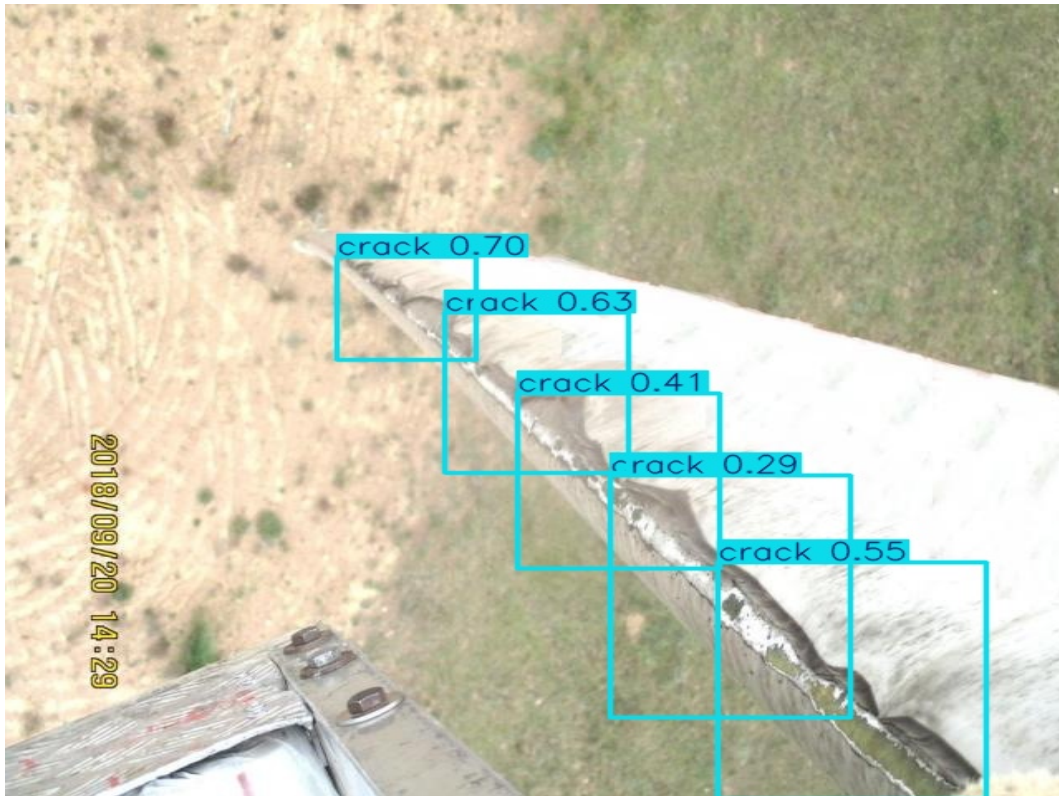
139\_jpg.rf.ca04b2d9950a452113d51716dc5ca21a.jpg

Score: 7.73 / 10

| Defect Type | Confidence | Bounding Box |
|---|---|---|
| crack | 41.5% | (310, 313) -> (431, 454) |
| crack | 29.2% | (365, 380) -> (510, 575) |

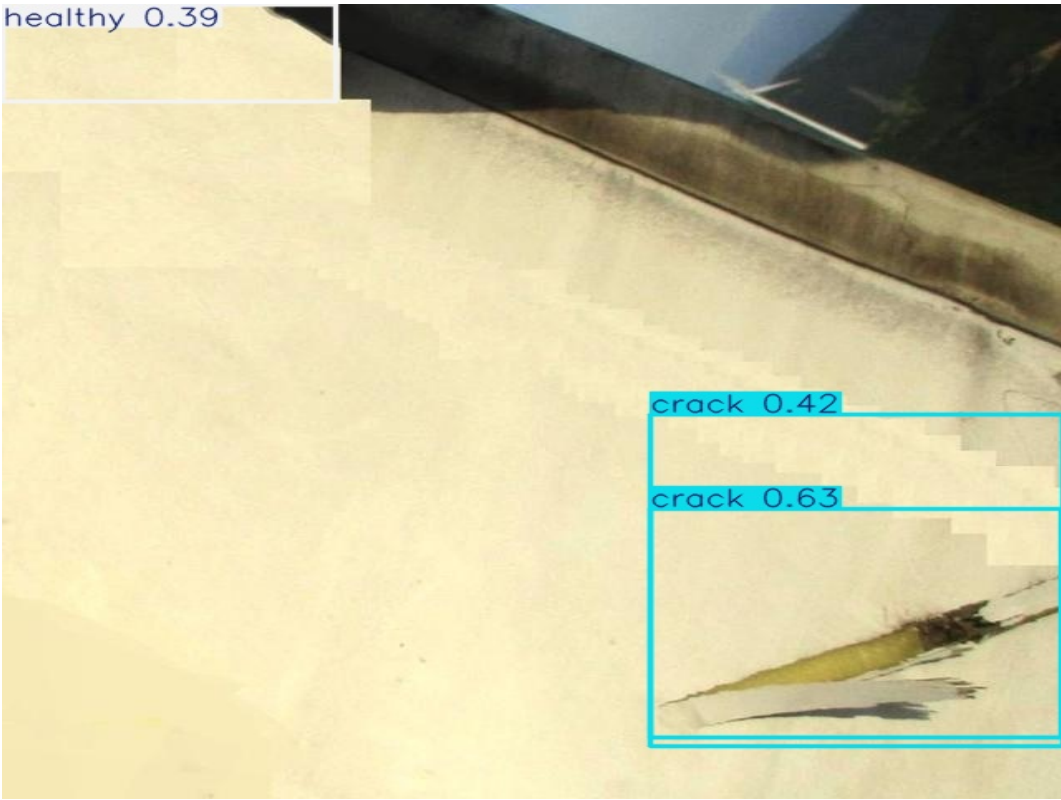
908\_jpg.rf.1627da4d4f716cbea7ff5aadaa72da39.jpg

Score: 3.16 / 10

| Defect Type | Confidence | Bounding Box |
|---|---|---|
| crack | 63.3% | (391, 407) -> (640, 590) |
| crack | 42.1% | (391, 331) -> (640, 598) |

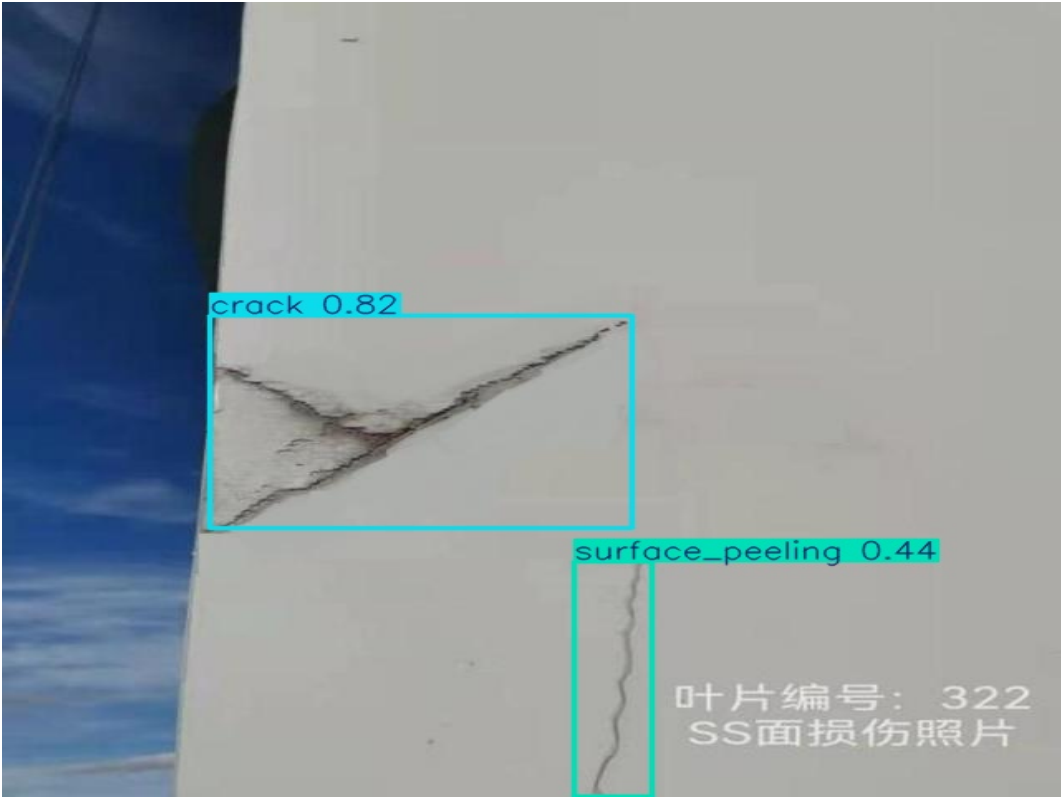
648\_jpg.rf.2d86b6e4728e1f2e6770c5cd25c3dd78.jpg

Score: 3.11 / 10

| Defect Type | Confidence | Bounding Box |
|---|---|---|
| crack | 81.8% | (126, 252) -> (381, 424) |
| surface_peeling | 43.6% | (345, 450) -> (392, 639) |

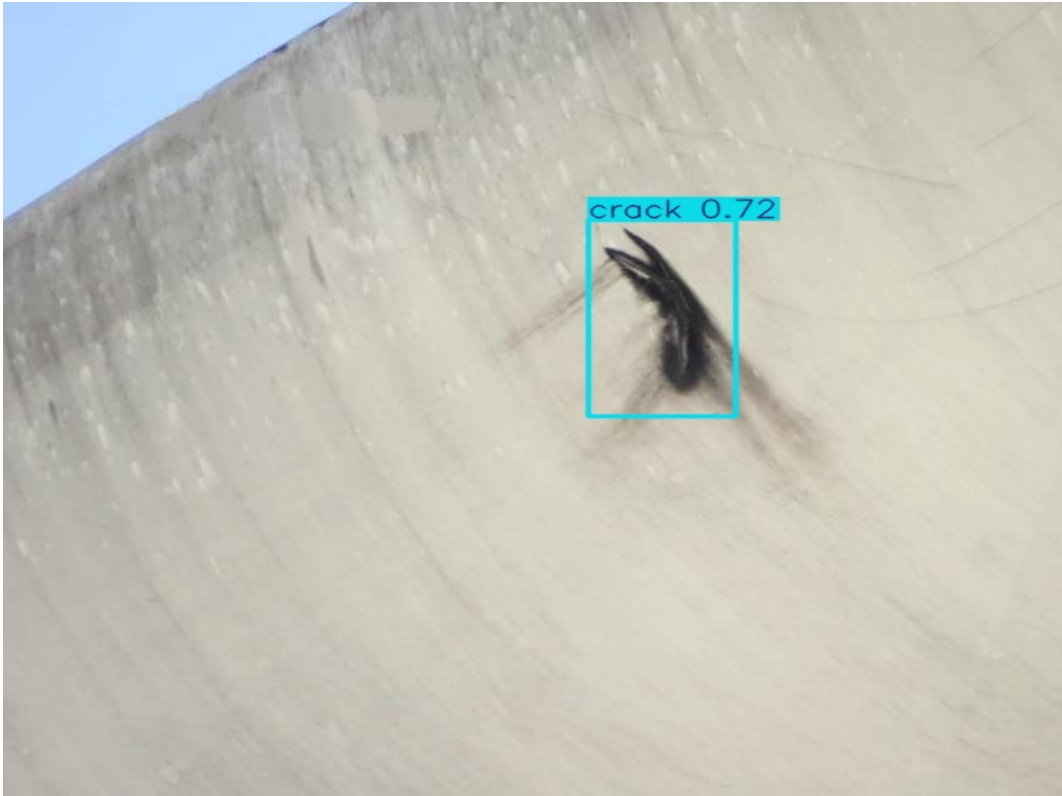
854\_jpg.rf.d86cb7d756bd088f4441cf30ad747ca3.jpg

Score: 2.17 / 10

| Defect Type | Confidence | Bounding Box |
|---|---|---|
| crack | 72.3% | (354, 175) -> (443, 333) |

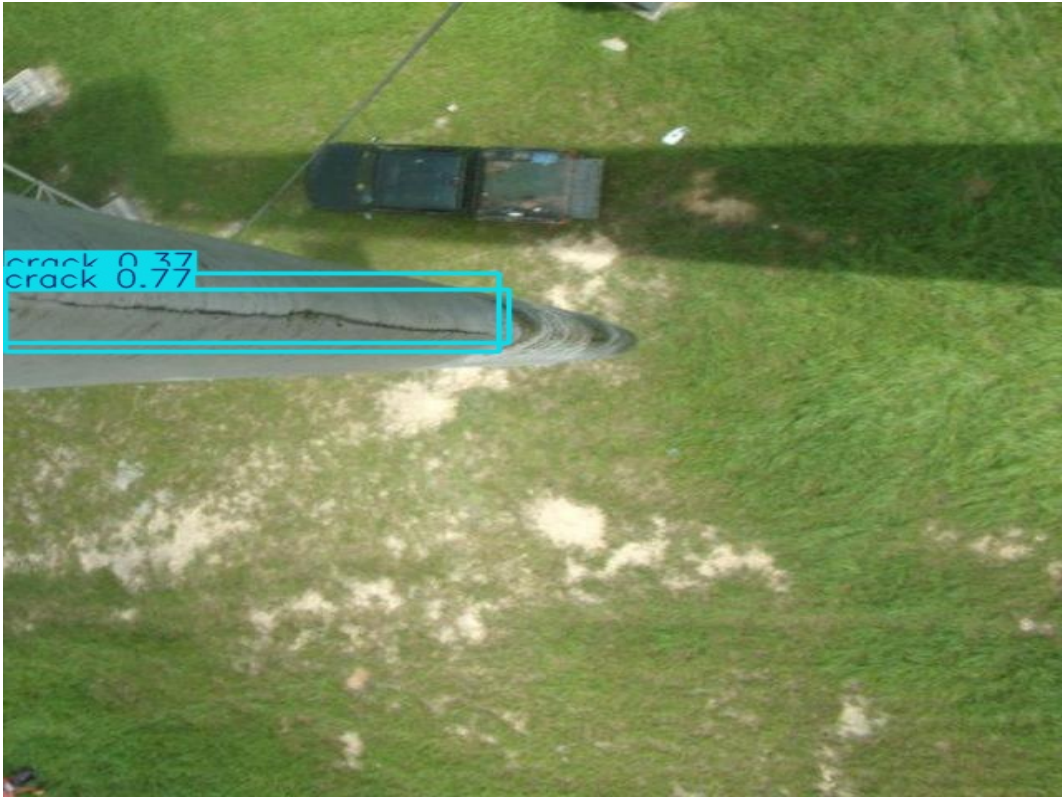
209\_jpg.rf.e4d5f11a36a6178c09861e843db34c56.jpg

Score: 3.42 / 10

| Defect Type | Confidence | Bounding Box |
|---|---|---|
| crack | 76.8% | (0, 231) -> (306, 274) |
| crack | 37.3% | (1, 218) -> (299, 282) |

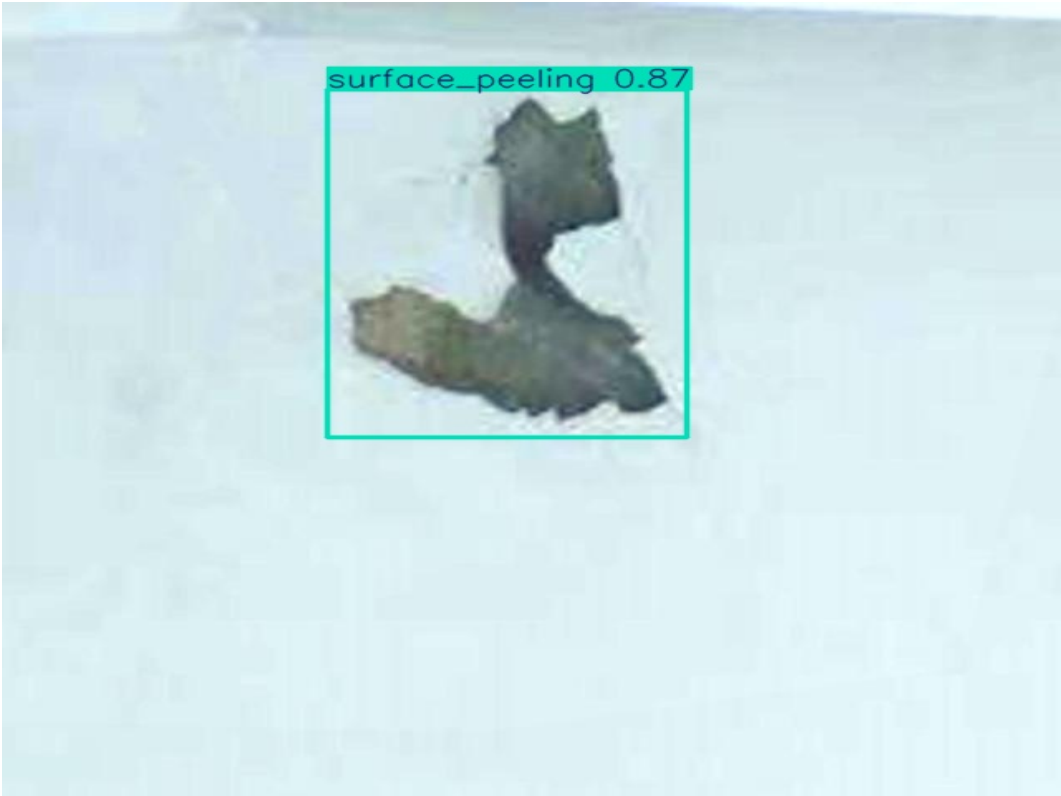
745\_jpg.rf.f9531ab214709dc89589142f0683c28b.jpg

Score: 1.3 / 10

| Defect Type | Confidence | Bounding Box |
|---|---|---|
| surface_peeling | 86.9% | (197, 70) -> (414, 350) |

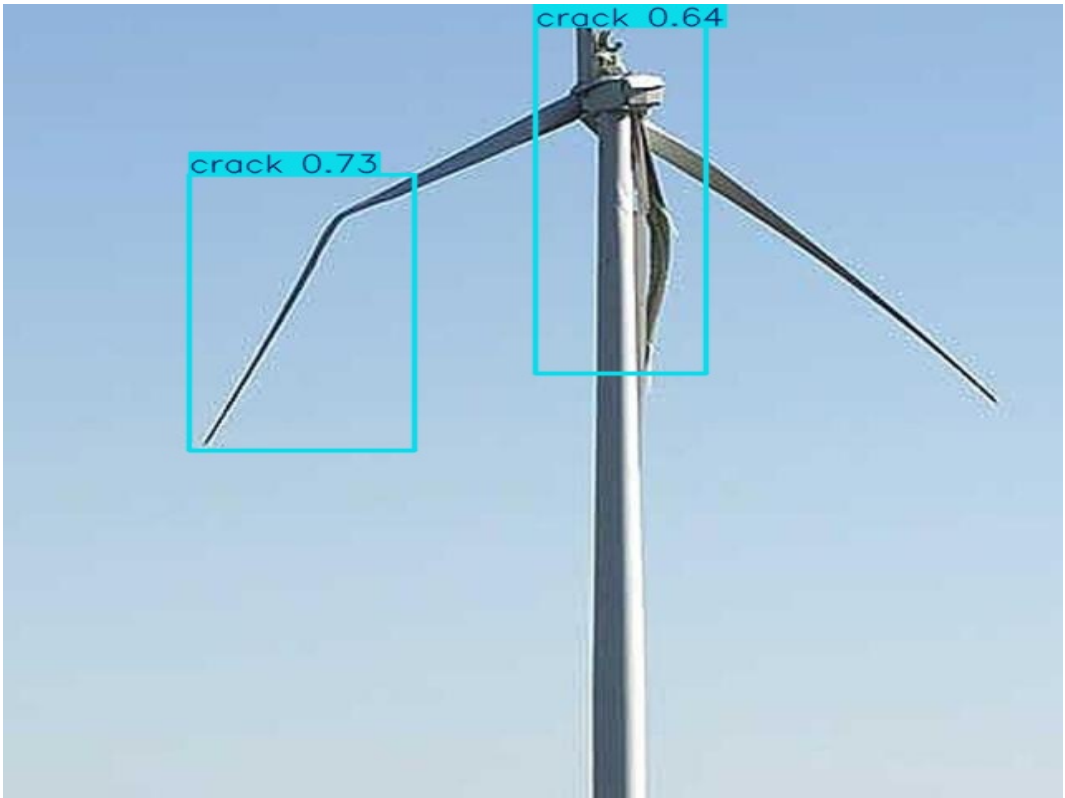
70\_jpg.rf.84deaf062fe4f46868c97488147f2e0f.jpg

Score: 4.08 / 10

| Defect Type | Confidence | Bounding Box |
|---|---|---|
| crack | 72.6% | (113, 138) -> (248, 360) |
| crack | 63.5% | (322, 0) -> (424, 297) |

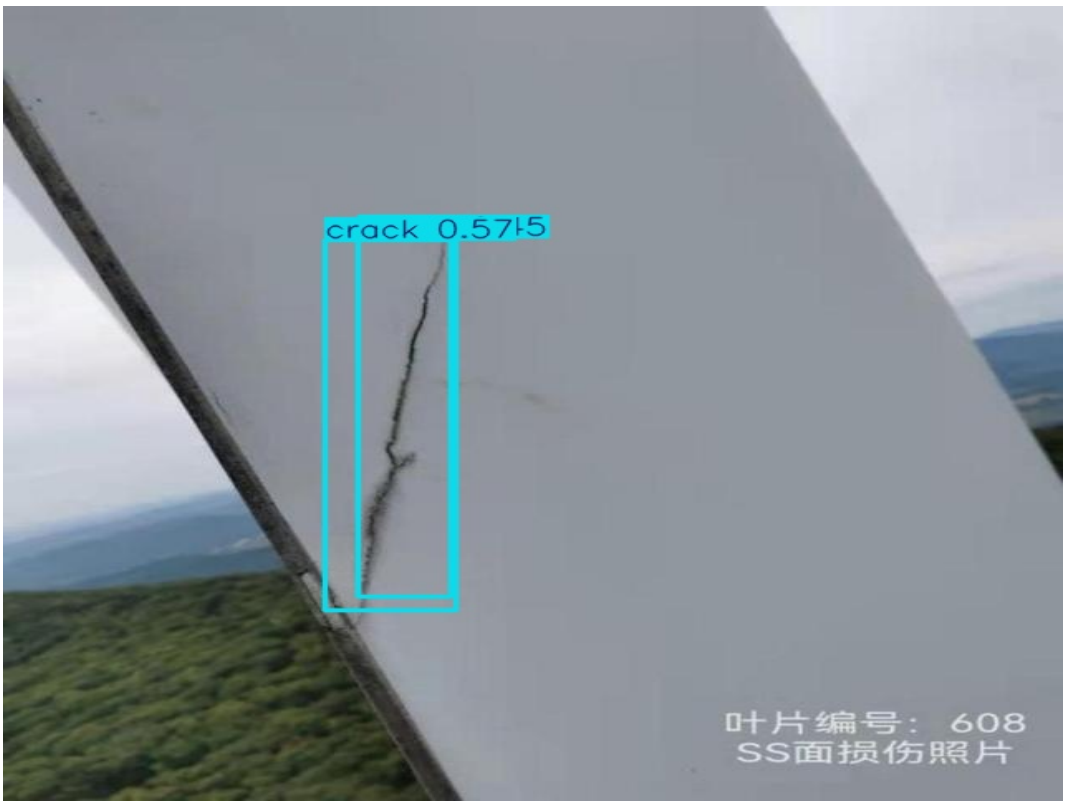
709\_jpg.rf.866a0aa0b8bcf7675565fe680db519e3.jpg

Score: 3.06 / 10

| Defect Type | Confidence | Bounding Box |
|---|---|---|
| crack | 57.2% | (195, 189) -> (273, 487) |
| crack | 44.8% | (214, 186) -> (270, 476) |

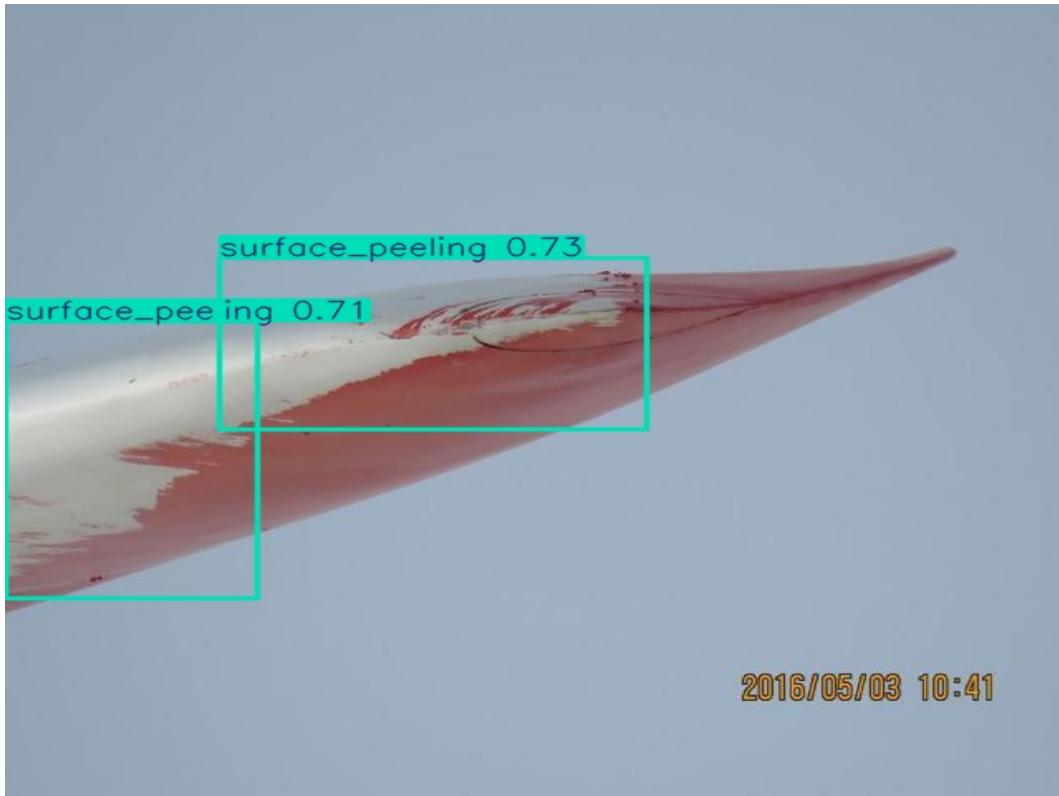
245\_jpg.rf.2909bb8b2c99dcc263eba1379a9f0e54.jpg

Score: 2.17 / 10

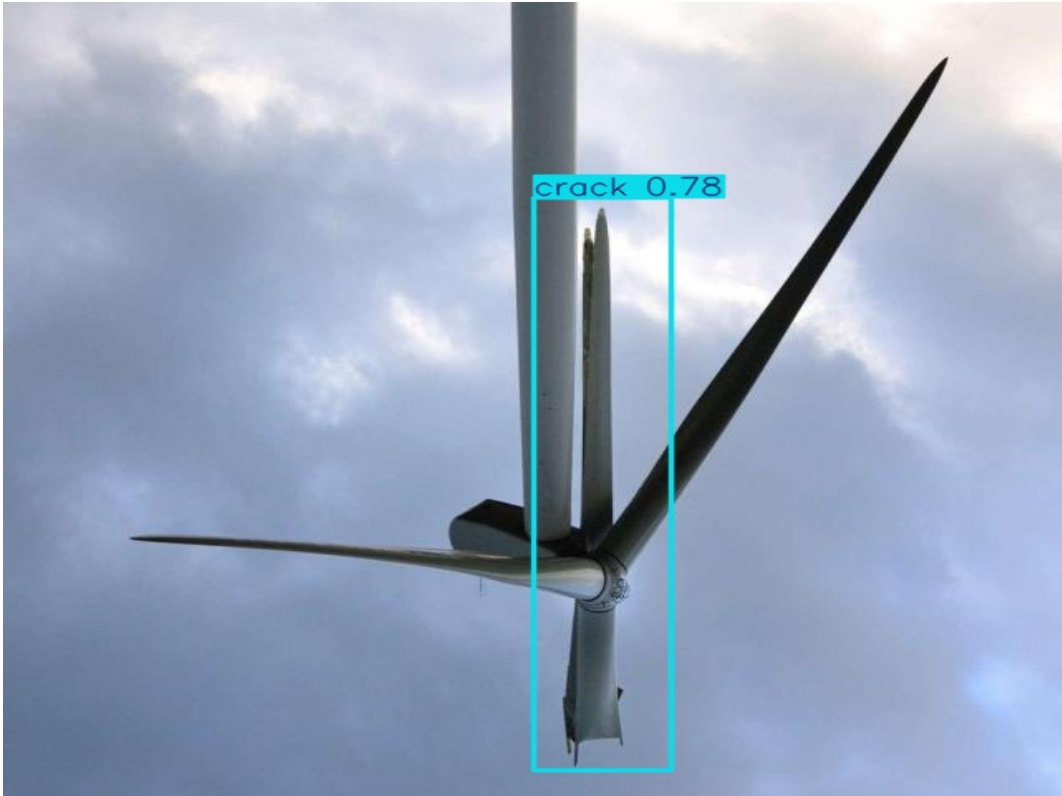
199\_jpg.rf.2bddb49bb4ed0b5ccd8cb154536d5f22.jpg

Score: 2.33 / 10

Moderate damage

| Defect Type | Confidence | Bounding Box |
|---|---|---|
| crack | 77.5% | (321, 158) -> (404, 619) |

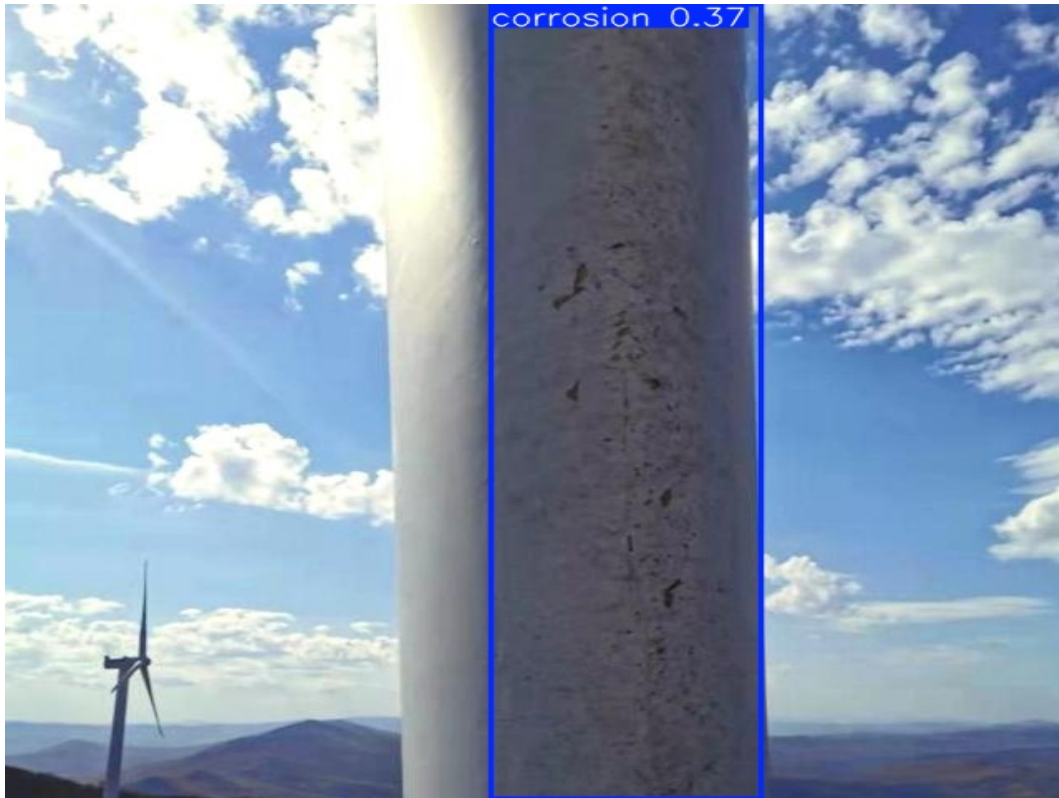
1031\_jpg.rf.5ab049420bf9f1695386d45975ca7a57.jpg

Score: 0.74 / 10

| Defect Type | Confidence | Bounding Box |
|---|---|---|
| corrosion | 37.2% | (294, 0) -> (456, 640) |

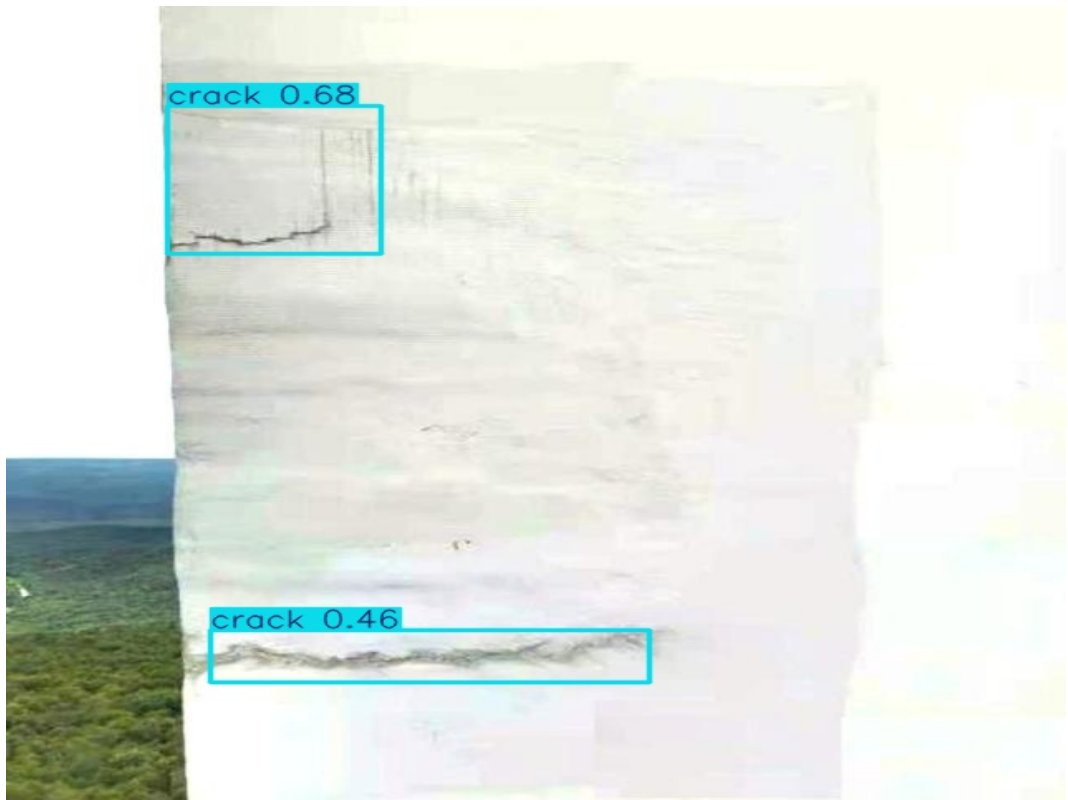
991\_jpg.rf.dbe83641c895ae5a99552b6a366638b9.jpg

Score: 3.4 / 10

| Defect Type | Confidence | Bounding Box |
|---|---|---|
| crack | 67.8% | (97, 81) -> (227, 199) |
| crack | 45.6% | (124, 503) -> (388, 545) |

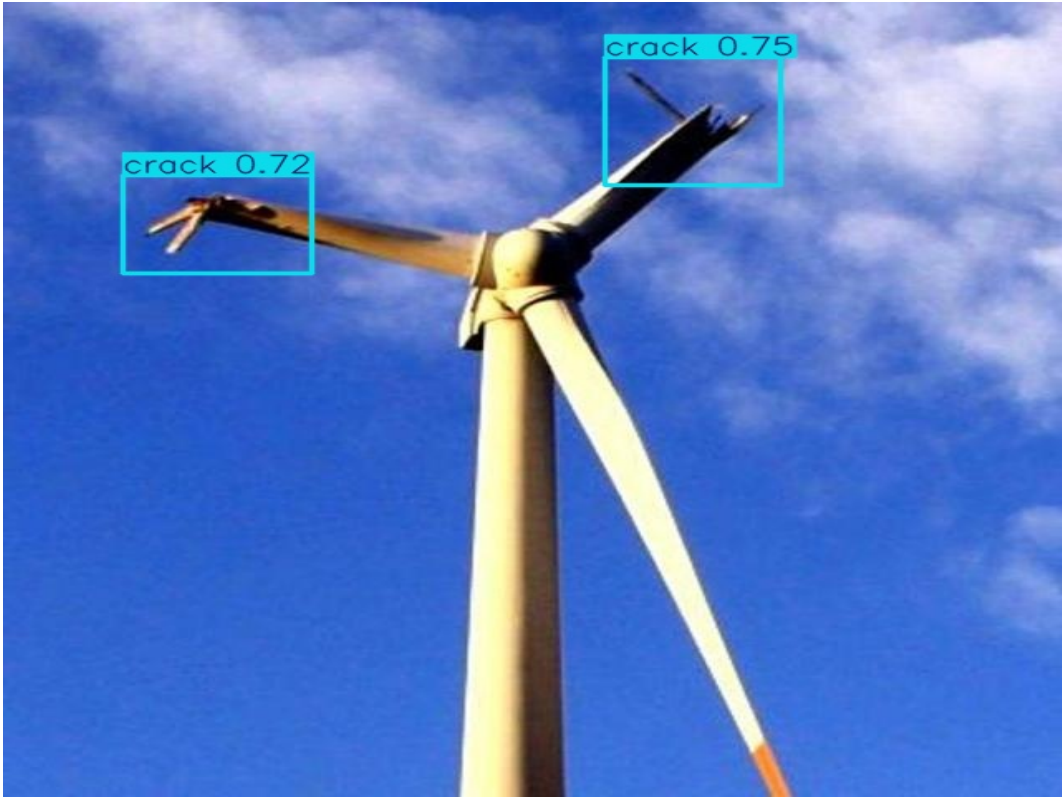
739\_jpg.rf.6f75fa7eebce8c687facaf93b43cb628.jpg

Score: 4.42 / 10

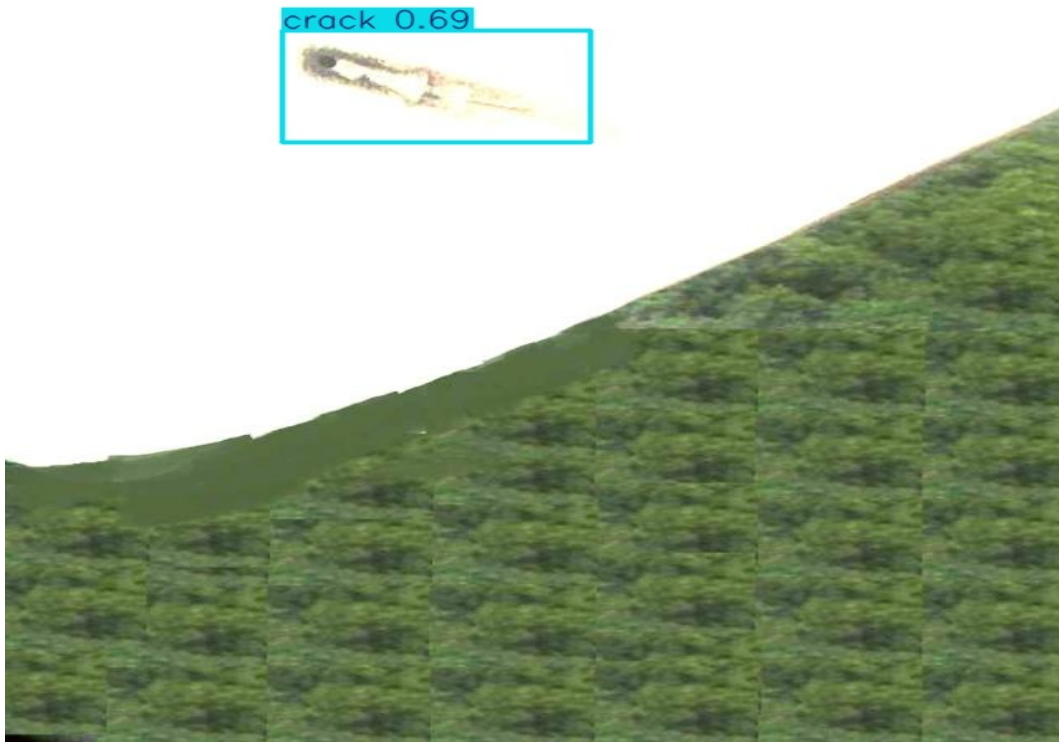
894\_jpg.rf.0ec6384c7f55b242380653570b3acc0c.jpg

Score: 2.07 / 10

Moderate damage

| Defect Type | Confidence | Bounding Box |
|---|---|---|
| crack | 68.9% | (167, 66) -> (354, 156) |

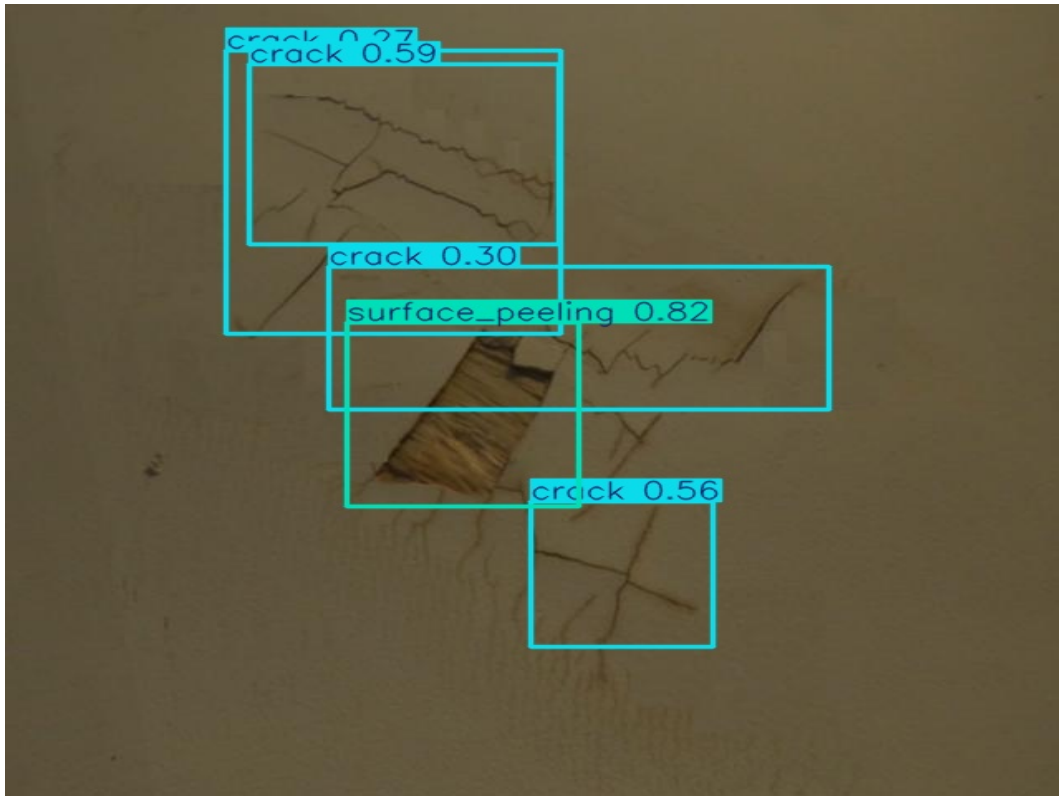
827\_jpg.rf.ff91c808f2c0f901c1134226070c3338.jpg

Score: 6.38 / 10

| Defect Type | Confidence | Bounding Box |
|---|---|---|
| crack | 29.6% | (195, 211) -> (497, 326) |
| crack | 27.0% | (134, 38) -> (335, 266) |
