# WIND TURBINE INSPECTION REPORT

Autonomous Drone Inspection System

| Turbine ID | TRB-001 |

Overall Status: Moderate damage detected

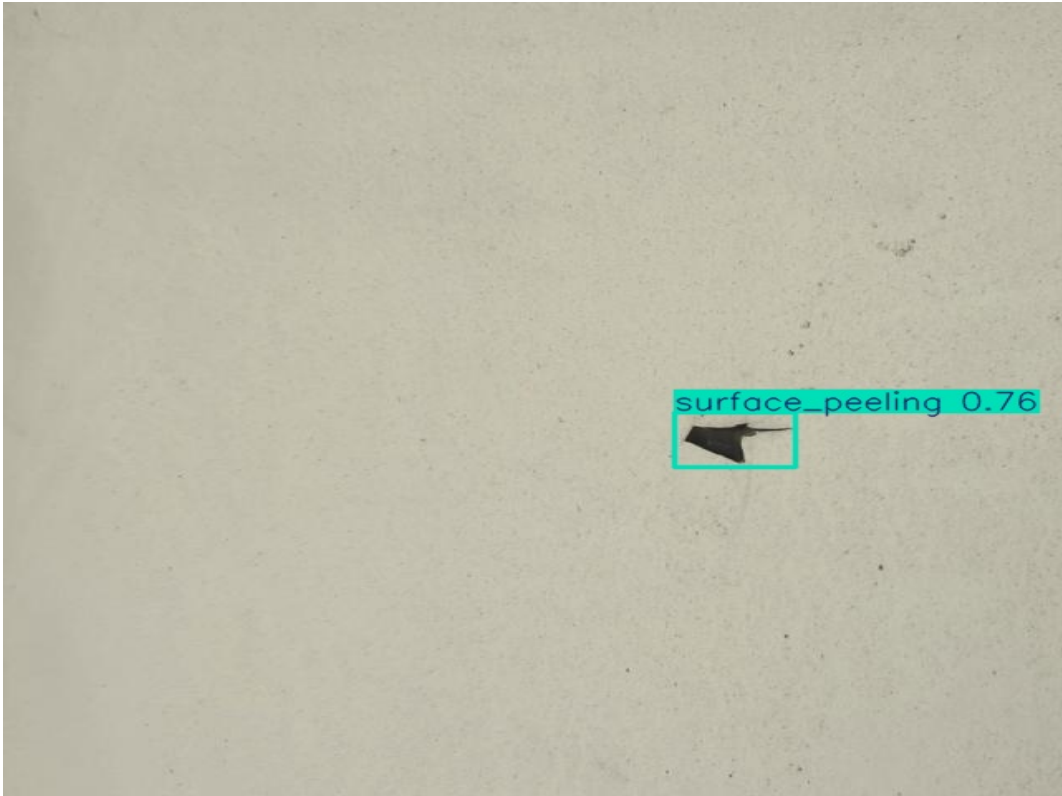
1013\_jpg.rf.a9b058a46bc2d461925dbebf3c1ee23  
8.jpg

Score: 1.13 / 10

| Defect Type | Confidence | Bounding Box |
|---|---|---|
| surface_peeling | 75.6% | (406, 330) -> (479, 374) |

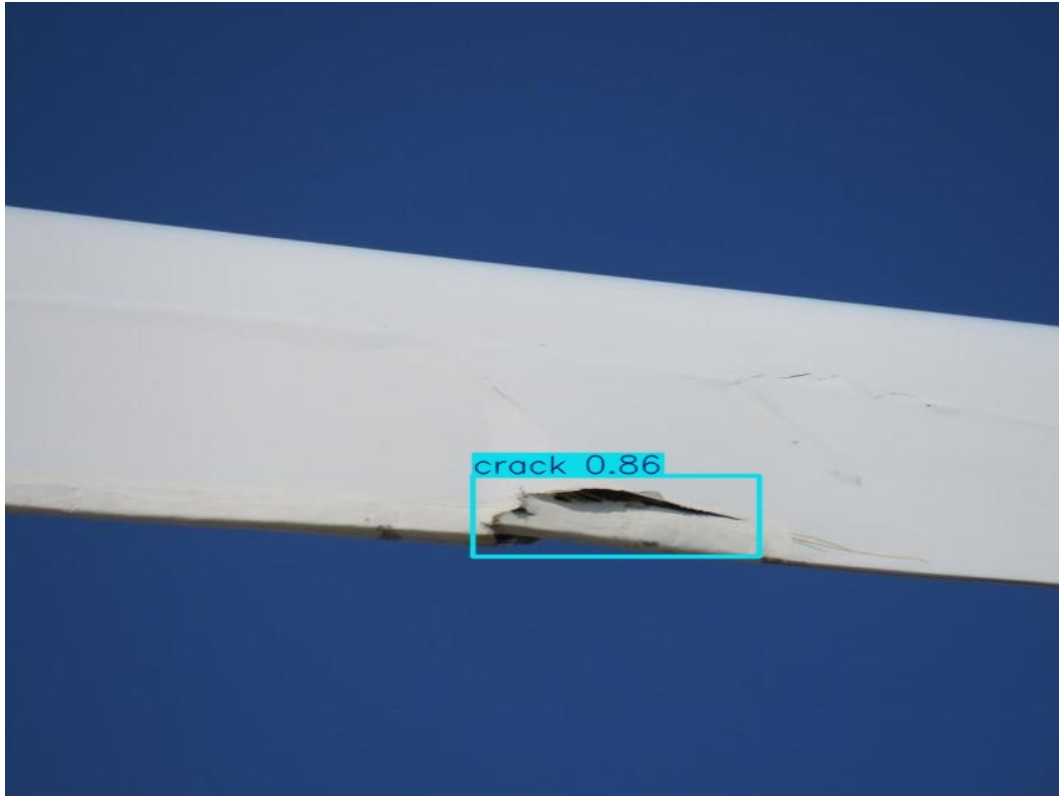
98\_jpg.rf.b236752272400f1e5f3d2dfba9cdfa67.jpg

Score: 2.57 / 10

| Defect Type | Confidence | Bounding Box |
|---|---|---|
| crack | 85.8% | (283, 381) -> (456, 446) |

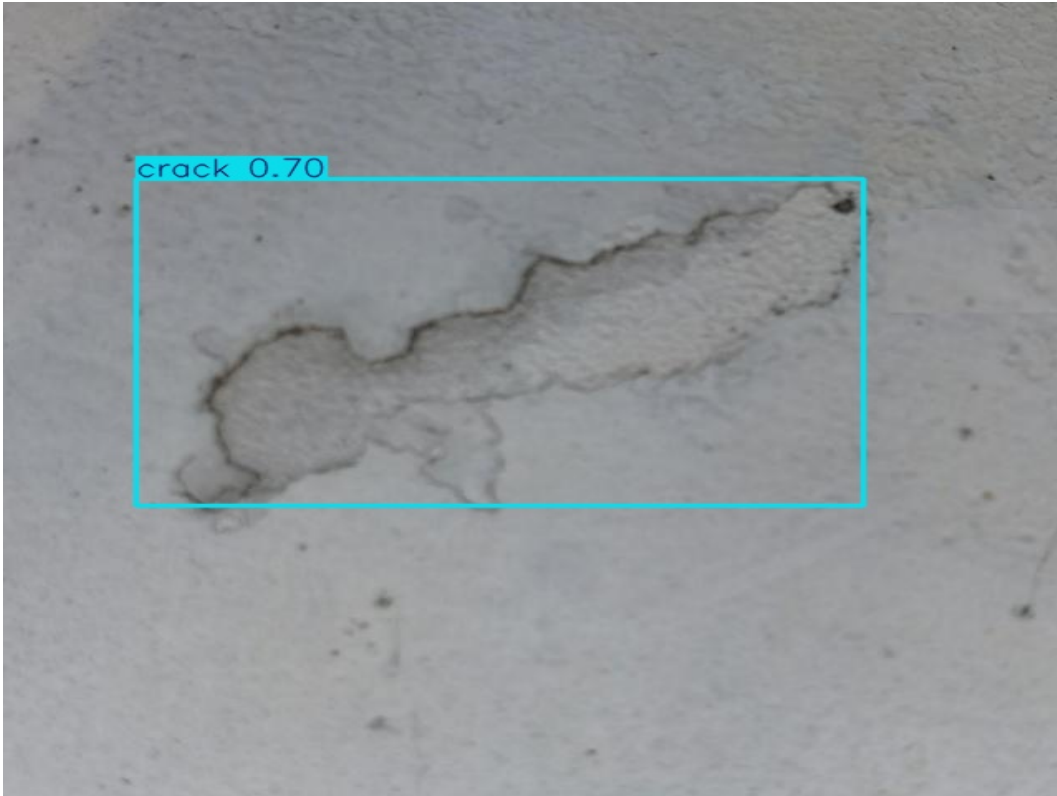
679\_jpg.rf.e7265cbd8b3bb23756887525ff9ebb88.jpg

Score: 2.11 / 10

| Defect Type | Confidence | Bounding Box |
|---|---|---|
| crack | 39.2% | (102, 171) -> (196, 199) |
| crack | 32.4% | (92, 65) -> (224, 200) |

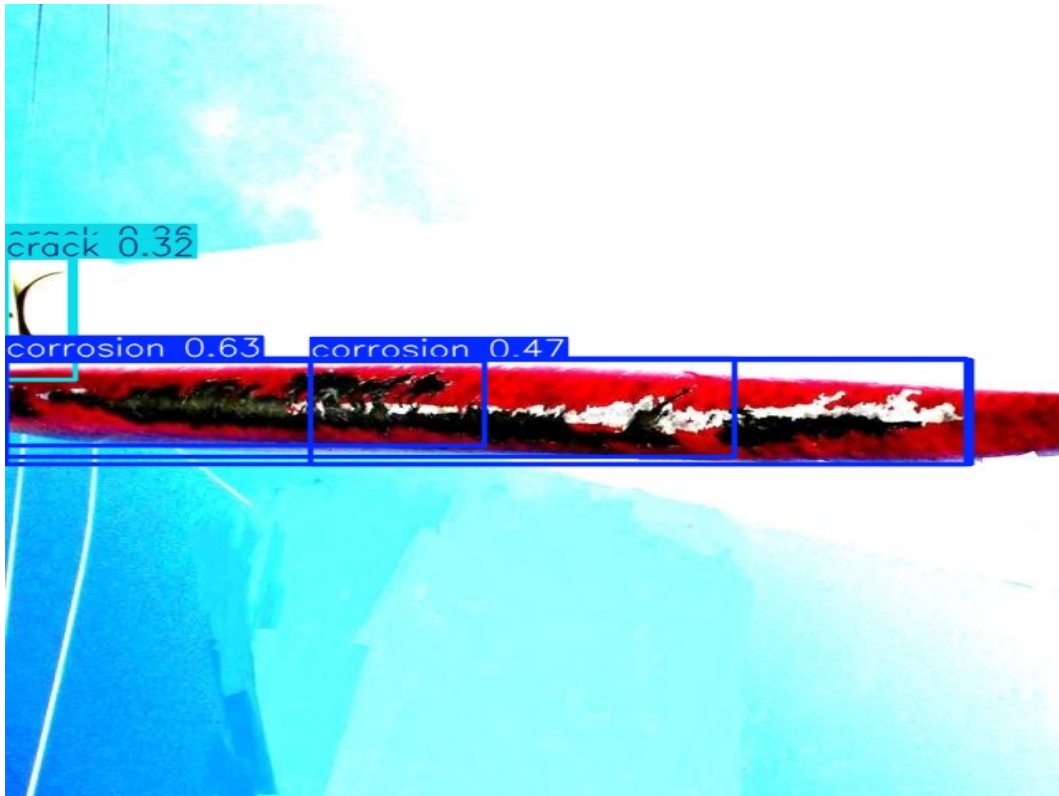
865\_jpg.rf.3407e64552aff8d89b28534ef875151c.jpg

Score: 5.92 / 10

| Defect Type | Confidence | Bounding Box |
|---|---|---|
| crack | 32.4% | (0, 204) -> (40, 286) |
| crack | 26.1% | (0, 195) -> (43, 303) |

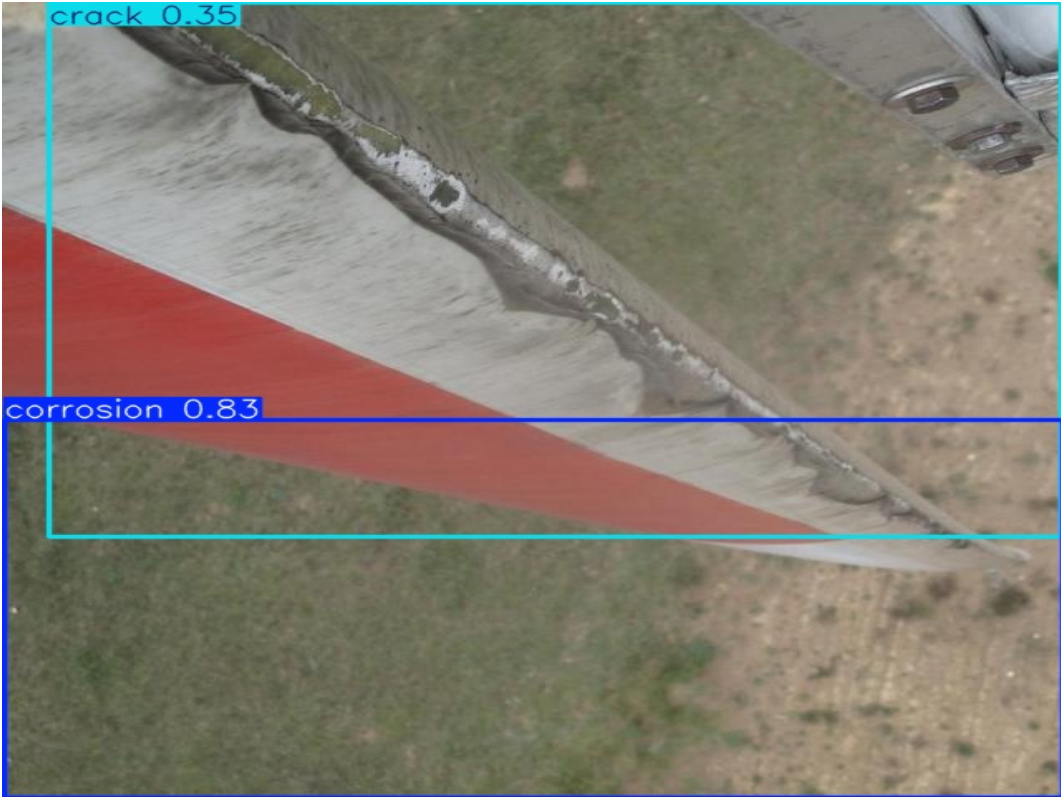
289\_jpg.rf.b87219b931b514f594d5f8345206c53f.jpg

Score: 2.72 / 10

| Defect Type | Confidence | Bounding Box |
|---|---|---|
| corrosion | 82.9% | (1, 336) -> (640, 640) |
| crack | 35.3% | (28, 0) -> (640, 431) |

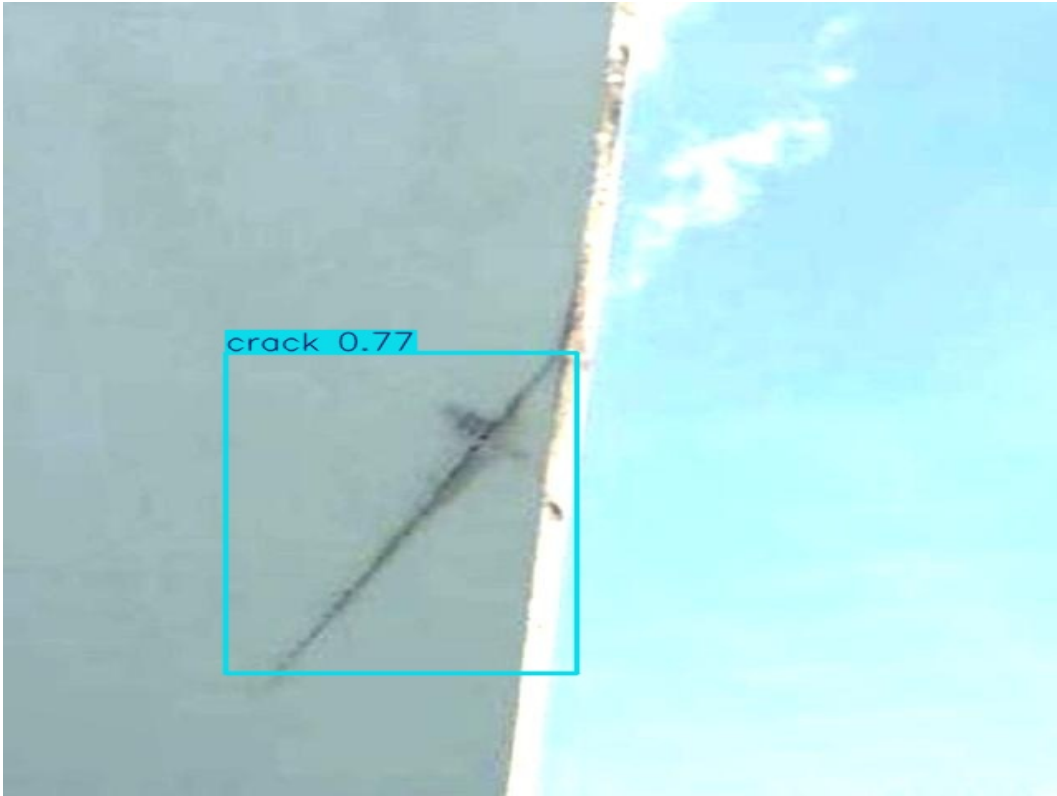
910\_jpg.rf.bff73ed0e670ce758e6aaa14b0e5ca2c.jpg

Score: 2.32 / 10

| Defect Type | Confidence | Bounding Box |
|---|---|---|
| crack | 31.5% | (282, 15) -> (358, 640) |
| crack | 30.0% | (284, 28) -> (333, 640) |

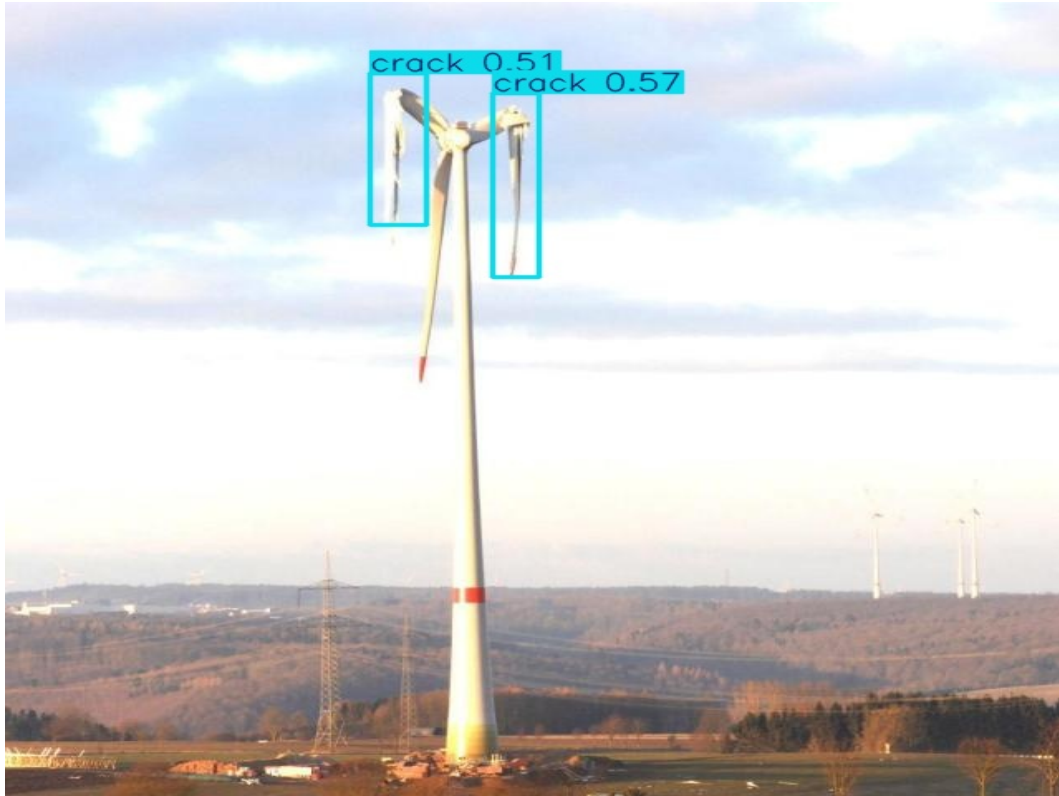
176\_jpg.rf.84f24d19764b23660c459c98beb3b0c2.jpg

Score: 3.22 / 10

| Defect Type | Confidence | Bounding Box |
|---|---|---|
| crack | 56.6% | (294, 73) -> (322, 222) |
| crack | 50.6% | (220, 57) -> (254, 180) |

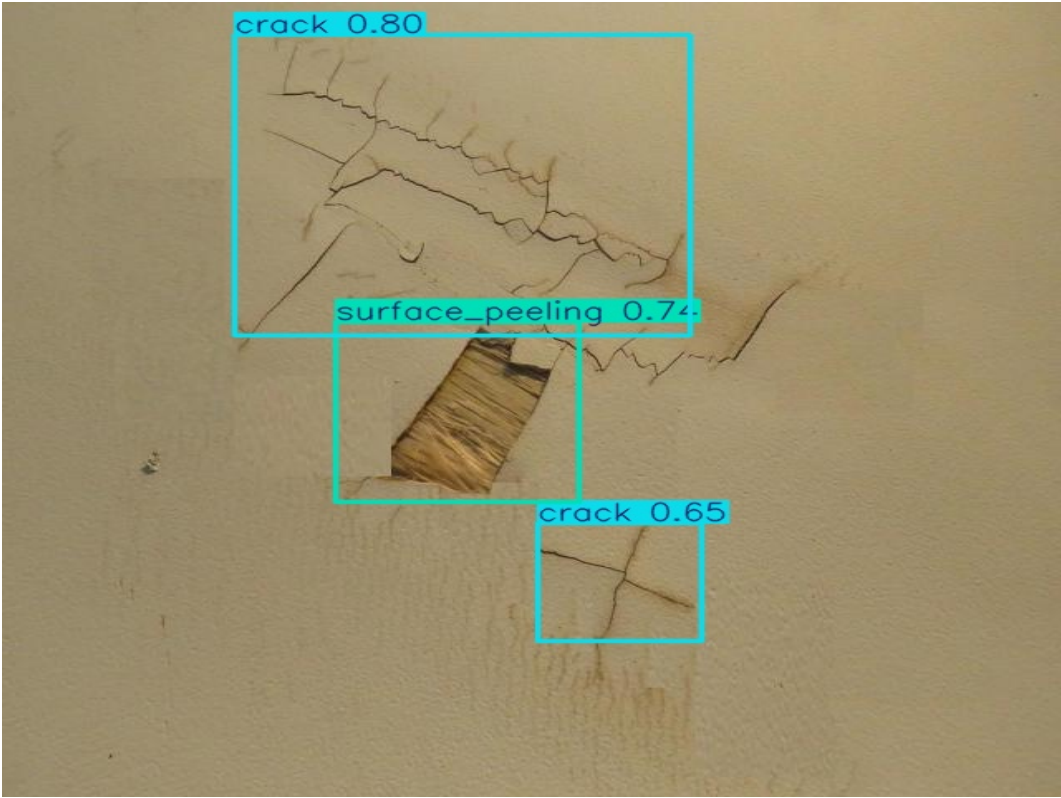
234\_jpg.rf.c2c27b72a5a3c7cc57472a0e5c855d2c.  
jpg

Score: 5.47 / 10

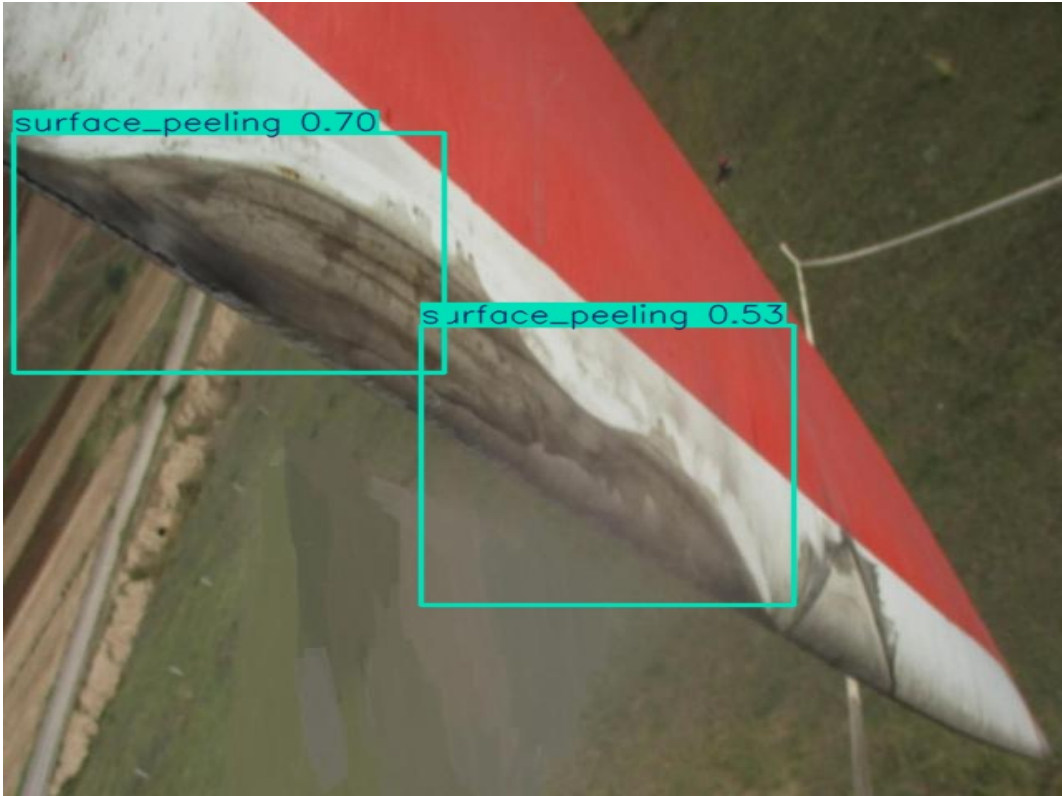
27\_jpg.rf.400fcf30590ded4a8325431458ece618.jpg

Score: 1.85 / 10

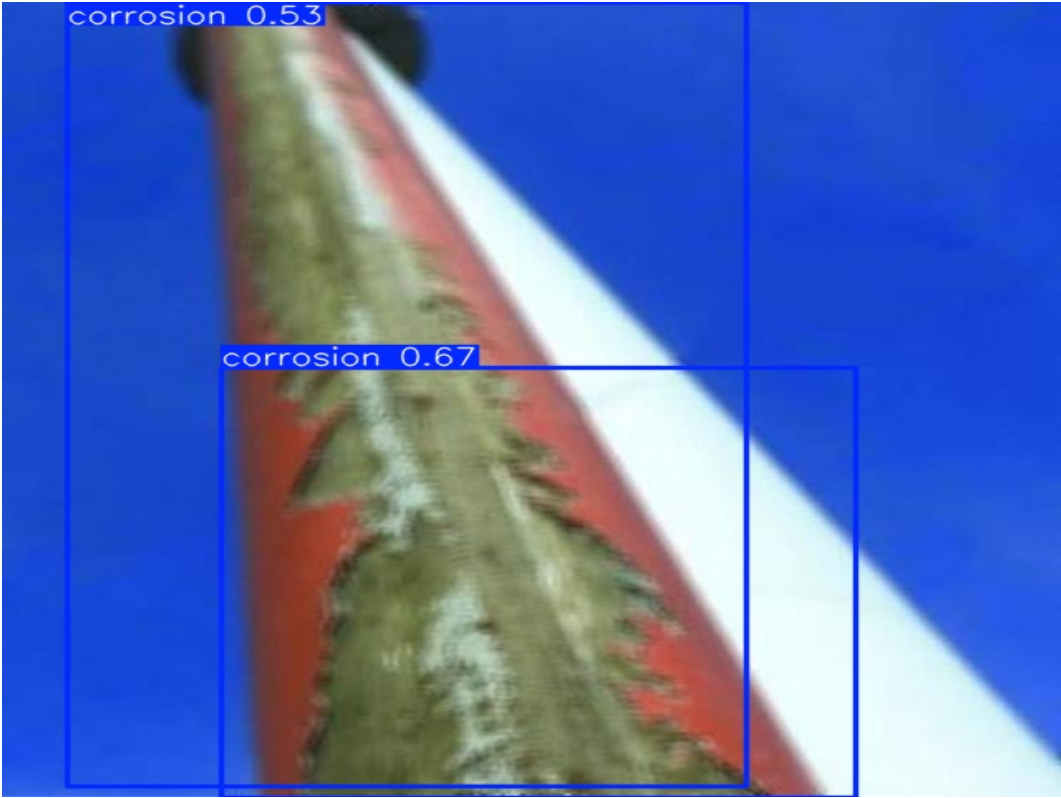
165\_jpg.rf.57febbc56db351bd5b04e01c3b83cb60.  
jpg

Score: 2.42 / 10

Moderate damage

| Defect Type | Confidence | Bounding Box |
|---|---|---|
| corrosion | 67.4% | (133, 294) -> (516, 640) |
| corrosion | 53.4% | (40, 1) -> (449, 631) |

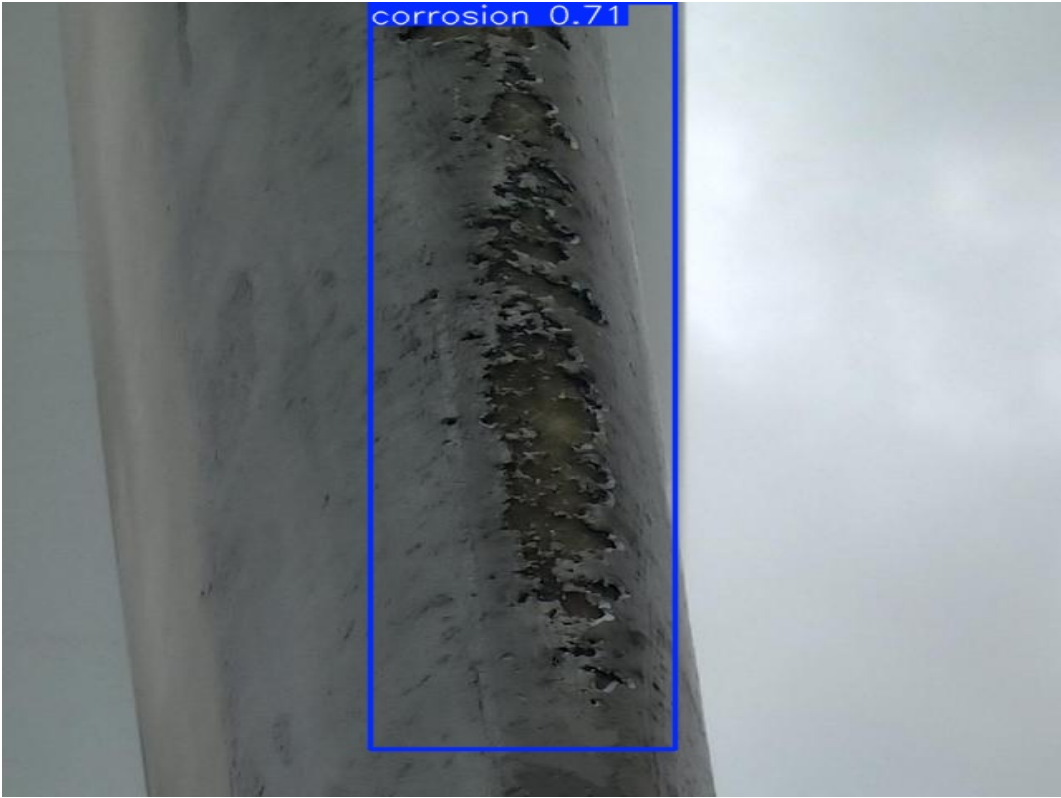
566\_jpg.rf.fe37290058c2340ac76f18dd58628cdf.jpg

Score: 1.43 / 10

| Defect Type | Confidence | Bounding Box |
|---|---|---|
| corrosion | 71.5% | (223, 0) -> (406, 601) |

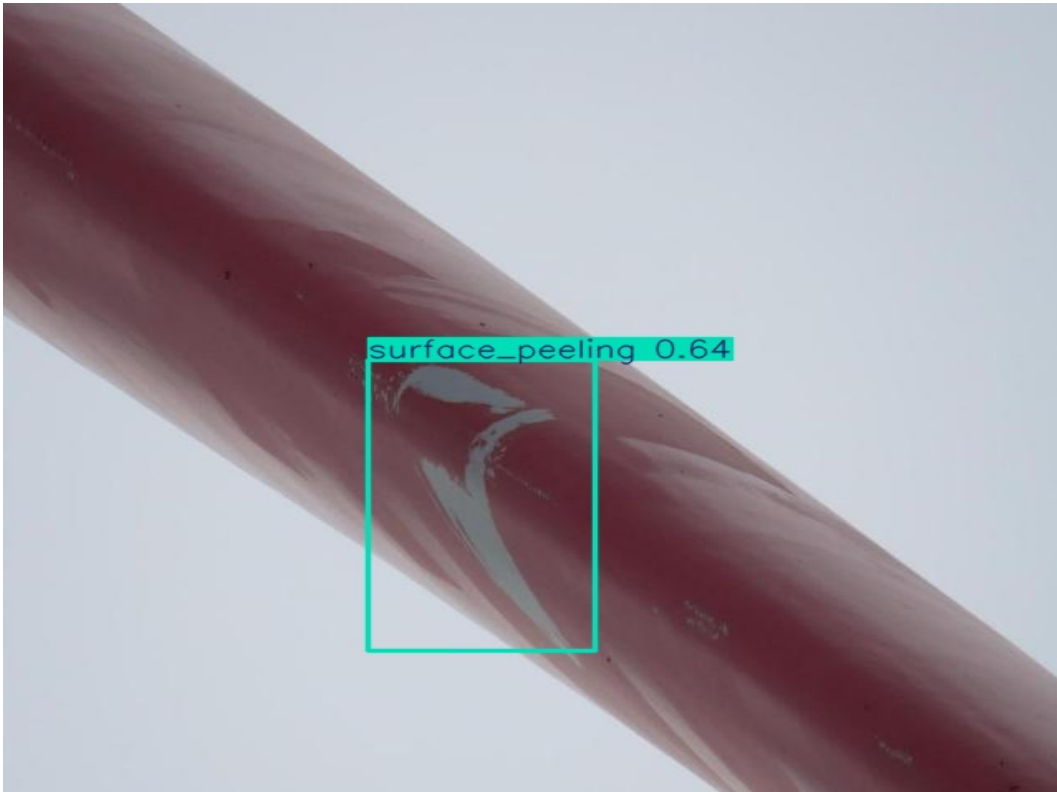
105\_jpg.rf.dcaa68a4e5919b81d91c0a44a7a6546b.jpg

Score: 0.96 / 10

Minor wear

| Defect Type | Confidence | Bounding Box |
|---|---|---|
| surface_peeling | 63.8% | (221, 287) -> (357, 521) |

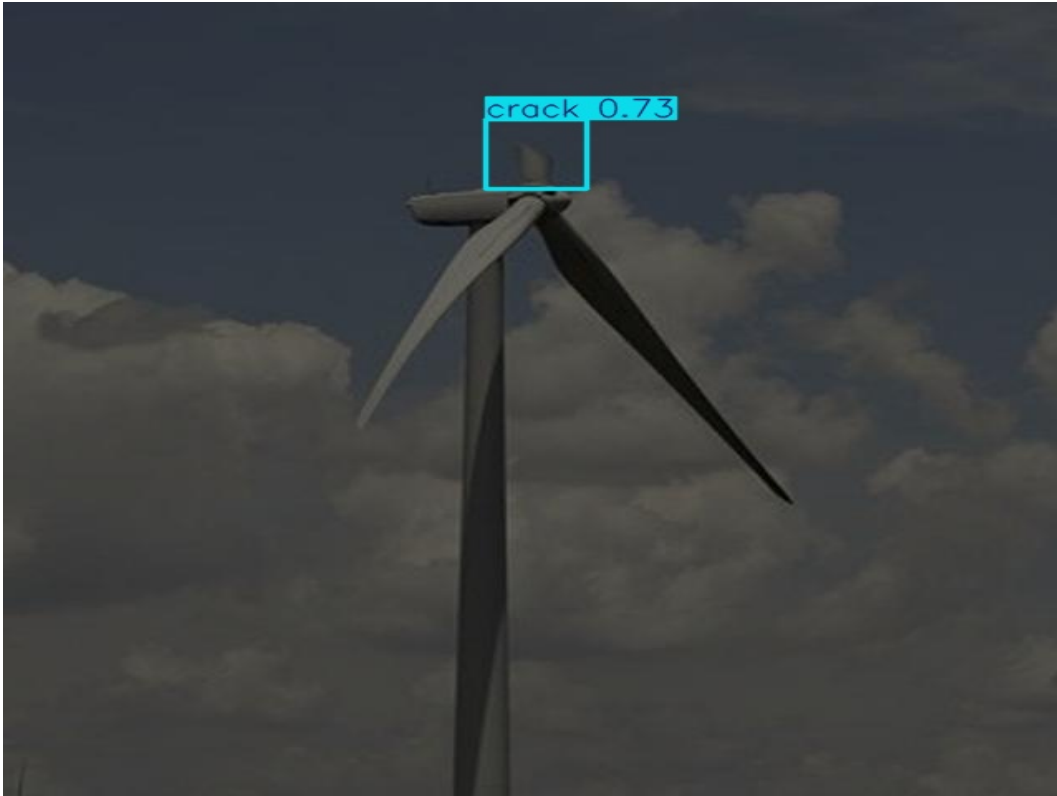
1057\_jpg.rf.30c3727d592b693867065b27b6920417.jpg

Score: 2.2 / 10

Moderate damage

| Defect Type | Confidence | Bounding Box |
|---|---|---|
| crack | 73.2% | (291, 95) -> (352, 150) |

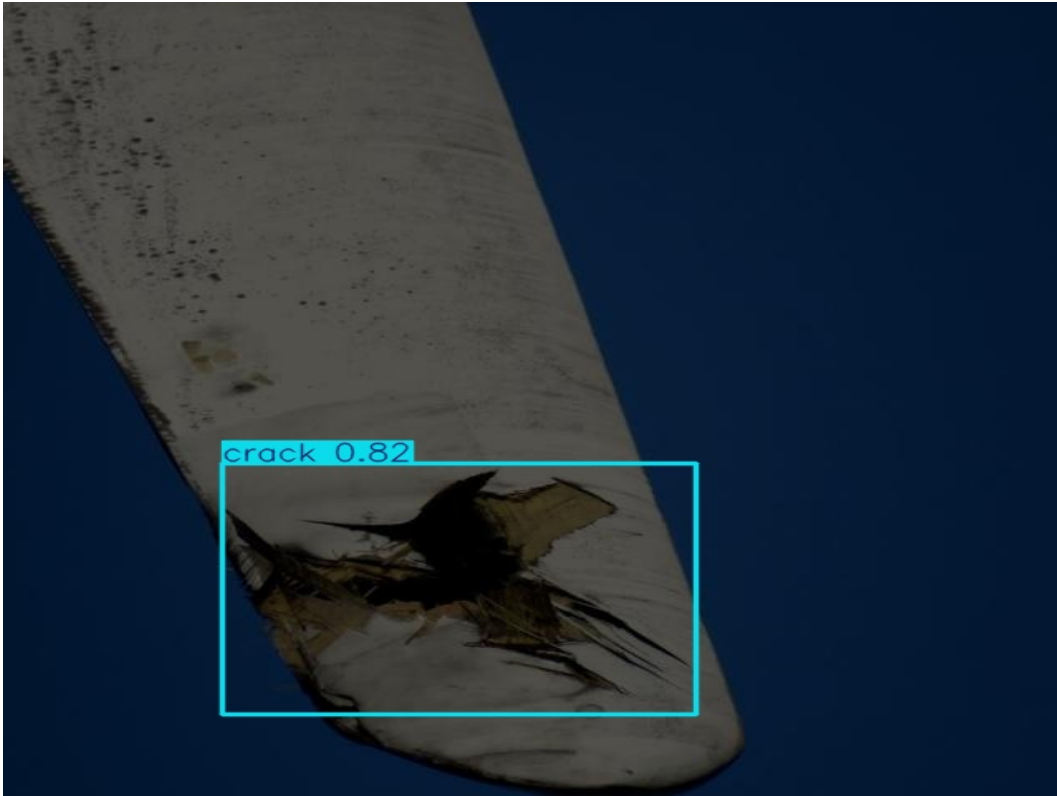
970\_jpg.rf.e0a5c24ca1528e1baaba787d7d17f342.jpg

Score: 2.46 / 10

Moderate damage

| Defect Type | Confidence | Bounding Box |
|---|---|---|
| crack | 81.9% | (132, 372) -> (419, 574) |

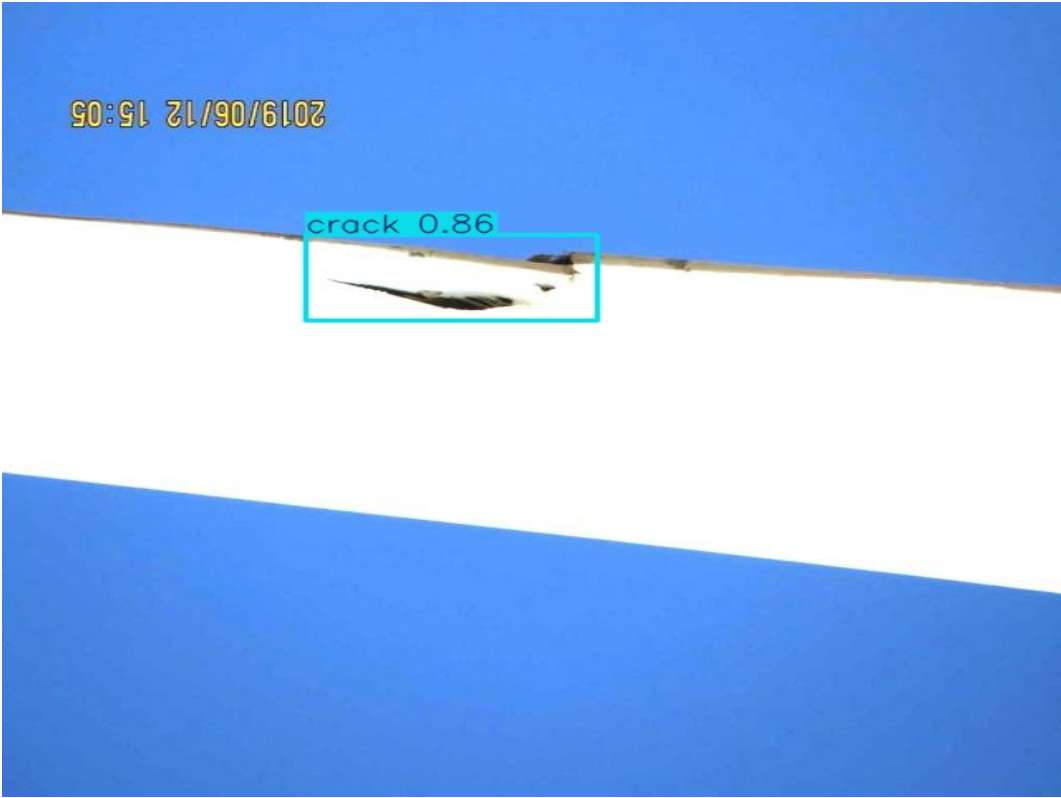
779\_jpg.rf.25f7f25c4ec9ca548cf7867b4150afc5.jpg

Score: 2.58 / 10

Moderate damage

| Defect Type | Confidence | Bounding Box |
|---|---|---|
| crack | 86.1% | (183, 188) -> (360, 256) |

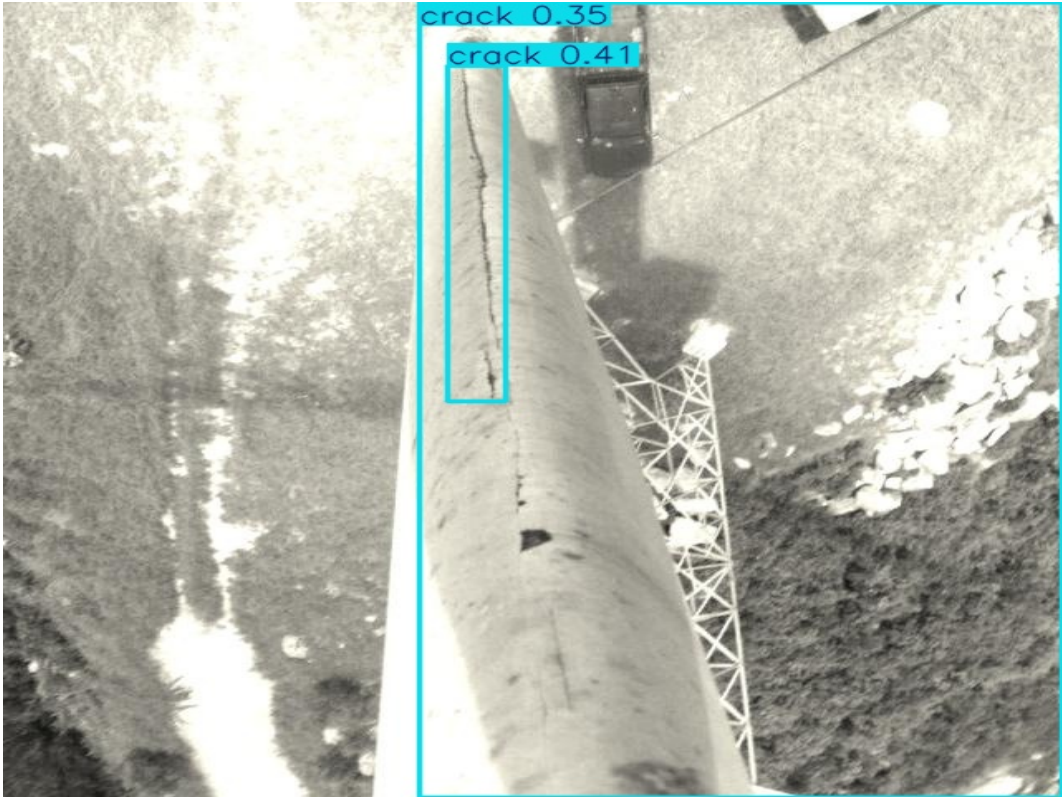
753\_jpg.rf.7551ed184731565da538da39c43c42ed.jpg

Score: 2.29 / 10

Moderate damage

| Defect Type | Confidence | Bounding Box |
|---|---|---|
| crack | 40.9% | (269, 51) -> (304, 321) |
| crack | 35.4% | (252, 0) -> (639, 640) |

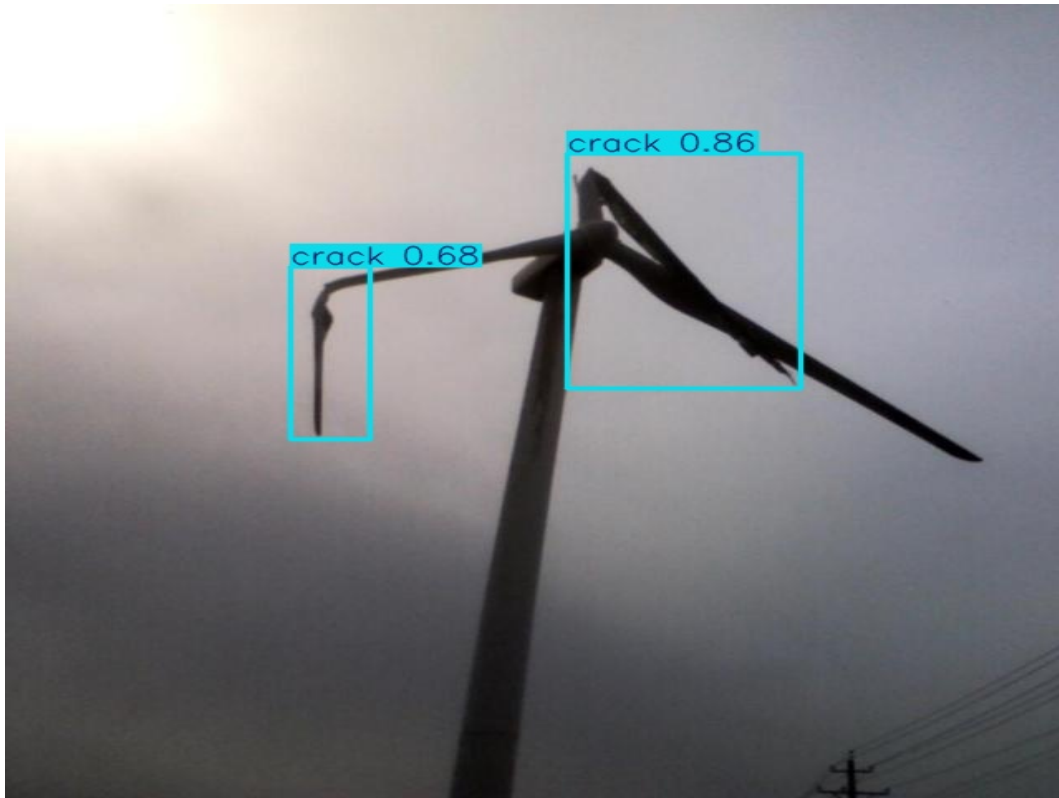
537\_jpg.rf.6bdf7972c37208b6c35d2d8bd5e8f815.jpg

Score: 4.63 / 10

| Defect Type | Confidence | Bounding Box |
|---|---|---|
| crack | 86.2% | (339, 121) -> (480, 310) |
| crack | 68.0% | (172, 212) -> (220, 351) |

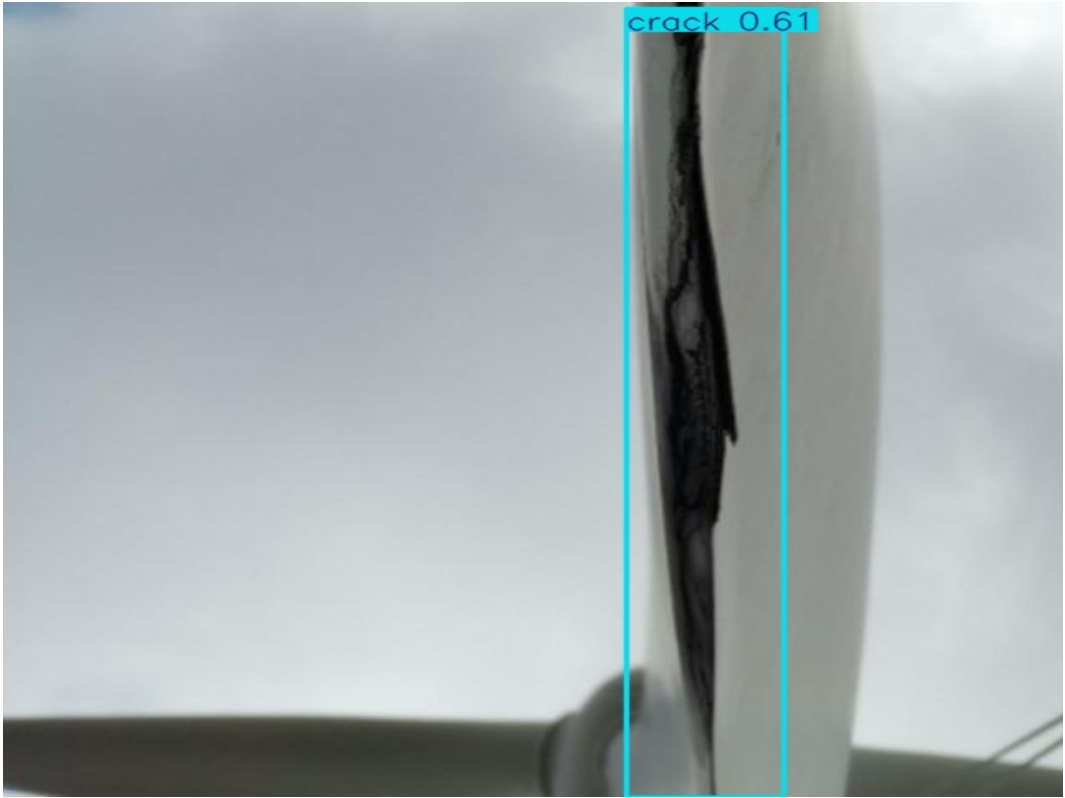
634\_jpg.rf.79a2e02cb797bdb35c008bf836be7013.jpg

Score: 1.83 / 10

Minor wear

| Defect Type | Confidence | Bounding Box |
|---|---|---|
| crack | 61.0% | (377, 5) -> (471, 640) |

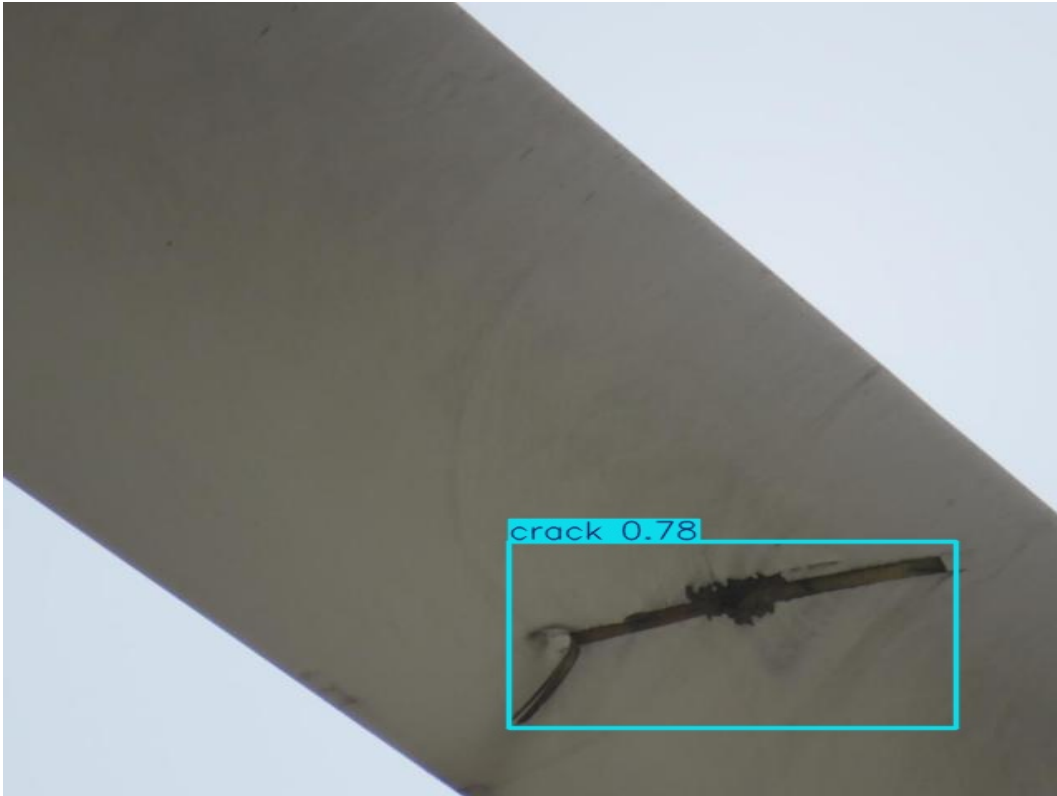
55\_jpg.rf.84c8deea5c9dc47eca9355b7b4496c8c.jpg

Score: 2.34 / 10

Moderate damage

| Defect Type | Confidence | Bounding Box |
|---|---|---|
| crack | 78.0% | (305, 435) -> (576, 585) |

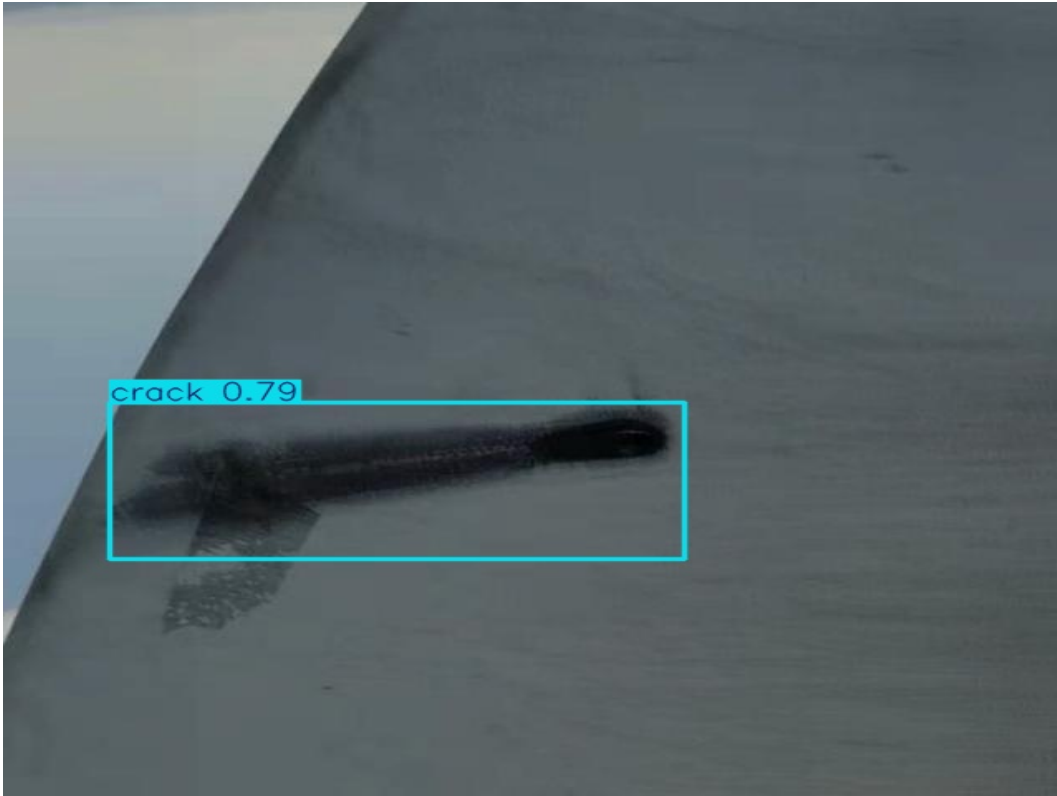
1021\_jpg.rf.9062592d4958f20ad94b7f69fb08a10e.jpg

Score: 2.37 / 10

Moderate damage

| Defect Type | Confidence | Bounding Box |
|---|---|---|
| crack | 79.1% | (65, 322) -> (412, 448) |

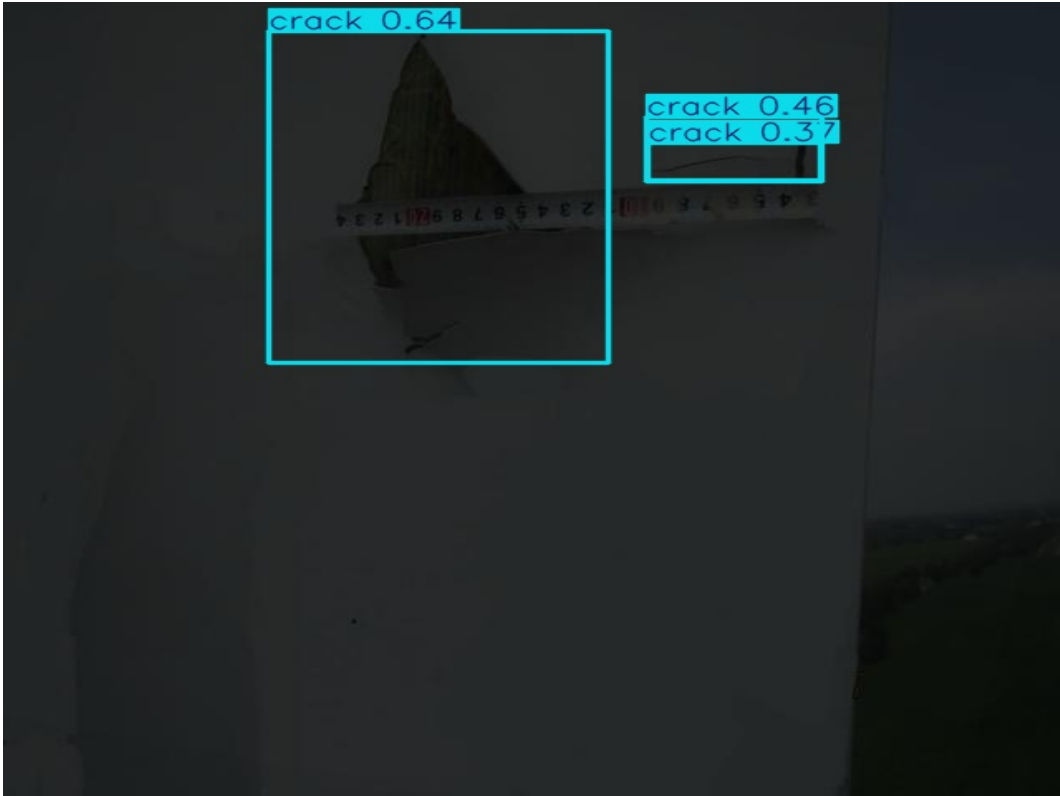
861\_jpg.rf.097ad4aa0e32a31507752358a15f2098.jpg

Score: 4.41 / 10

Moderate damage

| Defect Type | Confidence | Bounding Box |
|---|---|---|
| crack | 64.0% | (161, 23) -> (366, 290) |
| crack | 46.0% | (388, 93) -> (494, 145) |
| crack | 37.1% | (390, 113) -> (494, 144) |

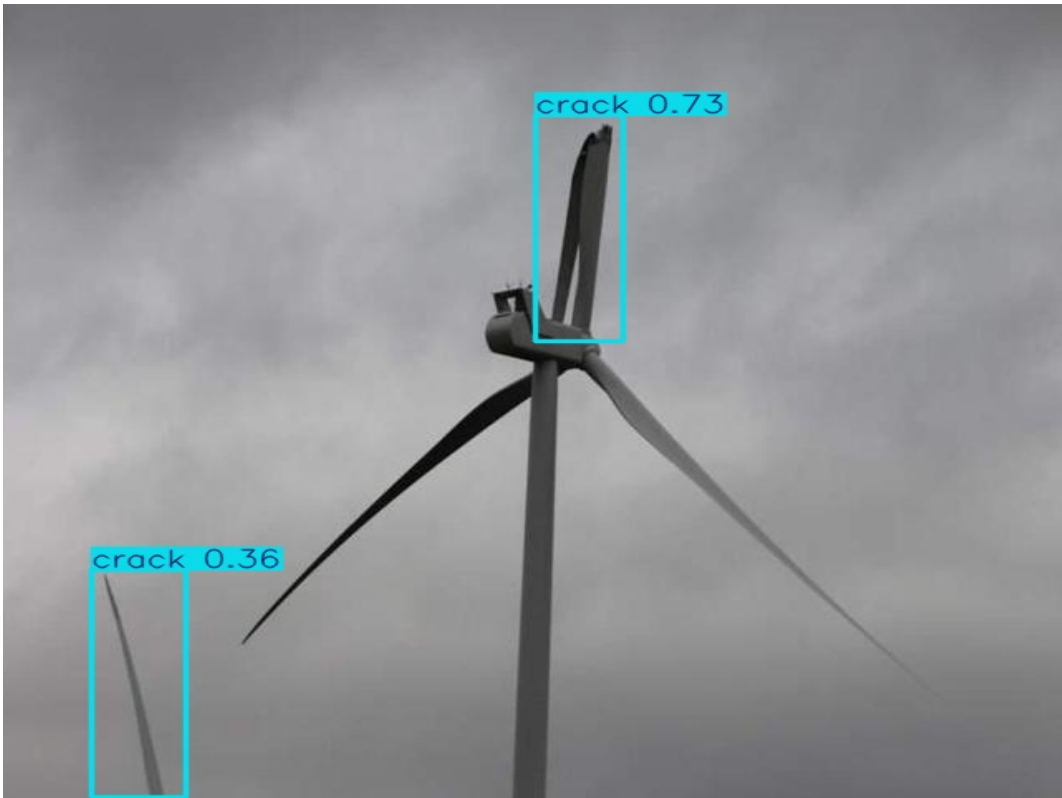
159\_jpg.rf.8b21f1fddba3a967ed41ecf07e735b73.jpg

Score: 3.28 / 10

Moderate damage

| Defect Type | Confidence | Bounding Box |
|---|---|---|
| crack | 72.9% | (322, 89) -> (375, 271) |
| crack | 36.3% | (53, 456) -> (111, 639) |

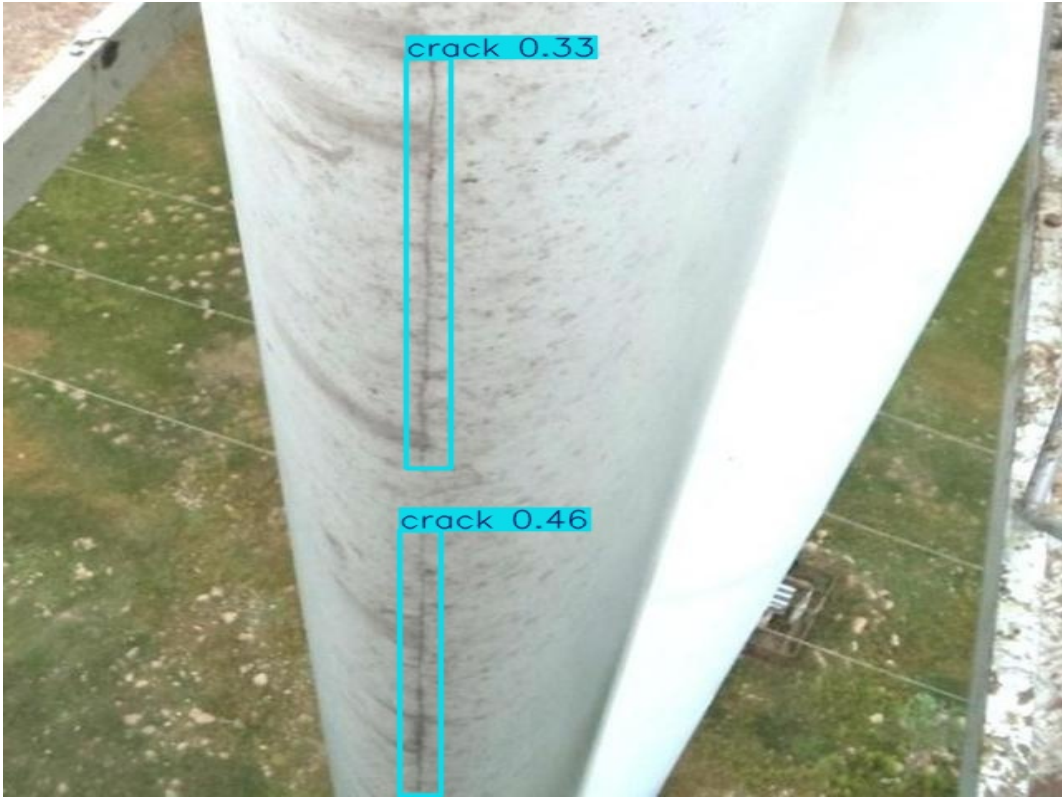
456\_jpg.rf.bcbcef2e238dad7c11af4c45951f03d2.jpg

Score: 2.37 / 10

Moderate damage

| Defect Type | Confidence | Bounding Box |
|---|---|---|
| crack | 45.6% | (239, 425) -> (264, 638) |
| crack | 33.3% | (244, 46) -> (270, 375) |

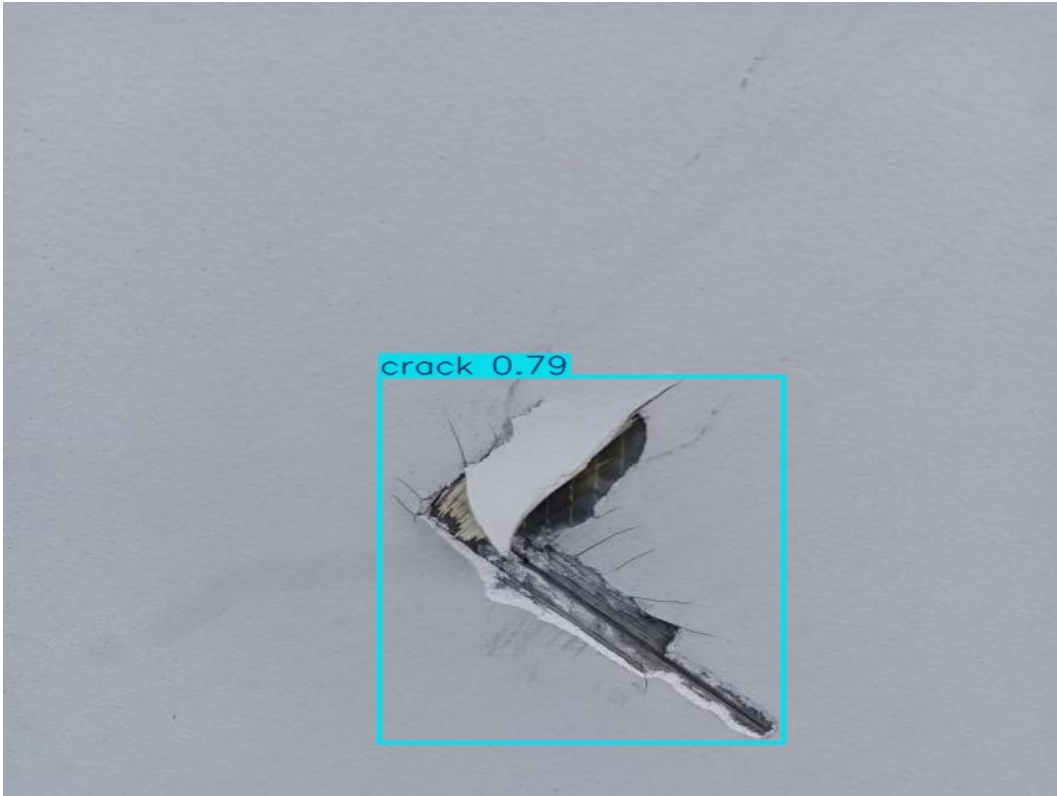
565\_jpg.rf.505dcbbebaee00387f2032231dee66e9.jpg

Score: 2.35 / 10

Moderate damage

| Defect Type | Confidence | Bounding Box |
|---|---|---|
| crack | 78.5% | (228, 301) -> (472, 597) |

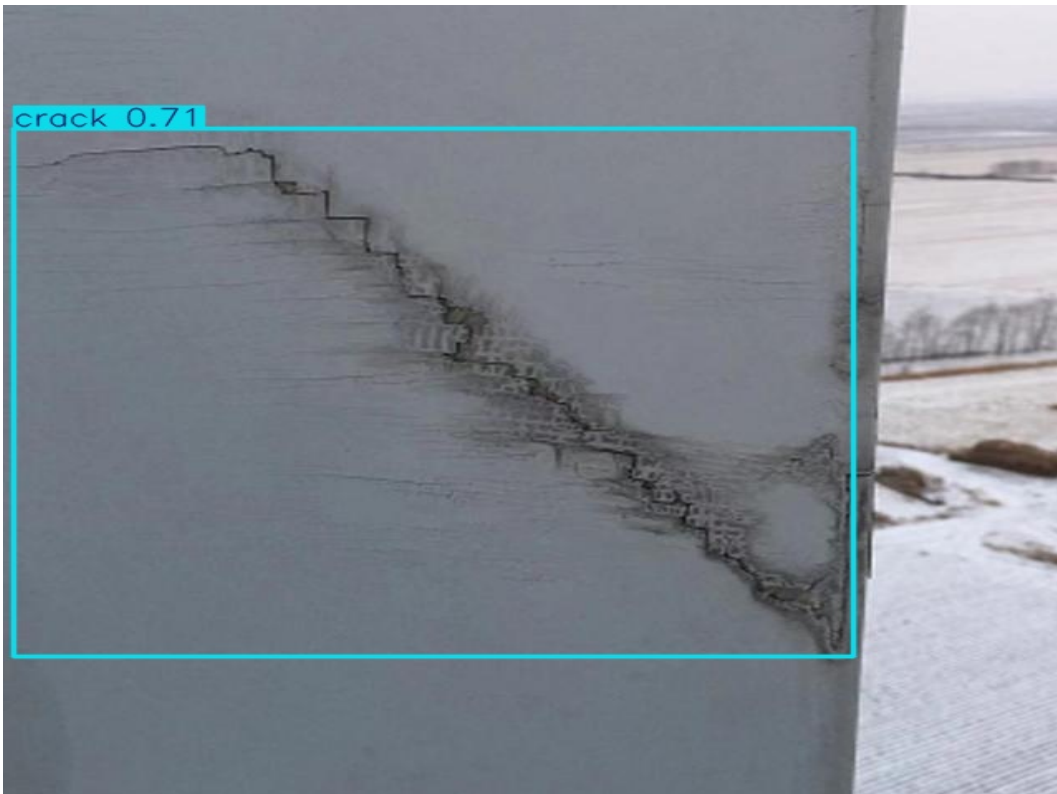
612\_jpg.rf.4a9575dfb38a0c641cdf7878f04125c7.jpg

Score: 2.12 / 10

Moderate damage

| Defect Type | Confidence | Bounding Box |
|---|---|---|
| crack | 70.7% | (7, 100) -> (513, 525) |
