# WIND TURBINE INSPECTION REPORT

Autonomous Drone Inspection System

| Turbine ID | TRB-001 |

Overall Status: Moderate damage detected

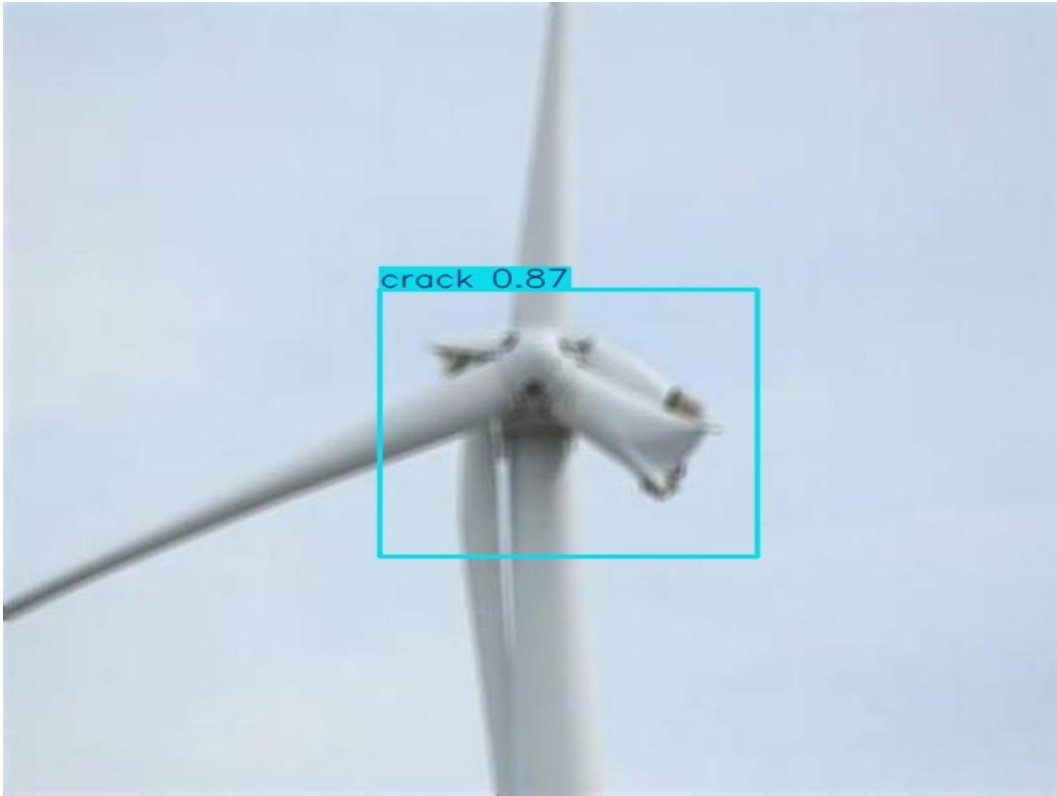
104\_jpg.rf.2e3077bca01881ba7d4ba17d84d3f3df.jpg

Score: 2.6 / 10

Moderate damage

| Defect Type | Confidence | Bounding Box |
|---|---|---|
| crack | 86.8% | (228, 232) -> (456, 447) |

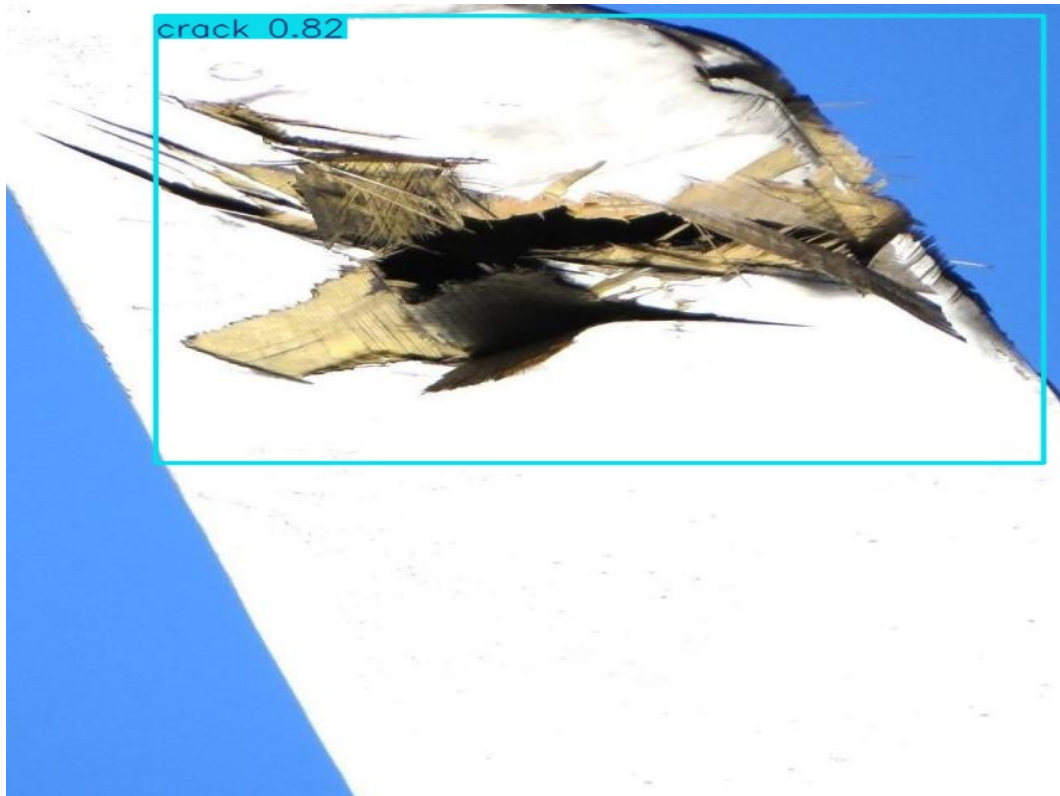
572\_jpg.rf.ad294dccd0c153a6ddfa3fd4b0720120.jpg

Score: 2.45 / 10

Moderate damage

| Defect Type | Confidence | Bounding Box |
|---|---|---|
| crack | 81.8% | (91, 10) -> (626, 370) |

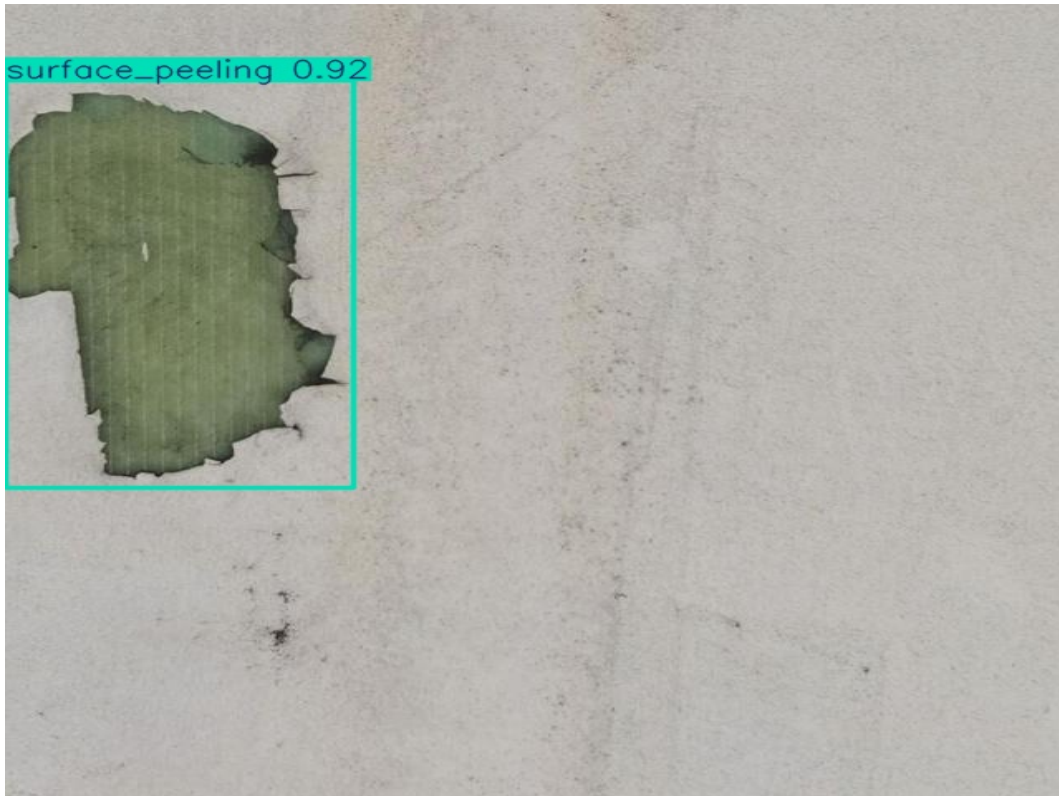
287\_jpg.rf.3e7c936d3e52ee836638b2c48c760b5f.jpg

Score: 1.39 / 10

Minor wear

| Defect Type | Confidence | Bounding Box |
|---|---|---|
| surface_peeling | 92.4% | (0, 61) -> (210, 389) |

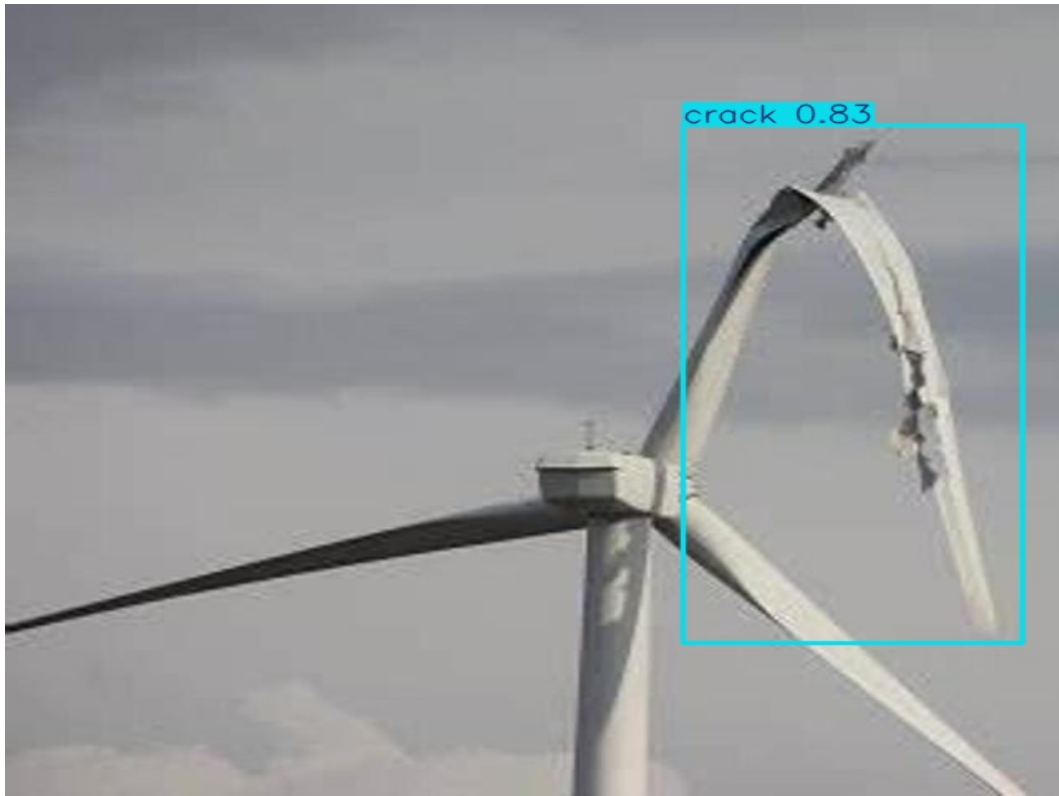
531\_jpg.rf.8bd202df6e16c08297c7a1899b9d561f.jpg

Score: 2.48 / 10

Moderate damage

| Defect Type | Confidence | Bounding Box |
|---|---|---|
| crack | 82.8% | (410, 97) -> (614, 514) |

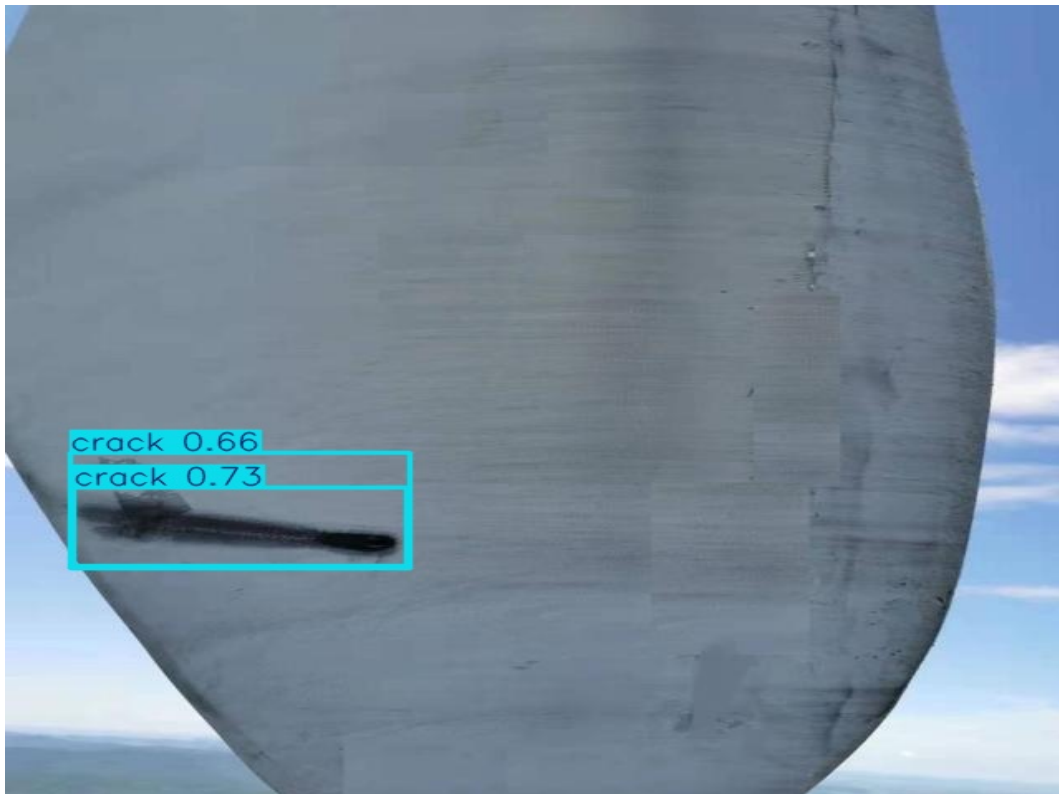
| Defect Type | Confidence | Bounding Box |
|---|---|---|
| crack | 72.8% | (42, 389) -> (243, 452) |
| crack | 65.8% | (40, 361) -> (244, 454) |

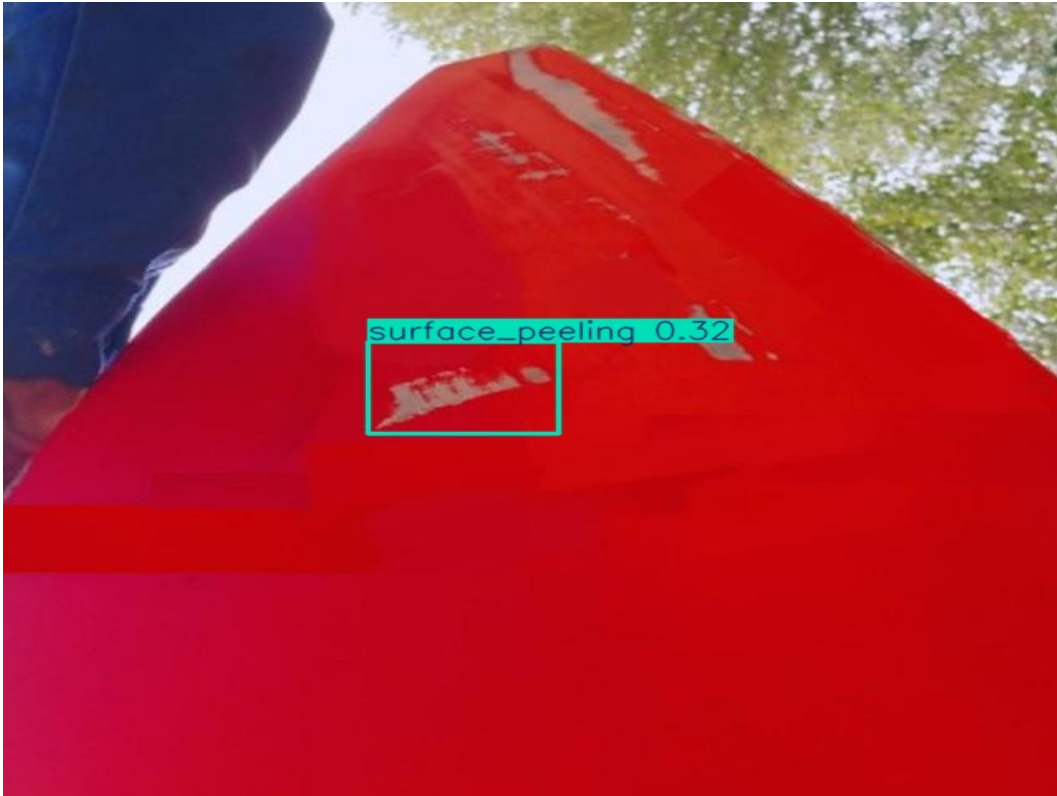
427\_jpg.rf.f2a1bce918b0c8cd4b78ccd798c50f1f.jpg

Score: 0.48 / 10

Minor wear

| Defect Type | Confidence | Bounding Box |
|---|---|---|
| surface_peeling | 32.3% | (221, 274) -> (335, 347) |

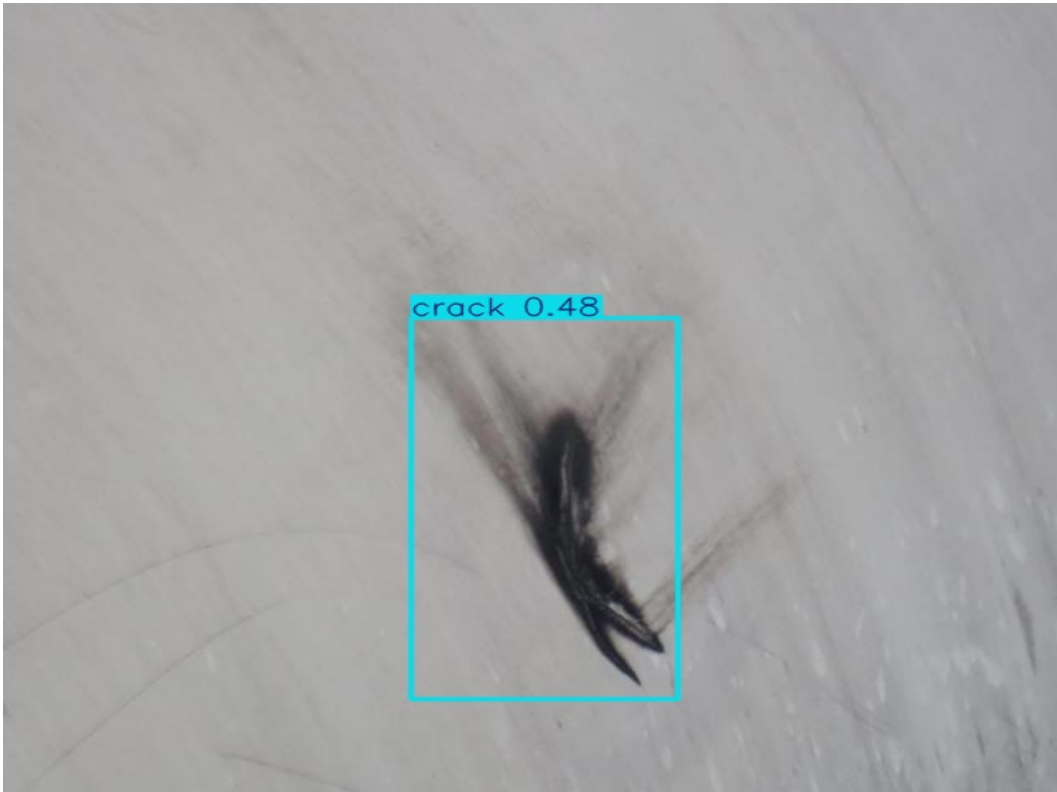
| Defect Type | Confidence | Bounding Box |
|---|---|---|
| crack | 47.8% | (247, 254) -> (407, 560) |

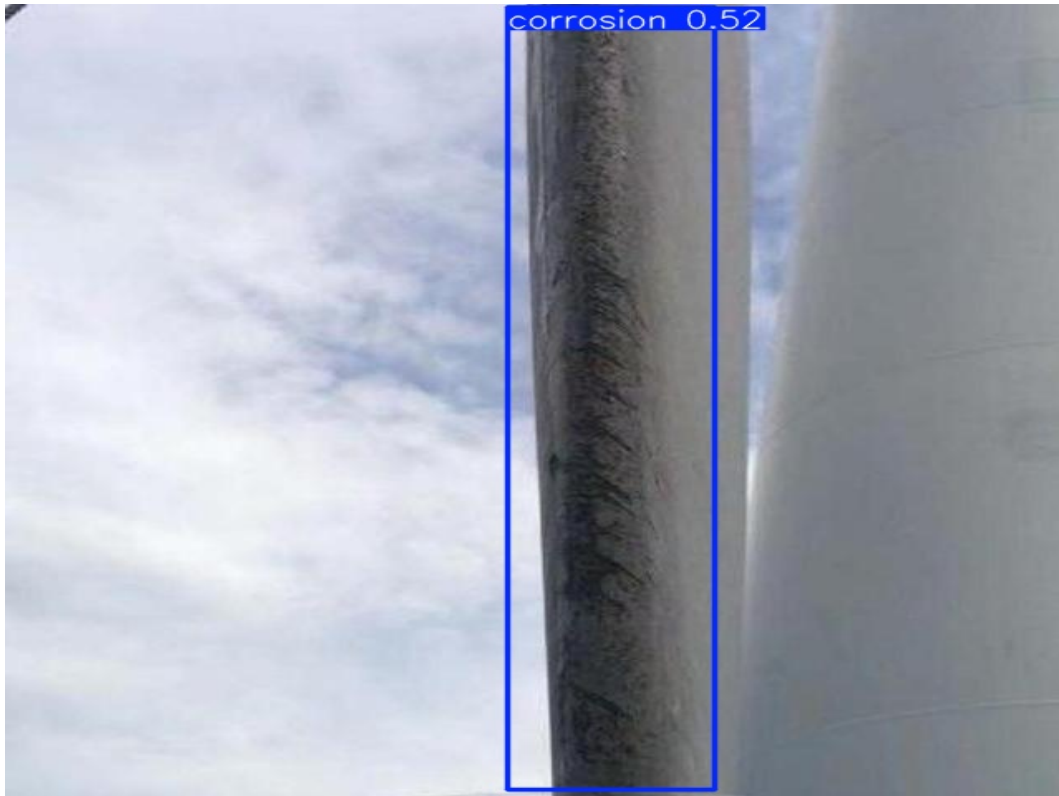
120\_jpg.rf.a7f078c9ec36c8bcf2e78aedba739533.jpg

Score: 1.03 / 10

Minor wear

| Defect Type | Confidence | Bounding Box |
|---|---|---|
| corrosion | 51.7% | (303, 2) -> (428, 633) |

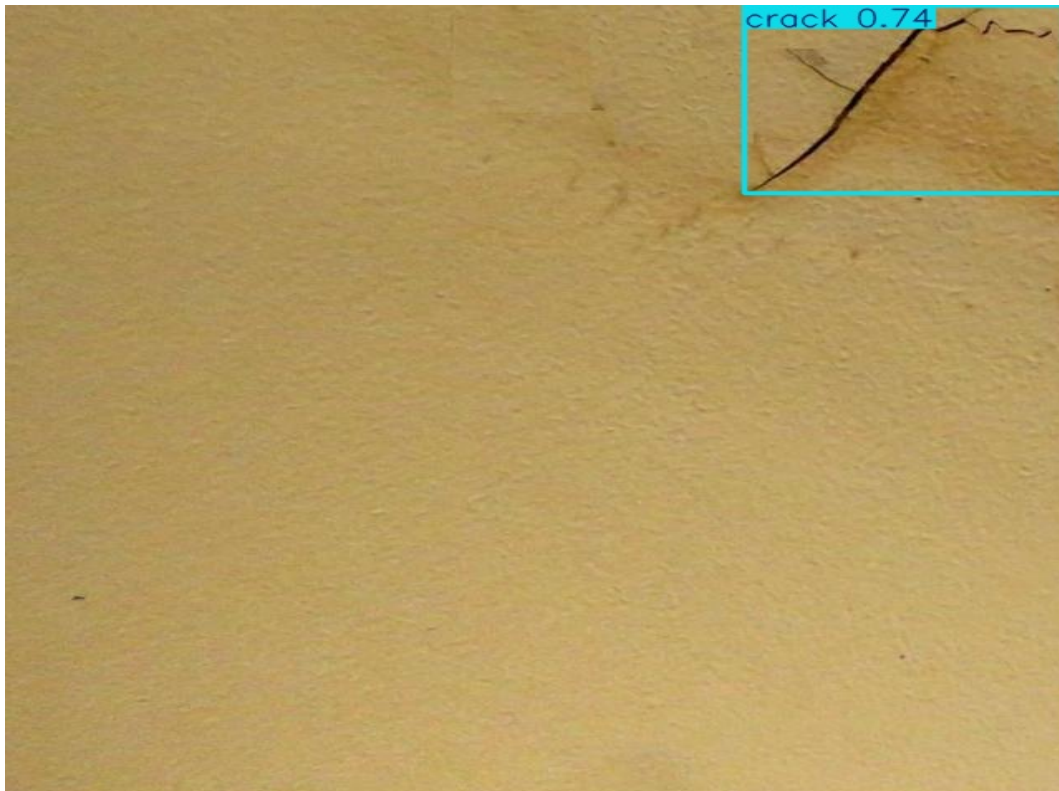
121\_jpg.rf.5e6feeed4099d6f689b25661f532b5cf.jpg

Score: 2.22 / 10

Moderate damage

| Defect Type | Confidence | Bounding Box |
|---|---|---|
| crack | 73.9% | (446, 0) -> (640, 152) |

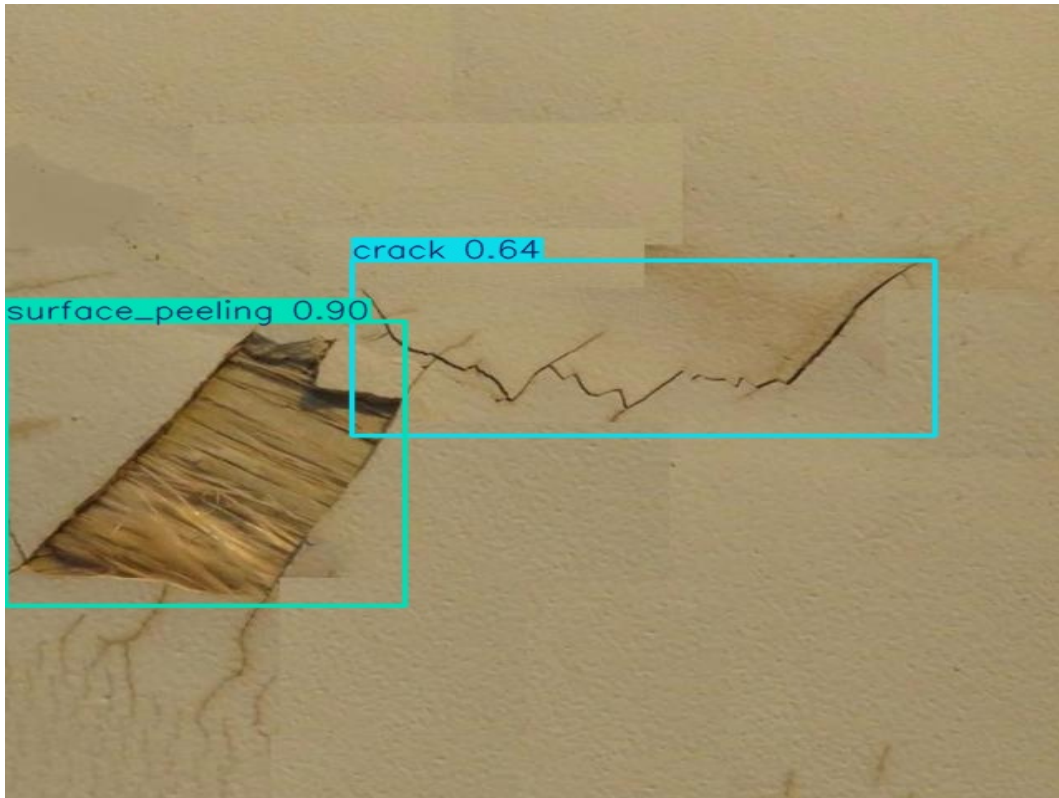
595\_jpg.rf.17f5d3601e70a4ca29c21110fc76eb3c.jpg

Score: 3.27 / 10

Moderate damage

| Defect Type | Confidence | Bounding Box |
|---|---|---|
| surface_peeling | 89.7% | (0, 255) -> (241, 484) |
| crack | 64.2% | (210, 206) -> (561, 348) |

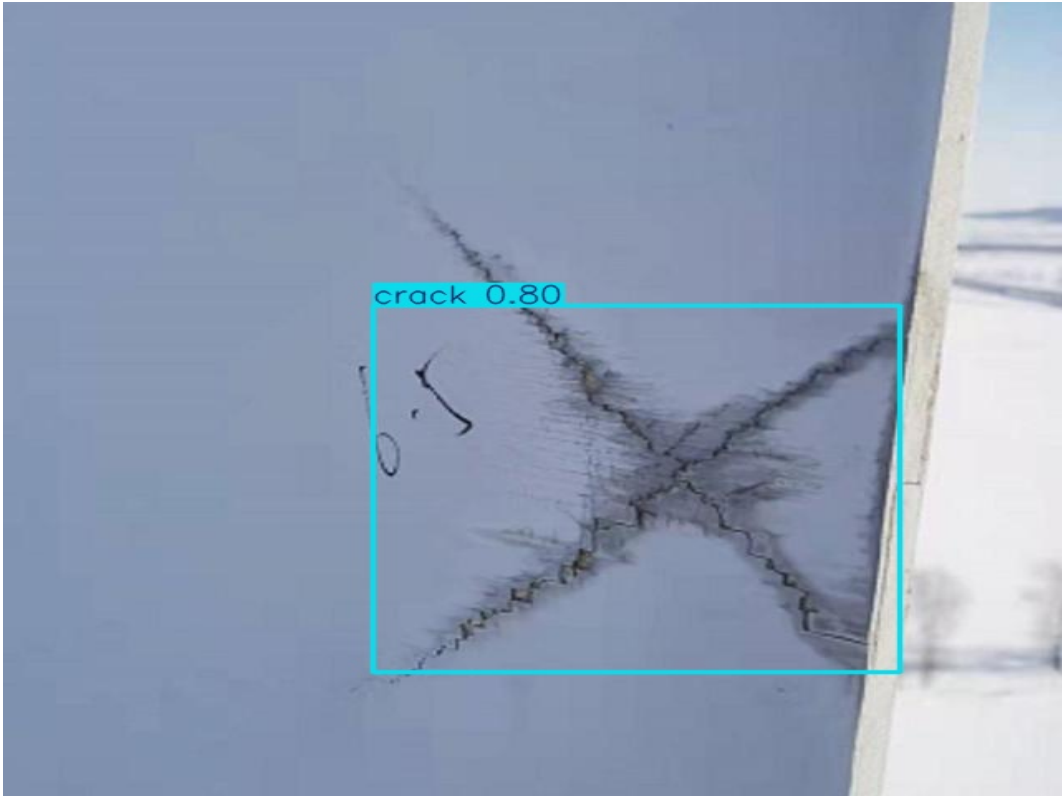
618\_jpg.rf.1878d31e066ba366e295a21342e088c0.  
jpg

Score: 2.4 / 10

Moderate damage

| Defect Type | Confidence | Bounding Box |
|---|---|---|
| crack | 79.9% | (224, 244) -> (542, 540) |

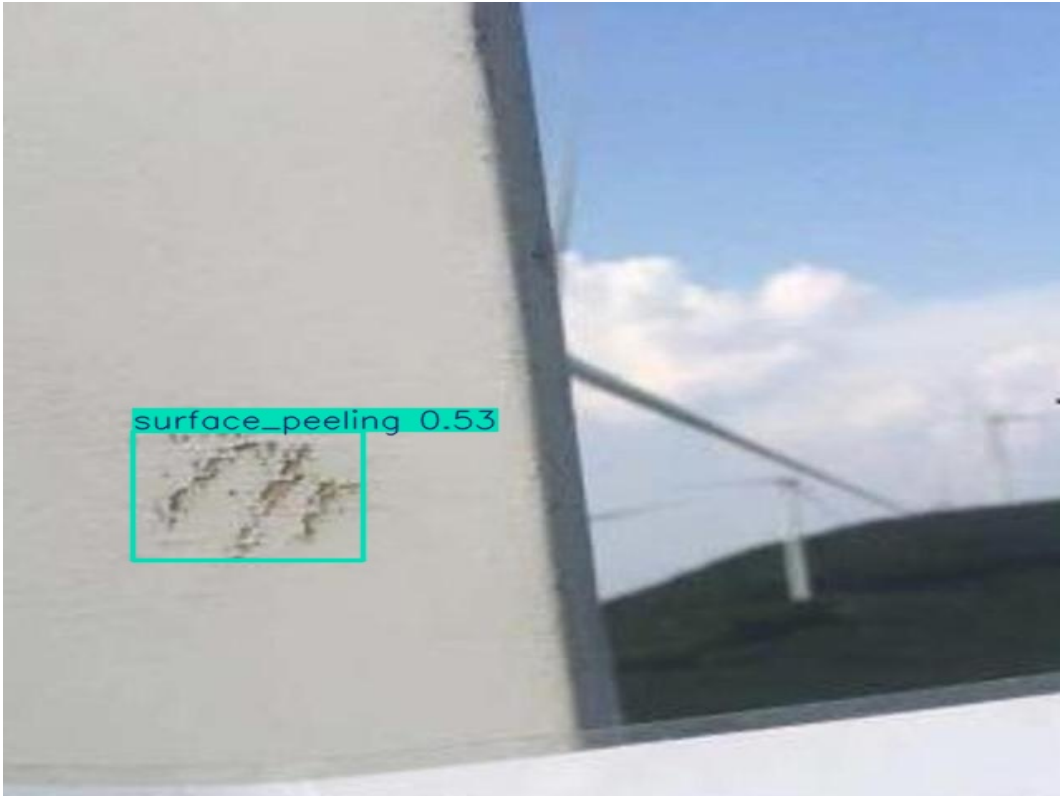
390\_jpg.rf.373ad02a3ab116042c178ed21fe5cb31.jpg

Score: 0.79 / 10

Minor wear

| Defect Type | Confidence | Bounding Box |
|---|---|---|
| surface_peeling | 52.6% | (78, 346) -> (218, 450) |

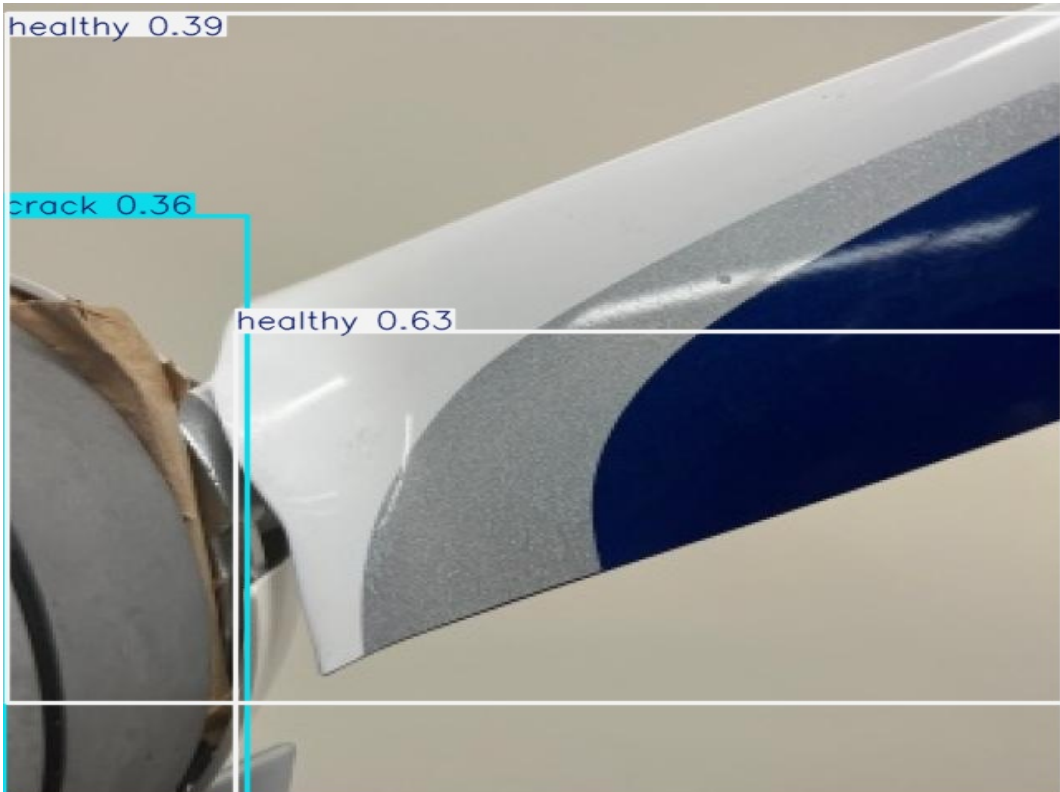
| Defect Type | Confidence | Bounding Box |
|---|---|---|
| crack | 36.4% | (0, 172) -> (148, 640) |

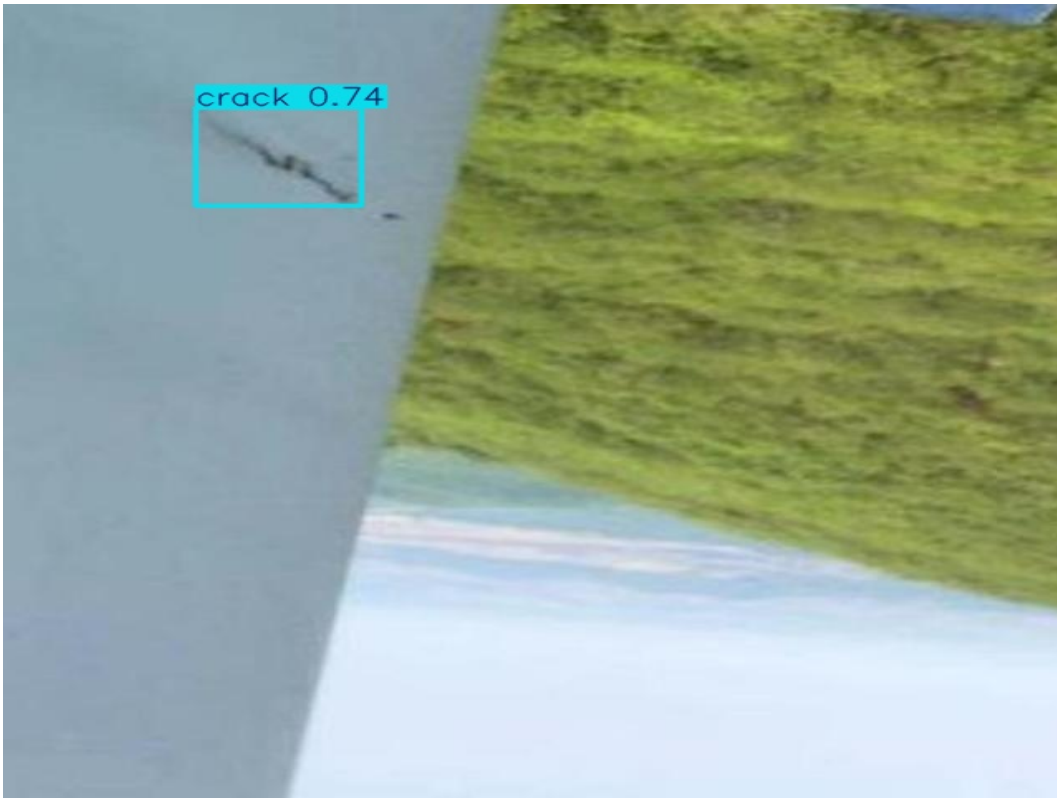
463\_jpg.rf.cc217e5a7c912cd87820ee3153790208.jpg

Score: 2.23 / 10

Moderate damage

| Defect Type | Confidence | Bounding Box |
|---|---|---|
| crack | 74.5% | (116, 84) -> (216, 162) |

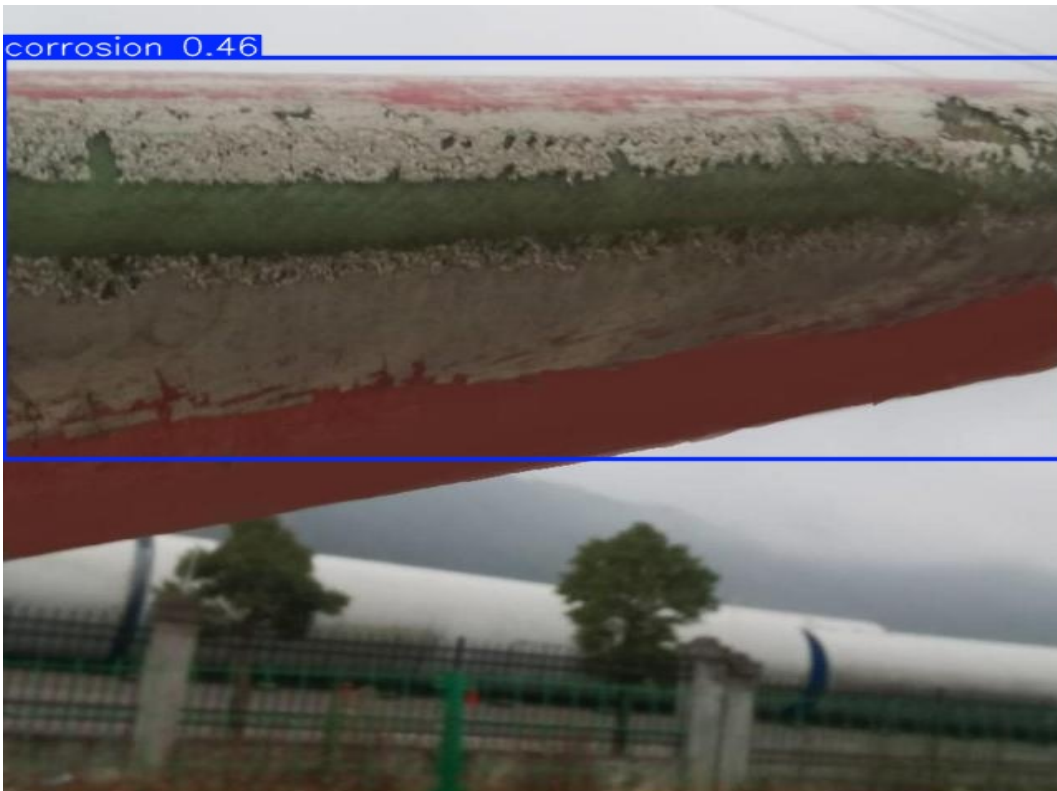
| Defect Type | Confidence | Bounding Box |
|---|---|---|
| corrosion | 45.8% | (0, 42) -> (640, 365) |

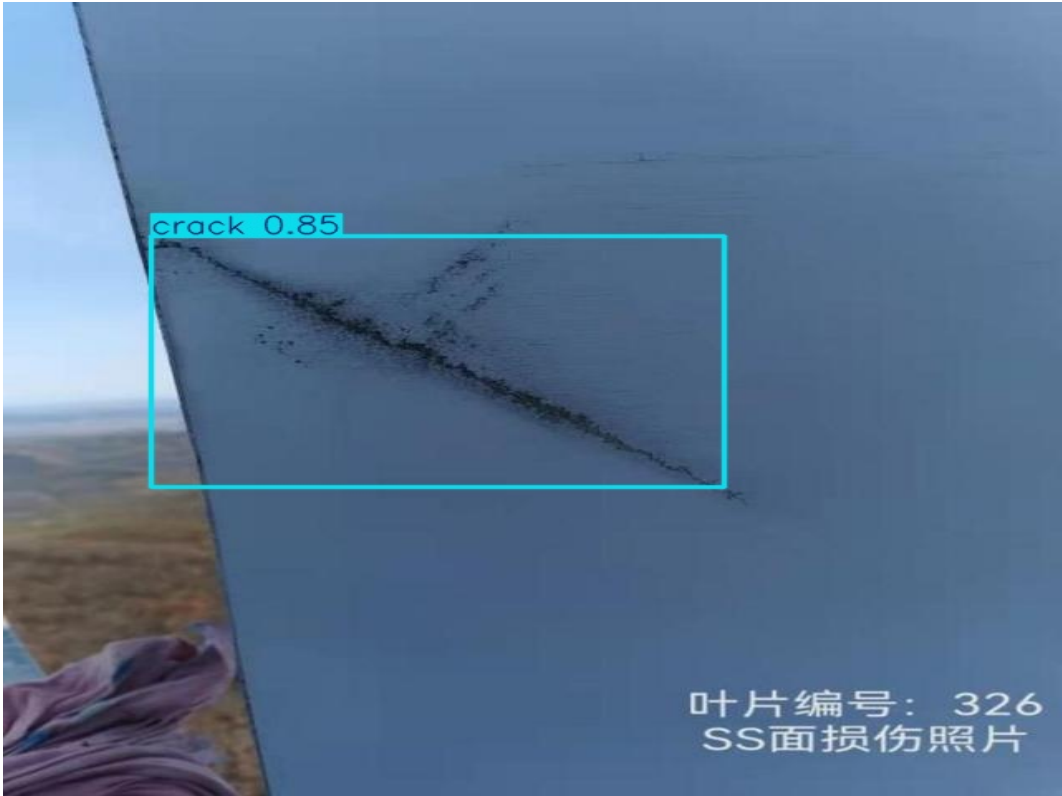
718\_jpg.rf.1268d71b307a54c2f9ef73849ef84421.jpg

Score: 2.56 / 10

Moderate damage

| Defect Type | Confidence | Bounding Box |
|---|---|---|
| crack | 85.2% | (89, 189) -> (436, 391) |

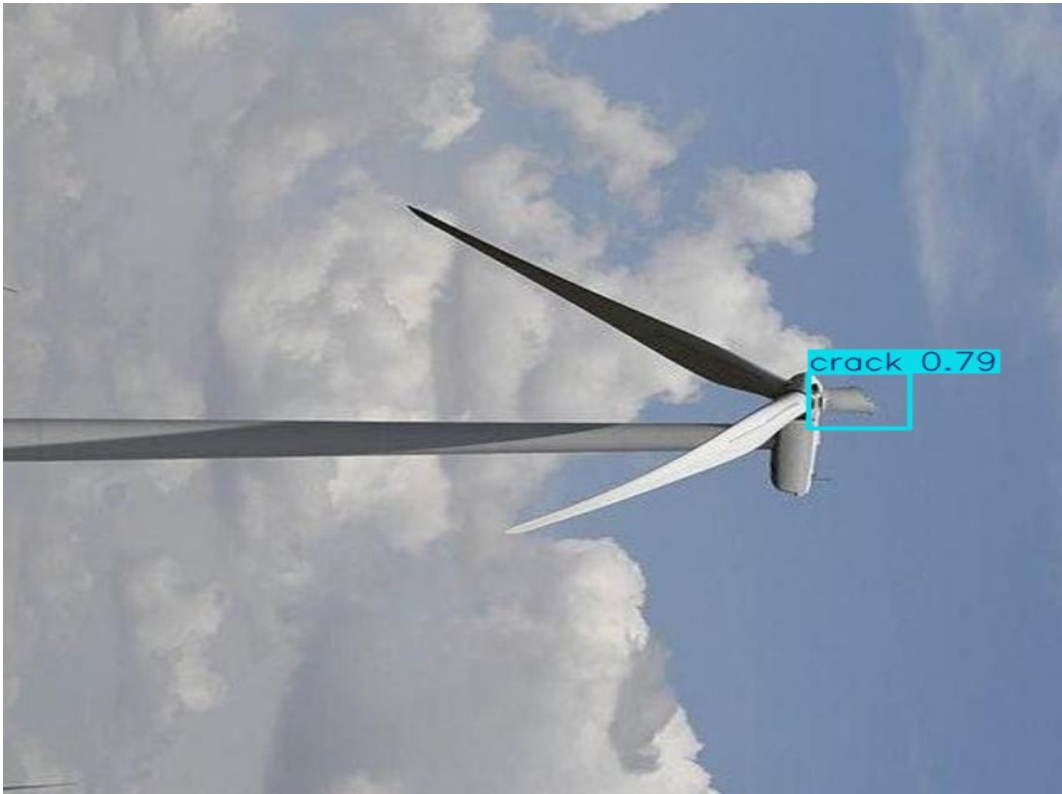
| Defect Type | Confidence | Bounding Box |
|---|---|---|
| crack | 78.9% | (487, 298) -> (547, 342) |

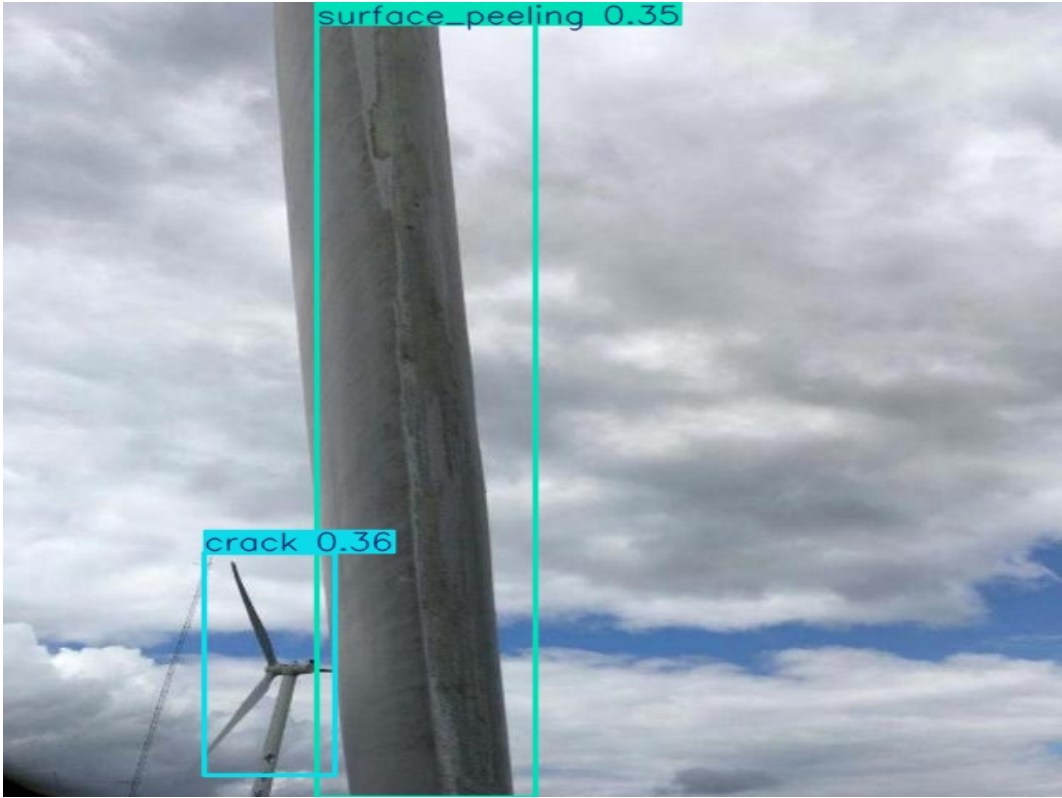
162\_jpg.rf.a9468bda2367593d8f1c546f027db3de.jpg

Score: 1.62 / 10

Minor wear

| Defect Type | Confidence | Bounding Box |
|---|---|---|
| crack | 36.4% | (122, 444) -> (200, 622) |
| surface_peeling | 35.2% | (190, 0) -> (322, 640) |

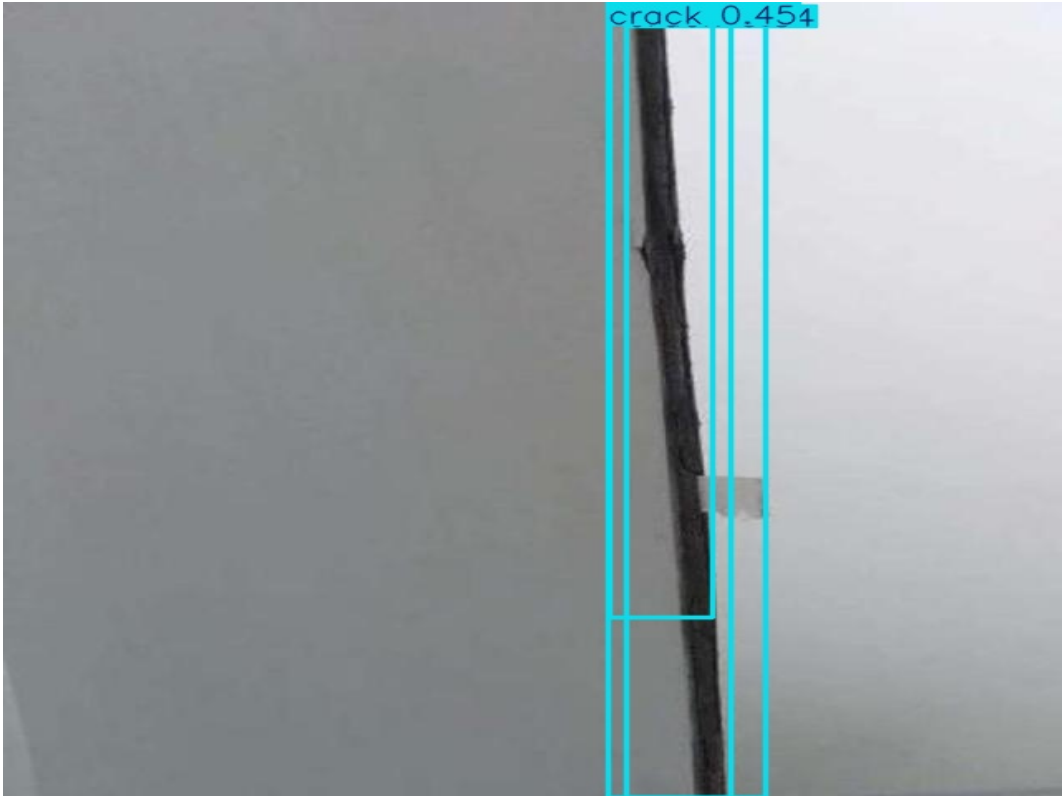
329\_jpg.rf.45c807749a947a7eaa5db97c252c84a4.  
jpg

Score: 3.12 / 10

Moderate damage

| Defect Type | Confidence | Bounding Box |
|---|---|---|
| crack | 44.8% | (366, 1) -> (439, 640) |
| crack | 34.1% | (376, 3) -> (460, 640) |
| crack | 25.1% | (366, 0) -> (429, 495) |

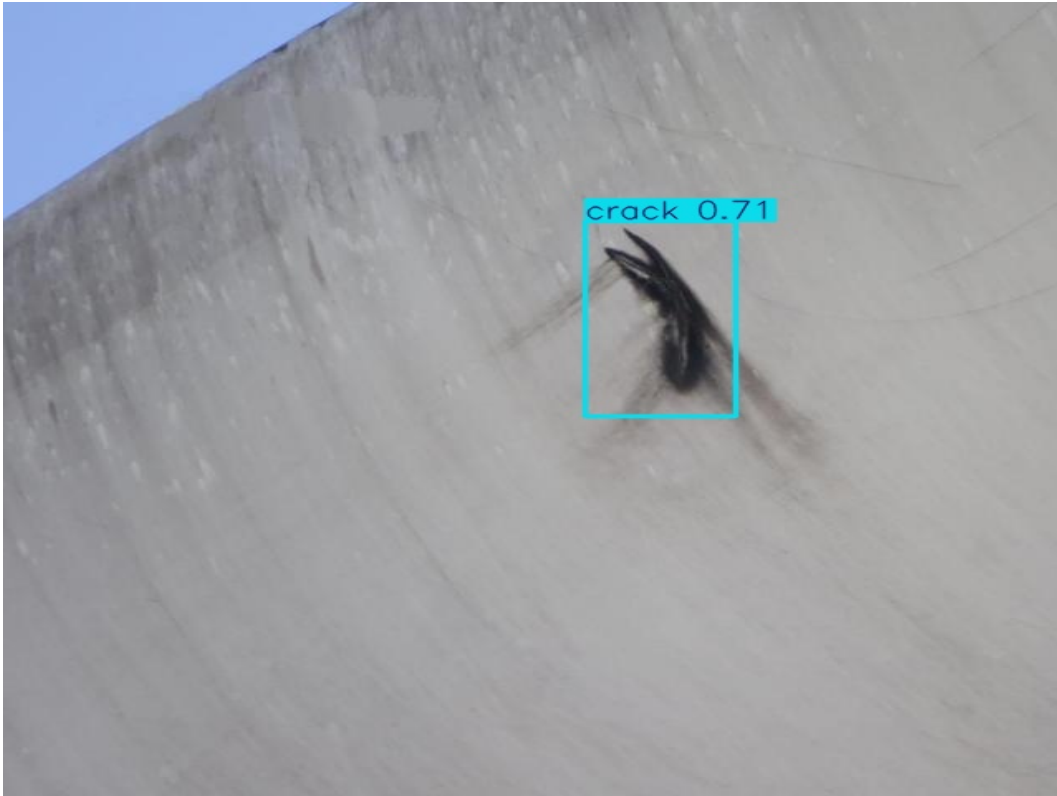
316\_jpg.rf.4a55d51cd22d82601aaea6994a81a876.  
jpg

Score: 2.12 / 10

Moderate damage

| Defect Type | Confidence | Bounding Box |
|---|---|---|
| crack | 70.6% | (351, 176) -> (443, 334) |

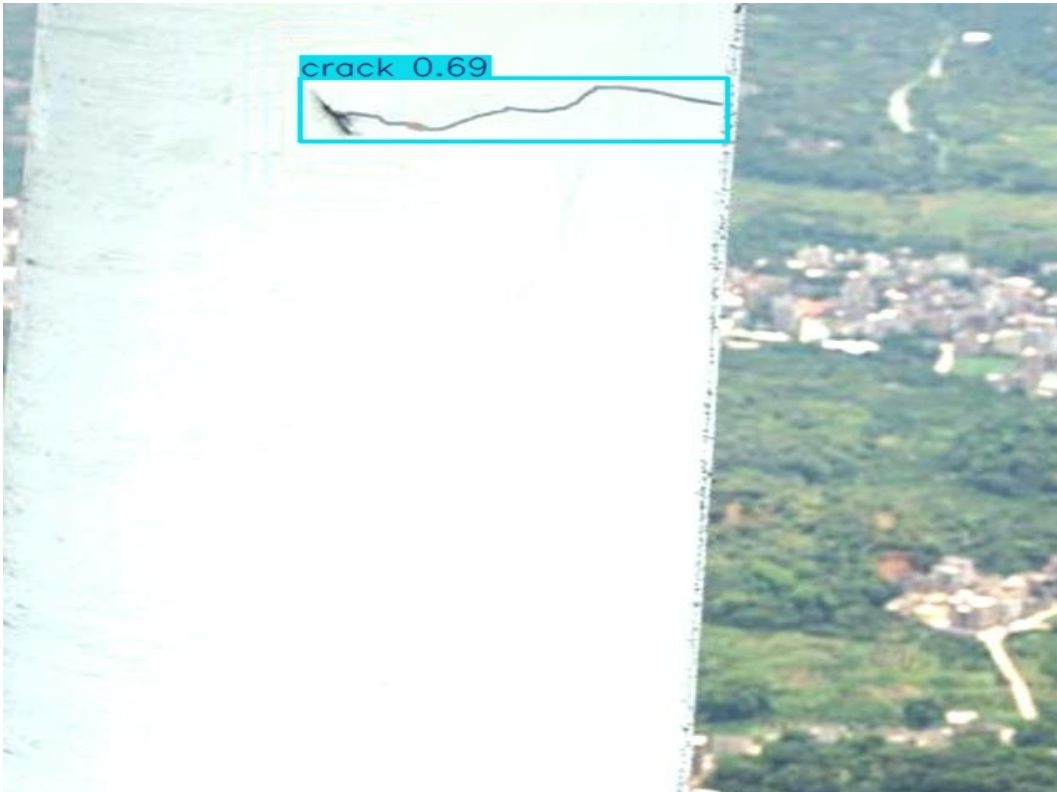
| Defect Type | Confidence | Bounding Box |
|---|---|---|
| crack | 69.0% | (180, 61) -> (437, 112) |

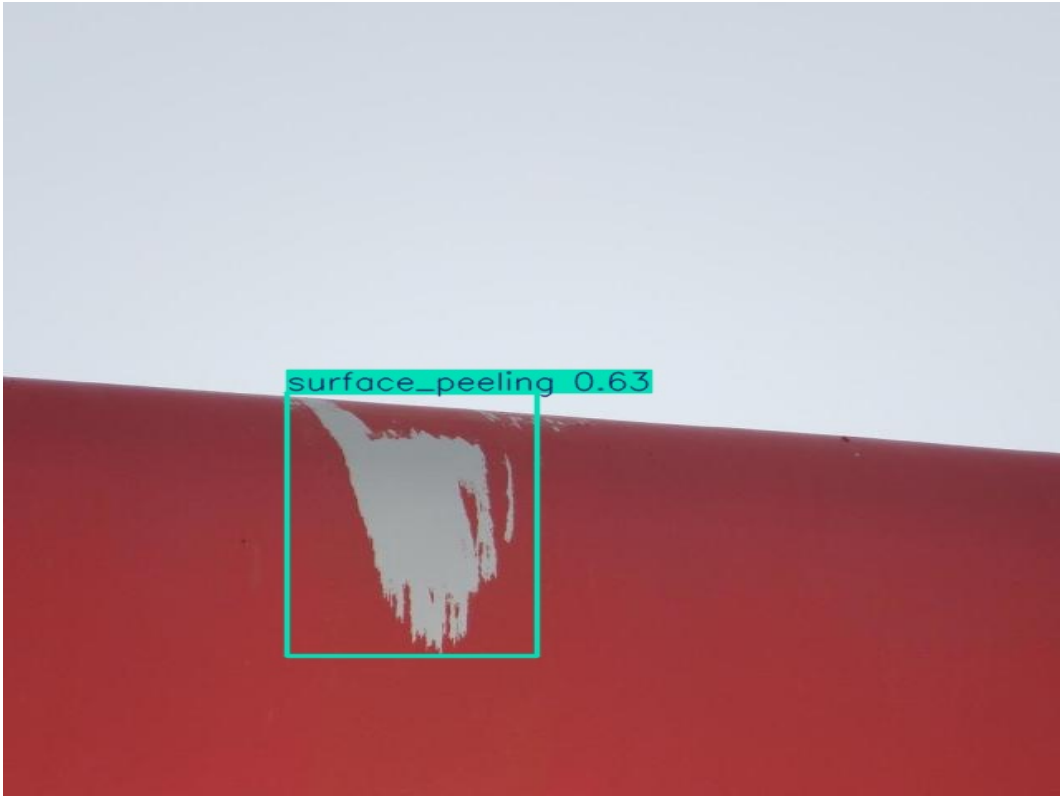
432\_jpg.rf.9d73e841fcc724468ce465d050fd5812.jpg

Score: 0.94 / 10

Minor wear

| Defect Type | Confidence | Bounding Box |
|---|---|---|
| surface_peeling | 62.8% | (171, 315) -> (322, 526) |

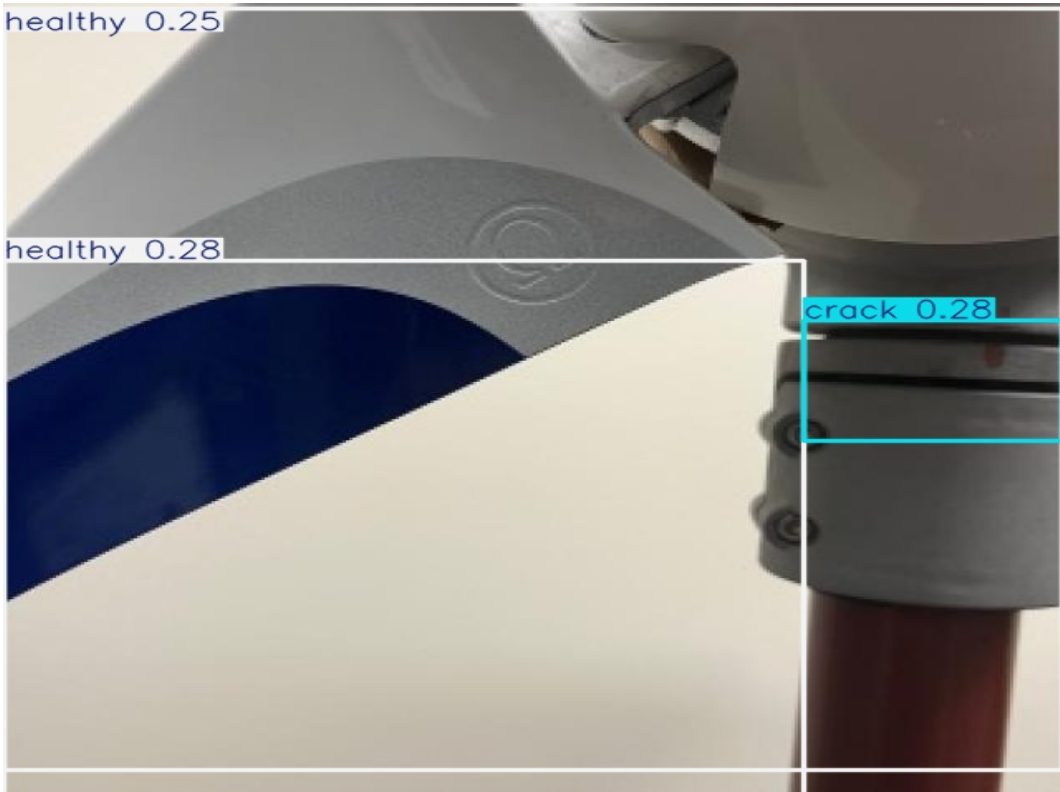
| Defect Type | Confidence | Bounding Box |
|---|---|---|
| crack | 27.7% | (483, 256) -> (640, 352) |

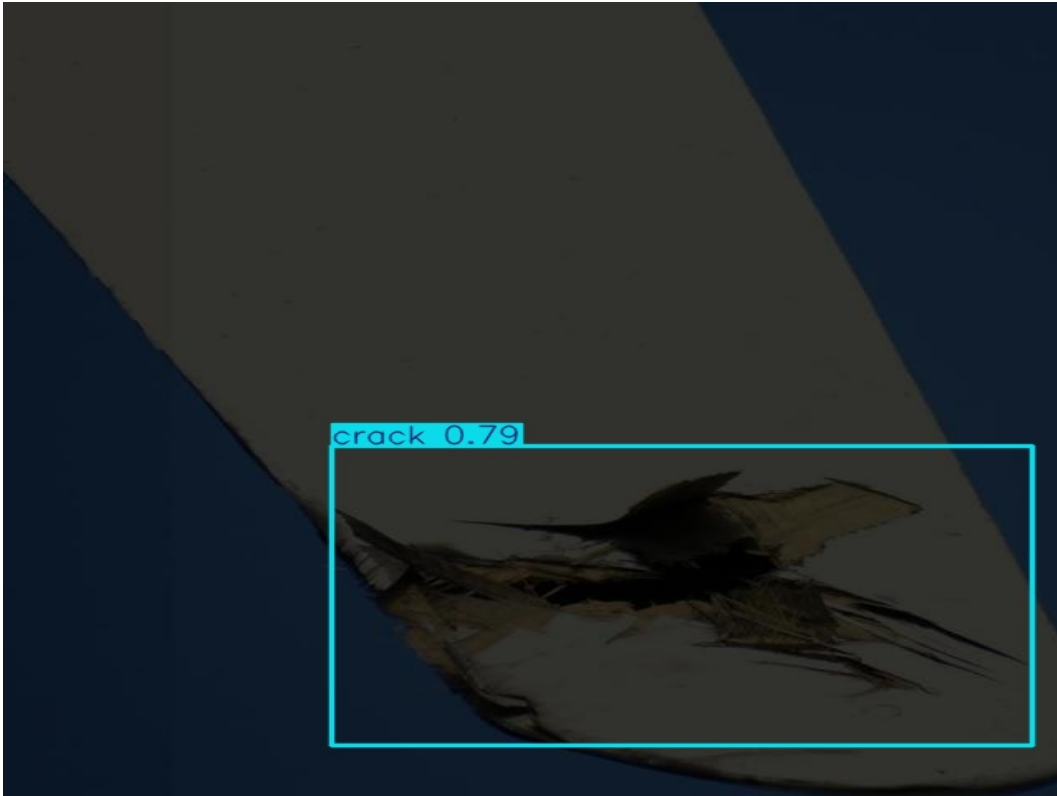
886\_jpg.rf.309a886db30299969625ce69d7dff3ae.jpg

Score: 2.37 / 10

Moderate damage

| Defect Type | Confidence | Bounding Box |
|---|---|---|
| crack | 79.1% | (198, 358) -> (622, 598) |

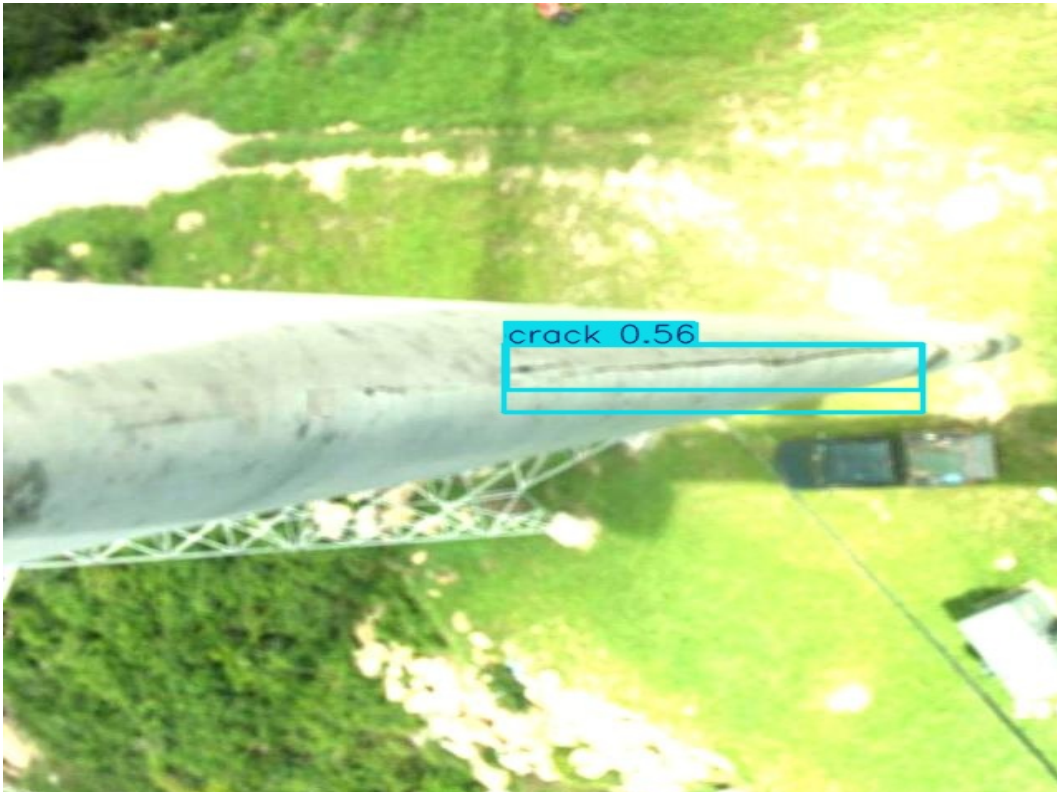
946\_jpg.rf.d8ea32f2ccd70a95ae0b1d72254ab58d.jpg

Score: 2.5 / 10

Moderate damage

| Defect Type | Confidence | Bounding Box |
|---|---|---|
| crack | 55.9% | (305, 275) -> (554, 312) |
| crack | 27.6% | (303, 274) -> (556, 330) |

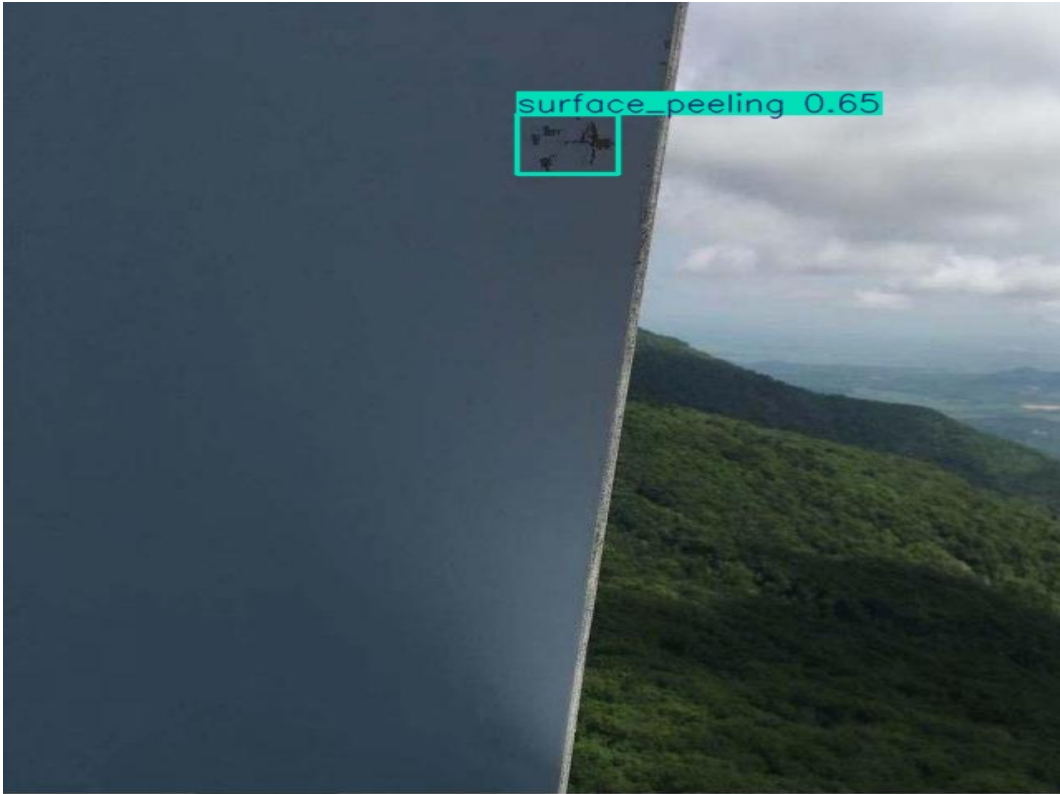
2\_jpg.rf.852b98d4d1e25f2add492c0eb5d35857.jpg

Score: 0.98 / 10

Minor wear

| Defect Type | Confidence | Bounding Box |
|---|---|---|
| surface_peeling | 65.0% | (311, 90) -> (372, 139) |
