# WIND TURBINE INSPECTION REPORT

Autonomous Drone Inspection System

| Turbine ID | TRB-001 |

Overall Status: Moderate damage detected

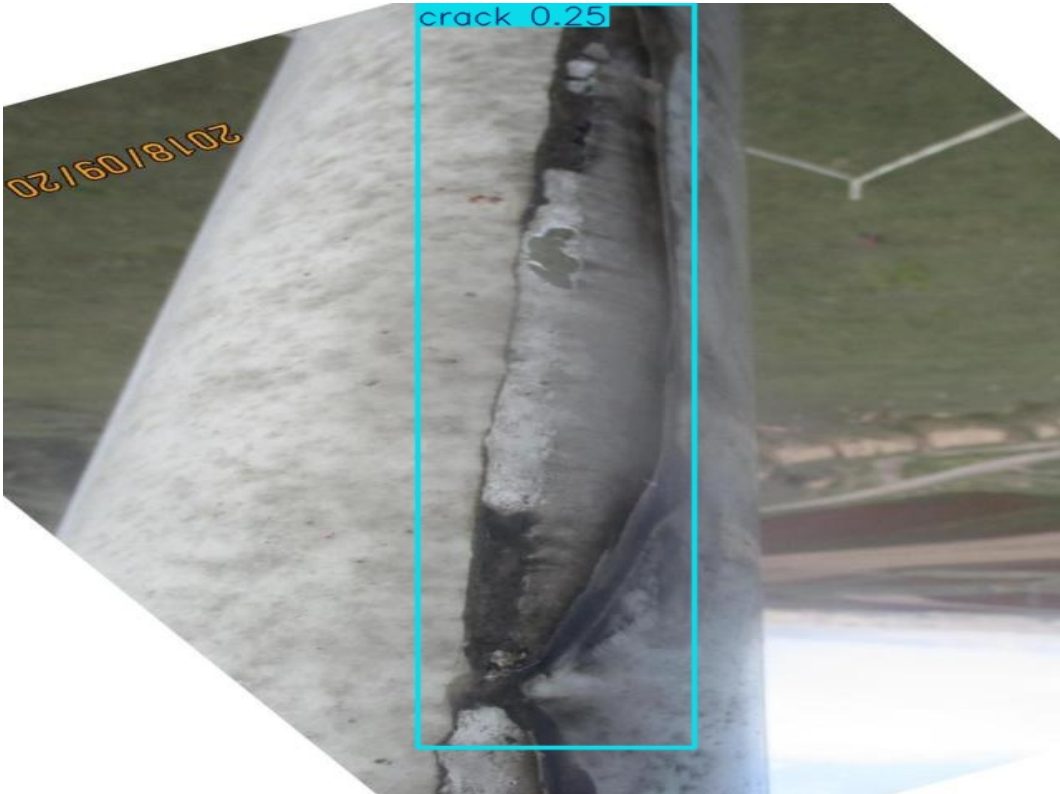
| Defect Type | Confidence | Bounding Box |
|---|---|---|
| crack | 25.5% | (250, 0) -> (417, 600) |
