# Drone Inspection

Wind turbine blade & solar panel defect analysis

Generated September 6, 2026 at 7:15 PM · 4 of 4 images analysed · models: turbine turbine.onnx

## Minor wear detected

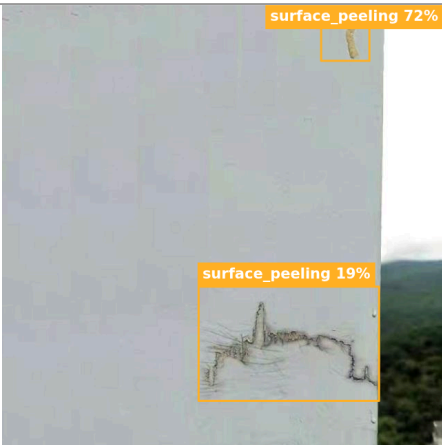
blade\_01.jpg

Minor wear · score 0.91

Wind turbine blade · 2 detections

- surface\_peeling — 71.6%
- surface\_peeling — 19.1%

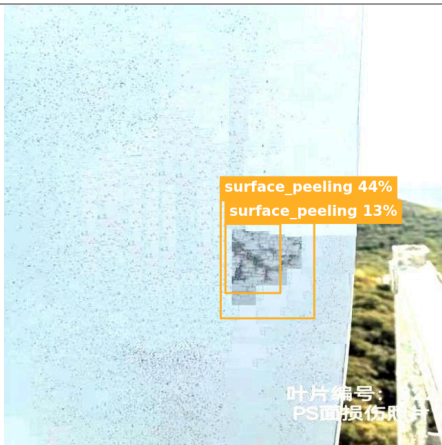
blade\_02.jpg

Minor wear · score 0.58

Wind turbine blade · 2 detections

- surface\_peeling — 44.4%
- surface\_peeling — 13.4%

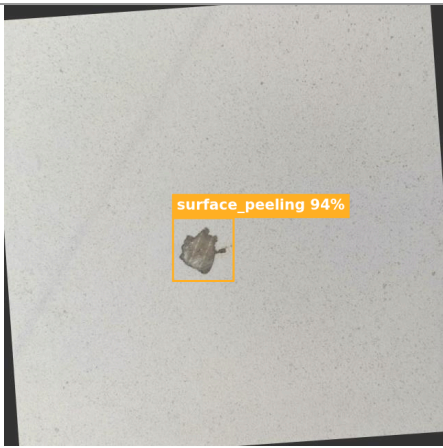
**blade\_03.jpg**

Minor wear · score 0.94

Wind turbine blade · 1 detection

■ surface\_peeling — 94.0%

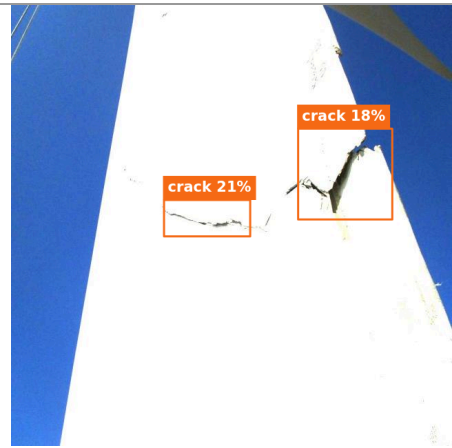
**blade\_04.jpg**

Minor wear · score 1.17

Wind turbine blade · 2 detections

■ crack — 20.7%

■ crack — 18.4%
