Pigeon Roosting Mitigation – Telegraph-Channing Garage

Berkeley Public Works Site Visit Summary

September 03 2024

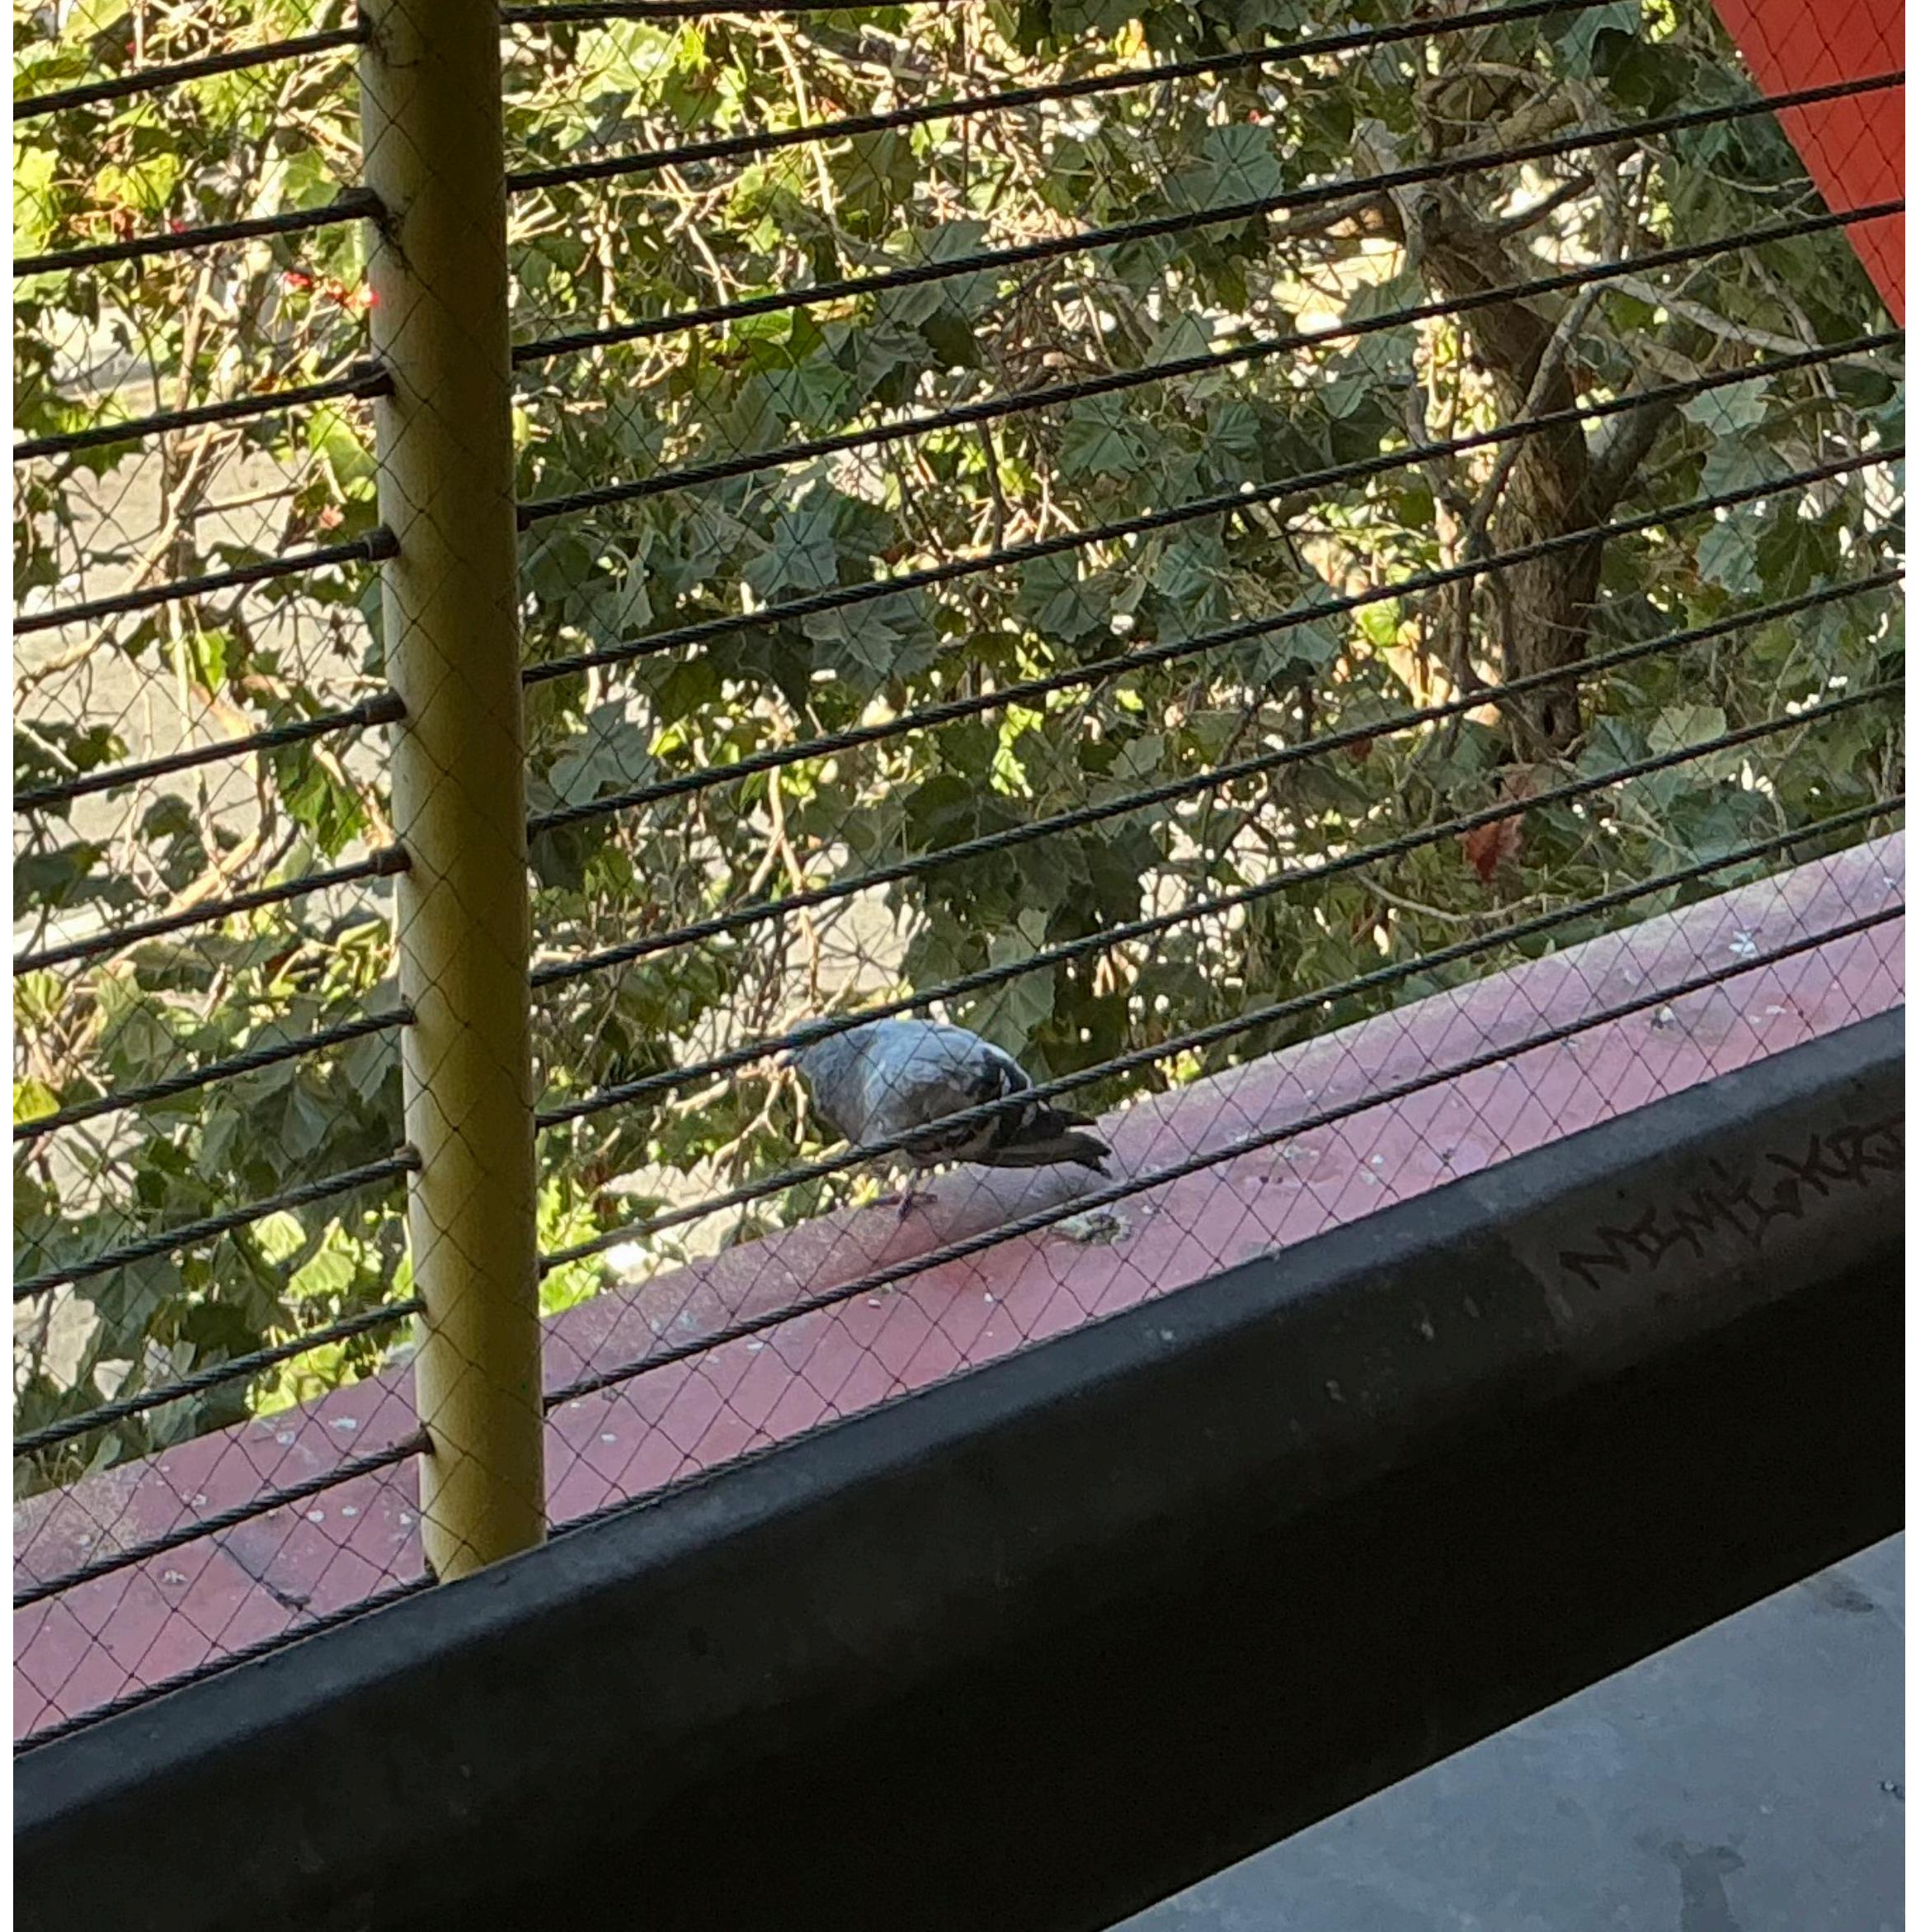
- Pigeons have become a persistent problem, roosting on various levels of the parking garage and causing operational and cleanliness issues.
- **Purpose of the site visit:** To observe the current pigeon deterrent measures and identify areas for improvement.

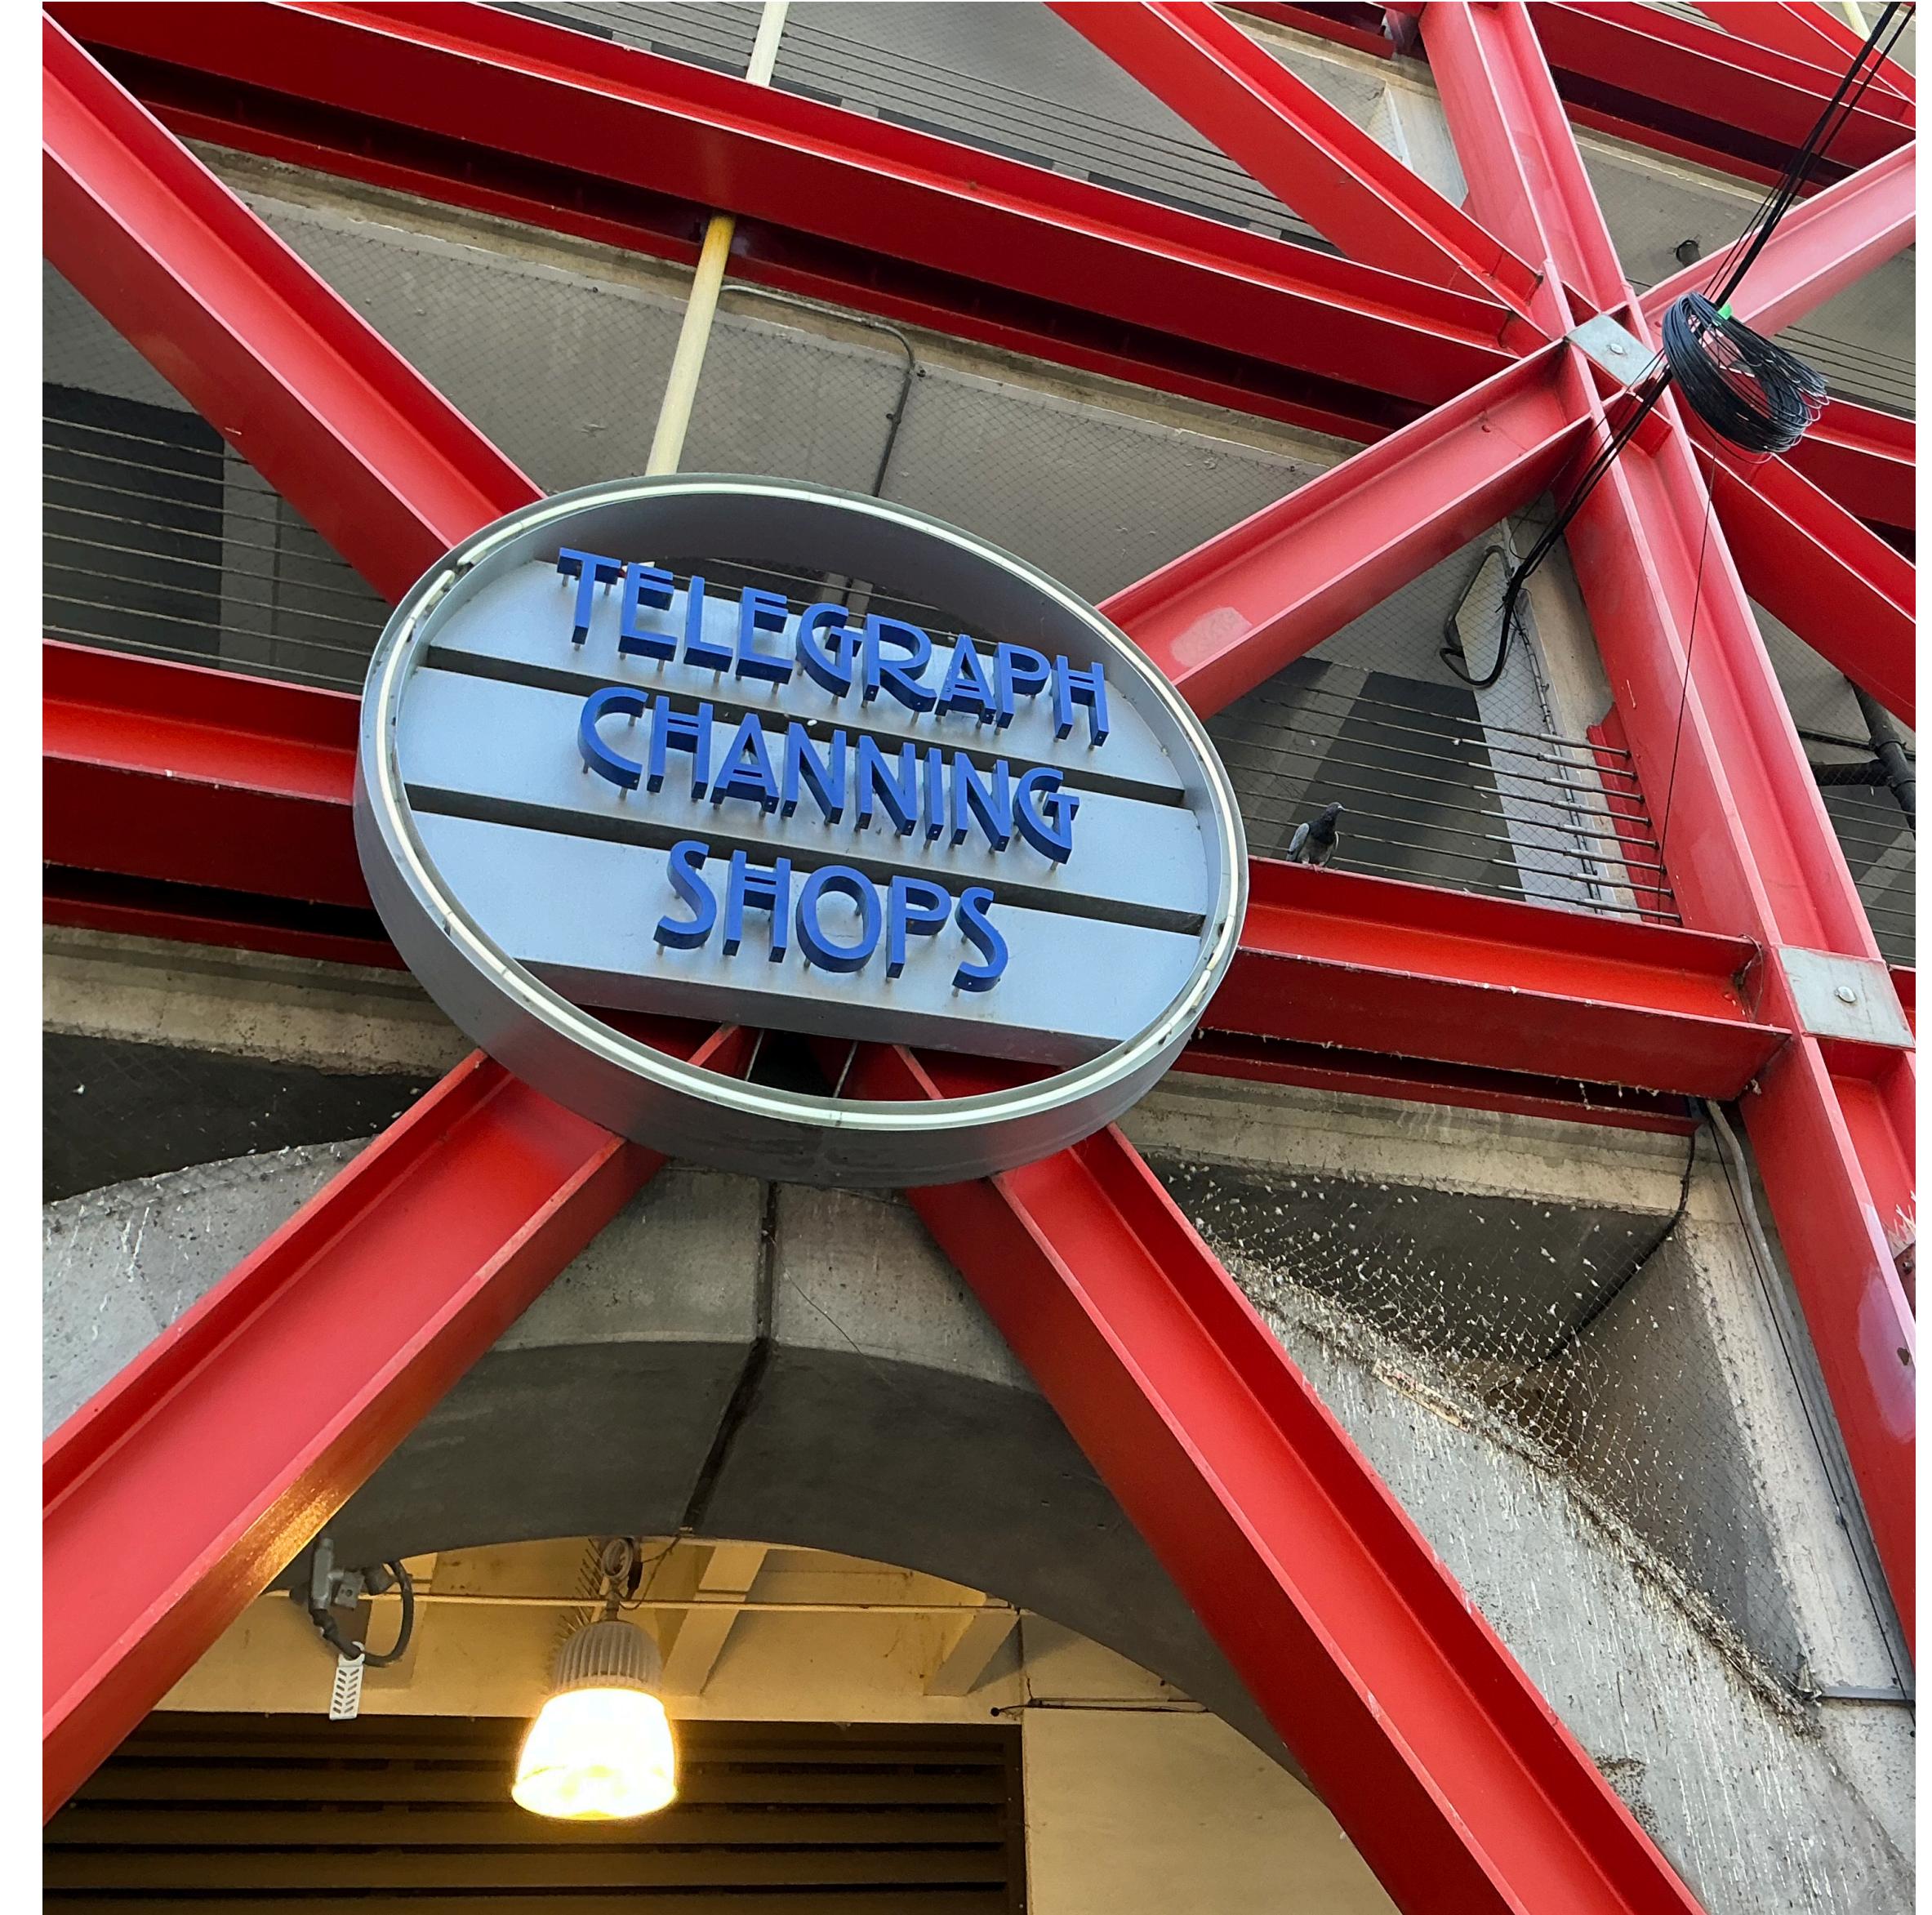
- The parking garage is primarily maintained by outsourced companies that focus more on revenue than building upkeep.
- **This leads to ineffective maintenance, which exacerbates the pigeon roosting issue. Grey space with responsibilities.**

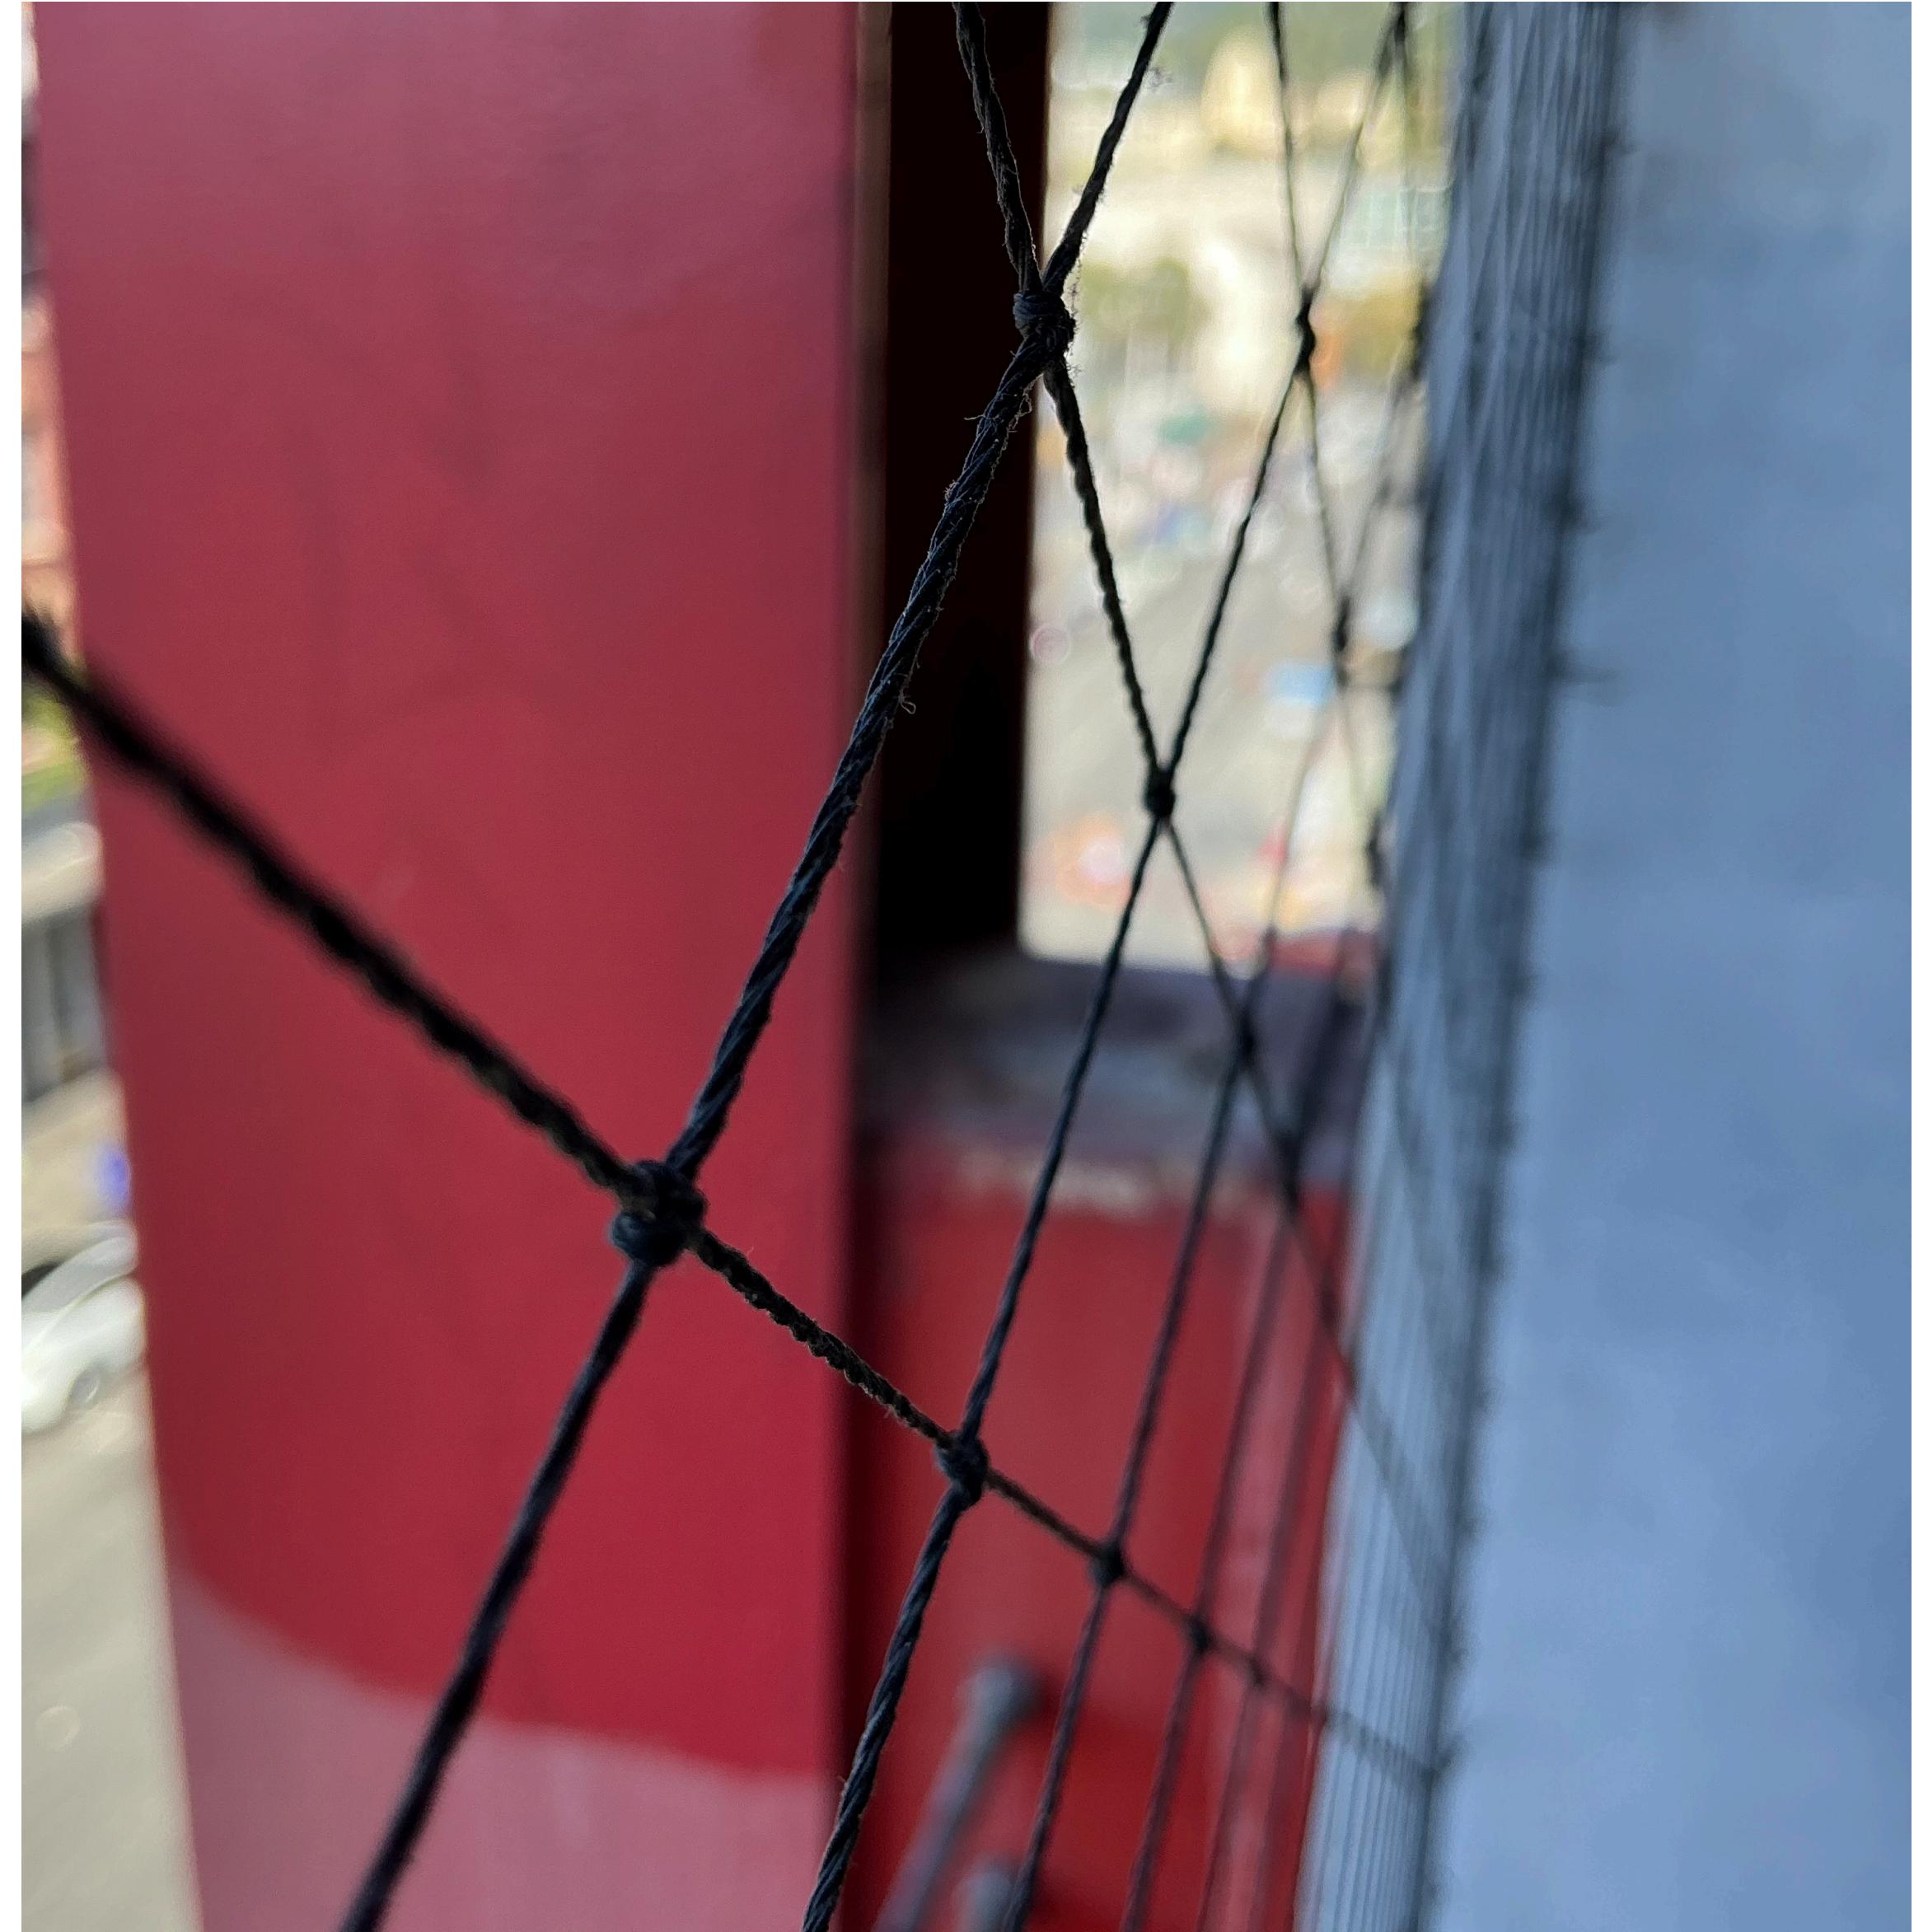
Nylon Netting

- Rather successful in preventing pigeons from accessing certain areas, particularly in the middle levels of the garage. However, the netting has torn over time and requires consistent maintenance to remain effective. This is a material issue, and we feel can be resolved with the deployment of stronger netting. Also, netting is inside building, so pigeons still perch on ledge.

Upgrade the netting material to something more durable, capable of withstanding the outdoor environment

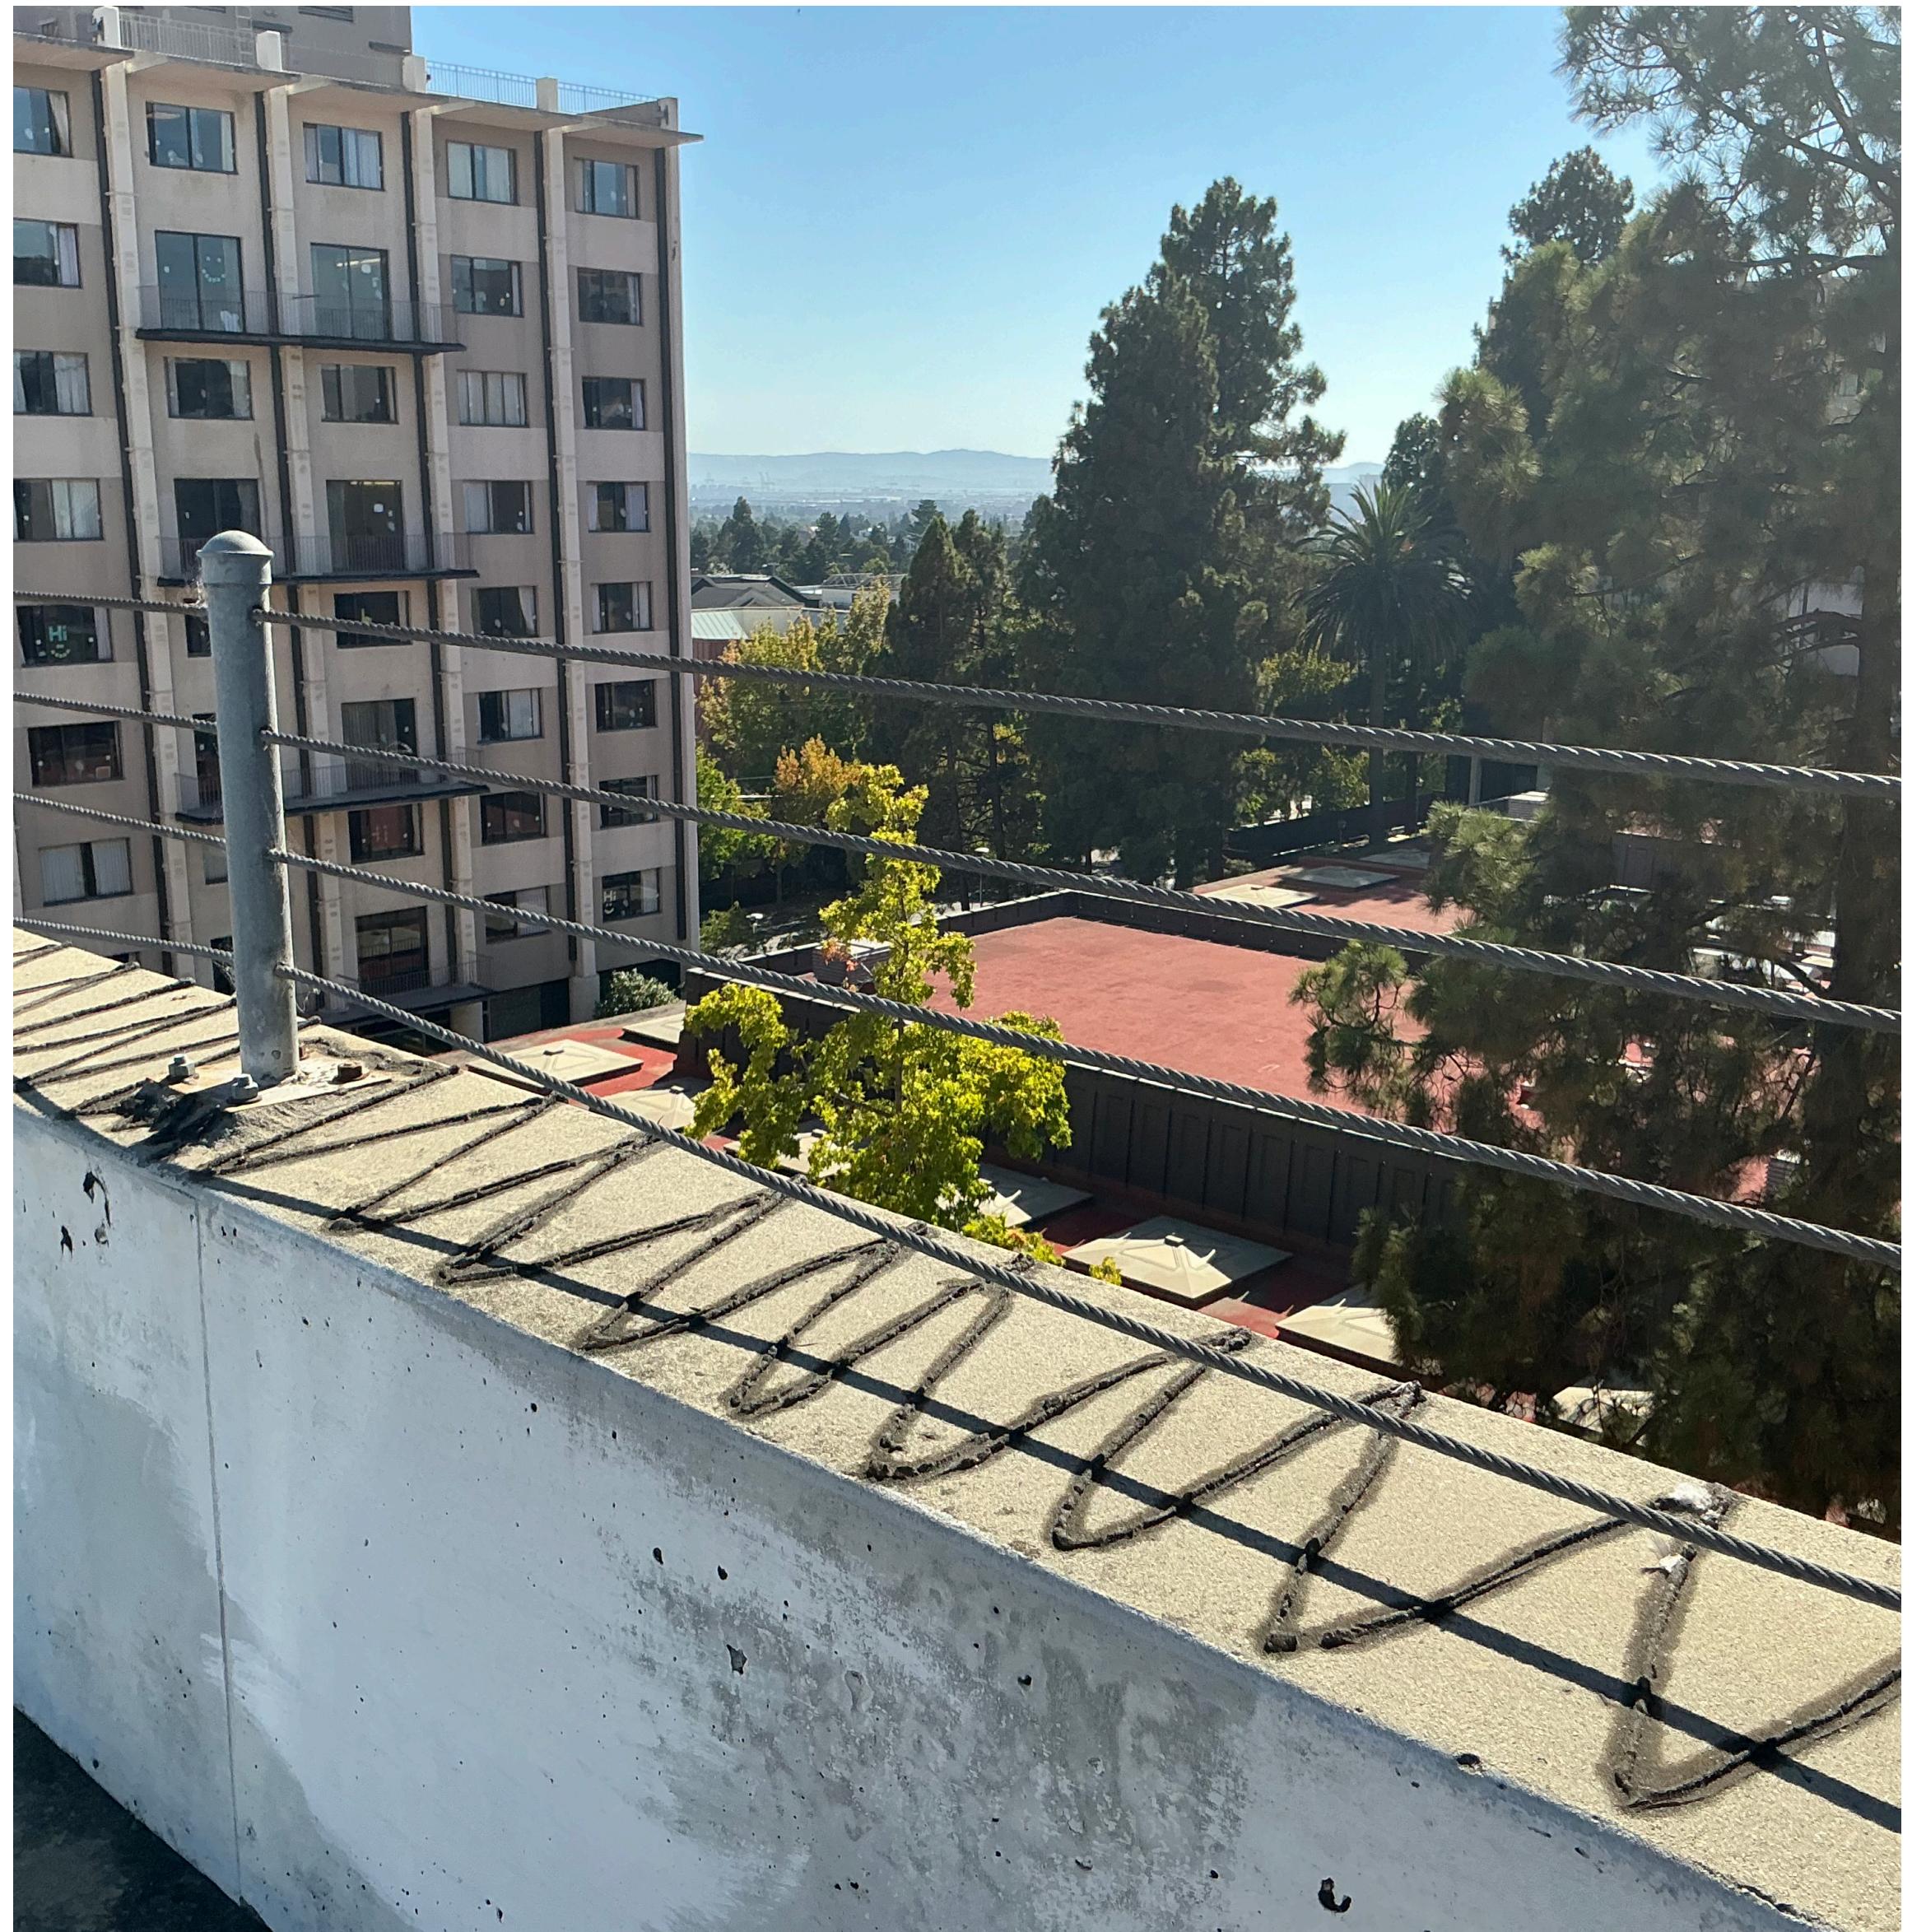
Sticky Solution

- Initially seems like a good deterrent but loses effectiveness quickly as it attracts debris, loses stickiness, and becomes both unappealing and nonfunctional over time.

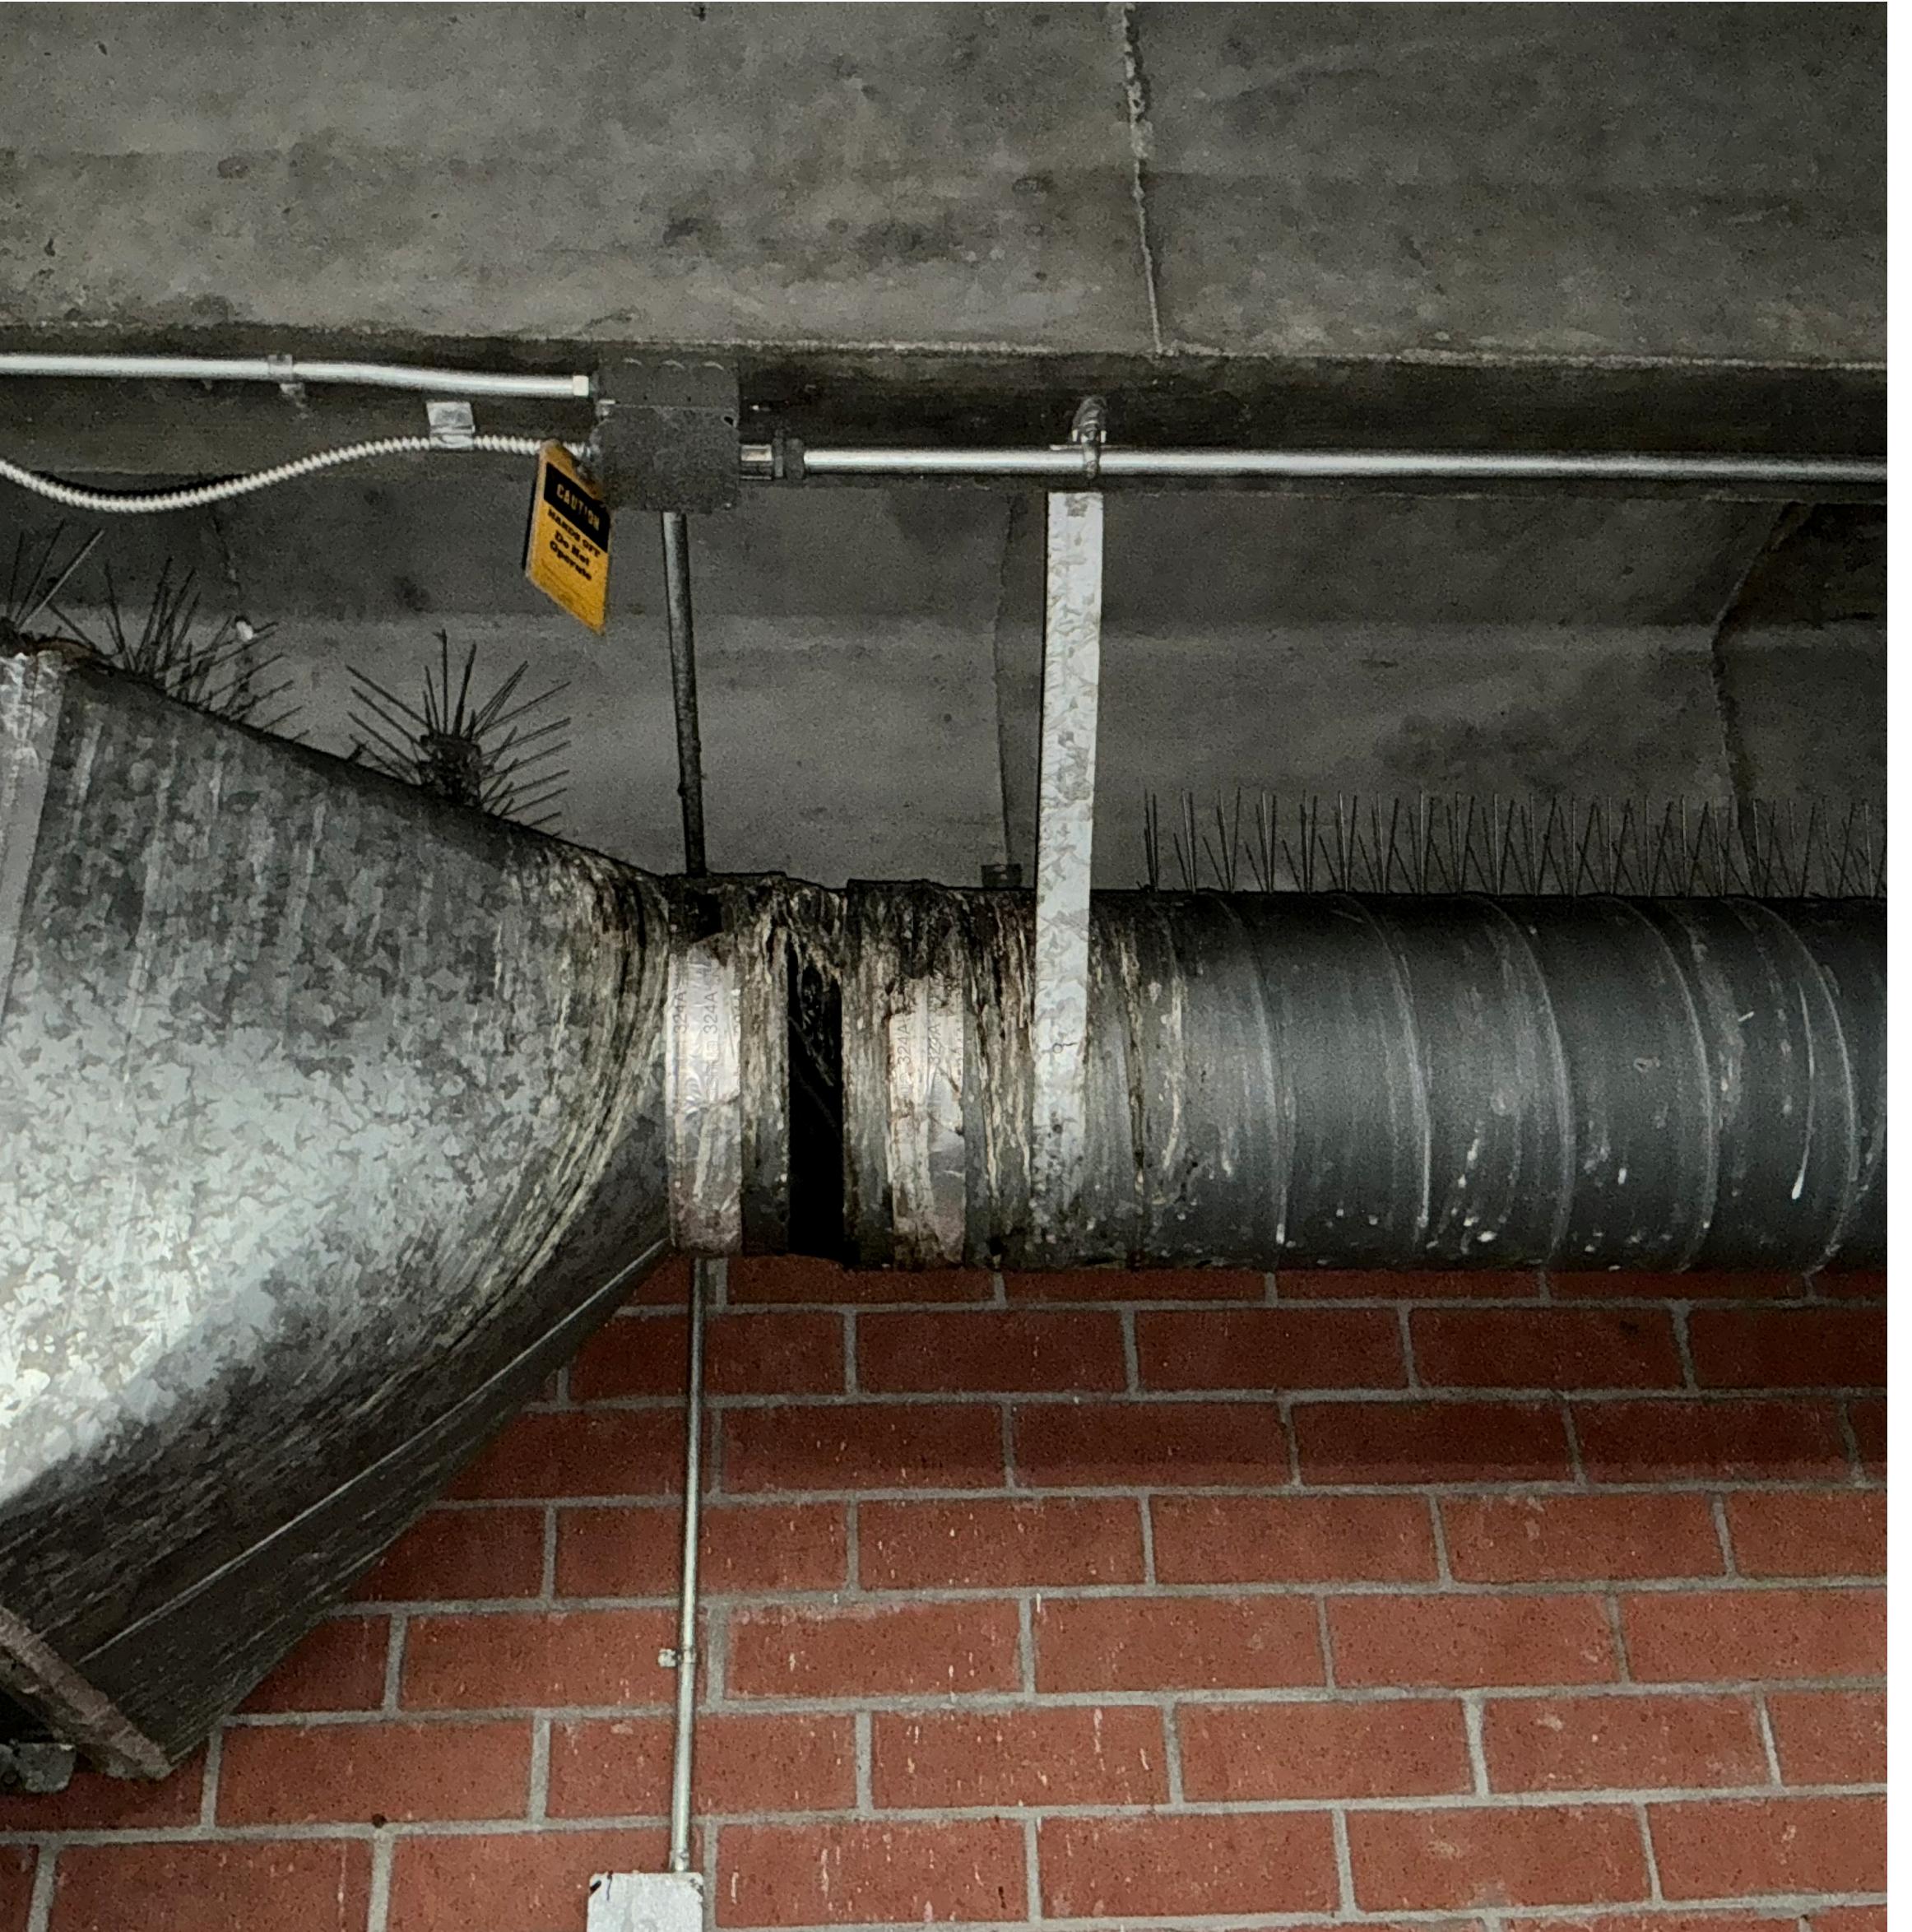
Spikes

- The most successful method so far, as pigeons avoid roosting where they are placed. However, they are only effective if fully intact, meaning any missing or broken spikes lead to pigeons returning.

Install color-matching spikes along the red exoskeleton of the building to maintain aesthetics while preventing roosting

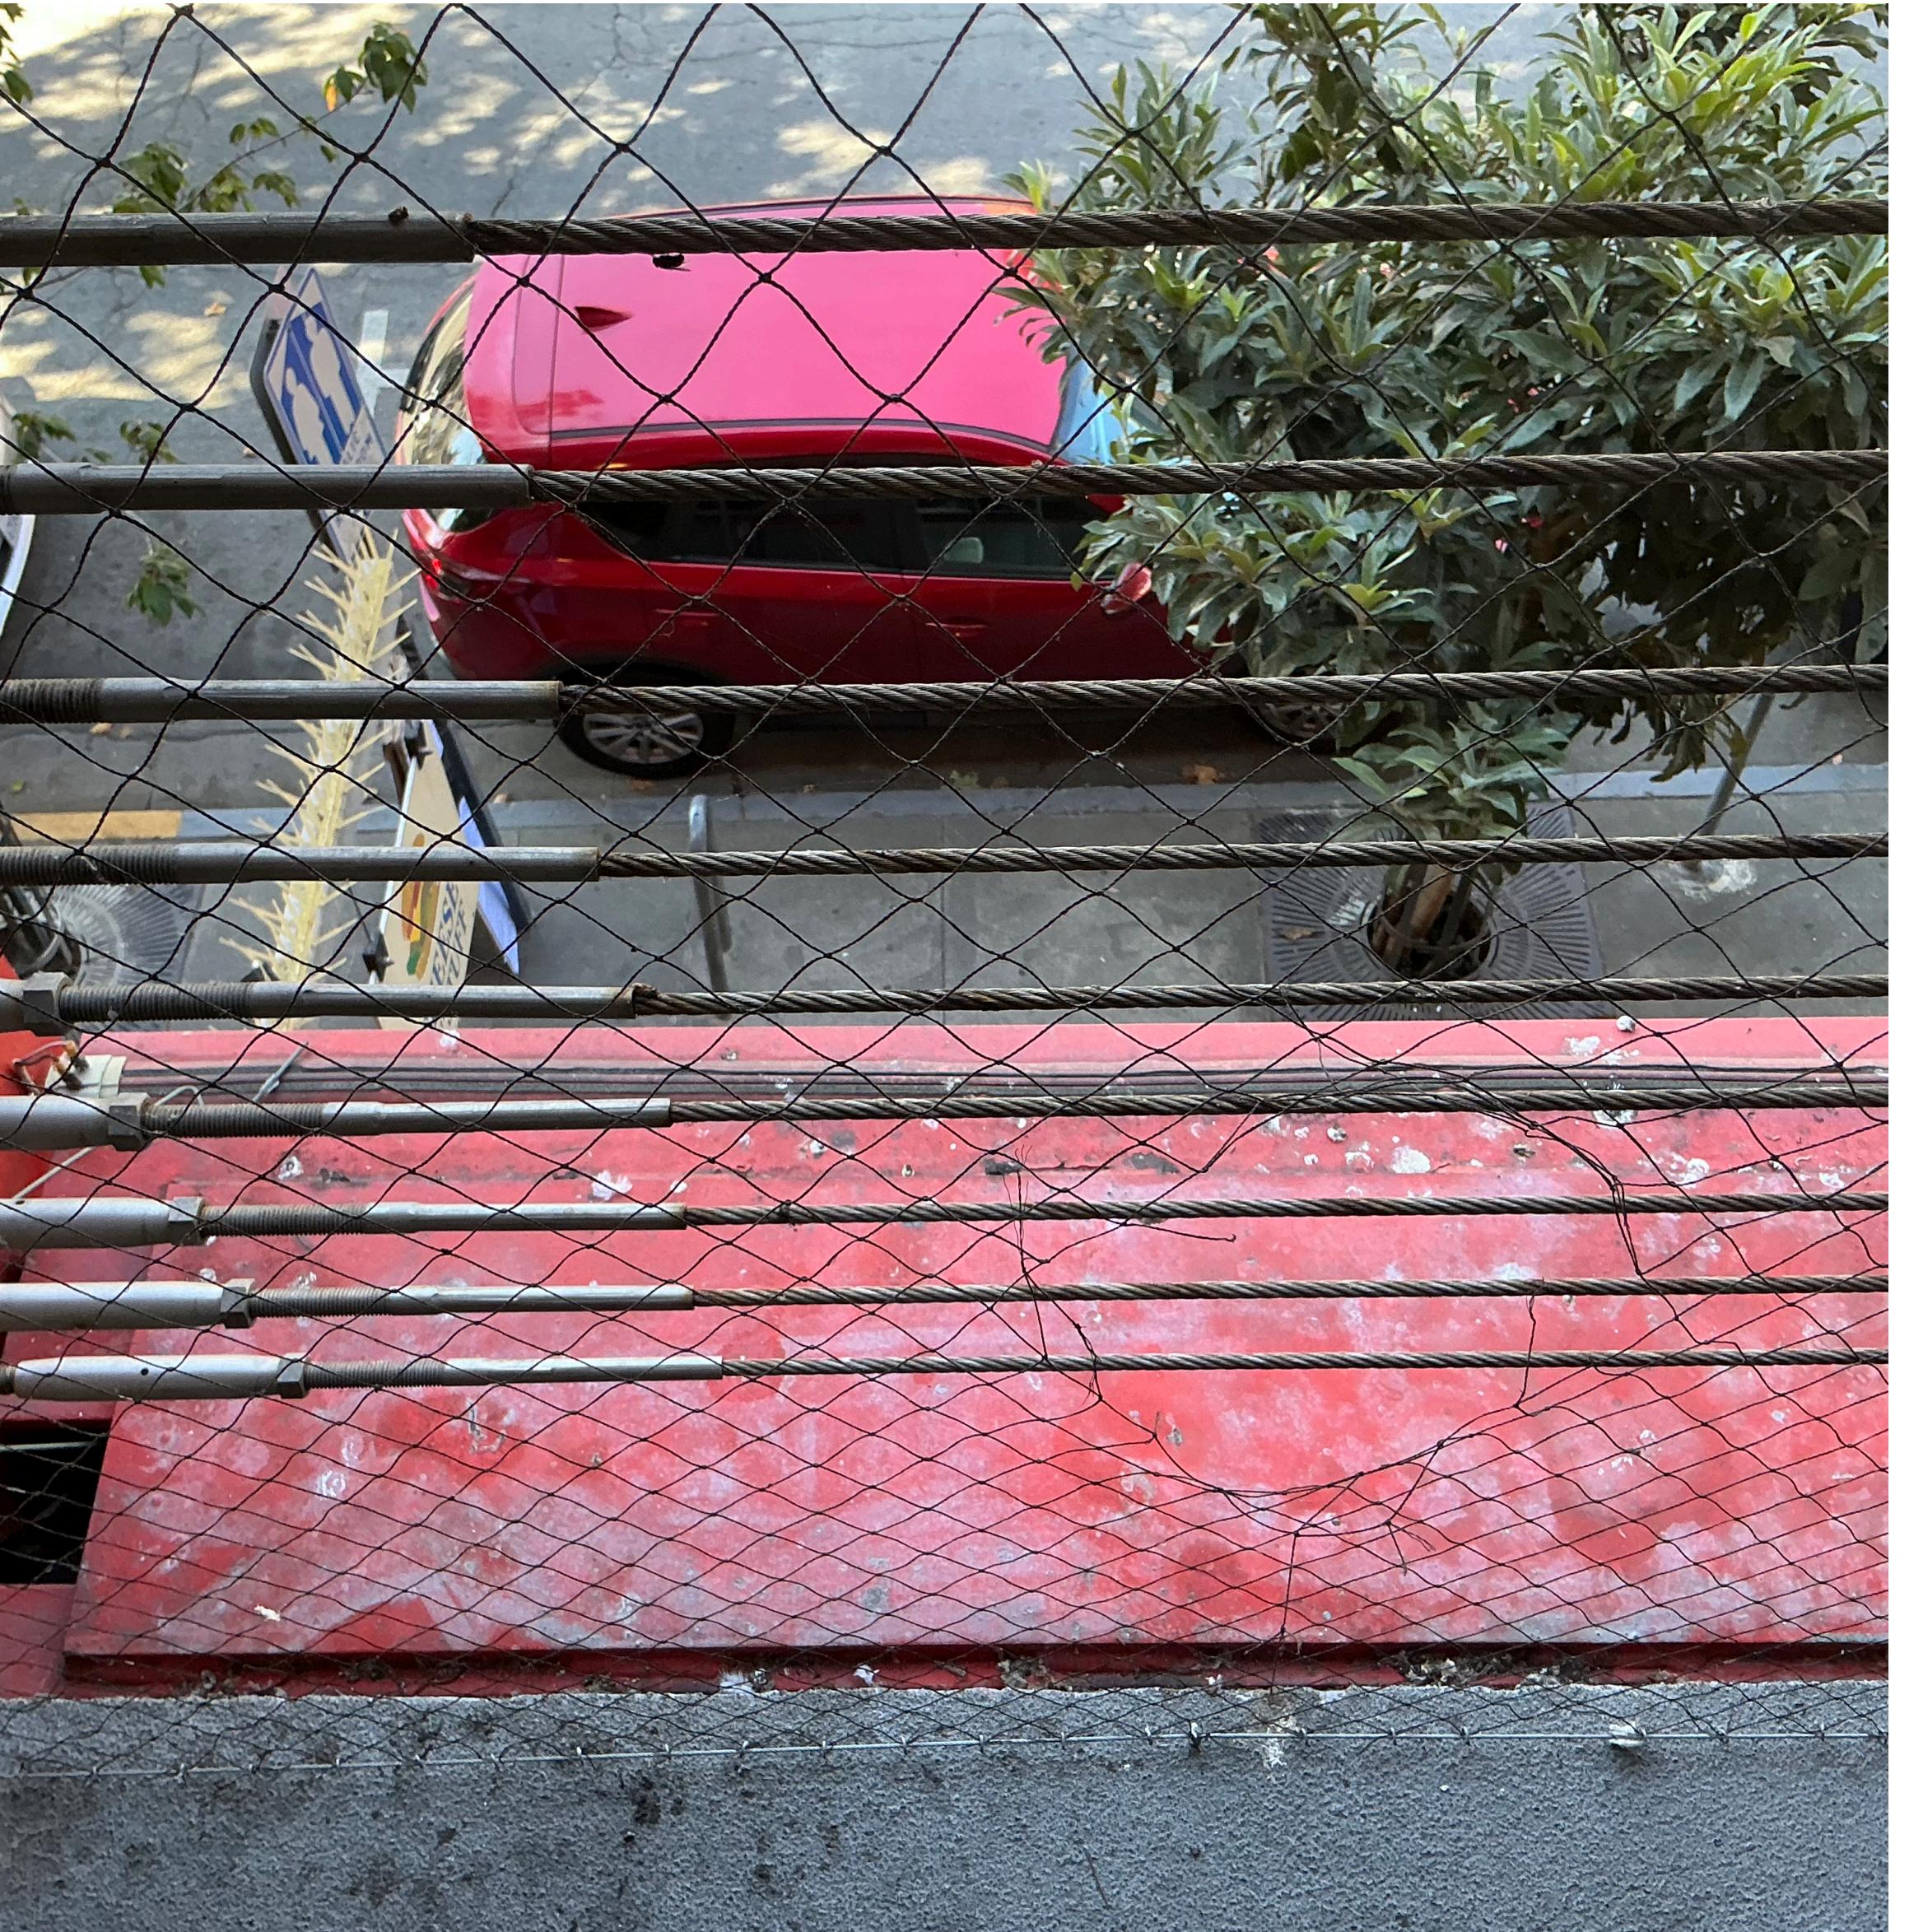
Electric Shock System

- Initially designed to deter pigeons by delivering small shocks when they land.
- However, due to lack of maintenance, the system has stopped working, and pigeons now roost on the wires.
