АВ	С	D	Е	F	G	Н	I	J	K	L
		agi DESIGN-BUILD	+		3 • 3rd Floor	• 104 - 106 Ha		baston • E	irmingh	s limited nam • West Midlands • B16 8LT gilebs.co.uk	
3 1	PROGRESS REPORT DATED 13-05-2013			1	1			RECOR	DED A	AGAINST IES OLDBURY TARGET M&E PROGRAMME 15	5-02-13
5											
	Ref Activity	Original Start Date	Original Finish Date	Original Weeks allowed	Actual Start Date	Actual Finish Date	Programmed Progress %	Actual Progress %	Delay in Week +/-	Description of Event	Effect upon the Works
8	To installing lighting trunking, and light fittings between gridlines E & D	18-Feb-13	01-Mar-13	2			100%	0%		Could not gain access to area, as fairport have stored there materials there. As previous repot	Area is on hold until vacated by fairport. As previous report
9	2 To installing high level containment between gridlines E & D	18-Feb-13	01-Mar-13	2			100%	0%		Could not gain access to area, as fairport have stored there materials there. As previous repot	Area is on hold until vacated by fairport. As previous report

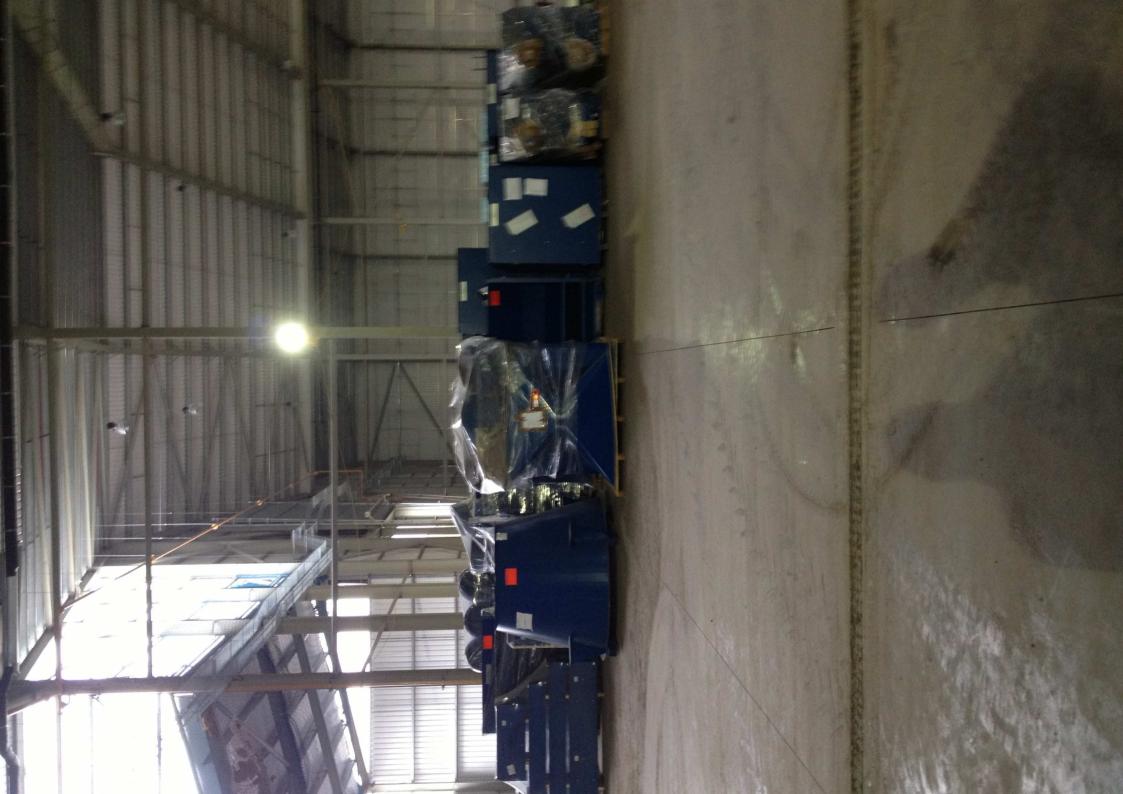
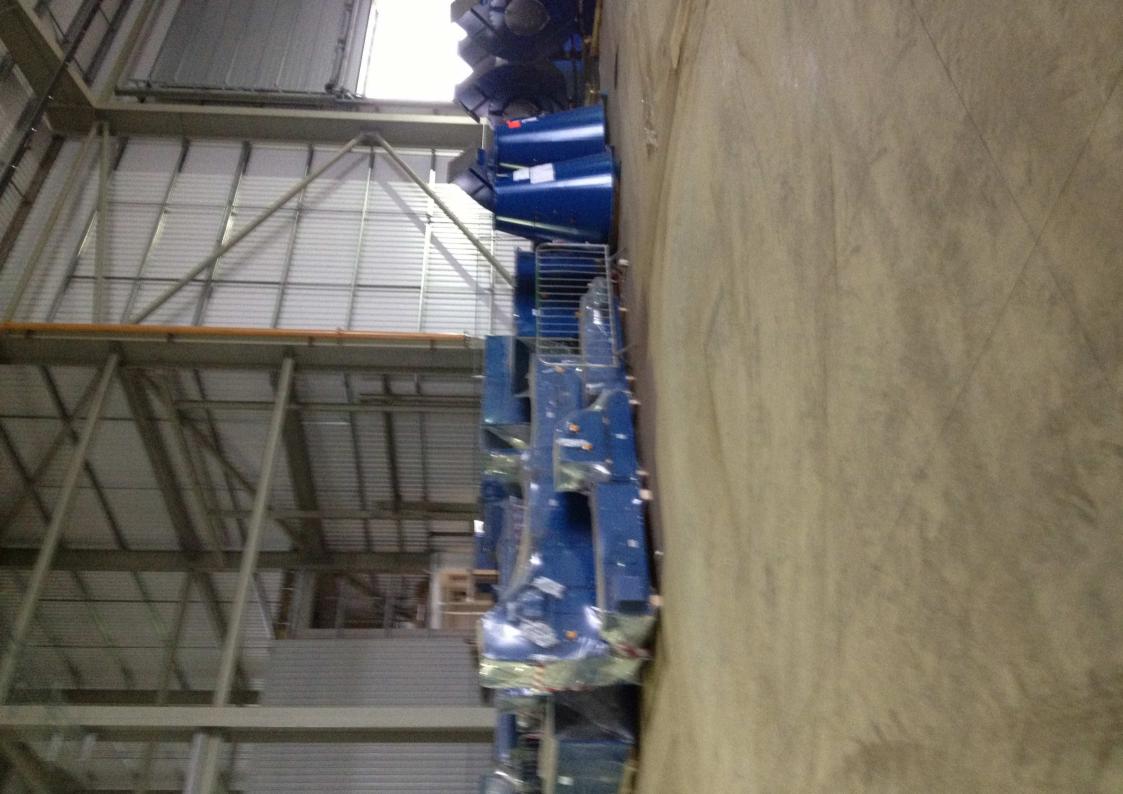
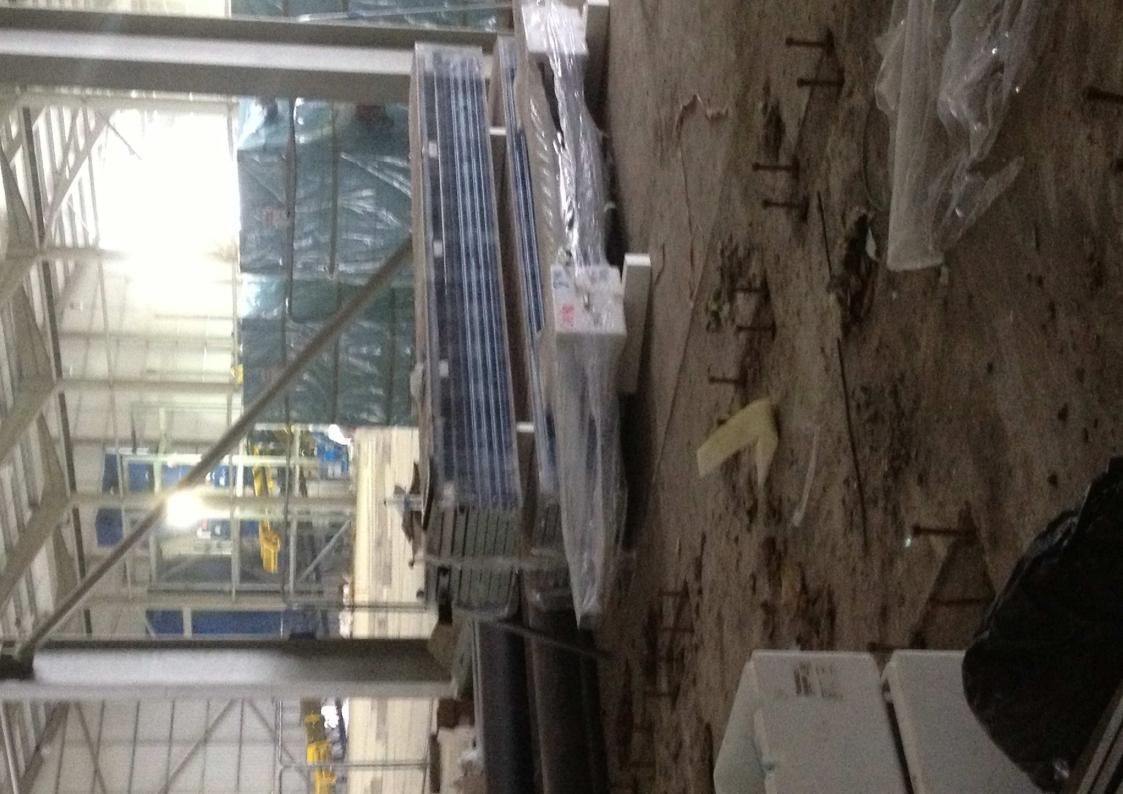
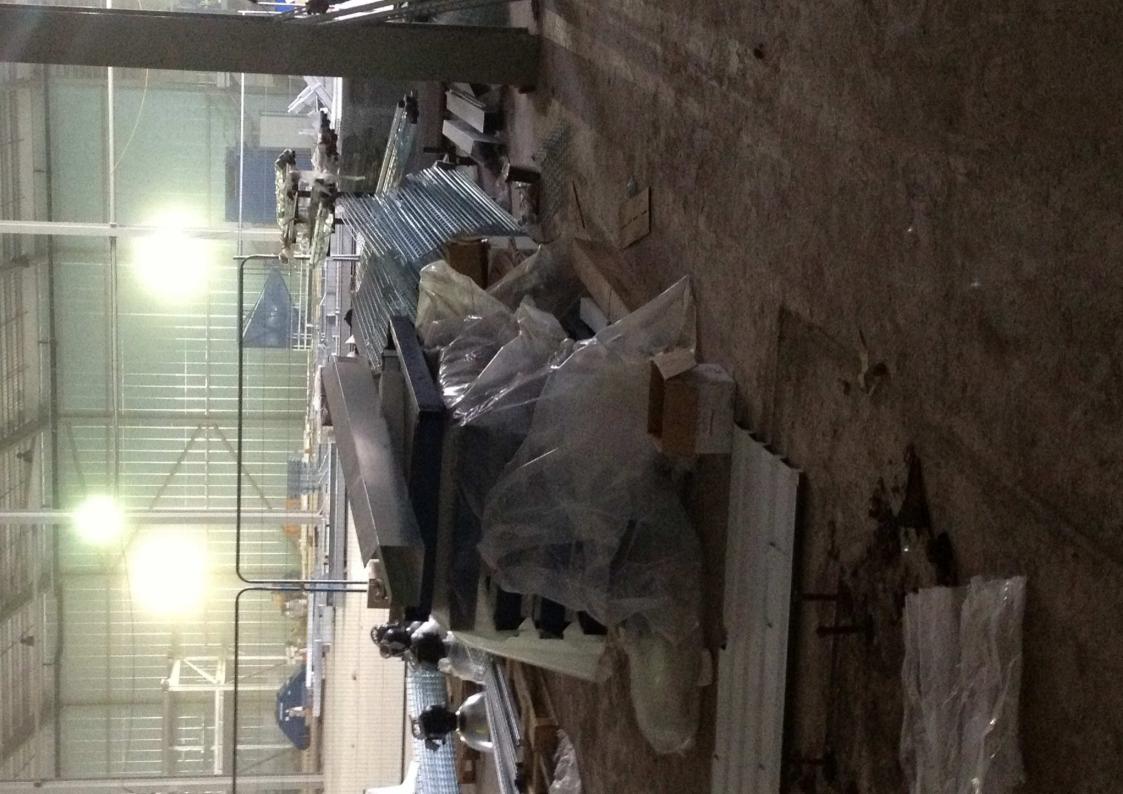
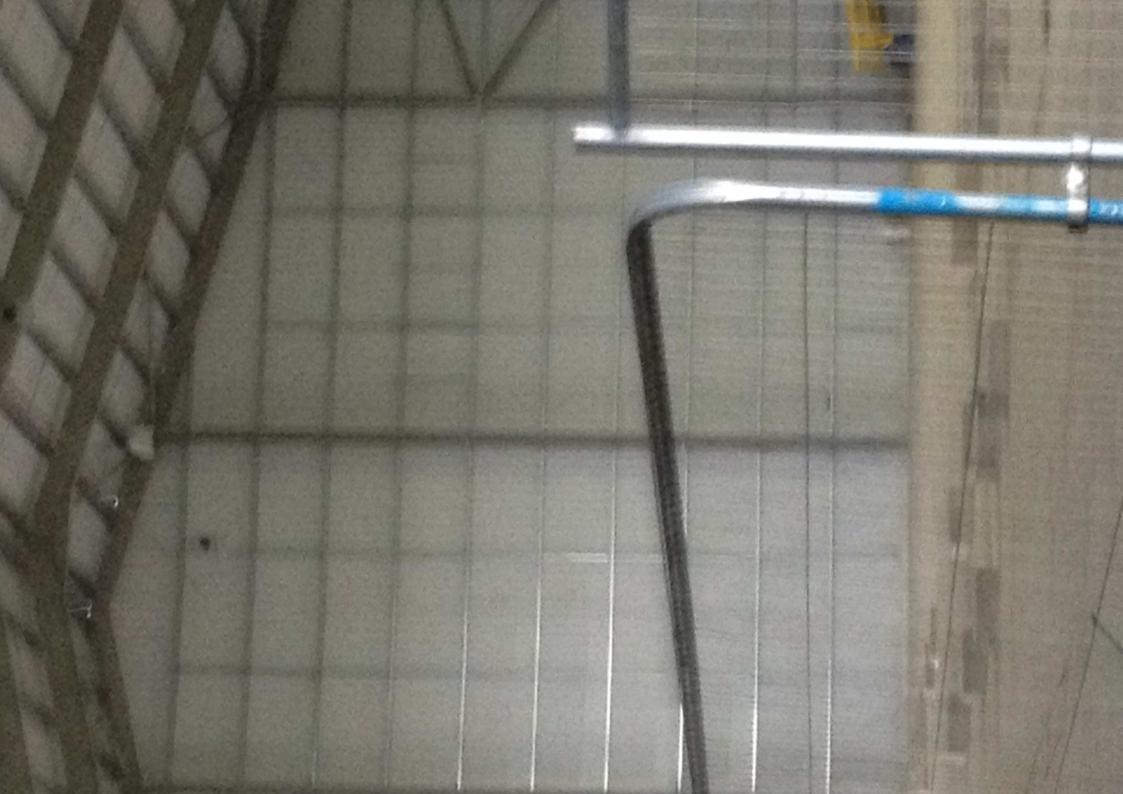
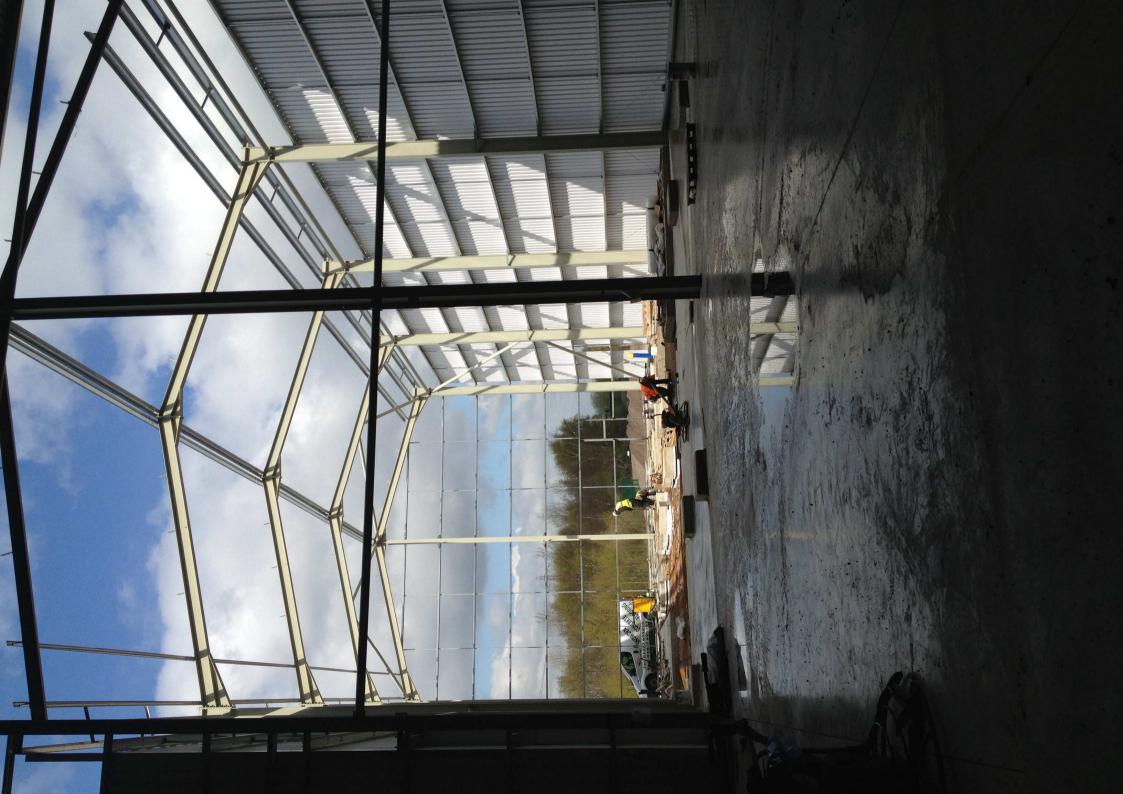
28 Report for 10-05-2013 in red writing													
	Due to Fairport taking ocupation of most of the site now is is getting more and more difficult to progress with the installation, coupled with design changes and clashes with our proposed installation, and the fact that if we are required to work in the fairport area we have to complete daily risk and method statements which all take time. The materials which are in our way are not being moved when we request then to be which inturn is slowing down our installation. Please find attached photos of materials and areas not completed by judging wise.
