INSPECT IT AUSTIN

929 Dubina Ave
Georgetown, TX 78626

PROPERTY INSPECTION REPORT FORM

Joel Ruiz <i>Name of Client</i>	05/27/2022 8:30 am <i>Date of Inspection</i>
929 Dubina Ave, Georgetown, TX 78626 <i>Address of Inspected Property</i>	TREC 20959 NAWT 14504ITC, <i>TREC License #</i>
Joey O'Brien, Chloe Bush <i>Name of Inspector</i>	 <i>TREC License #</i>
<i>Name of Sponsor (if applicable)</i>

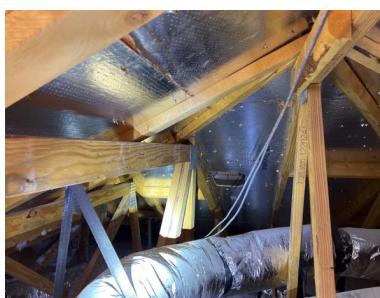
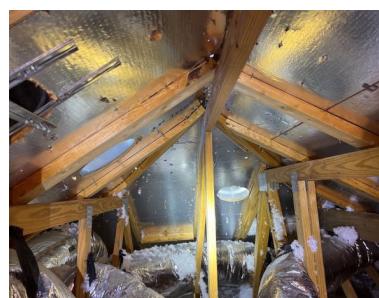
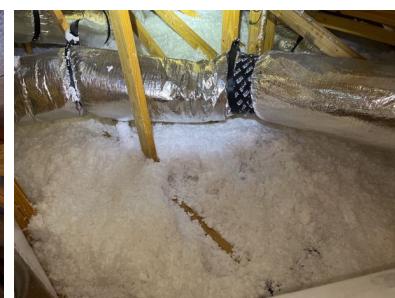
At the time of the inspection, the attic framing structures and their bracing components appear stable and performing as intended. No evidence of active roof leakage was visible from readily accessible parts of the attic during inspection.

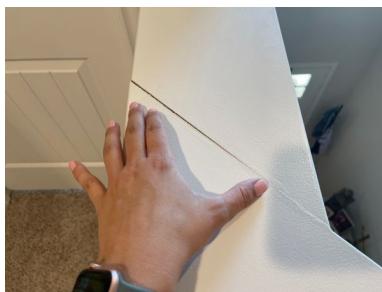
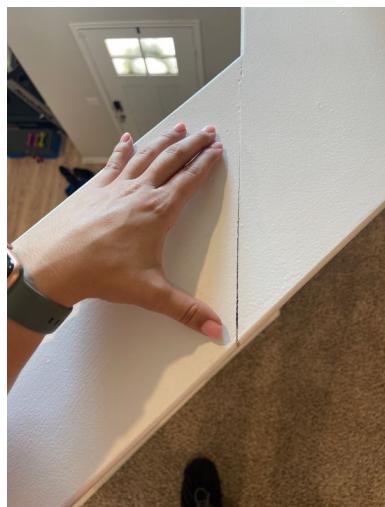
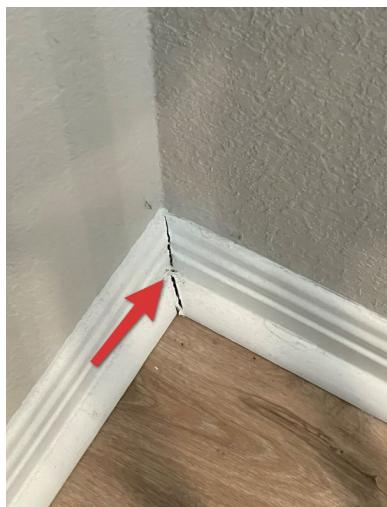
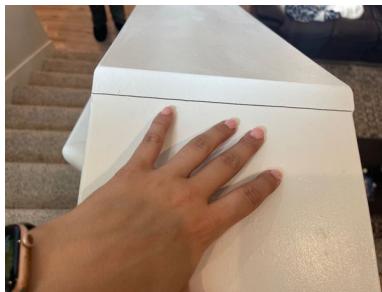
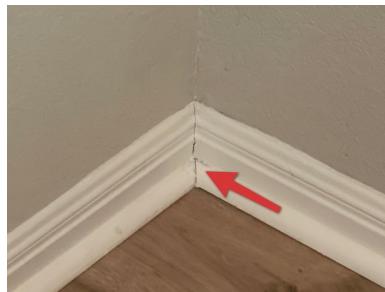
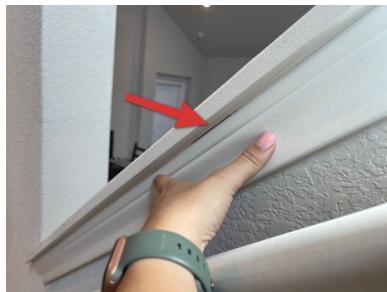
1: Cracks/voids in trim at joints**⚠Priority items or Safety concerns**

Caulk/paint/seal gaps in trim

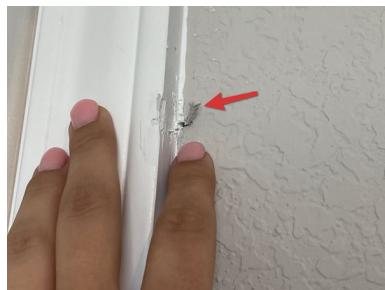
2nd Floor Front Right Bedroom

I=Inspected**NI=Not Inspected****NP=Not Present****D=Deficient****I NI NP D****2: Remove nail from door trim****⚠ Priority items or Safety concerns**

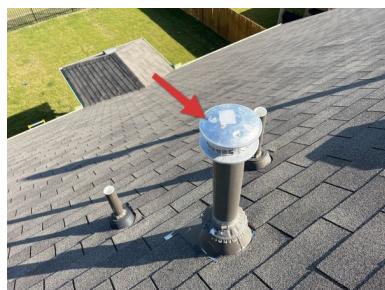
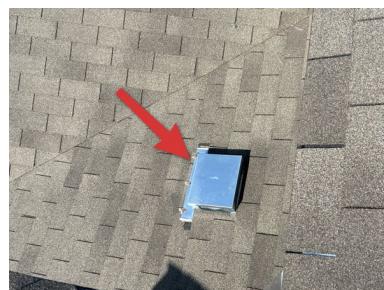
3: Unpainted flashing observed at rooftop**⚠ Priority items or Safety concerns**

Not completed from predelivery inspection

Paint all flashing and plumbing vents at rooftop - Paint punch items

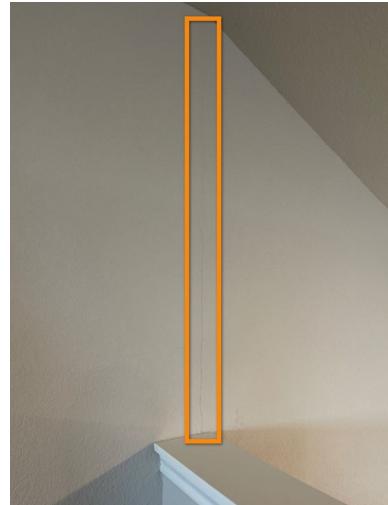
I=Inspected**NI=Not Inspected****NP=Not Present****D=Deficient****I NI NP D****1: Sheetrock Cracks****General Repairs/Maintenance**

Cracks observed at sheet rock seam and ceiling/wall at various locations. In most cases this occurs from settling and shifting of the house.

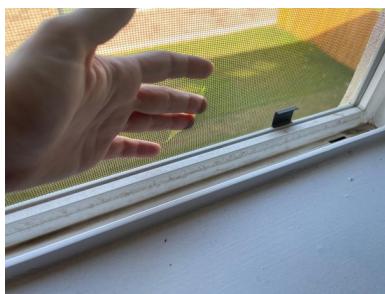
2nd Floor Front Left Bedroom

1: Missing/damaged Screens**General Repairs/Maintenance**

Missing screens or damaged screen/bent frame(s) were observed at one or more locations. Screens are mentioned in this part of the report as they are a specific item in the T.R.E.C. Guidelines. Screens that are torn enough to allow insect infestation should be repaired or replaced. All windows that have channels for screens should have them installed.

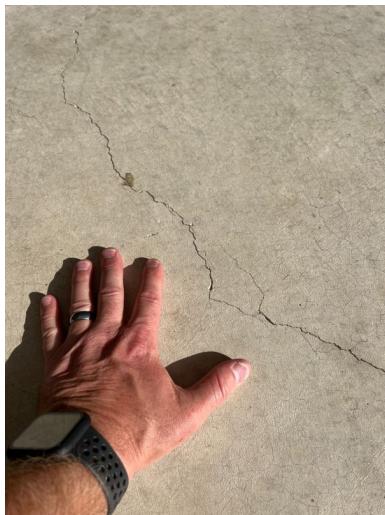
Driveways and walks appear to be performing the function intended, with minor cracks noted less than 2mm.

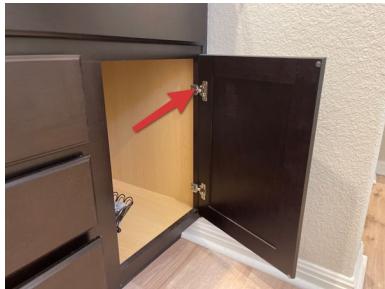
Master Bathroom

1: Cabinet Punch

Cabinet punch needed: adjust doors/drawers and remove scratches/dents at various locations. (See below photos) Notated on free delivery inspection never completed

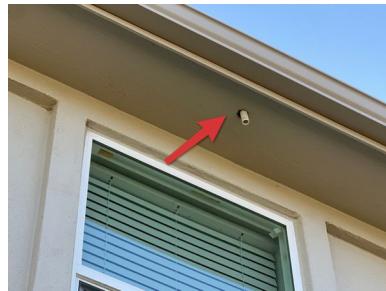
Left Exterior

1: Escutcheon cover is damaged/missing at ECD (Emergency condensation Drain)**▲Priority items or Safety concerns**

Escutcheon cover is damaged/missing at HVAC drain line penetration. Entry point for insects and/or rodents.
Notated on free delivery inspection never completed

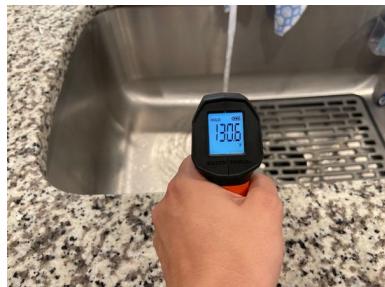
130°F

The water heater(s) and its components were found to be performing and in satisfactory condition at the time of the inspection.:

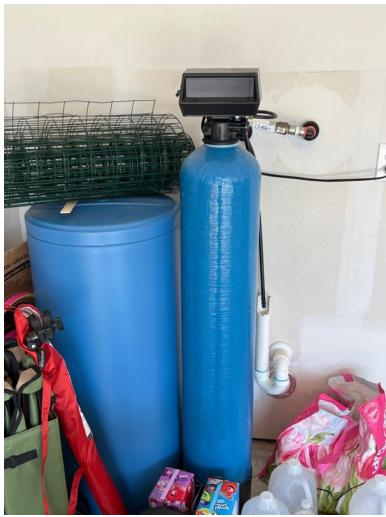
Not inspected

Water softeners are not tested if present. If you would like the water softener tested/inspected, a water softener company can do a full inspection of the system. No visual evidence of leaks were observed around the water softener during inspection.

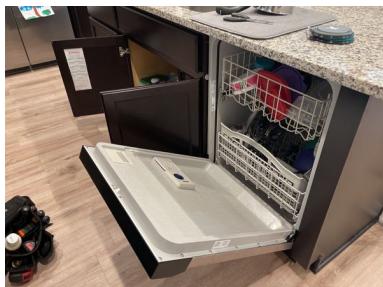
Dishwasher operated normally and the soap dish cover opened correctly. Dishwasher was run on normal wash with heated drying and no operational problems were noted on day of inspection. Dishwashers most commonly fail internally at the pump, motor or seals. We do not disassemble these units to inspect these components.

Working as Intended

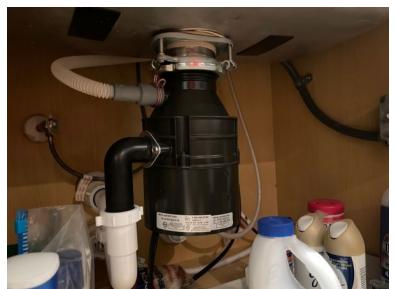
Working as Intended

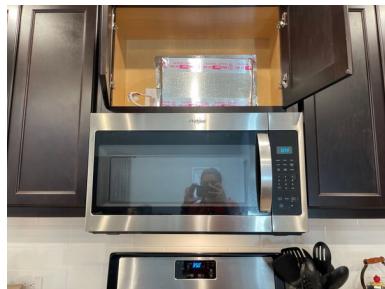
Working as Intended

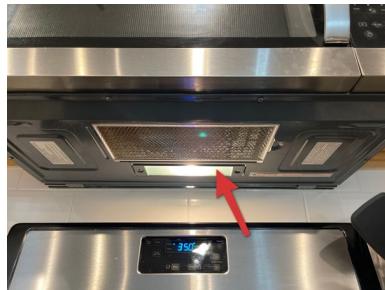
1: Light does not turn off**⚠ Priority items or Safety concerns**

Vent hood light does not turn off

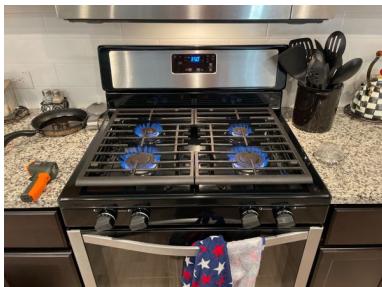
Working as Intended

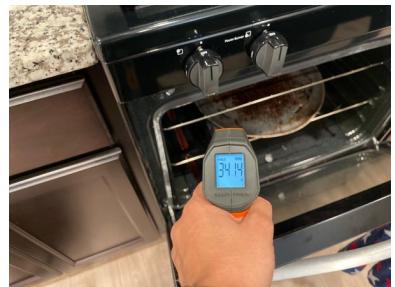
Working as Intended

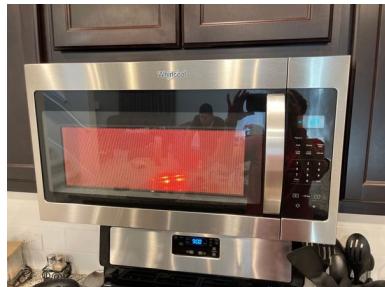
The microwave was working as intended at time of inspection.:

Working as Intended

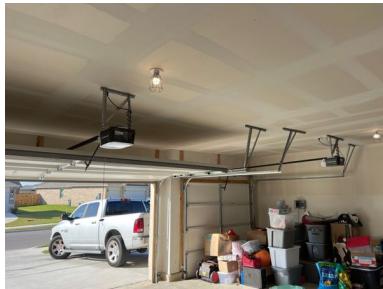
Garage door opener/s present at time of inspection - Observed no problems. The reversing function was tested blocking the electric eye sensors and by blocking the door on the down cycle with both arms outstretched "approximately 10 - 12 Lbs resistance pressure" This is called the "Forced reversing test" And the Manual Reversing Test/Anti entrapment. Where you place a 1-1/2" high (3.8 cm) high object (or a 2x4 12" long laid flat) on the floor at the bottom of where the garage door closes. The Manual Reversing test is a Safety issue to help prevent entrapment of small children, animals, Etc.

Working as Intended

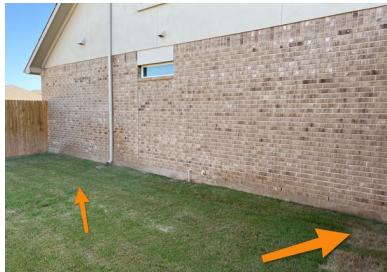
Zone 4

The irrigation spray heads were observed spraying on house, street, driveway, fencing, and/or condenser. These heads should be adjusted to prevent wasted water and premature damage of siding, fencing, etc.

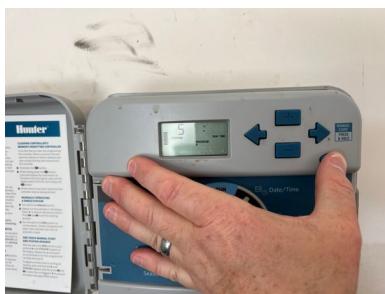
2: Control panel will not allow different program schedules

Possible bad control board. Have irrigation company further evaluate

Program A is only program available
