FEE alignments to reduce data loss through ECC

Version 1.0 2014-08-06

Application Note AN-ISC-8-1161

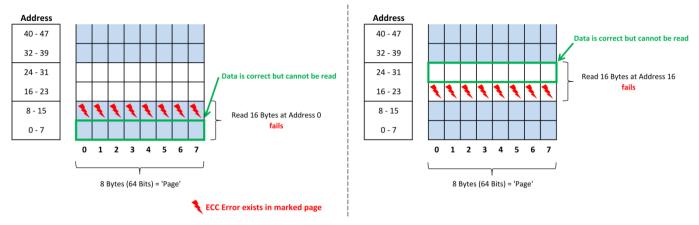
Figure 2 – ECC error affects read operation

The reason for an uncorrectable ECC error in a flash page is for example an aborted programming access due to a reset. Figure 2 illustrates how one ECC error affects read operations.

Figure 2 depicts that one ECC error within a 16 byte address boundary leads to an unsuccessful reading. If one ECC error is received during read access, the flash memory controller does not update the read buffer. Thus reading from this address fails even if one of the two pages is consistent.

This means the occurrence of one uncorrectable ECC error in a page treats the neighboring page within the 16 byte address boundary also as corrupted. This situation is particularly problematic if the start addresses of two neighboring data blocks are not aligned to 16 byte address boundaries, as shown in figure 3.

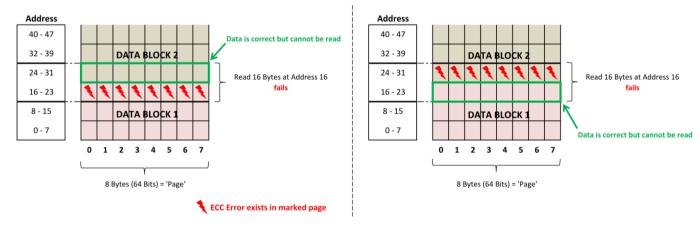
Figure 3 – Two data blocks not aligned to 16 Byte (128-bit) address boundaries

As depicted in figure 3, an ECC error in one data block may result in the corruption of another data block. Either the first page of data block 2 (left diagram) or the last page of data block 1 (right diagram) cannot be read in case of an ECC error in the other block. Usually the first and the last pages of a data block contain information (e.g. block id, block length) which is used for management purposes. If these pages cannot be read the entire data block may be corrupted.

An application using the MICROSAR FEE with such insufficient alignment settings may run in data consistency issues as described in the following example:

A (simplified) configuration contains one block with multiple instances. After writing this block several times, the programming access is aborted due to a reset while writing the first page of the block. In consequence the block with latest data was not written successfully and an uncorrectable ECC error occurs. Generally, when reading data of a specific block from flash memory, the MICROSAR FEE returns the content of the last written data. In case the

last written instance is corrupt, e.g. due to a write abort (reset), the MICROSAR FEE returns the second latest data. In this scenario the uncorrectable ECC error in the latest instance corrupts the second latest instance and thus the MICROSAR FEE returns the data of the third latest instance to the application. Thus it cannot be assured that the returned data is up-to-date.

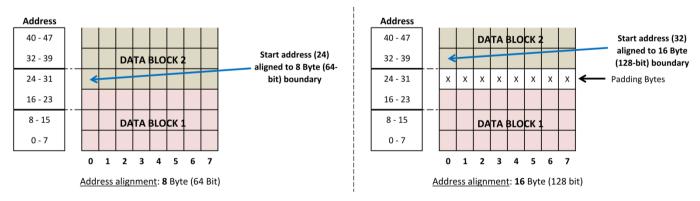
Figure 4 – Effect of different FEE Address Alignment configurations

Left diagram of figure 4 shows that the start address of each data block is aligned to an 8 byte (64 bit) boundary. Whereas the right diagram pictures a configuration in which the start address of each data block is aligned to a 16 byte (128 bit) boundary.

If performing read accesses to the flash memory, these configurations make a difference as soon as ECC errors are considered. As illustrated in figure 3 an ECC error in one page corrupts the neighboring page due to the hardware dependent size of read alignment.
