## Structural Assessment and Rehabilitation of High-Rise Buildings: A Case Study of RNA Mirage Tower Mumbai

Rohan Kumar Choudhary\*<sup>1</sup> Amit Kumar Jha<sup>1</sup>

<sup>1</sup>Department of Civil Engineering,  
School of Engineering & Technology Sandip University Nashik,  
Maharashtra- 422213, India

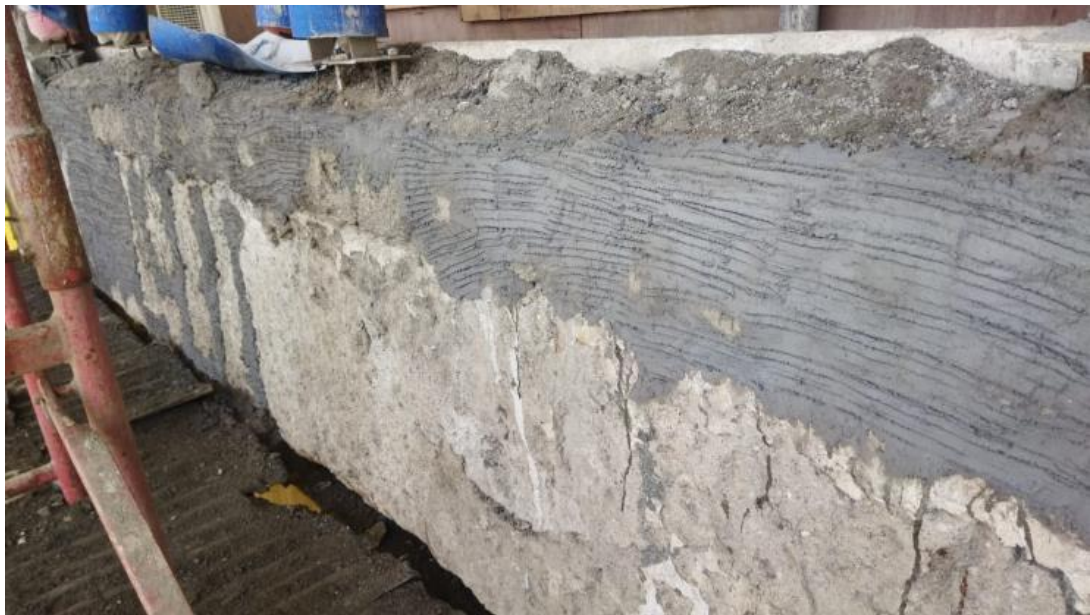
The RNA Mirage building exhibited extensive structural distress, primarily attributed to reinforcement corrosion. Notable signs of deterioration included widespread spalling and delamination at column corners across various floors, as well as damage to the

soffits of beams, slabs, and architectural fins. Additional issues observed included leached plaster on parapets, corroded and leaking water and drainage pipes, and water stagnation on the terrace due to an improperly designed slope.

Structural cracks were also found in masonry infill walls, with certain areas showing complete disintegration, as illustrated in **Figure 2**. Severe debonding and degradation of plaster on both interior and exterior surfaces further emphasized the building's deteriorated condition.

Figure-2- Structural defects and visible discrepancies and signs of distress

Given the advanced state of deterioration and associated safety hazards, immediate rehabilitation was deemed necessary. This case study highlights the vital role of early intervention and regular maintenance in preserving the safety, usability, and lifespan of high-rise structures.

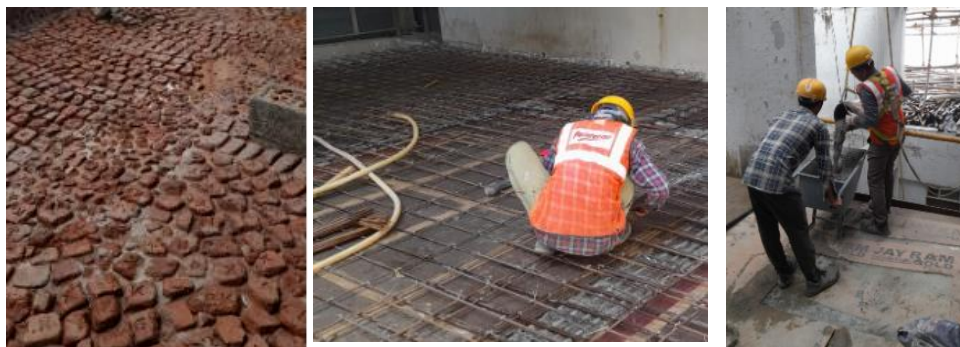
**Figure 4** (a) - Deteriorated blockwork

A polymer-modified mortar mix (1:5:15 ratio of AR Std polymer, cement, and quartz sand) was applied to the treated surfaces. This was followed by two layers of cement plaster. Severely deteriorated blockwork areas underwent guniting to restore structural strength. Post-guniting, two coats of waterproof plaster were applied for enhanced durability and moisture resistance, as shown in **Figure 4** (a) and (b) and the surface was finished with a water-based acrylic paint

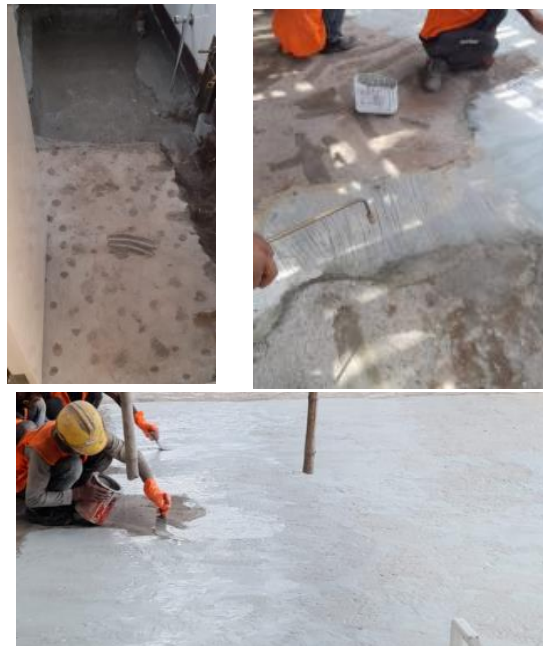
**Figure 4 (b)** The surface was finished with a water-based acrylic paint
