# Seismic behavior of a full-scale RC frame repaired using CFRP laminates

A. Balsamo<sup>a</sup>, A. Colombo<sup>b</sup>, G. Manfredi<sup>c</sup>, P. Negro<sup>d</sup>, A. Prota<sup>c,\*</sup>

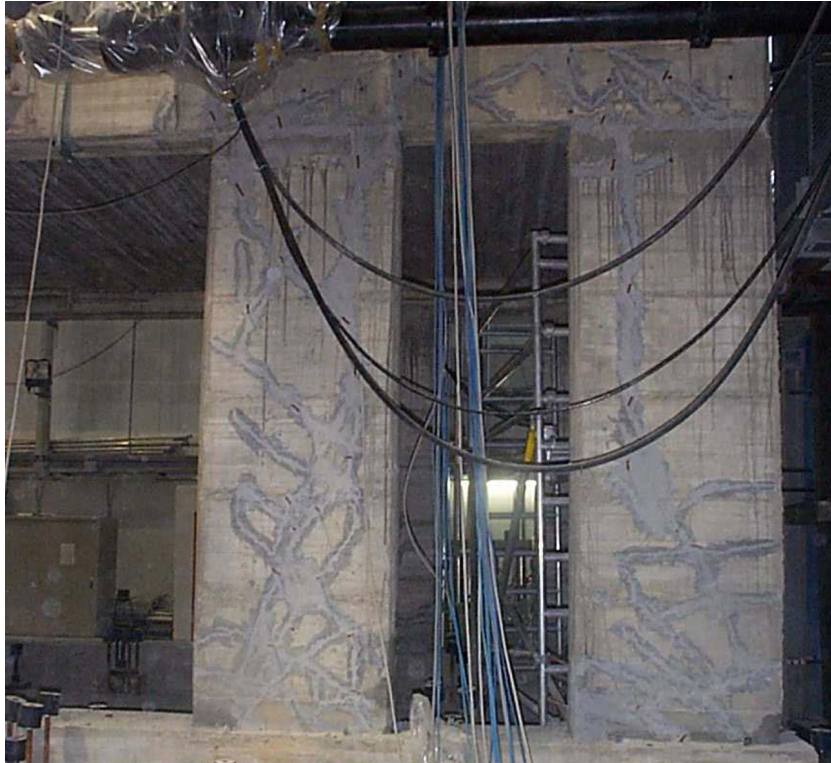
Fig. 7. Repaired cracks on the walls.

Once testing of the original structure was completed, the cracks caused by the 1.5 design earthquake were epoxy injected. Then, the structure was strengthened by using CFRP laminates with uniaxial, biaxial ( $0^\circ$ – $90^\circ$ ) and quadriaxial ( $0^\circ$ – $90^\circ$ – $\pm 45^\circ$ ) fiber texture. The design of the repair and the selection of fiber textures on different structural elements were performed taking into account damages and deficiencies underlined by tests on the original configuration, and aiming at optimizing the benefits of the externally bonded FRP reinforcement along the directions of dominant stresses. The bases of the design of the CFRP repair are outlined in the following sections with reference to joints, columns, walls and beams.

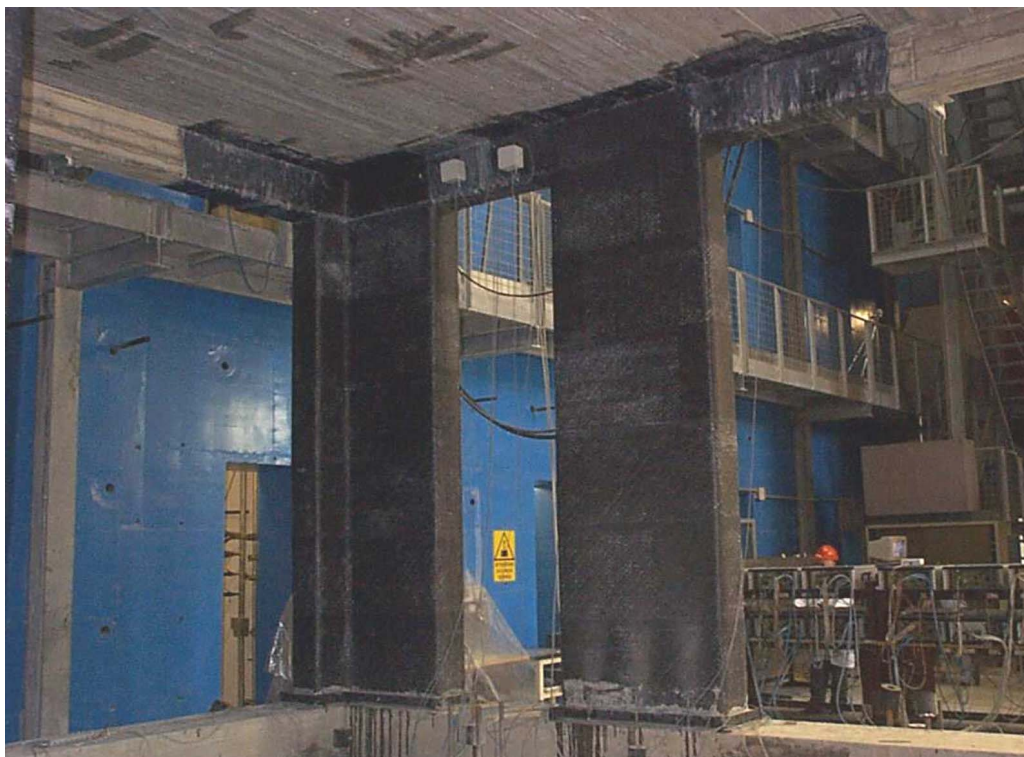
Fig. 8. Walls at the first floor.

hysteretic behavior with high ductility levels. Considering the specific state of stress, the shear upgrade of both walls was achieved by wrapping along its entire height quadriaxial laminates (Fig. 8).

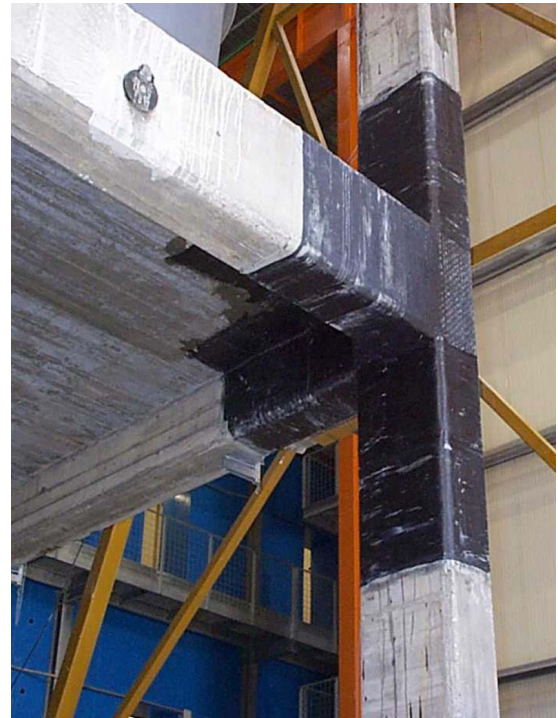
Fig. 10. U-wrapping of beams.

No FRP repair was designed for long beams (between W1 and C1, C1 and C2 in Fig. 9); however, a U-wrapping with uniaxial fibers parallel to the column axis was installed at their ends (Fig. 10); this was done to ensure a good anchorage for the joint laminates without increasing the strength of the end zone of the beams under bending, and without modifying the strength hierarchy of the nodal zone.
