# Road Condition Analysis Report

Road: Marine Drive in Mumbai

Date: 2025-04-22 21:02:44

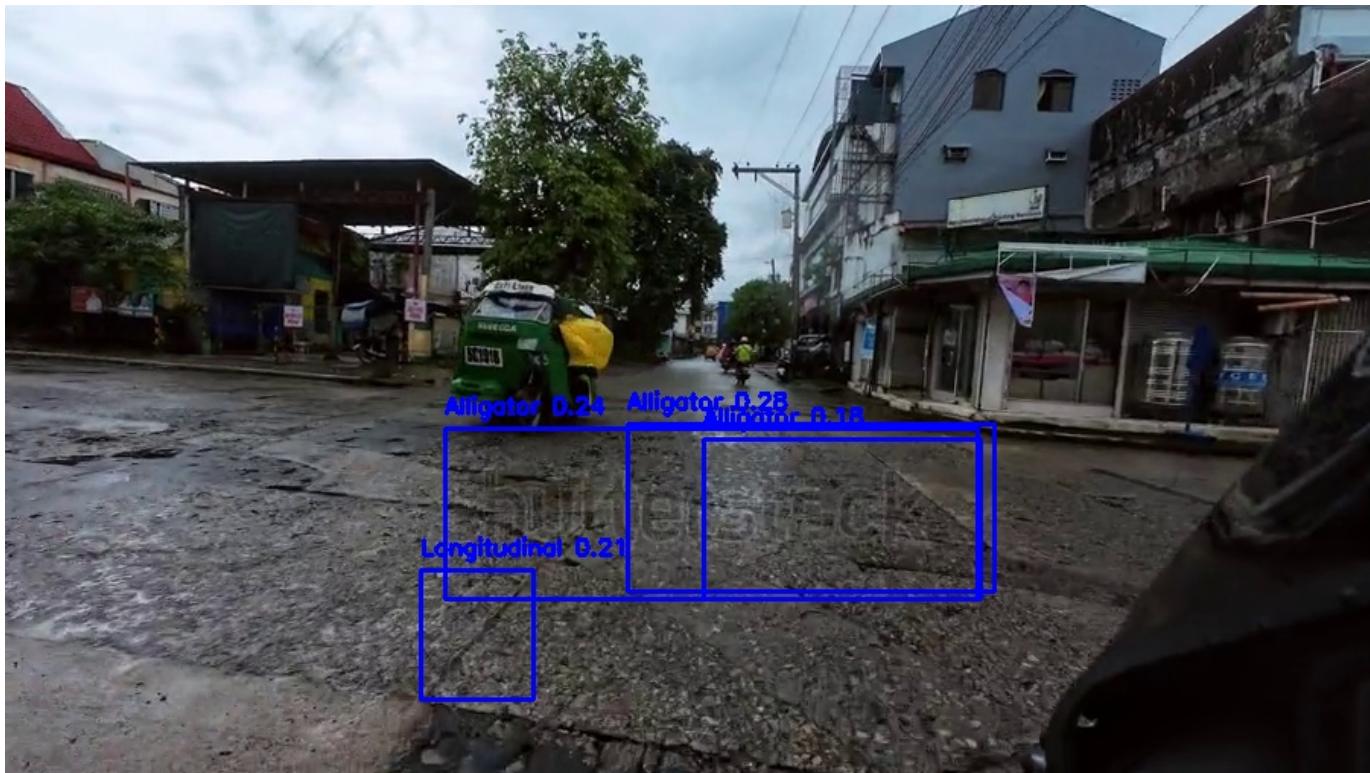
Frame 7: Detected defects - Alligator (0.28), Alligator (0.24), Longitudinal (0.21), Alligator (0.18)

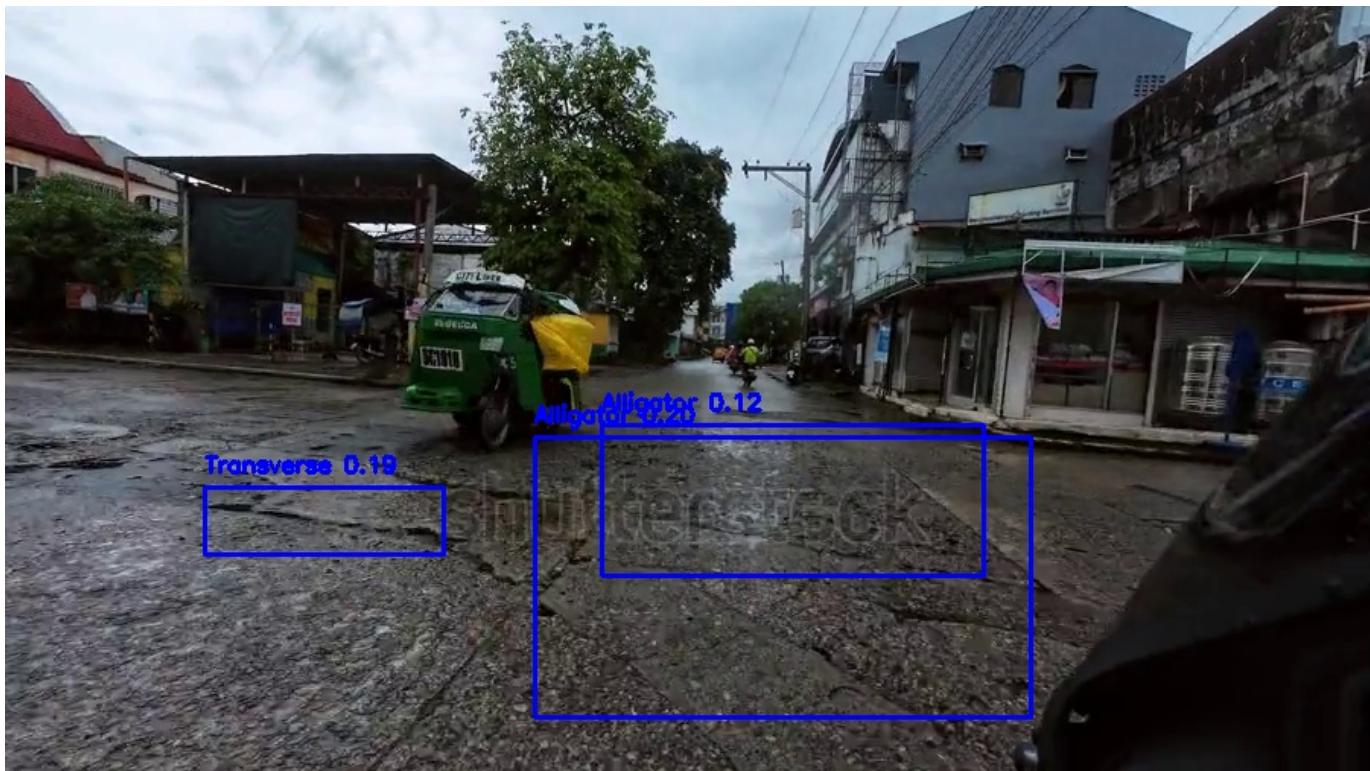
Frame 8: Detected defects - Alligator (0.20), Transverse (0.19), Alligator (0.12)

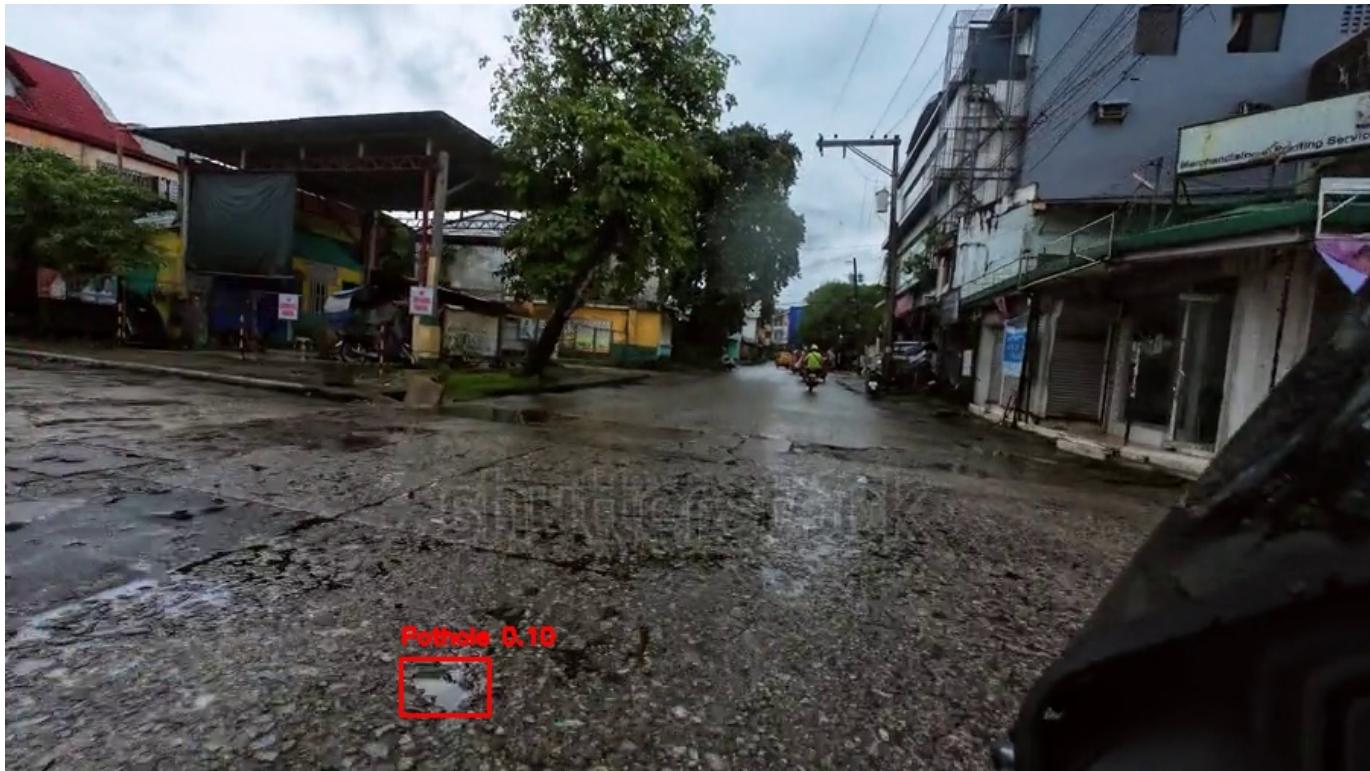
Frame 14: Detected defects - Pothole (0.10)

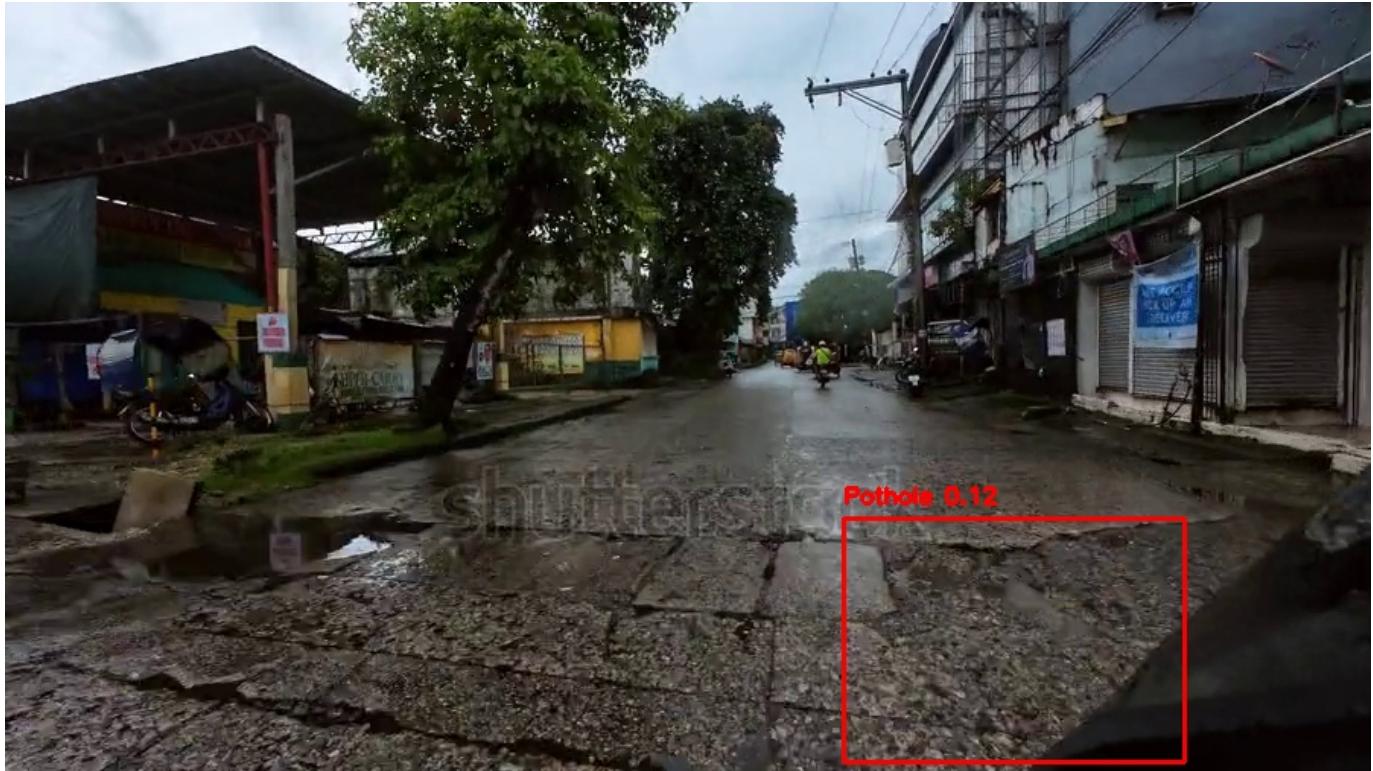
Frame 20: Detected defects - Pothole (0.12)

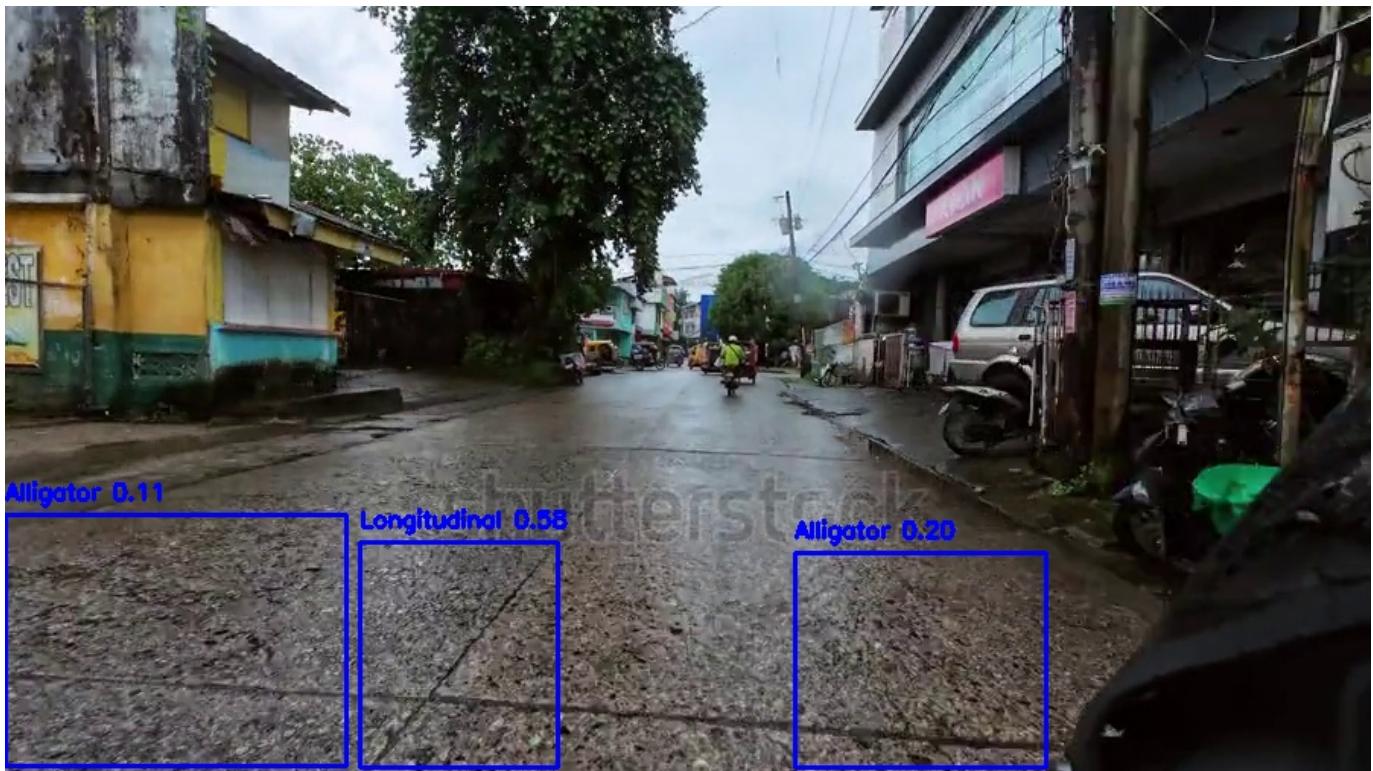
Frame 36: Detected defects - Longitudinal (0.58), Alligator (0.20), Alligator (0.11)

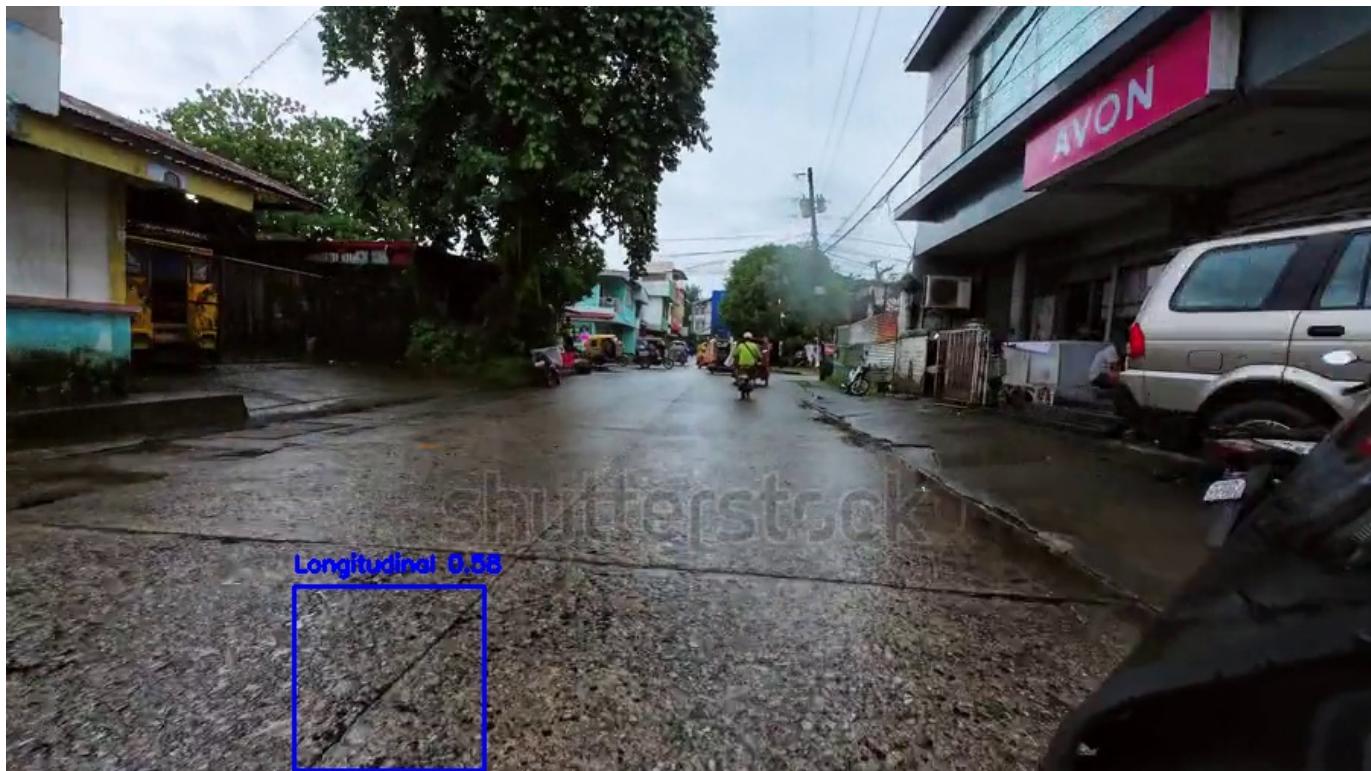
Frame 40: Detected defects - Longitudinal (0.58)
